Hume Highway Upgrade

# Woomargama bypass

Technical Paper 2 – Aboriginal Heritage

**HUME HIGHWAY TOWN BYPASS: WOOMARGAMA  
ABORIGINAL CULTURAL HERITAGE  
Cultural Heritage Assessment Report**

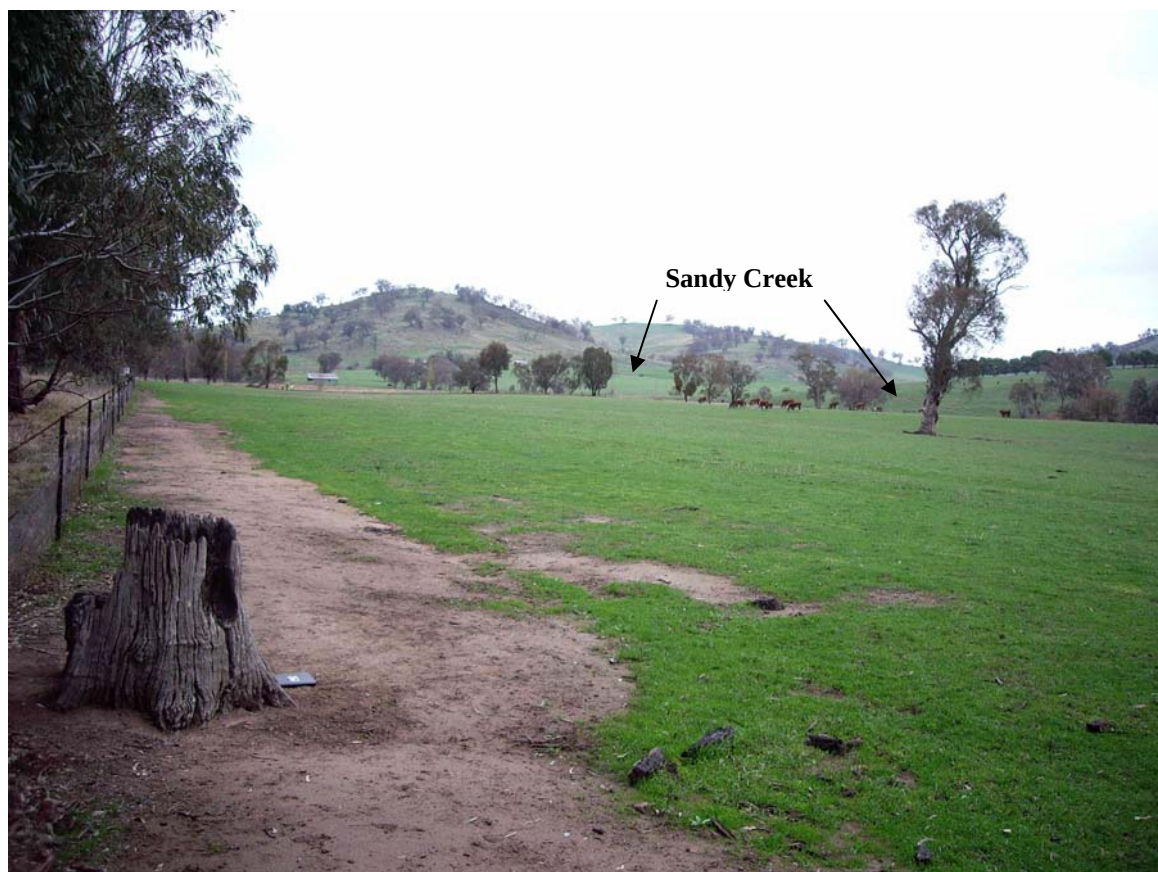
Site W1 consisted of a scatter of seven artefacts across a broad, gently sloping lower slope context bordering the eastern margin of an ephemeral 1<sup>st</sup> order tributary of Sandy Creek. Sandy Creek was located approximately 170 m west of site W1. The site was located on the western side of the Hume Highway and approximately 5.7 km north of Woomargama. The artefacts were identified on an exposure along the western side of a fence line. The Hume Highway easement and a large RTA stockpile were located on the eastern side of the fence. The exposure measured up to 3.5 m wide and was present along the majority of the fence line within site W1 – approximately 400 m. To the west of the exposure was a cleared, grassed pastoral paddock with 0% surface visibility. Artefacts include seven quartz flakes and flake fragments. The soils of the site are a mixture of degrading granites and young alluvial deposit all exhibiting good artefact retention.

Plate 1. W1 scatter along fence line.

| Site | Type | Description | Significance | Impact Assessment | Mitigation Strategy |
|---|---|---|---|---|---|
| W1 | Artefact Scatter | This site is an artefact scatter located on a terrace-like feature associated with a drainage channel of Sandy Creek (an interface of degrading granite and alluvium). The eastern portion of the site has been impacted by the existing road corridor. The archaeological deposit contains quality archaeological material. [REDACTED] | Moderate to High | Would be impacted (partial) | Salvage excavation recommended. |

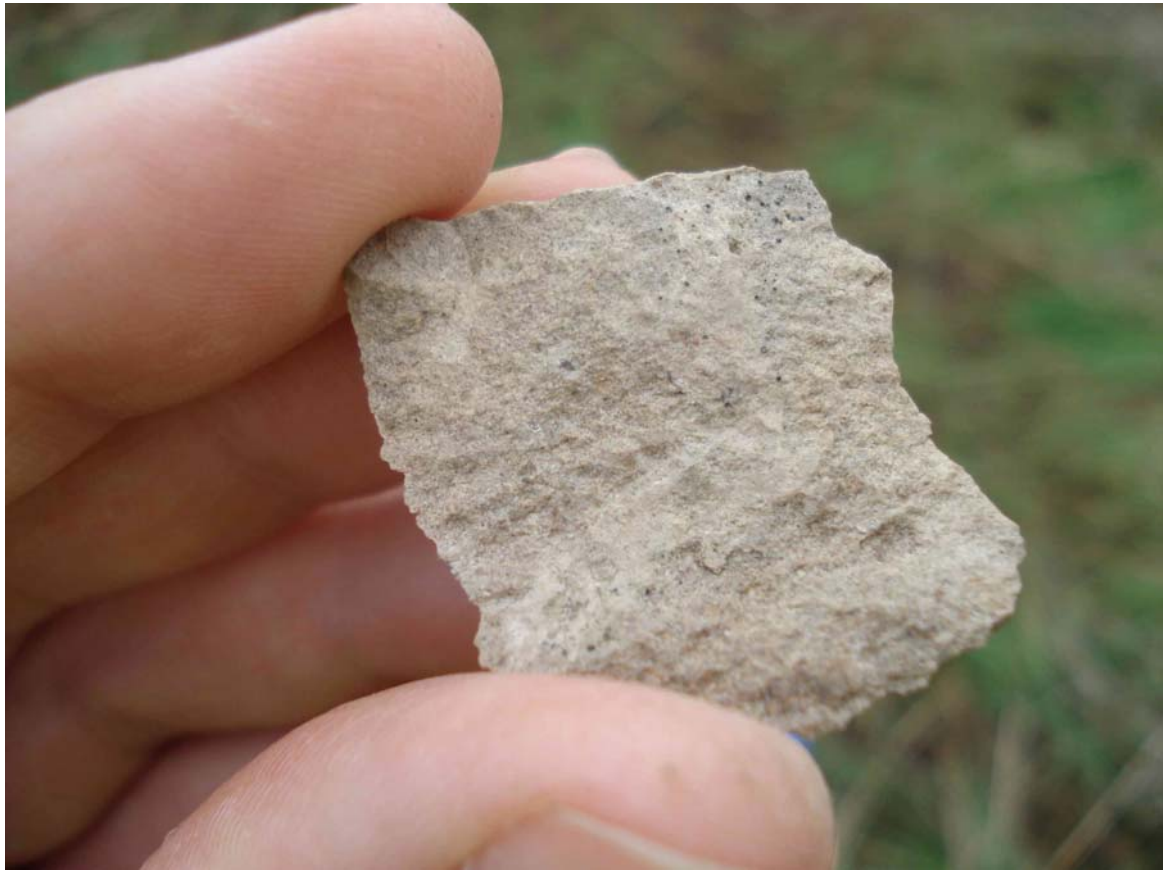
Site W2 consisted of a single artefact identified eroding out of the creek bank at the convergence of Sandy Creek and a 1<sup>st</sup> order tributary. The creek lines were well incised at this location, with the creek banks approximately 4m high. Surface visibility across the area was less than 5%, with the main areas of visibility limited to vertical to very steep exposures on the creek bank. Site W2 incorporated the location of the artefact on the creek bank and the flat area to the south, covering an area of 100m north-south and 60m east-west. Vegetation across site W2 primarily consisted of dense exotic grasses, with occasional yellow box to across the southern portion of the site. An optic fibre cable marker pole (# H 65W) and manhole were located towards the centre of site W2. The site is located on grey sodosols (low slope deposit) that has been incised by the creek.

The artefact was a quartzite flake measuring 28mm x 27mm x 7mm. Attributes included a plain platform, three dorsal scars, feather termination.

**Plate 2. W2 quartzite flake artefact found in the deposit along Sandy Creek.**

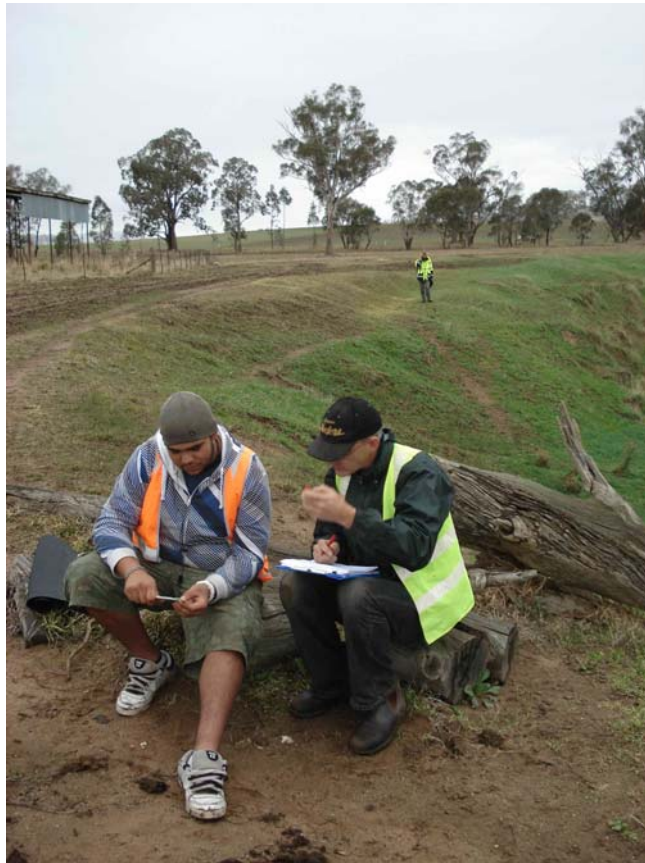
Site W4 consisted of a scatter of stone artefacts across a creek bank and creek flat context on the eastern margin of Sandy Creek. Sandy Creek was quite deeply incised at this location, with creek banks between 4 – 5m high. The artefacts were identified across a series of surface exposures towards the centre of site W4 associated with cattle tracks, erosion scours and a vehicle track and ford crossing of Sandy Creek. The site extended to incorporate the comparable landform within an area 35 – 40m along approximately 350m of the eastern margin of Sandy Creek where surface visibility was much lower (less than 20%). The site displays some young alluvium which probably is the reason for the more extensive range of identified raw materials. W4 is related to a complex of high value archaeological sites (e.g. W6, W7) following Sandy Creek.

Plate 3. W4 recording a range of artefacts at the crossing along Sandy Creek.

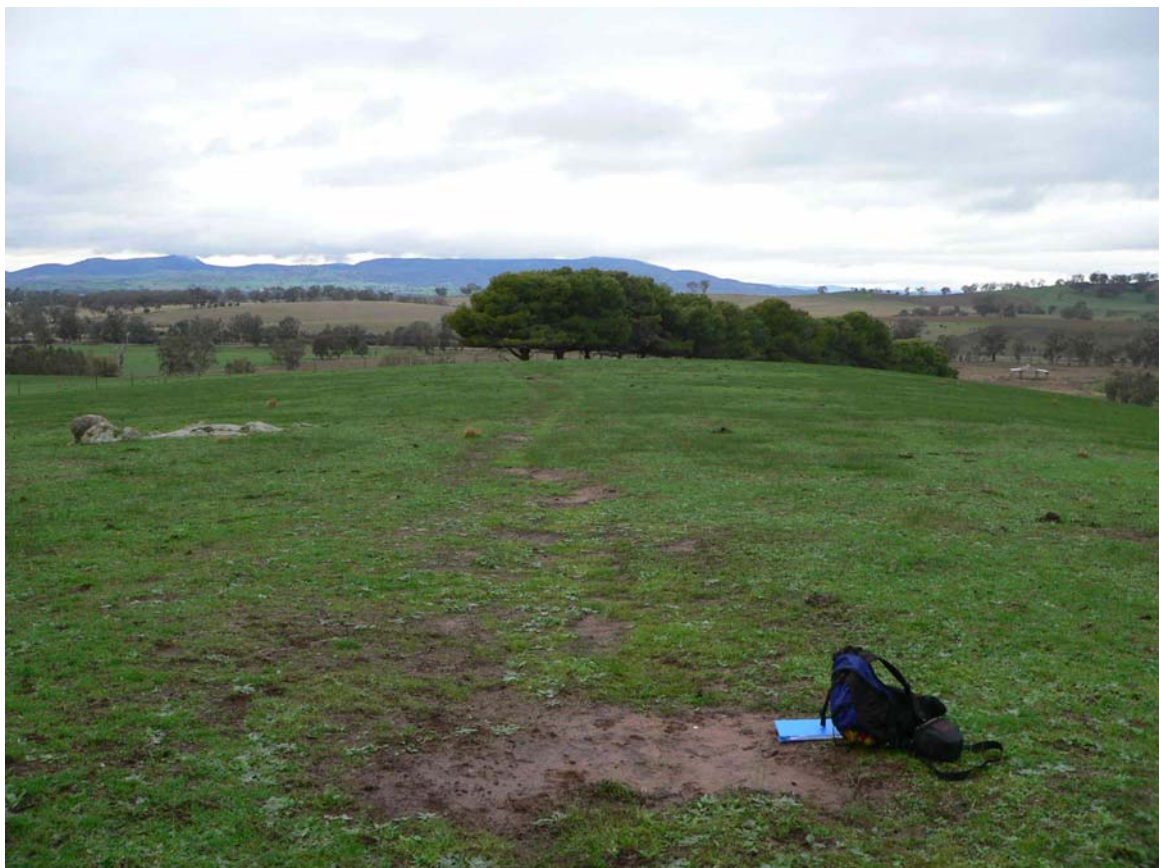
Plate 4. W5 main artefact scatter looking east with W1, W-PAD-1 and W4 in the distance.

| Site | Type | Description | Significance | Impact Assessment | Mitigation Strategy |
|---|---|---|---|---|---|
| W5 | Artefact Scatter | This site is a large collection of quartz artefact scatters following the contours of a high hill slope overlooking Sandy Creek and one of its tributaries. Artefacts are exposed along the flat 'bench-like' features of the slope and associated granite outcrop further up the slope. Quality of artefact raw material is mixed with more evidence for opportunistic knapping. | Moderate | Would be impacted (partial) | Salvage excavation recommended for the eastern portion of the site if avoidance not possible. The western portion of the site should not be impacted. If the western portion (upper slope near the granite outcrops) is impacted as the result of detailed design a second salvage excavation is recommended. |

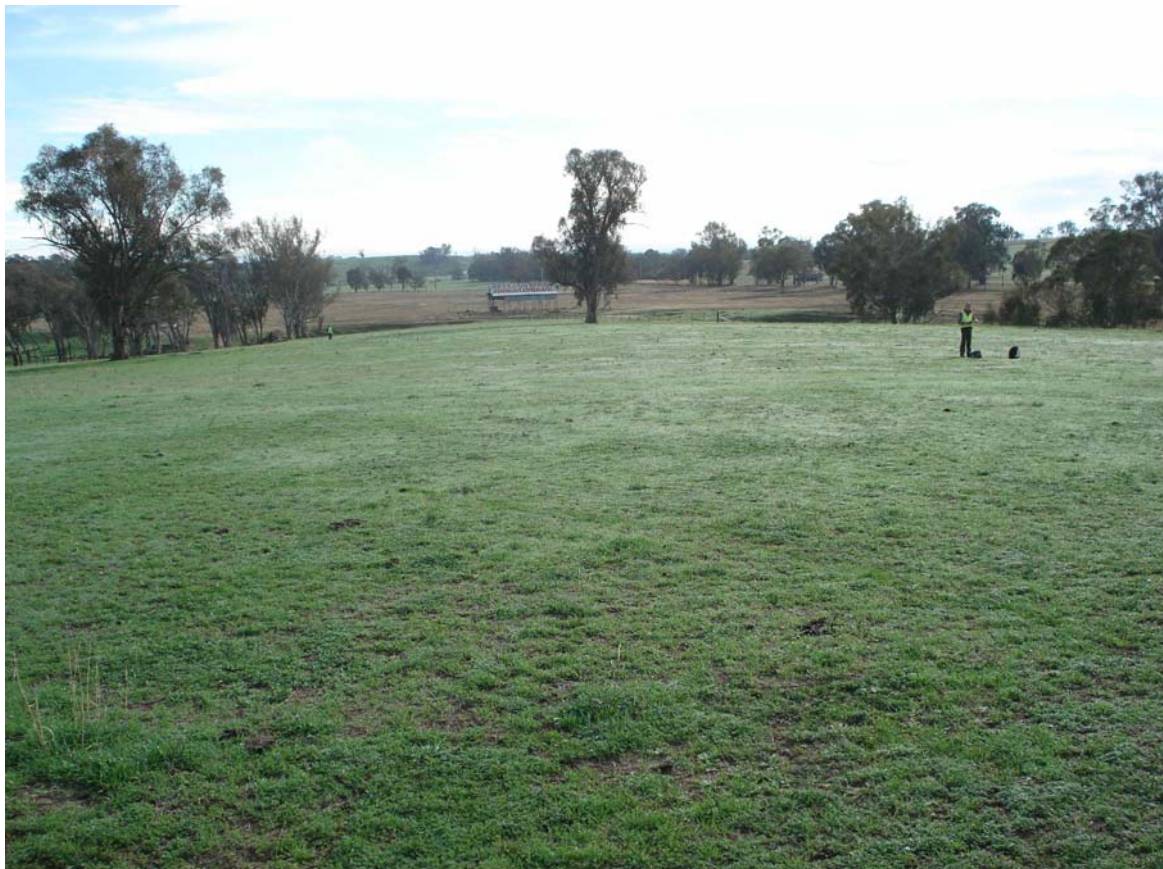
Site W6 consisted of an extensive scatter of over 100 stone artefacts across the mid slopes and spur lines associated with a local high point. The site extended north from the homestead to Sandy Creek and a 2<sup>nd</sup> order tributary. The site covered an area of approximately 500m north-south and 180m east-west. Site W6 predominantly consisted of a grassed pastoral paddock, with the exception being an existing property access road and various farm buildings within the southern portion of the site. Besides various trees and shrubs surrounding the homestead, vegetation within the site was largely cleared with occasional eucalypts across the paddock and bordering Sandy Creek. Surface visibility across site W6 was less than 15%, with localised disturbance in some parts – including the homestead, access road and a shallow, excavated hole in the middle of the paddock. At least 100 artefacts were counted across the surface of site W6 of which eighteen artefacts were recorded. Eight of these artefacts were recorded across the spur crest bordering Sandy Creek in the eastern portion of the site, two were recorded on a smaller spur crest immediately northwest of the homestead and a further ten artefacts were identified on a sheet eroded exposure at a gate 330m west of the homestead.

The site has only limited impacts from erosion and represents good soil integrity. The fan slopes of degrading granite underline good artefact retention (similar to Yellow Creek and Kyeamba Creek) and the proximity to alluvial deposits in the nearby creek underscore the prevalent resources near the site.

Plate 5. W6 looking north across the terrace towards Sandy Creek.

| Site | Type | Description | Significance | Impact Assessment | Mitigation Strategy |
|---|---|---|---|---|---|
| W6 | Artefact Scatter | W6 is the largest site identified during the survey of Woomargama. The site consists of three significant scatters of quartz artefacts with over 100 artefacts recorded. The site is situated in prime position on elevated level ground overlooking Sandy Creek. The site has only limited impacts from erosion and represents good soil integrity. The fan slopes of degrading granite underline good artefact retention (similar to Kyeamba). | High | Would be impacted (partial) | Site would be partially impacted by the upgrade of an existing road. This is only a minor impact on the site's archaeological significance. Barrier fencing should be erected along the road (construction boundary) and the location of the site would be identified in the construction heritage site map to ensure it is not inadvertently affected. If the site is further impacted as the result of detailed design a salvage excavation would be required. |

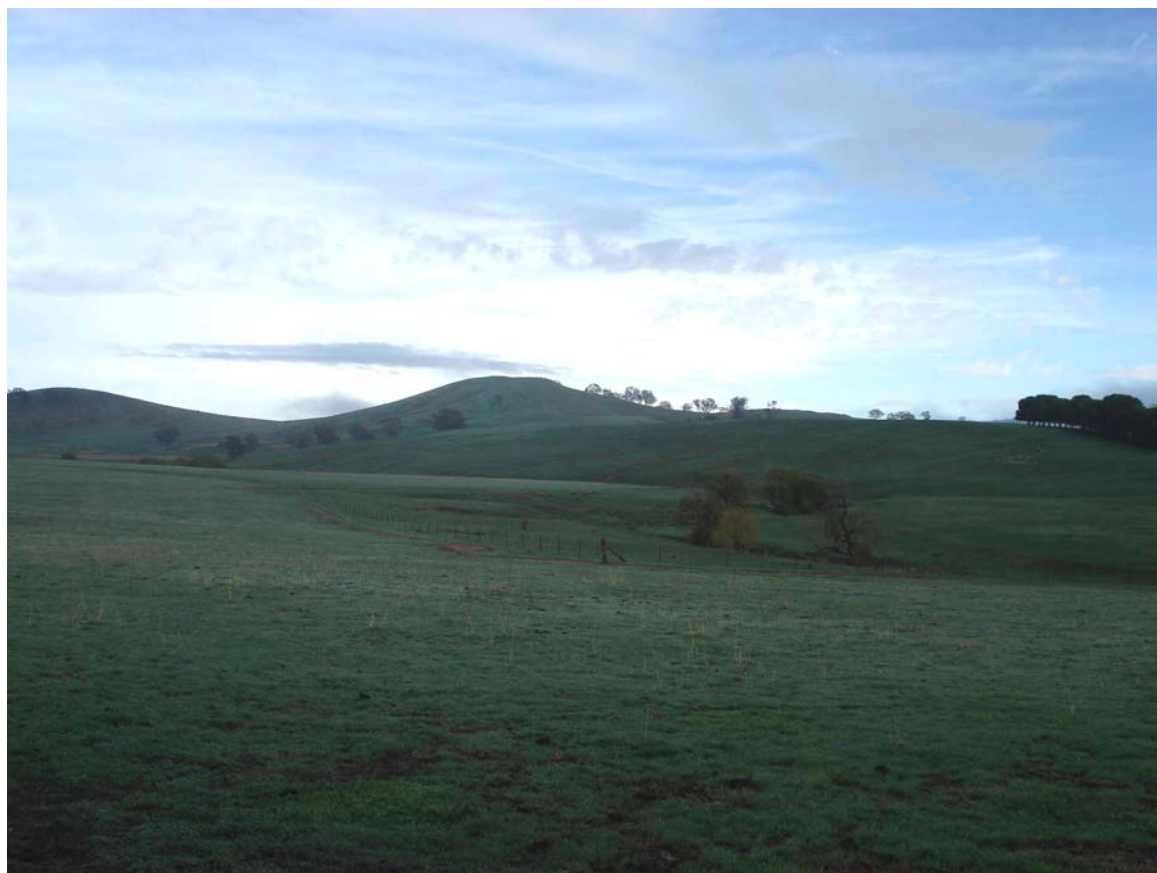
**Plate 6. Sandy Creek archaeological sites.**

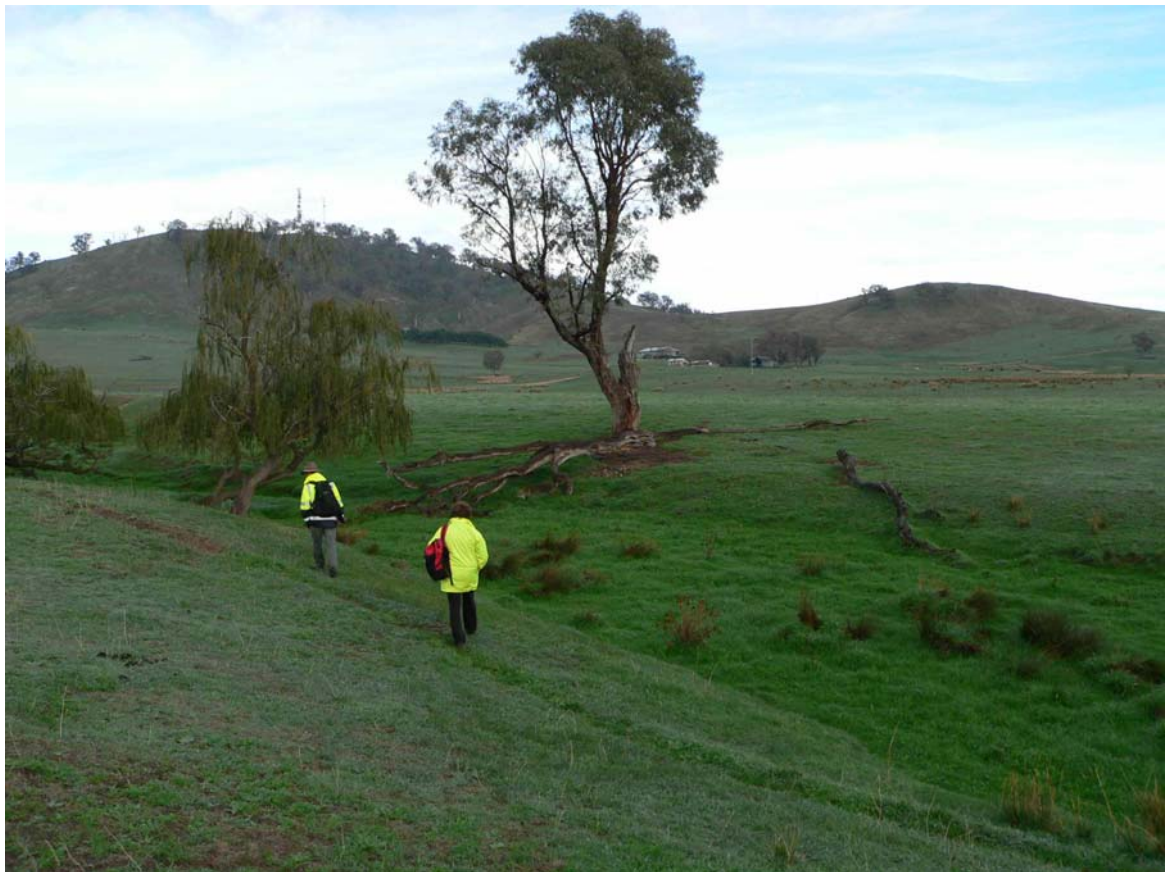
Site W10 covered a narrow, gently sloping spur bordered by two 1<sup>st</sup> order tributaries of Sandy Creek. To the west and east of the 1<sup>st</sup> order tributaries bordering site W10 were sites W11 and W9 respectively. Each of these three sites was located in a similar landform context – spurs located in lower slope contexts with site margins defined by incised 1<sup>st</sup> order tributaries of Sandy Creek. Site W10 covered an area of approximately 500m north-south and 100m east-west. Vegetation across the site consisted of occasional trees along the creek lines, including apple box and willow trees. Surface exposures were limited to occasional cattle tracks, an exposure beneath an apple box tree, where four artefacts were identified, and occasional exposure along

the creek banks. Surface visibility across the remainder of site W10 was less than 5%. The exposure beneath the apple box tree measured 7m x 4m.

**Plate 7. Archaeological sites W9, W10 and W11 along incised 1<sup>st</sup> order tributary to Sandy Creek.**

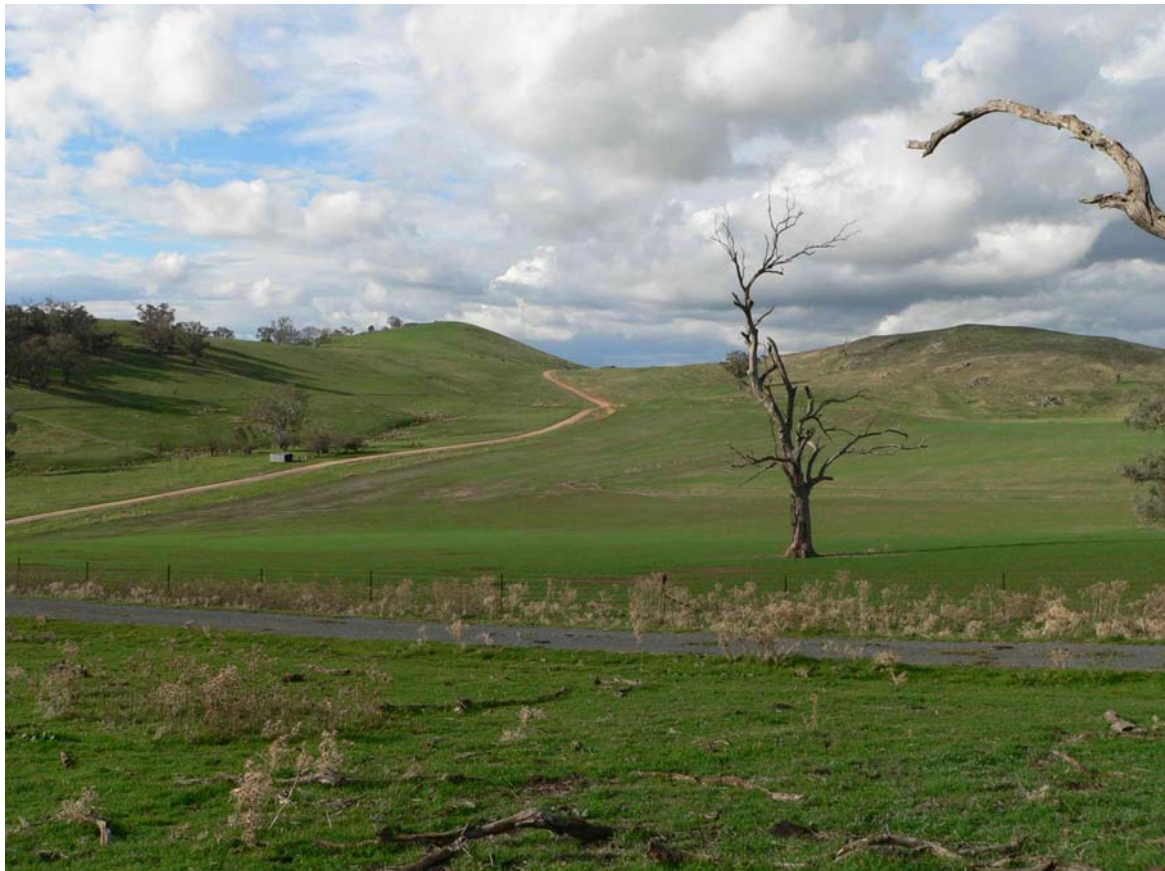
Site W15 was located in a lower slope context bordering the southern margin of a 1<sup>st</sup> order drainage channel for Native Dog Creek. A vehicle track cuts through middle of the site. On the northern side of the track was a cleared, grassed area with a small fenced off area containing an older water tank, power pole, a shed, various shrubs and a large yellow box bordering the drainage channel. To the south of the road was a ploughed paddock. Immediately bordering the southern margin of the road was a long, c.1m high spoil pile. The spoil appeared to have derived from a local context – most likely originating from earthworks along the vehicle track. Surface visibility across site W15 was predominantly along the vehicle track and associated spoil pile, where three artefacts were identified. Numerous fragments of naturally shattered quartz were also observed. Soils are colluvial and exhibit a high percentage of natural quartz/quartz crystal.

**Plate 8. W14 and W15 looking east into a 1<sup>st</sup> order tributary system of Native Dog Creek.**

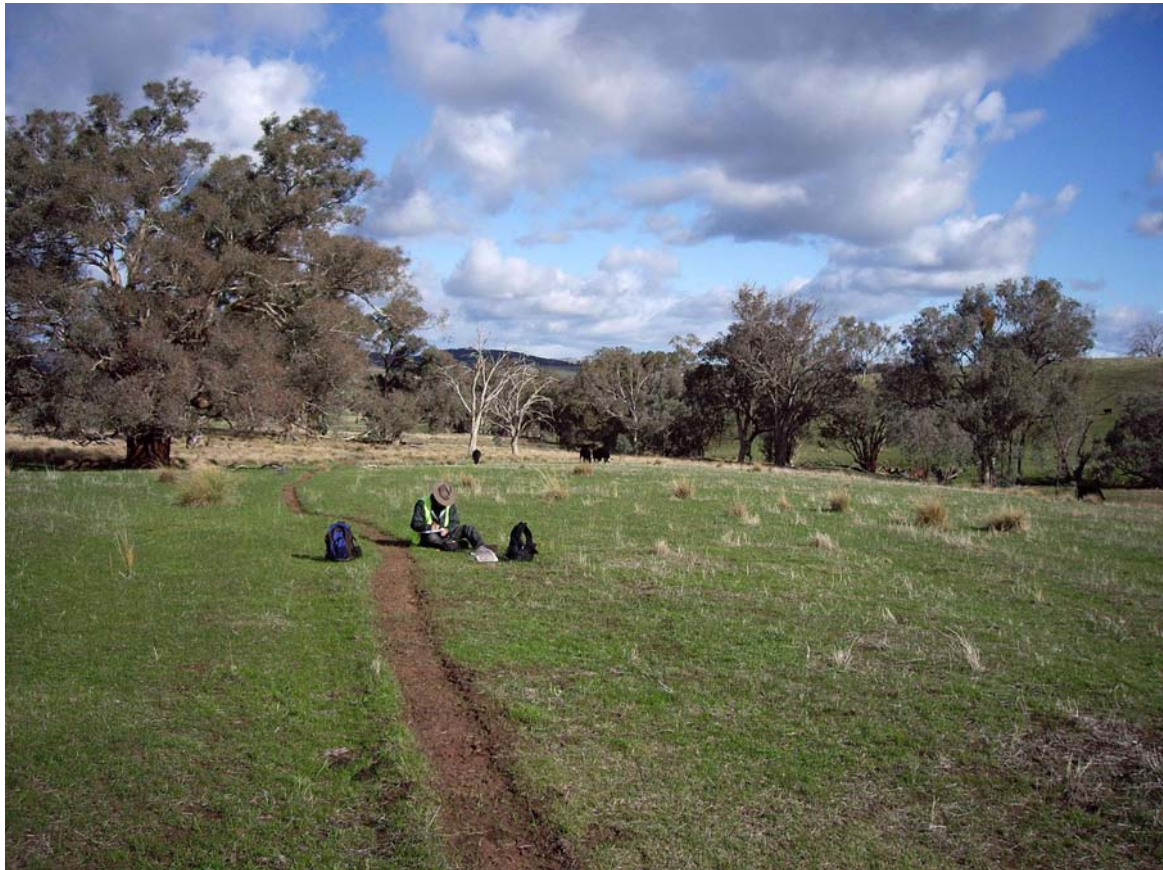
Site W16 was located across a lower colluvial slope/spur context overlooking a 2<sup>nd</sup> order tributary of Mountain Creek. The higher, eastern portion of the site consisted of the lower slopes of higher terrain immediately to the east (Mount McKenzie). A 1<sup>st</sup> order drainage channel and dam were located along the northern margin of the site. The lower, western portion of the site splits into two low-lying spurs divided by a 1<sup>st</sup> order drainage channel. The ephemeral 1<sup>st</sup> order drainage channel across the lower slope landform flowed west towards a 2<sup>nd</sup> order creek. The 2<sup>nd</sup> order creek flowed south along the western margin site W16 towards Mountain Creek. Areas of good surface visibility across site W16 were limited to cattle tracks where surface visibility was as high as 80%. Surface visibility across the remaining heavily grassed sections of the site was less than 5%. The site measured approximately 300m north-south and 400m east-west. Three artefacts were identified on a cattle track within 20m of the dam, and a further ten artefacts were identified on a cattle track across the spur crest in the south-western portion of the site.

Plate 9. W16 looking south across the spur crest.

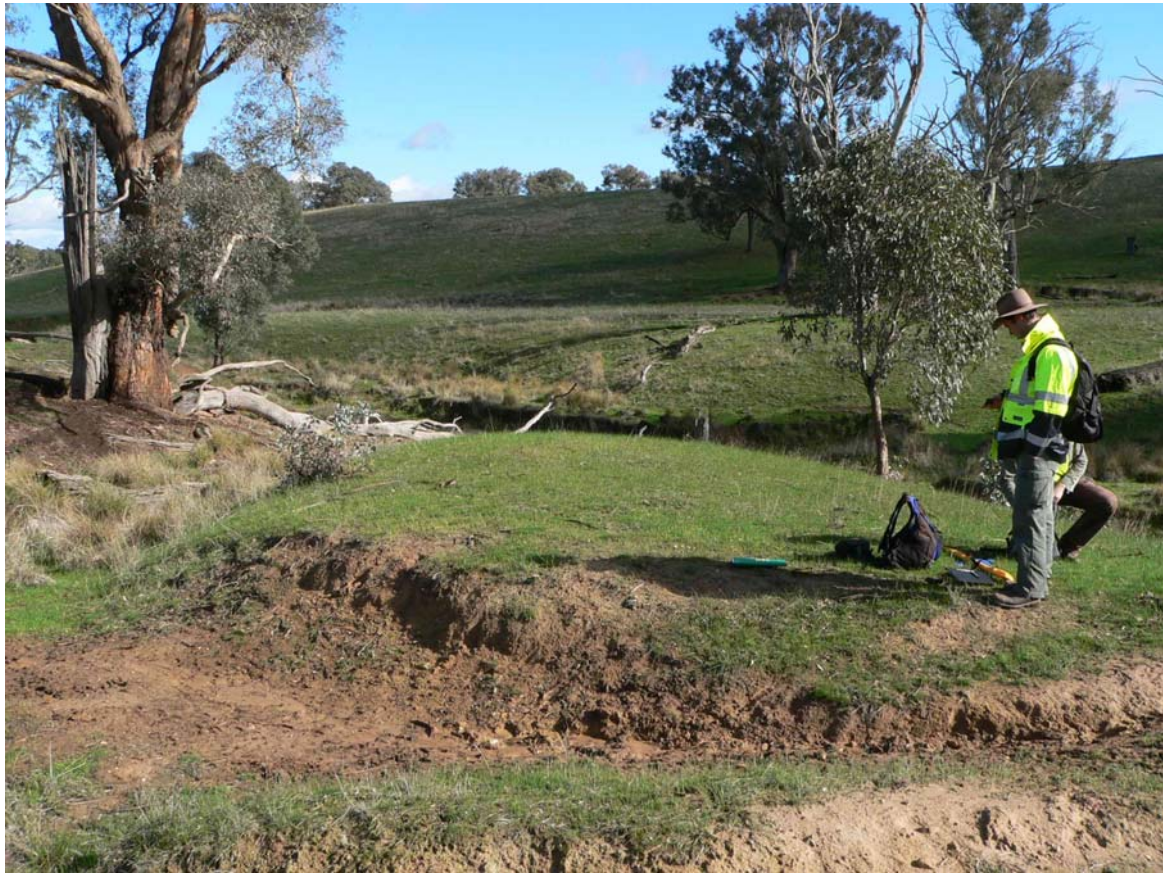
Site W17 was located in a colluvial lower slope/creek bank context bordering the eastern margin of a 2<sup>nd</sup> order tributary of Mountain Creek. The site consisted of a pastoral paddock with occasional yellow box trees. Site W17 measured approximately 40m north-south and 140m east-west. Surface visibility was mainly confined to cattle tracks across the site, with sheet wash enlarging sections of the cattle track that ran parallel with the 2<sup>nd</sup> order creek. Surface visibility in these contexts was up to 80%, whilst across the remainder of the site it was generally lower than 5%. Five artefacts were identified in an enlarged, 3m x 10m cattle track exposure. The archaeological value of the area has been limited by a series of high energy erosion events that have cut into the deposit.

**Plate 10. Part of W17 showing a recorded artefact location amongst the many disturbed cuttings.**

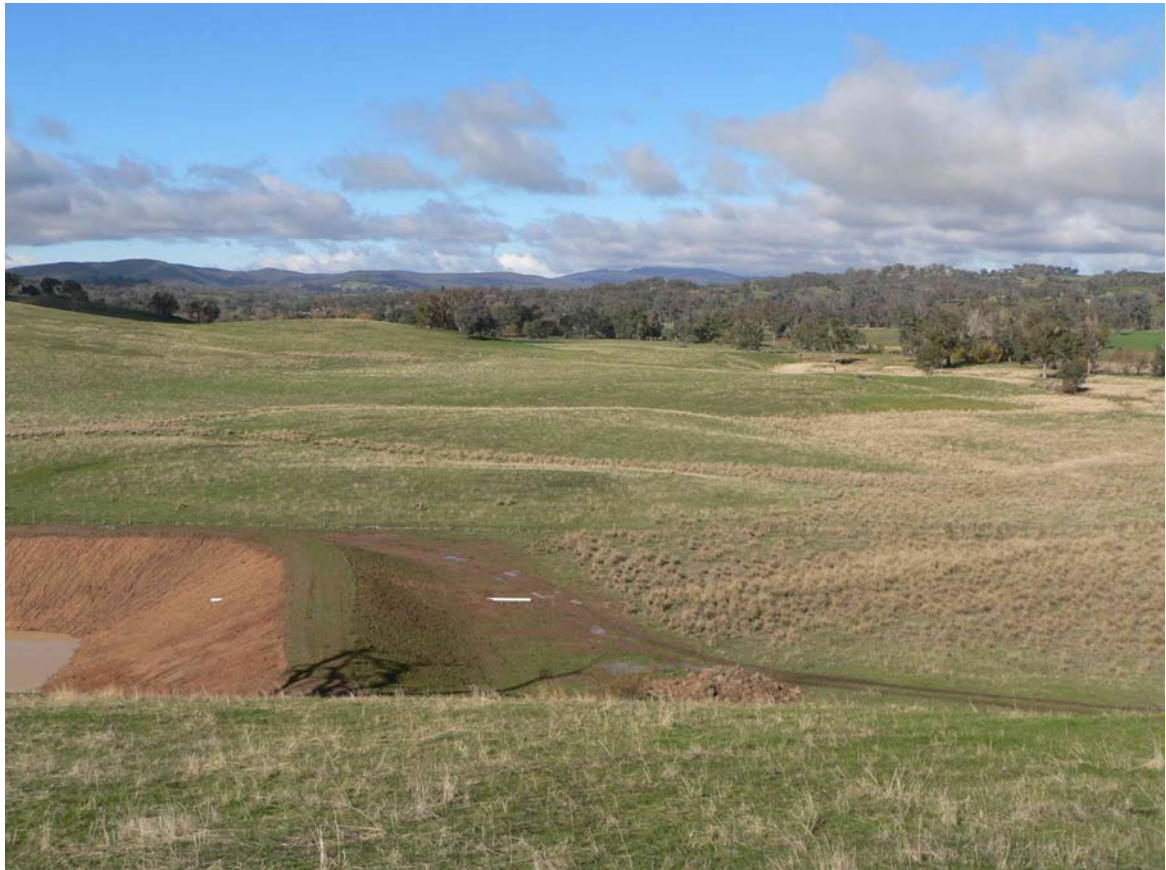
W18 is a series of terrace-sequenced deposits on the northeast side of Mountain Creek. Three well defined sequences were recorded during the survey. Site W18 measured approximately 600m north-south and 230m east-west. The site was part of a large, pastoral paddock, with surface visibility limited to cattle and vehicle tracks. These exposures were concentrated around the large dam on the northern margin of the site where ten artefacts were identified and surface visibility was up to 80%. Surface visibility across the remainder of the site was generally less than 5%. The location has optimal access to resources from the creek and nearby drainage channel. The deposit appears to be just above the high intensity floodplain which suggests good artefact survivability. Similar terrace deposits have yielded high artefact frequencies and antiquity at the nearby M21.

**Plate 11. W18 looking east across the terrace system.**

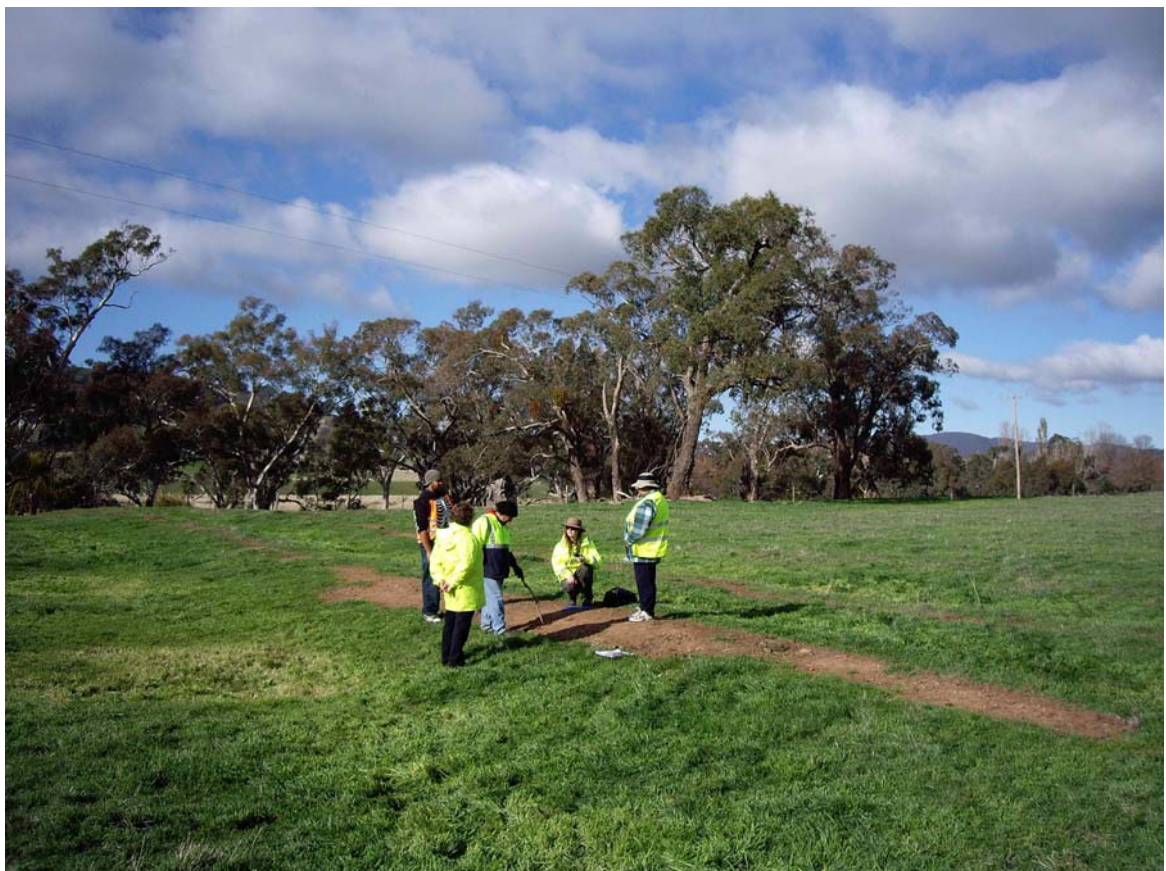
**Plate 12. Artefacts found eroding out of an agricultural bund at W19.**

| Site | Type | Description | Significance | Impact Assessment | Mitigation Strategy |
|---|---|---|---|---|---|
| W19 | Artefact Scatter | W19 is a moderately raised portion of land south of Mountain Creek just above the primary floodplain. Quartz artefacts were observed along a line of agricultural disturbance. The site is bounded by two very shallow and broad drainage channels extending from higher ground to the south. The site occupies the junction of colluvial-alluvium and displays good integrity. | Moderate to High | Would be impacted (partial) | The site would be partially impacted by the current design; however the most significant portion of the site is located outside of the construction site boundary. No mitigation is recommended based on the current level of impact. Barrier fencing should be erected along the construction boundary and the location of the site would be identified in the construction heritage site map to ensure it is not inadvertently affected. If the site is further impacted as the result of detailed design a salvage excavation would be required. |

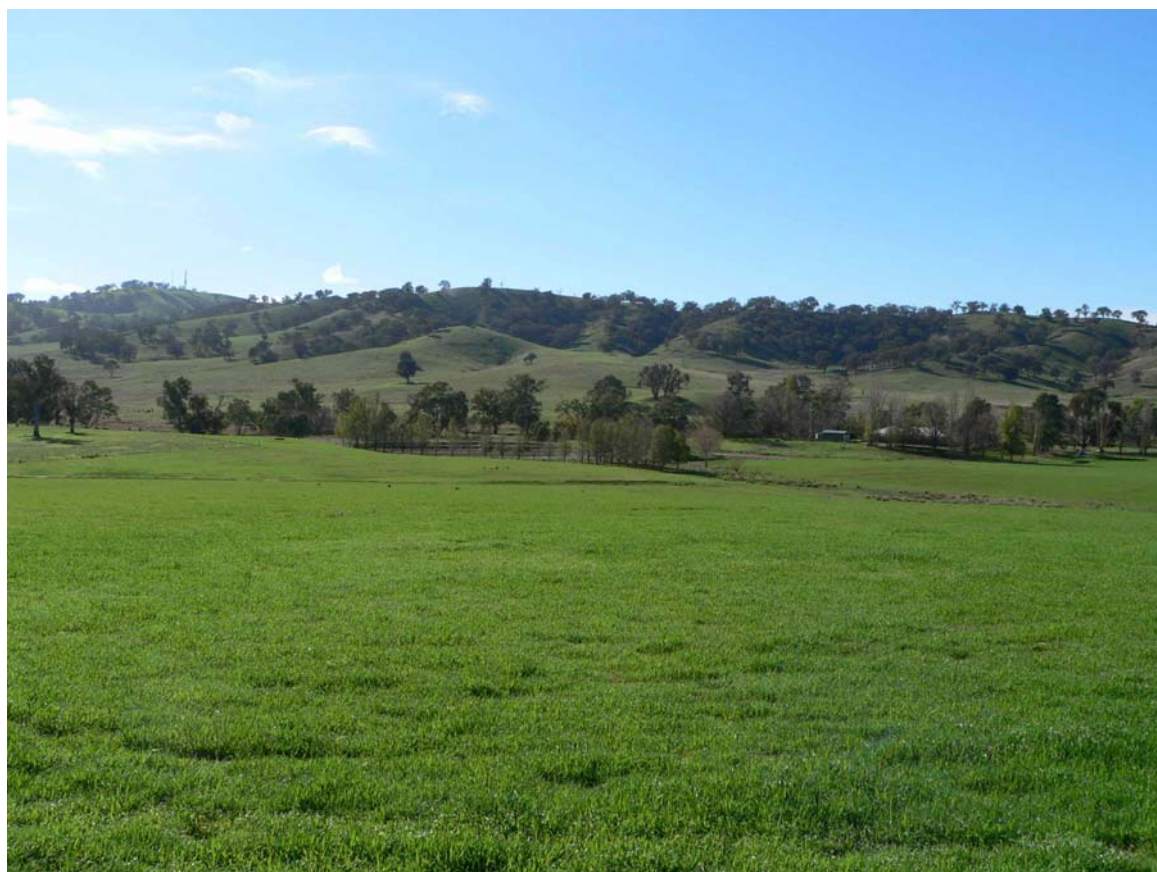
Site W20 was located across creek bank landforms overlooking Mountain Creek to the north and bordered to the east by a large dam fed by a 1<sup>st</sup> order creek (drainage channel). The site is situated at the interface of a colluvial-alluvial deposit. The site consisted mainly of a cleared, ploughed paddock, the only trees consisted of tree plantings within an electric fence enclosure bordering the western margin of the dam. The terrace landform was raised approximately 2m above the creek flats to the north. Surface visibility across the site was between 10 – 30%, with some surface exposure between the rows of sown crops and larger areas of surface exposure in areas of slight surface disturbance. Three artefacts were identified at site W20 – one identified next to the electric fence and two 20m to the west. W20 and W19 are separated by a shallow broad drainage channel.

**Plate 13. Archaeological complex W20-W23 along Mountain Creek looking north from W24.**

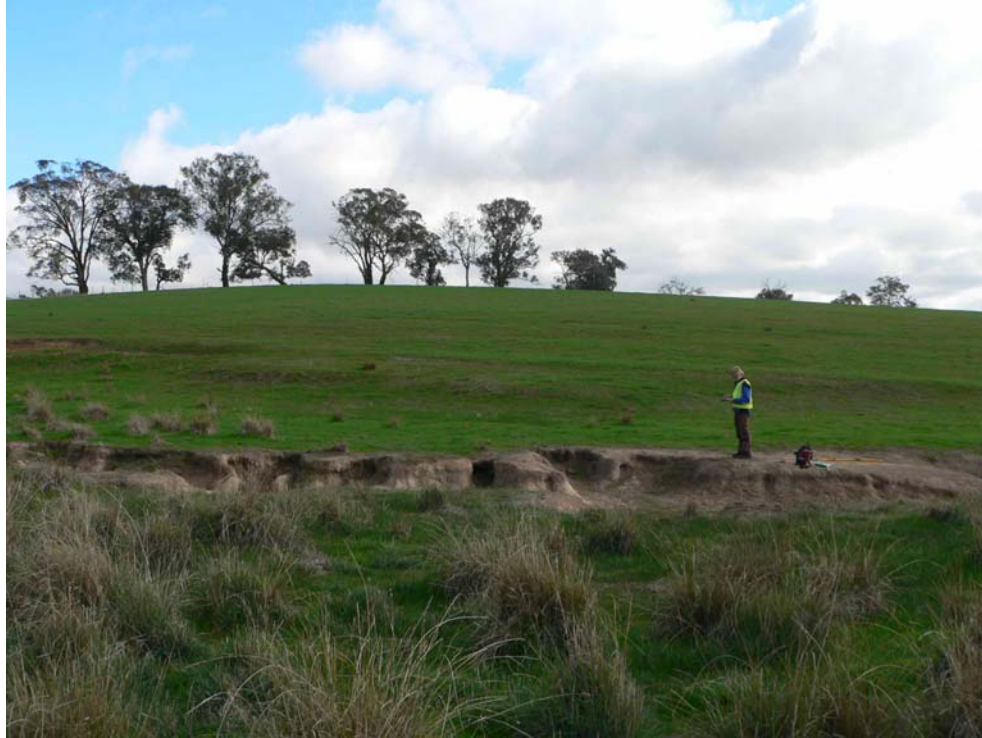
Site W22 consisted of two artefacts identified in an ephemeral drainage line washout. The drainage line was a 1<sup>st</sup> order tributary of Mountain Creek, which was located approximately 400m to the northeast. The washout was bordered to the east and west by spur lines, with the spur to the west steeper and higher (site W24) than the low-lying spur to the east (site W23). The surrounding area was cleared of vegetation apart from one large yellow box located approximately 35m southwest of the washout. The remaining area consisted of recently sewn crops. The washout was approximately 40m long, 8m wide and up to 70cm deep. The site is disturbed and the artefacts located in the washout are not in situ.

**Plate 14. Sites W24 (hill top) and W22 showing the eroded drainage channel.**

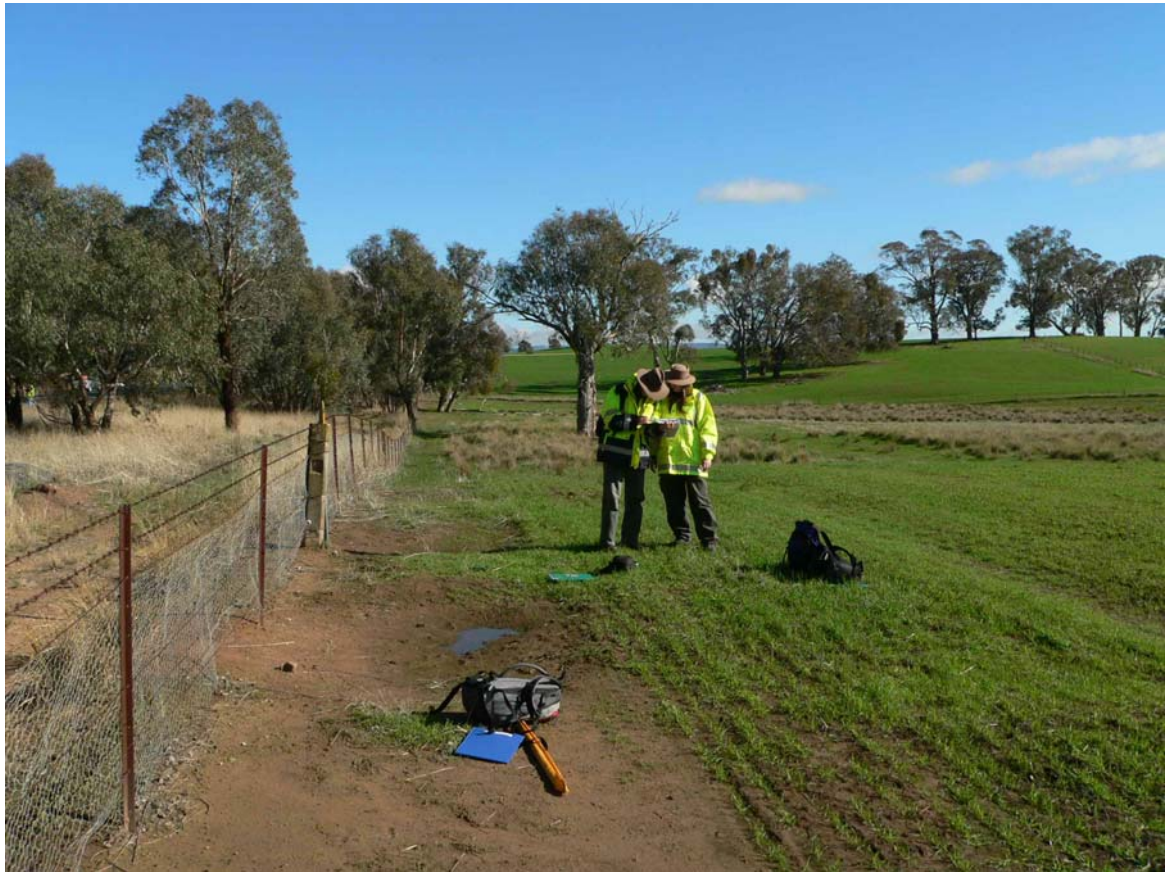
Plate 15. W23 located along fence line with site W24 on the hill top in the distance.

| Site | Type | Description | Significance | Impact Assessment | Mitigation Strategy |
|---|---|---|---|---|---|
| W23 | Artefact Scatter | W23 is high quality collection of quartz artefacts located on a colluvial derived rise emanating from hills south of the current Hume Highway. The site is adjacent to a drainage channel and just outside of the Mountain Creek floodplain. The site mirrors the deposit at M21. | High | Would be impacted (partial) | Salvage excavation recommended for the directly impacted portion of the site where subsurface disturbance is required. The remainder of the site will be conserved by installing a geofabric protective layer. Surface artefacts will be collected prior to the installation of the geofabric layer. The protective layer would be removed post construction. Investigative excavation is recommended post construction to verify the effectiveness of conservation management. |

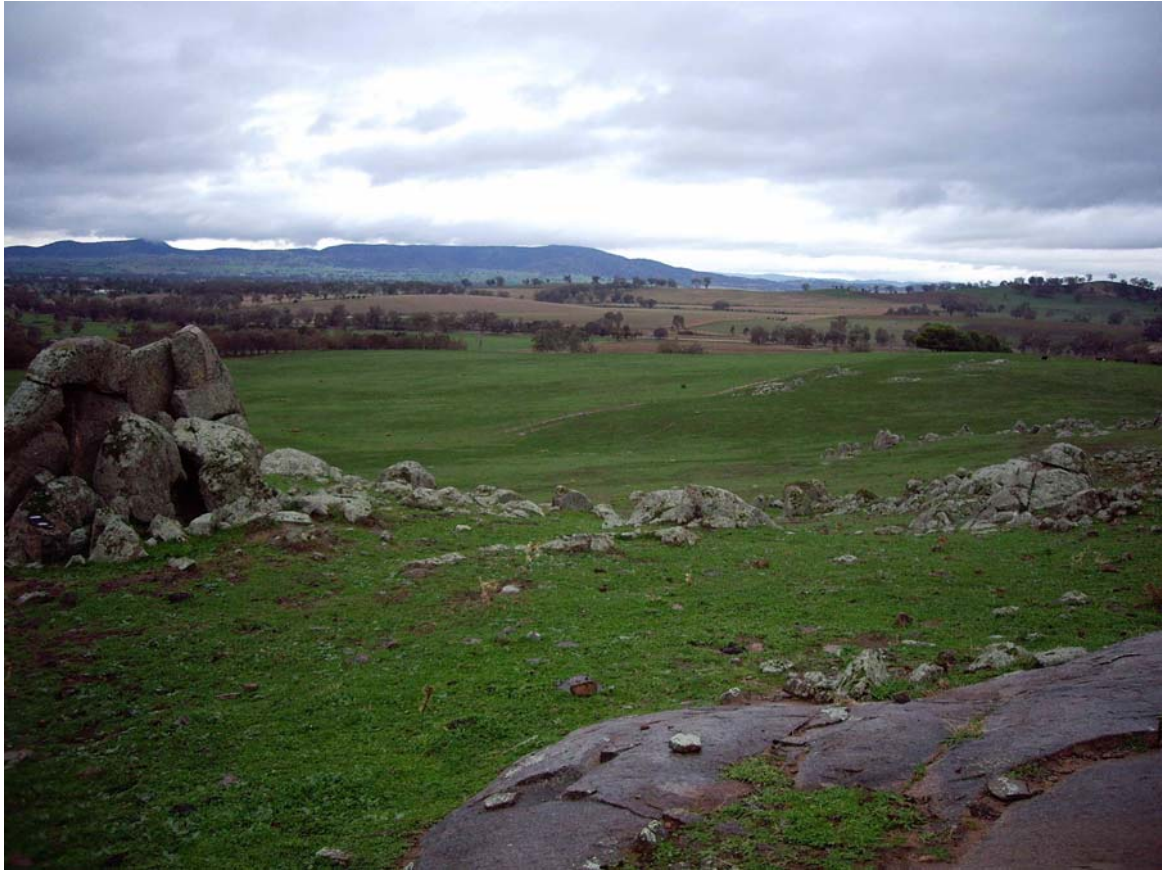
This area of potential is located on the northern slopes of granite hill overlooking Sandy Creek and is bounded to the north by a 1<sup>st</sup> order tributary to Sandy Creek. The area is predominately a cleared agricultural paddock. Several relatively level 'benches' similar to W5 were noted during field survey. The surrounding archaeological sites, elevation, soil structure, and proximity to Sandy Creek all mark this area as exhibiting high archaeological potential. In particular the interface of colluvial slope, podzolic soils and younger alluvium indicate good artefact survivability but more importantly underscore the 'junction point' aspect of the location. High archaeological significance is usually associated with such junction points.

Plate 17. W-PAD-1 looking from the top of site W5 with W1, W3 and Sandy Creek in the distance.

| Site | Type | Description | Significance | Impact Assessment | Mitigation Strategy |
|---|---|---|---|---|---|
| W-PAD-1 | PAD | This area of potential is located on the northern slopes of a hill overlooking Sandy Creek and is bounded to the north by a 1 <sup>st</sup> order tributary to Sandy Creek. The area is predominately a cleared agricultural paddock. Several relatively level 'benches' similar to W5 were noted within the PAD during field survey. The surrounding archaeological sites, elevation, soil structure, and proximity to Sandy Creek all make this a area of high potential | PAD | No impact | No action required. The location of the site would be identified in the construction heritage site map to ensure it is not inadvertently affected. If the site is to be impacted as the result of detailed design an investigative excavation would be required. W-PAD-1 is associated with W5 and W3. |

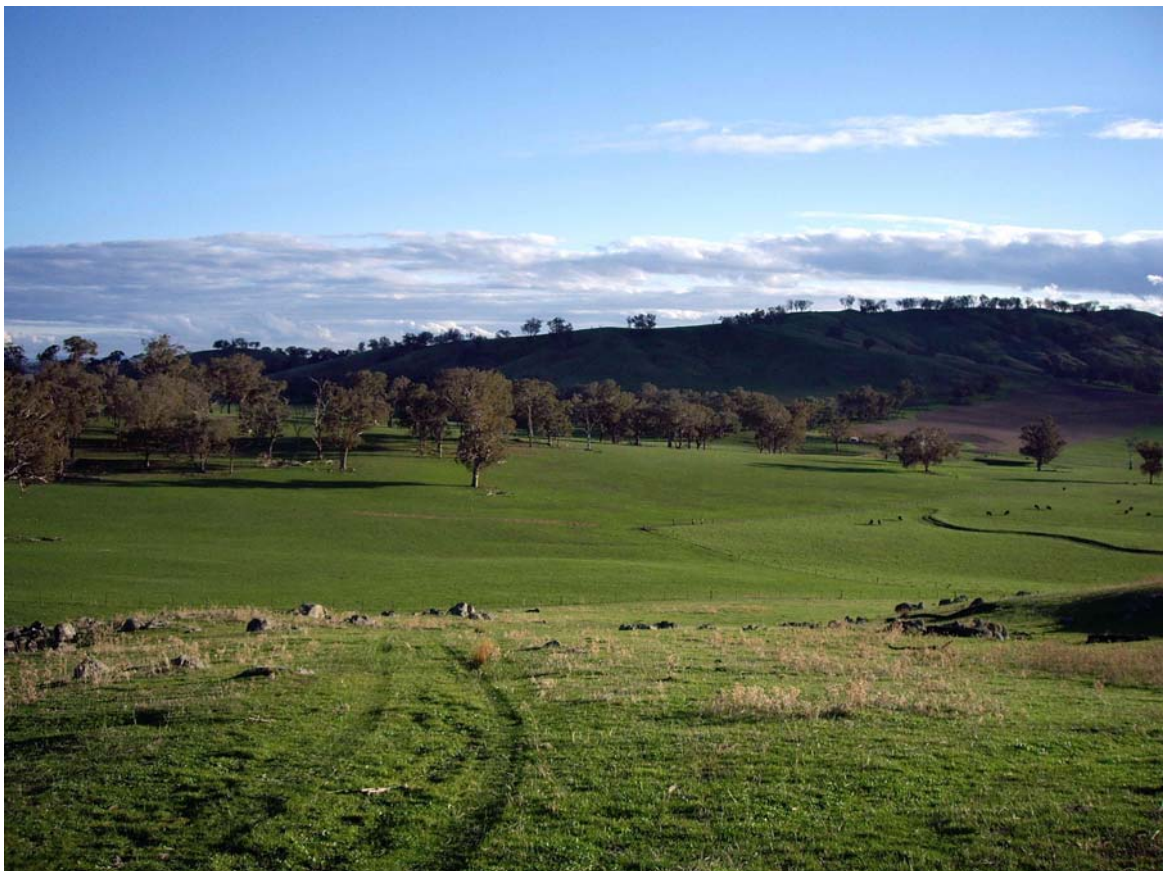
Plate 18. W-PAD-2 looking south into the Native Dog Creek catchment.

| Site | Type | Description | Significance | Impact Assessment | Mitigation Strategy |
|---|---|---|---|---|---|
| W-PAD-2 | PAD | This area of potential is located at the headwaters of Native Dog Creek. The PAD is a lower hillslope extending west from Mount McKenzie. Large trees cover a portion of the PAD and seem to have limited the colluvial movement off the high ground. The area was identified based on the geomorphology of the hillslope and proximity to the creek. A significant archaeological complex is located in the adjoining southern valley (drainage channel to Mountain Creek). | PAD | Would be impacted | Investigative excavation is recommended. If significant archaeological deposit is identified salvage excavation would be required prior to the commencement of construction activity at this location. |
