Hume Highway Upgrade

# Woomargama bypass

Technical Paper 3 – Surface Water

## Surface Water Report

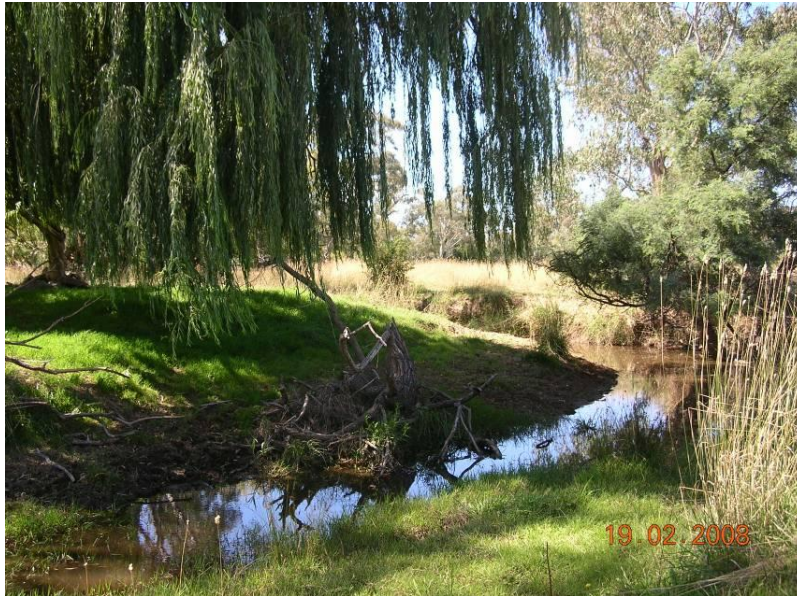
**Photograph 2-1 Typical Mountain Creek channel**

A field inspection of the study area was conducted on the 19th February 2008. During this inspection, it was noted that Mountain Creek had an incised channel with primarily sandy banks and floor. The creek exhibited a high level of sinuosity, which was attributed to the low gradient of the creek and the soils present. The creek had ponded water in locations at the time of the inspection, which was slowly flowing in some locations.

Vegetation in the main channel was sparse, but large eucalypts and willows lined the banks. There were also occasional large logs and snags across the channel. Floodplain vegetation consisted primarily of long grass with scattered native trees.

Photograph 2-1 shows a typical section of the Mountain Creek channel. Photograph 2-2 shows typical Mountain Creek over bank areas.

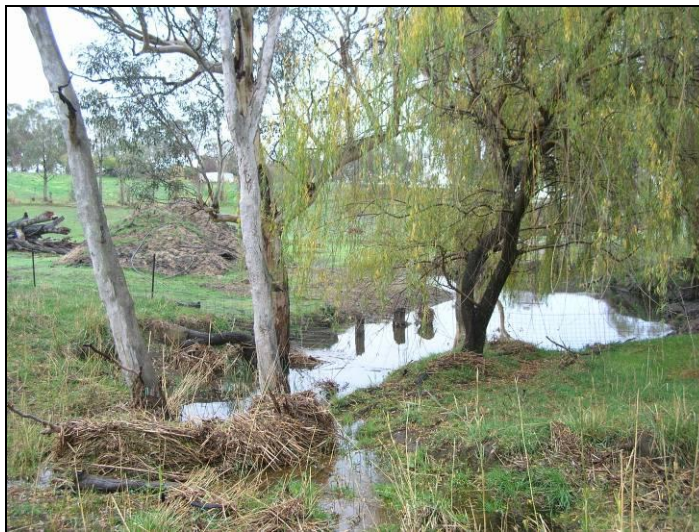
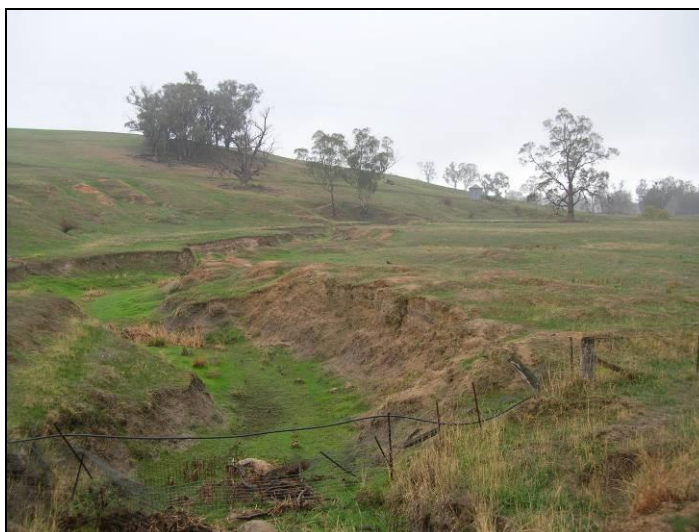
Drainage line 1 joins Sandy Creek (Drainage line 2) just downstream of the proposed bypass crossing at the northern end of the alignment. Drainage line 1 is classified as order 1 by the Strahler system, whereas Sandy Creek is classified as order 3. No fish species were identified to inhabit Sandy Creek (Technical Paper – 1, Flora and Fauna) though some flow was observed at the sampling site during the field investigation (Figure 3-1, Photograph 3-1). However, Sandy Creek was not flowing further north of the proposed bypass near Spring Valley Road (Photograph 3-2).

**Photograph 3-1 Sandy Creek (drainage line 2) at sampling site**

**Photograph 3-2 Sandy Creek downstream of Spring Valley Road**

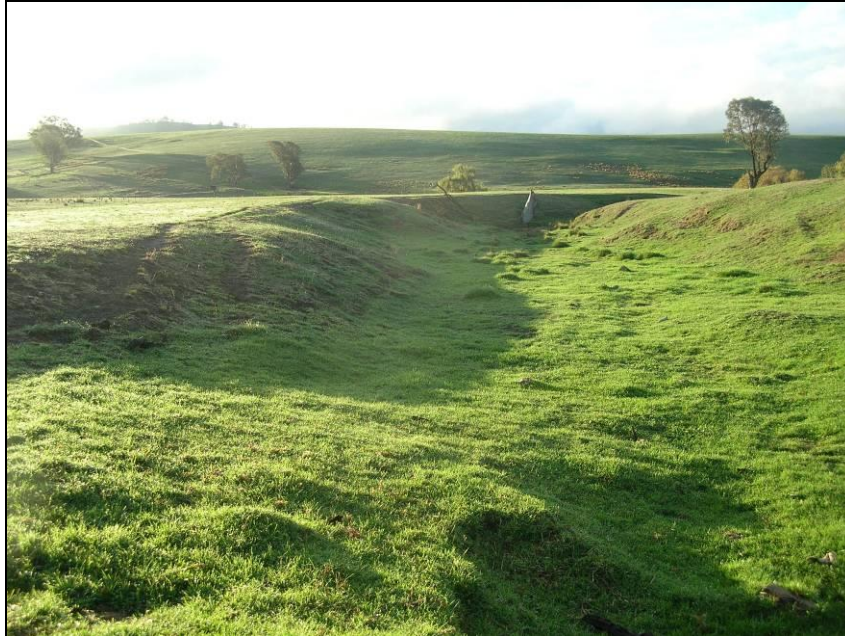
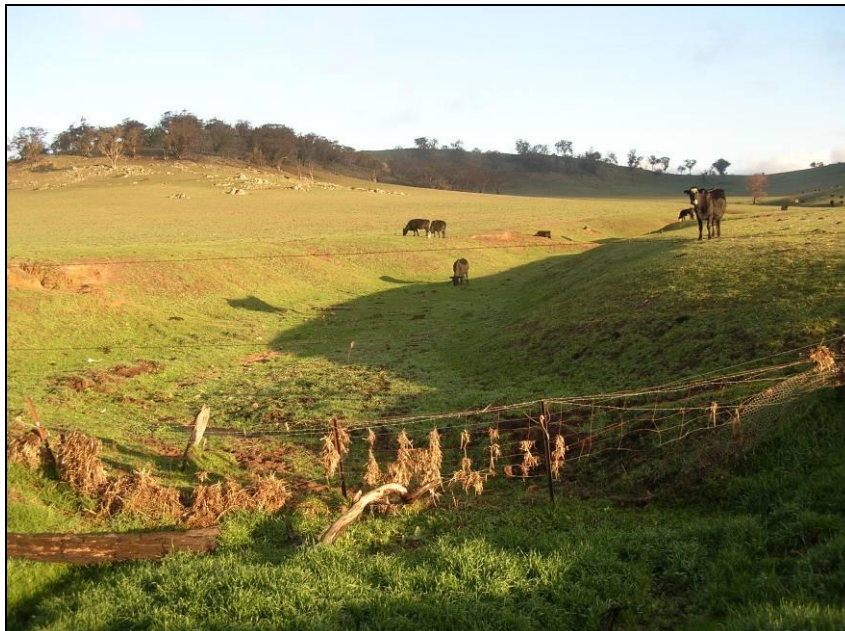
The proposed bypass would run almost parallel to a tributary of Sandy Creek at the northern end of the alignment, shown as Drainage line 3. This tributary is classified as Strahler order 2. Photographs 3-3 and 3-4 show the eastern tributary to Drainage line 3. Photograph 3-7 shows this drainage line downstream of Dam D1, with heavy vegetation present in part of the channel (willow trees in mid-ground of photograph). The tributary has a wide and shallow channel definition compared to other more narrow and incised channels in the area.

**Photograph 3-3 Tributary to Drainage line 3, facing downstream (north)**

**Photograph 3-4 Tributary to Drainage line 3, facing upstream (south)**

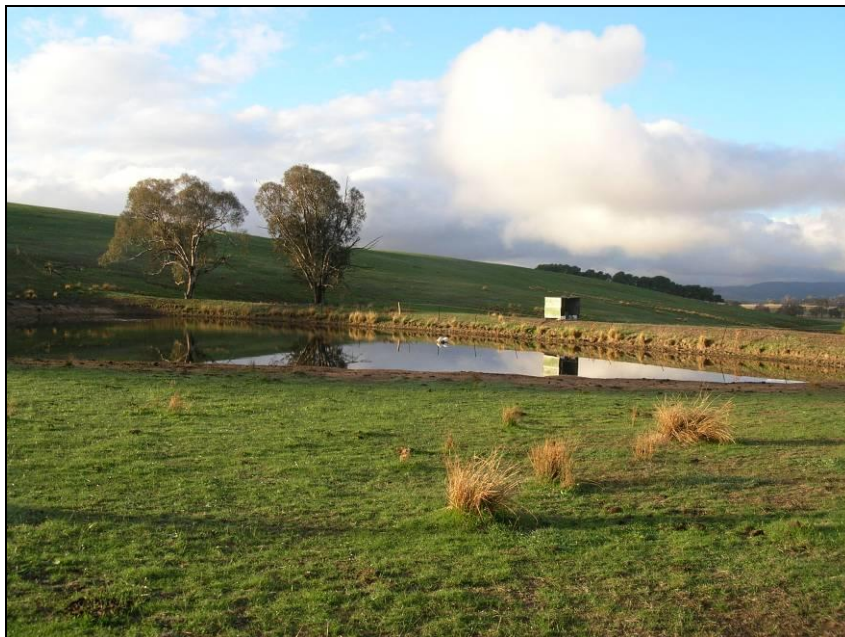
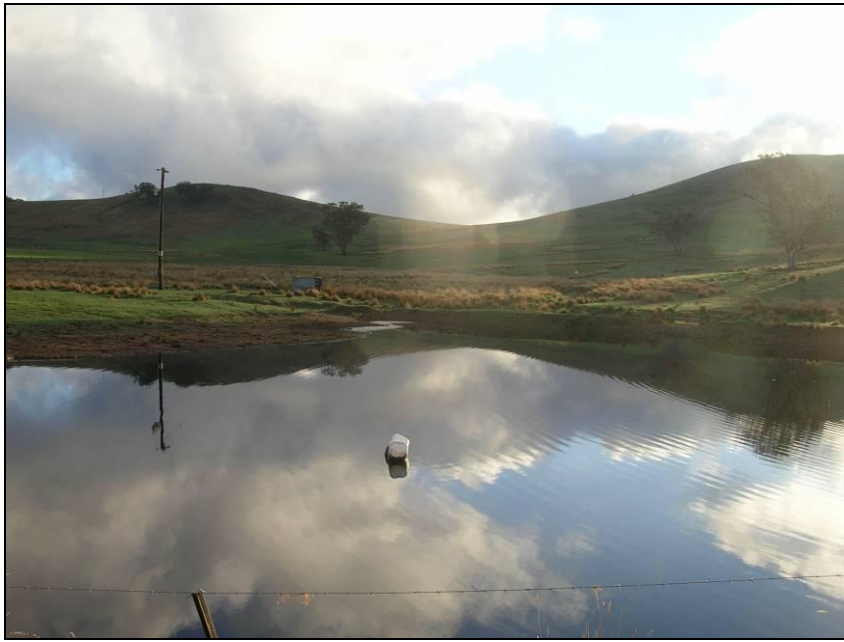
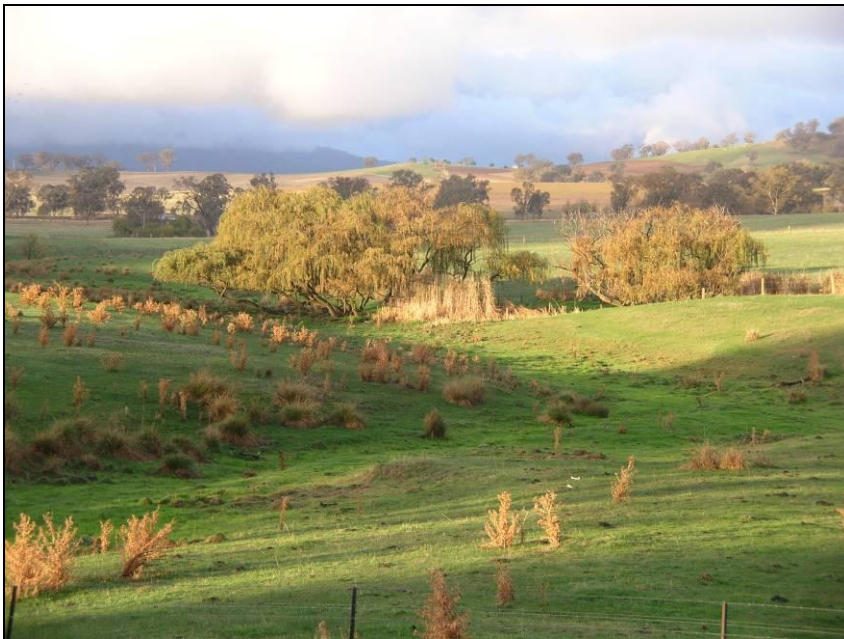
Dam D1 is located in this sub-catchment, along Drainage line 5, just upstream of the confluence with Drainage line 3. Water was present in this partially spring-fed dam, shown in Photograph 3-5. Photographs 3-6 and 3-7 show the landscape upstream and downstream of Dam D1 respectively. Dam D1 was surrounded by low ground cover. According to anecdotal evidence the study area had experienced a significant rainfall event several weeks prior to the field investigation. This may have caused nutrient-rich sediment to flow into the Dam D1, sighted as a yellowish brown colouring of the water. This is also the case for dams D2, D3 and D5.

**Photograph 3-5 Dam D1**

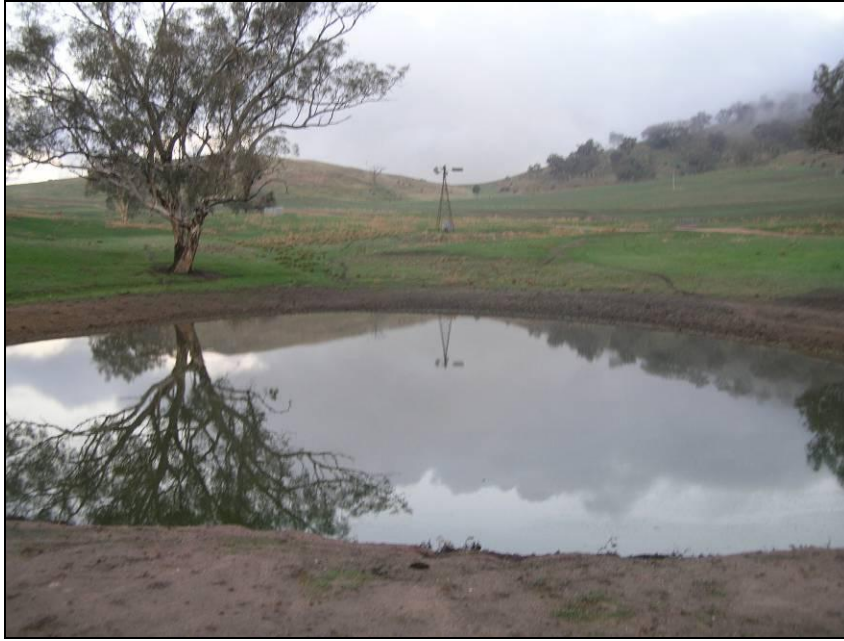
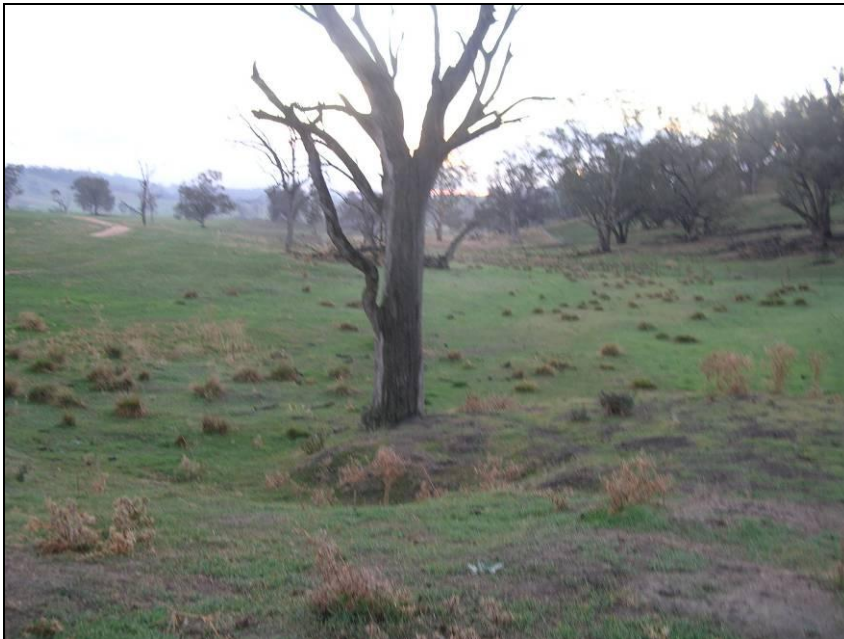
Drainage line 6, a tributary of Native Dog Creek, is crossed by the proposed bypass and is classified as Strahler order 2. A small dam, D3, is present along Drainage line 6 downstream of the proposed bypass crossing. This dam is locally known to be partially spring-fed in years of average rainfall. Photographs 3-8 and 3-9 show Drainage line 6, upstream and downstream of Dam 3, respectively. Minimal ground cover was observed within this drainage line, along with minimal channel definition.

**Photograph 3-8 Dam D3 – upstream**

**Photograph 3-9 Dam D3 – downstream**

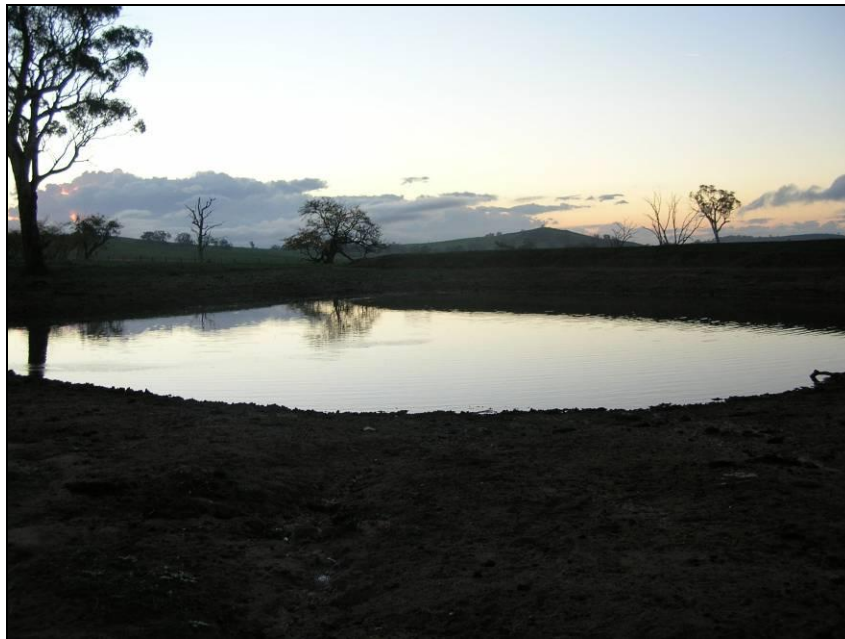
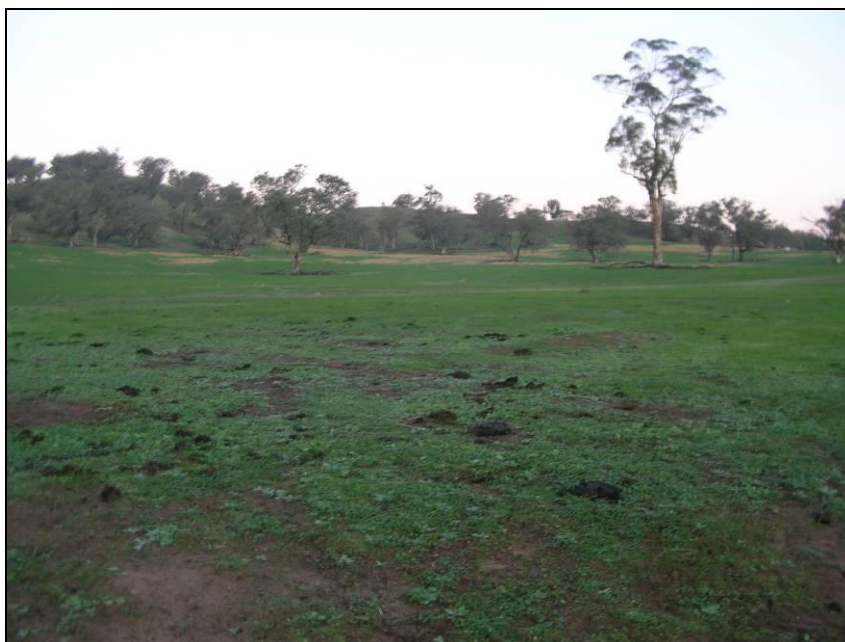
Two online dams (D4 and D5) exist downstream of the proposed crossing. Dam D4 was dry during the field investigation, whereas dam D5 had water present, as shown in Photograph 3-10. This dam is anecdotally known to not be spring-fed. Photograph 3-11 shows the landscape upstream of Dam D5, highlighting the lack of channel definition in the vicinity of the proposed bypass crossing.

**Photograph 3-10 Dam D5 – downstream**

**Photograph 3-11 Dam D5 – upstream**
