Port Kembla Outer Harbour Configuration Mod5

Non-Aboriginal heritage advice memo

Report to Arup

August 2025

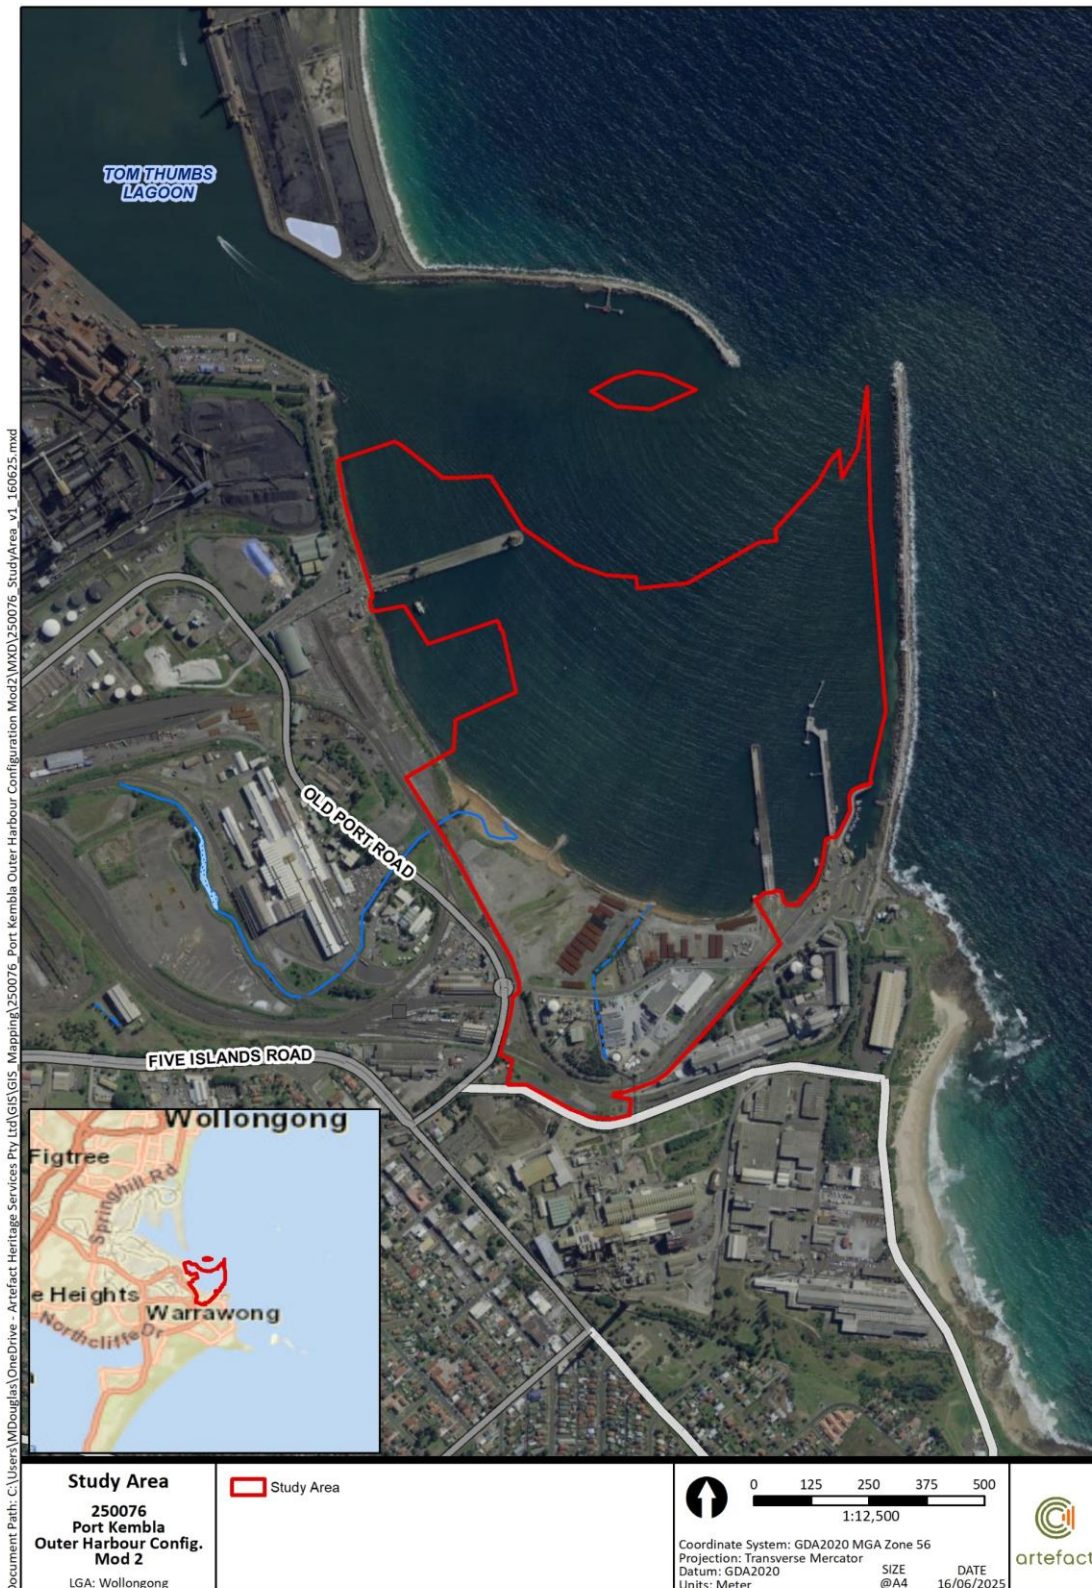
Figure 1: Location of the study area

The study area (Figure 1) is defined as a portion of the Port Kembla Outer Harbour. The study area includes both on land and harbour and is located within the City of Wollongong Local Government Area. The following lots are contained within the study area:

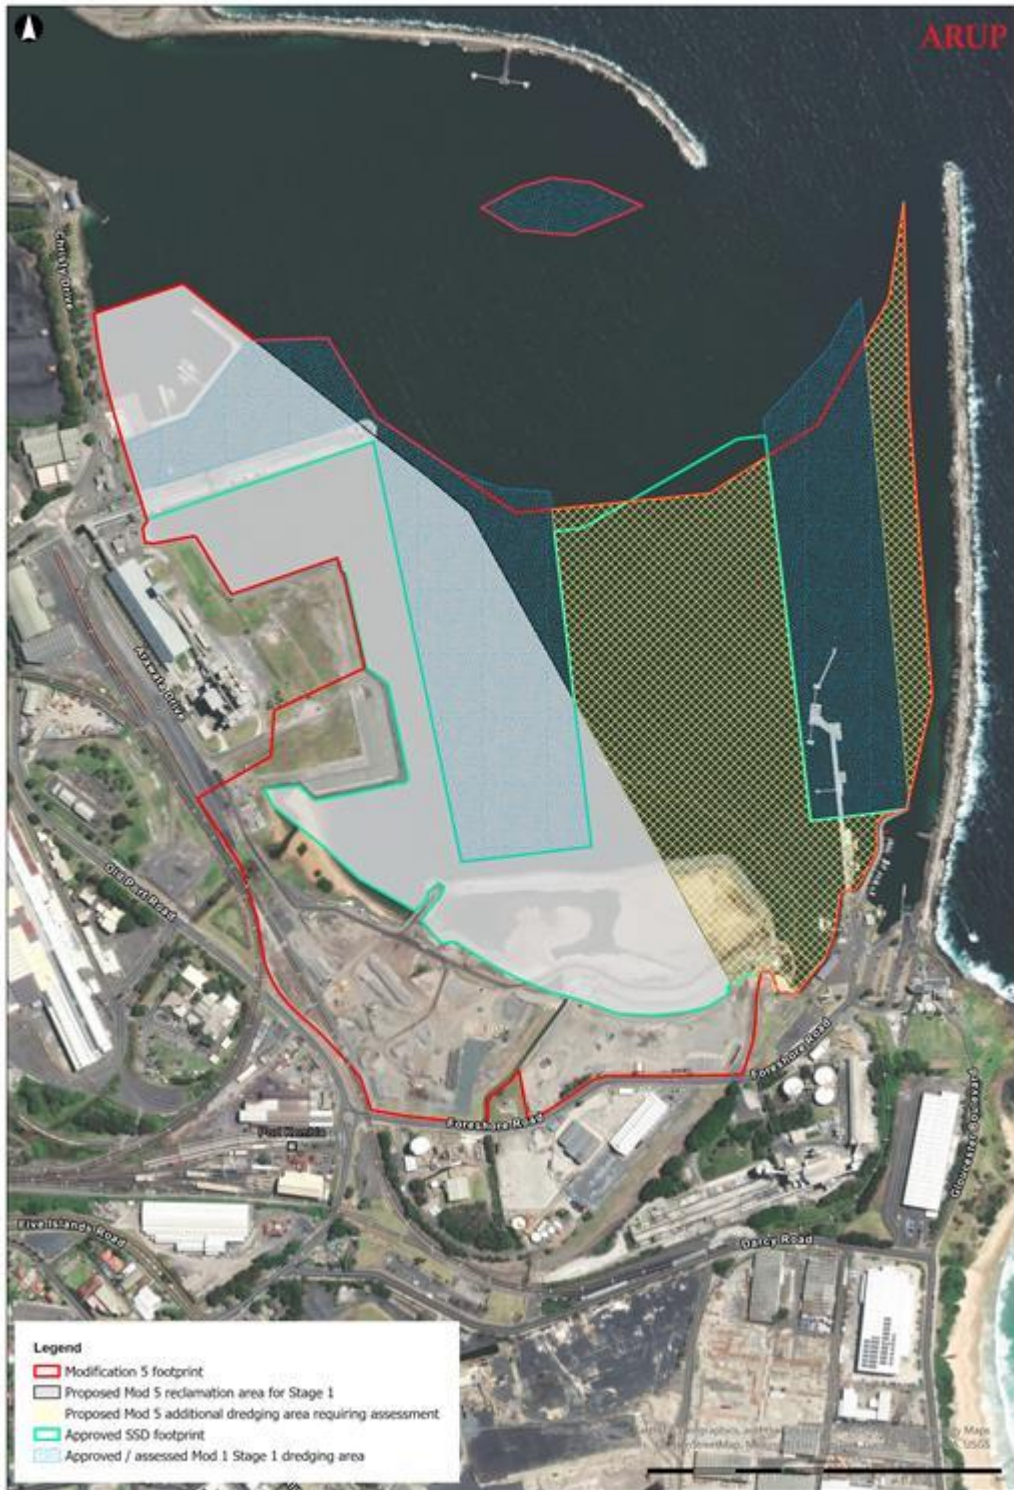
Figure 2: Proposed works locations⁴

- Stage 1:
 - Demolition of No.3, No.4 Jetties (including Berth 206) and Jetty No.6
 - Reconfigure the layout of the port facility to permit greater flexibility with the respect to the types of port uses that the development can accommodate. This reconfiguration aligns with the approved total reclamation area of 42 hectares. Reclamation works would now occur entirely within Stage 1

- Slight adjustment of dredging footprint
 - Construction of berths
 - Extension of Salty Creek and Darcy Road drain, through the reclamation area, the Outer Harbour

- Construction of a new road link from Christy Drive
 - Execution of civil works including services
 - Construction of new navigation lead towers.
- Concept:

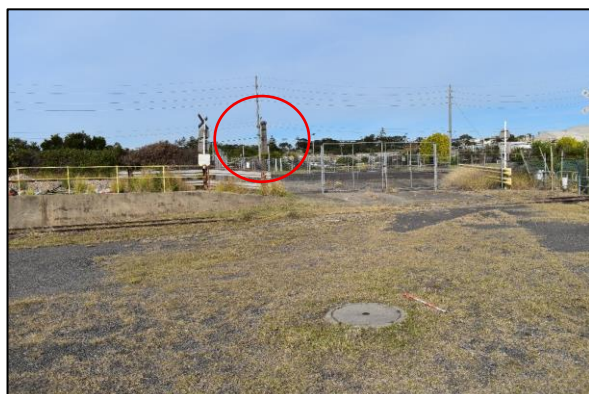
Figure 18: View south to SEPP Item 3 (Brick tower) from closest point of the proposed area (indicated in red)

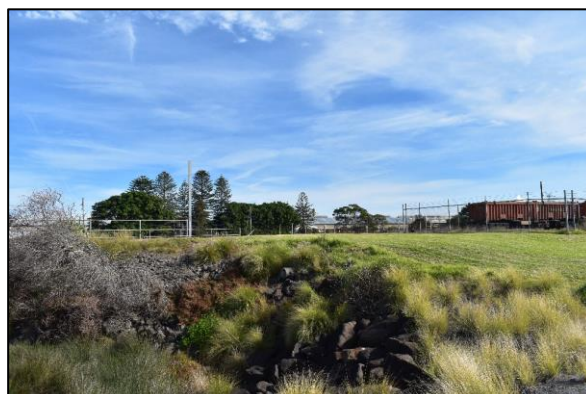
Much of the study area featured extant industrial and commercial structures, structures associated with the function of the Outer Harbour, and roadways, and only a relatively small portion of the site was vegetated. In these vegetated areas fill materials were ubiquitous, and it was apparent that the observed grass and plant cover were present as a function of intentional landscaping, or the growth of vegetation on soils that had accumulated on top of fill materials over time (Figure 19).

Figure 19: View southwest to SEPP Item 1 (Commonwealth Rolling Mill Plant and Gardens) from the closest point within the proposed works area. Majority of the SEPP item is obscured behind pines and other trees

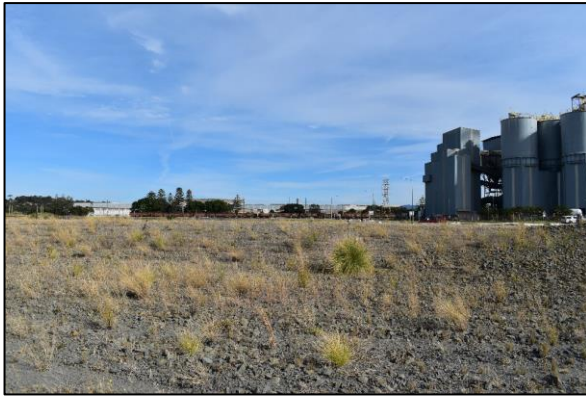
Figure 20: View southwest SEPP Item 1 (behind pines and other trees) from within the proposed works area

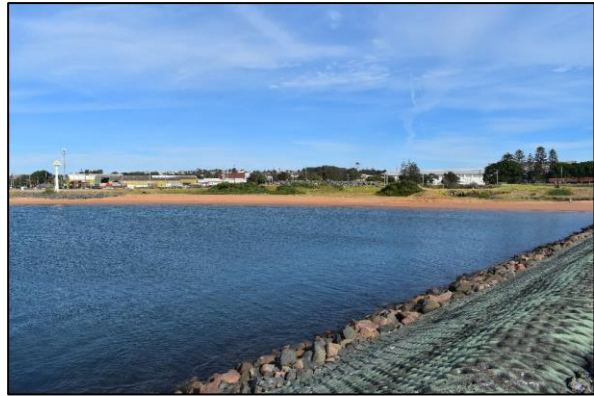
Figure 21: View towards SEPP item 1 (behind pines and other trees) from the reclaimed land to the west of the study area

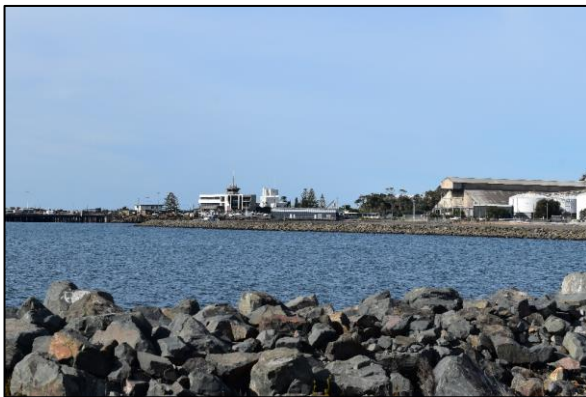
Figure 22: View east towards SEPP items 4 and 5, and SHR itemc01492 from eastern ground boundary of the proposed works

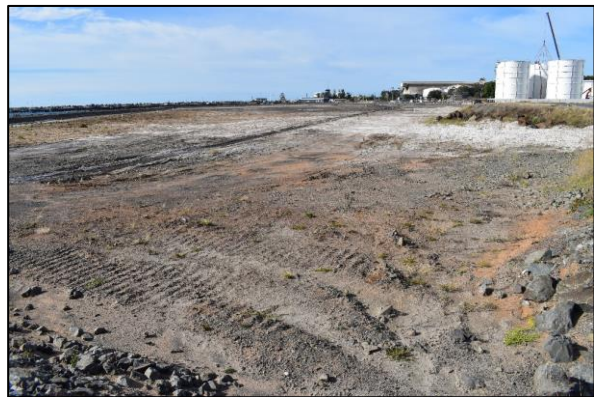
Figure 23: View east towards SEPP items 4 and 5, and SHR item from beach which has been subject to significance disturbance

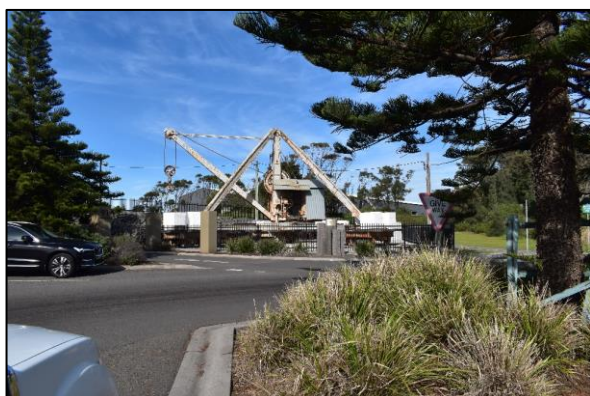
The Mobile Block Setting Steam Crane is locally significant as a tangible reminder of the construction of the Outer Harbour. It is also representative of cranes of this class and make which at one time operated throughout the state. It is also believed to be the last remaining of its type extant in the state. Its retention and preservation in a prominent yet historically appropriate location is recommended.

Figure 28: View of the Mobile Block Setting Steam Crane and towards heritage items and study area

Recommendation 3 – The Mobile Block Setting Steam Crane is a rare and representative example of such mobile cranes at a state level. It is therefore recommended that a Conservation Management Plan be implemented as soon as possible for the ongoing heritage management of the crane to ensure its continued maintenance in a condition befitting this status. As part of the plan a nomination for its inclusion on the State Heritage Register should be produced.

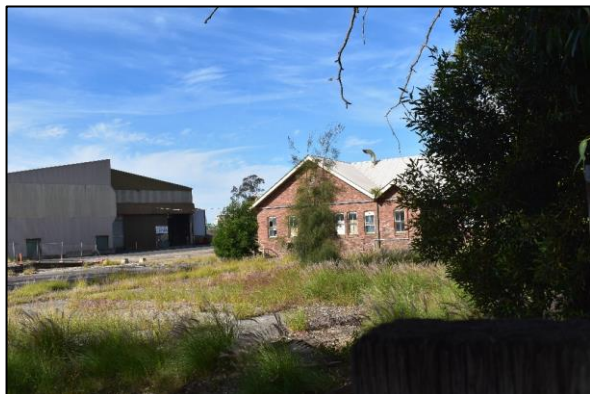
Figure 30: View north from SEPP item 2 (Brick structure) towards study area proposed works (obscured behind shed in background)

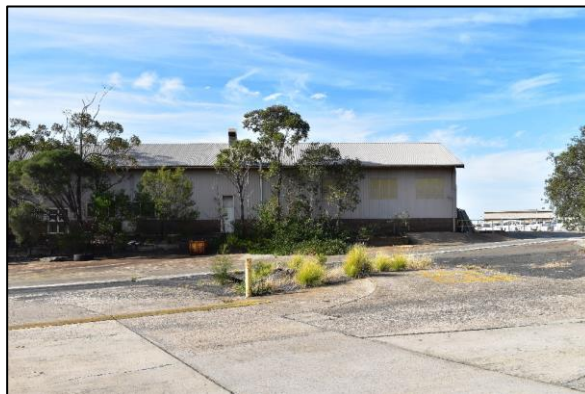
Figure 31: Views from SEPP items 2 (Brick structure) towards study area (behind shed in background)
