Engineering Log - Excavation

Project No: **GEOTWARA20576AA**

Client: **APP CORPORATION**

Project: **PROPSOED HMRI BUILDINGS**

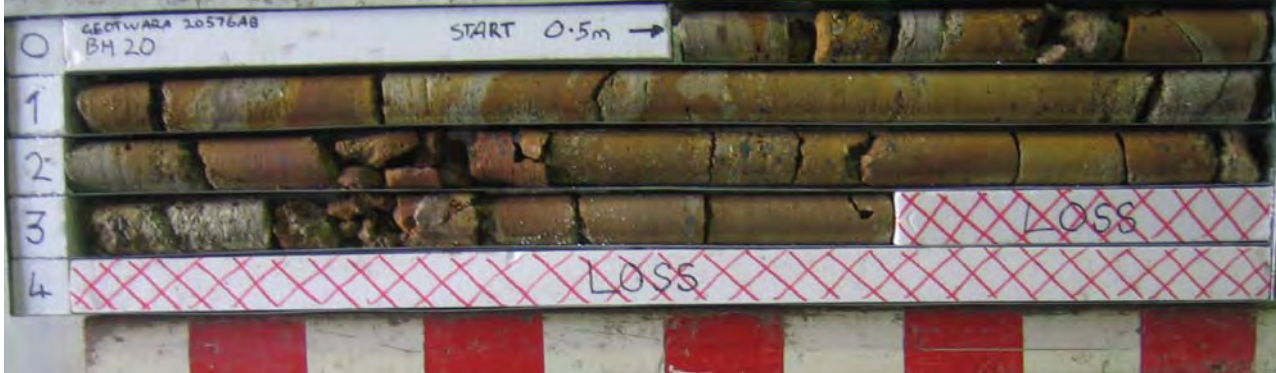
GEOTWARA20576AB
Box 1 of 2

BOREHOLE : BH20 0.5m to 5.0m

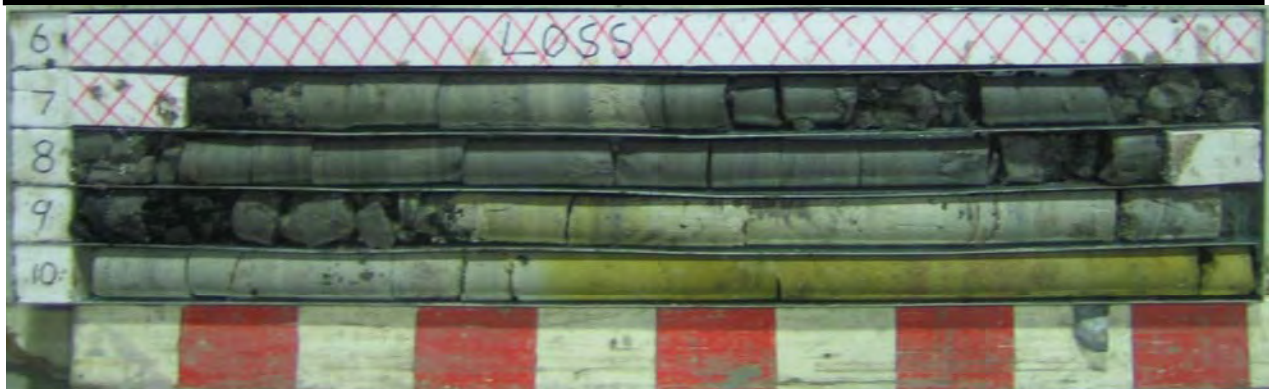
GEOTWARA20576AB
Box 2 of 3

BOREHOLE : BH21 6.0m to 11.0m

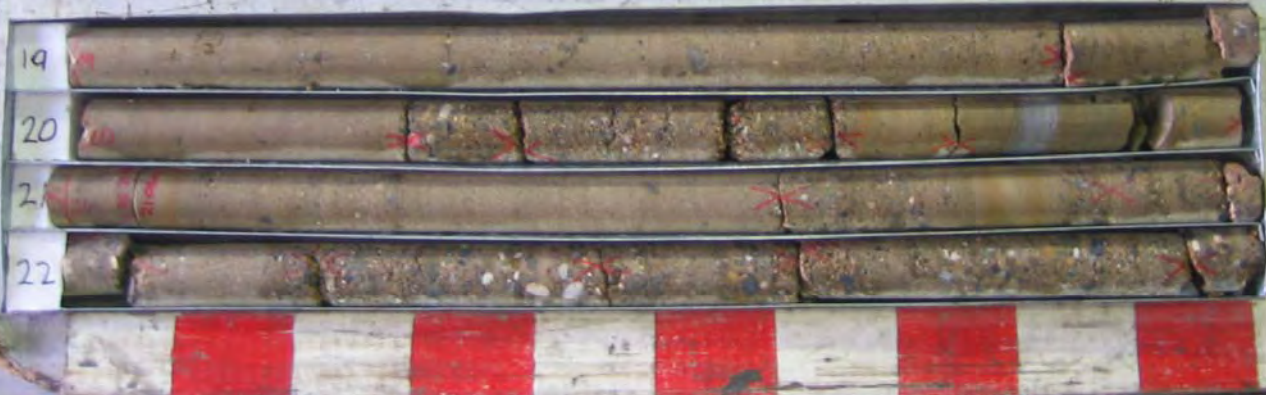
GEOTWARA20576AB
Box 2 of 20

BOREHOLE : BH22 19.00m to 23.00m

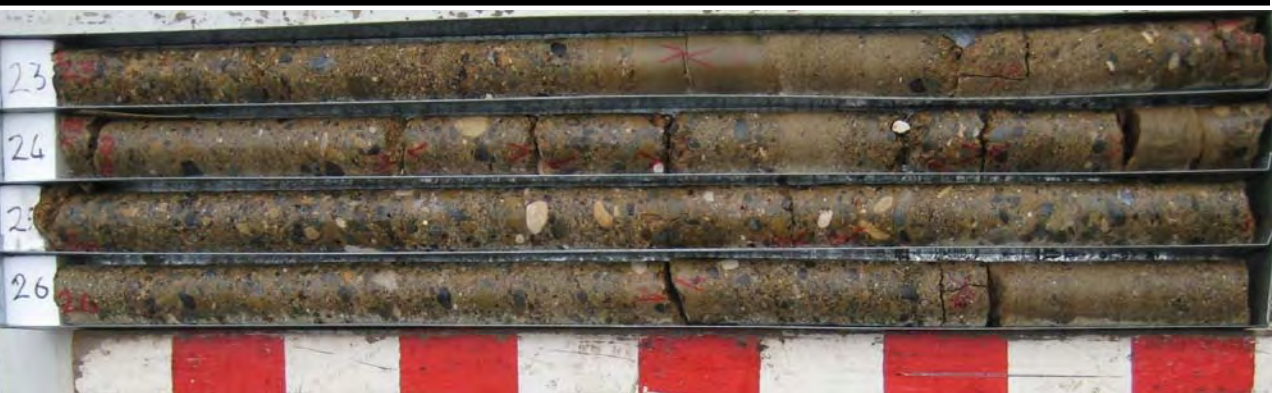
GEOTWARA20576AB
Box 3 of 20

BOREHOLE : BH22 23.00m to 27.00m

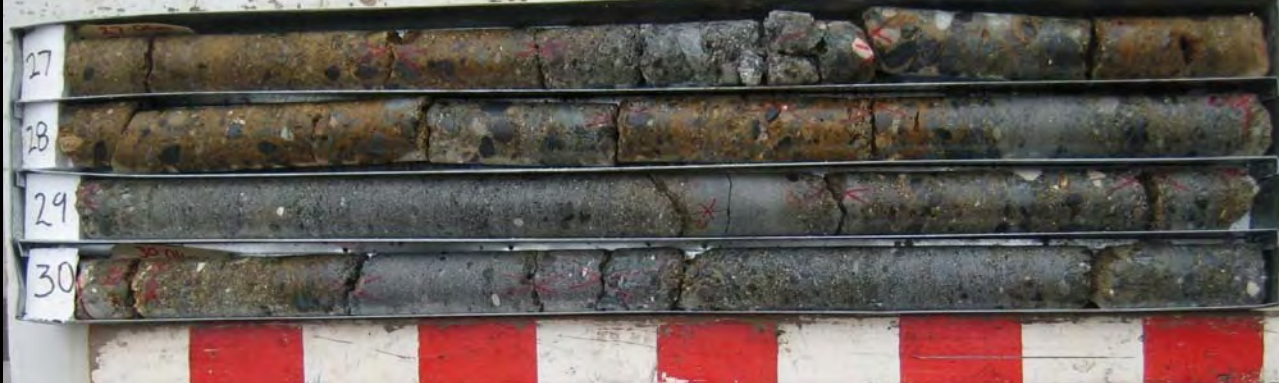
GEOTWARA20576AB
Box 4 of 20

BOREHOLE : BH22 27.00m to 31.00m

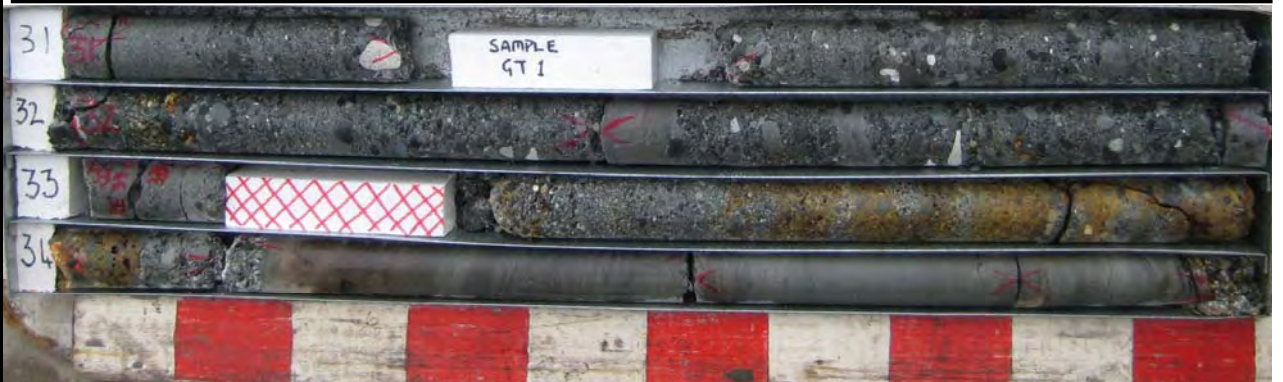
GEOTWARA20576AB
Box 5 of 20

BOREHOLE : BH22 31.00m to 35.00m

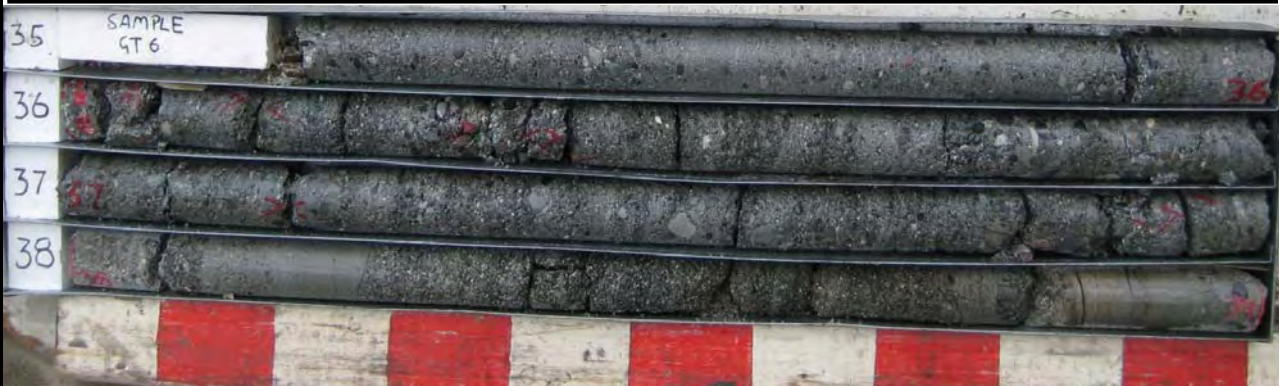
GEOTWARA20576AB
Box 6 of 20

BOREHOLE : BH22 35.00m to 39.00m

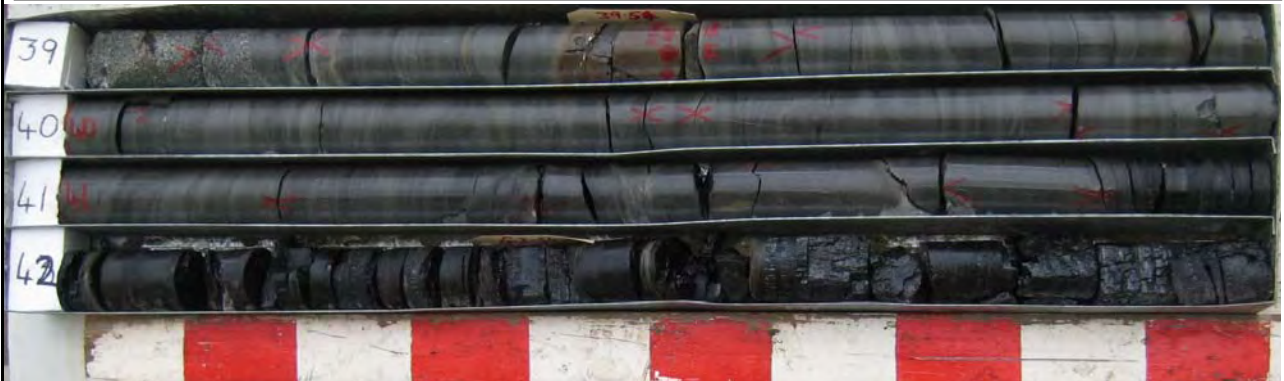
GEOTWARA20576AB
Box 7 of 20

BOREHOLE : BH22 39.00m to 43.00m

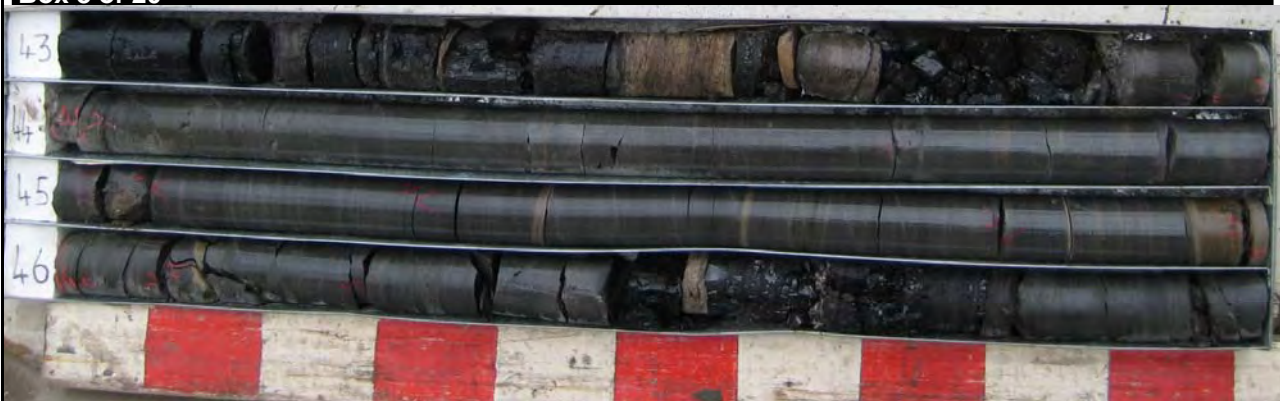
GEOTWARA20576AB
Box 8 of 20

BOREHOLE : BH22 43.00m to 47.00m

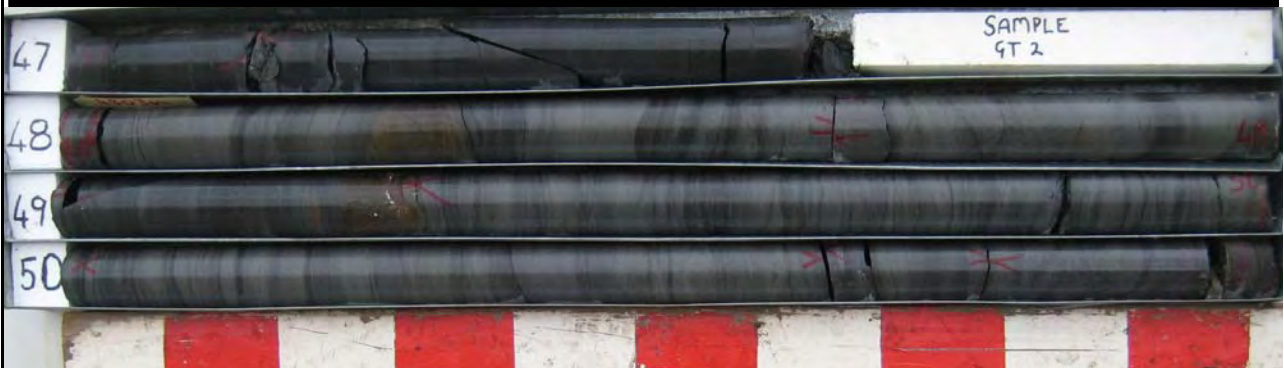
GEOTWARA20576AB
Box 9 of 20

BOREHOLE : BH22 47.00m to 51.00m
