2.4 Geology

2.5 Vegetation

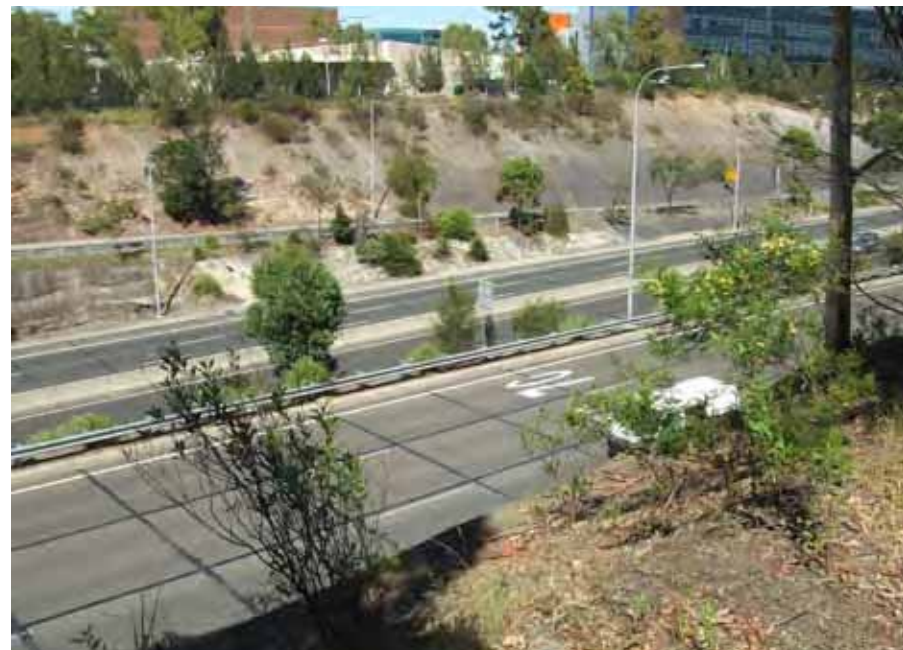
Photo 2.10 Shale seam in sandstone dominated geology

The Luddenham Soil Landscape characterises the corridor west of Windsor Road. This landscape is underlain by the Wianamatta Shale Group and is composed of Ashfield and Bringelly shale formations, between which Minchinbury sandstone is interlaid.

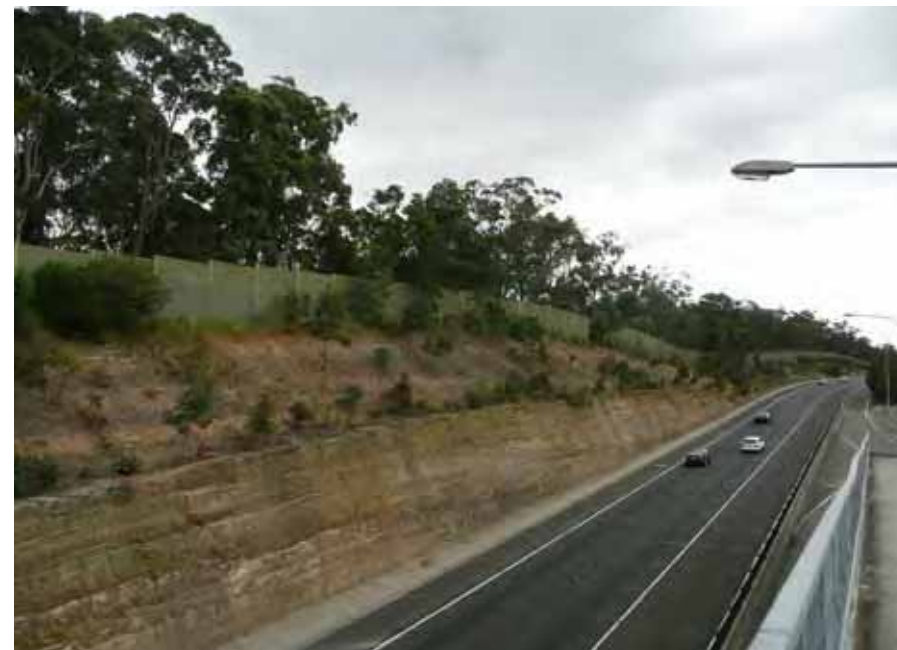
Photo 2.11 Sandstone is exposed in the motorway cuttings

Hawkesbury Soil Landscape is located between Windsor Road and Pennant Hills Road where it occurs in association with Blue Gum and Darling Mills Creeks, as depicted in Photo 2.11. The unit is characterised by steep rugged sandstone slopes and ridges of Hawkesbury sandstone which is a medium to coarse grained quartz sandstone with minor shale laminate lenses. A second area adjoins the Gymea landscape where the motorway follows the Devlins Creek Valley.

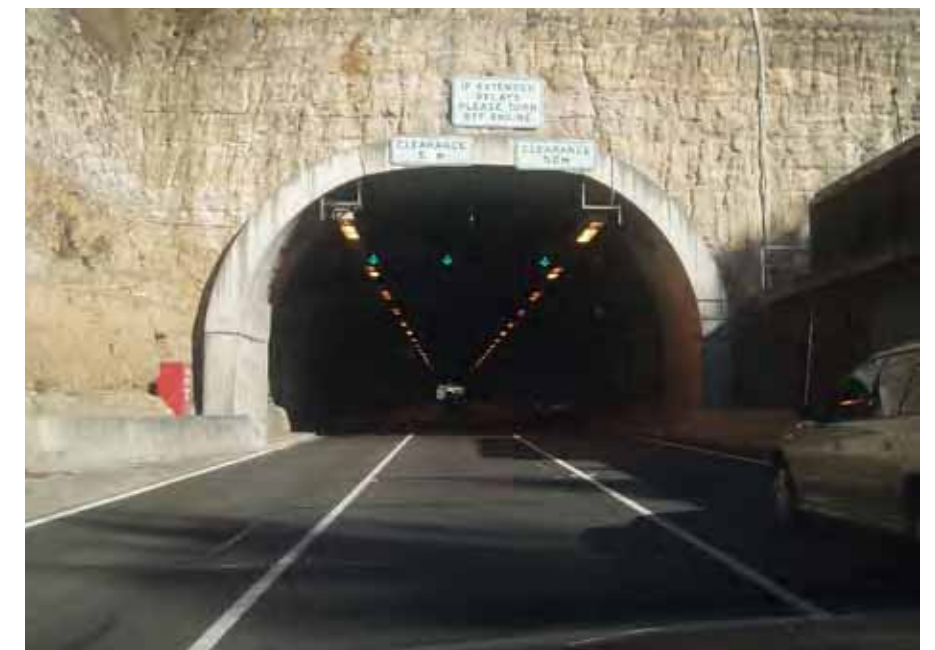
Photo 2.12 Tunnel portal area reveals the local geology

The Gymea Soil Landscape occurs in steeper terrain west of Terrys Creek and is evident by increased valleys. The steeper terrain is highlighted by the Norfolk Road Tunnel as depicted in Photo 2.12 and reveals the character of this rock. It marks the edge of the Hornsby Plateau. The geology is Hawkesbury sandstone which is a medium to coarse grained quartz sandstone with minor shale laminate lenses. The geology is similar to the Lambert and Hawkesbury Soil Landscapes.
