# APPENDIX H

## BLAST VIBRATION VULNERABILITY ASSESSMENT

# EDINGGLASSIE HOMESTEAD & ROUS LENCH

BLAST VIBRATION VULNERABILITY

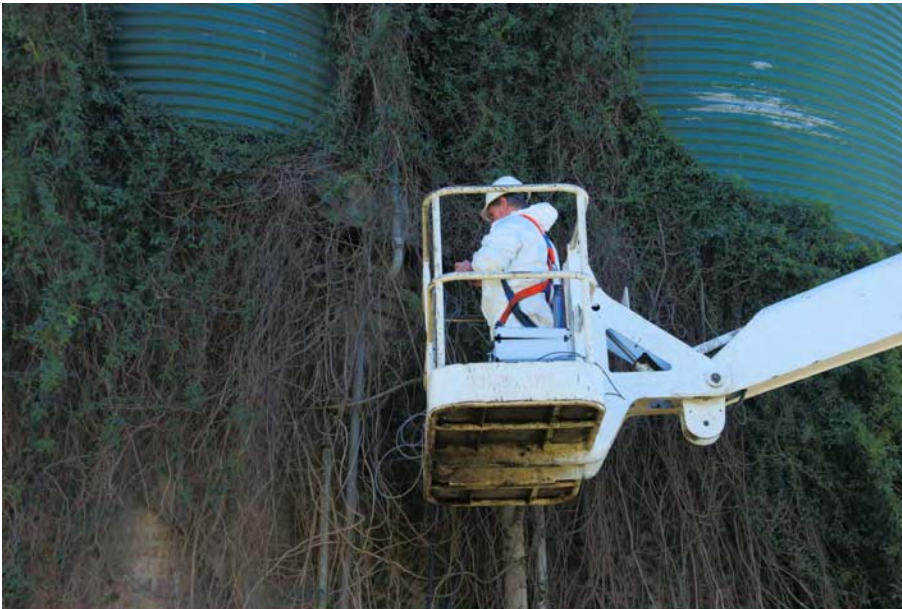
*Figure 3: The three sensors were set up on top of the brickwork at the narrow end of the tank stand at a location where maximum movement was expected in the first mode vibration.*

Monitoring using three separate geophone elements was carried out on Thursday 14 May 2009 (the tank stand) and Tuesday 19 May 2009 (the games room in Edinglassie). Figures 3 to 7 show the monitoring setup.

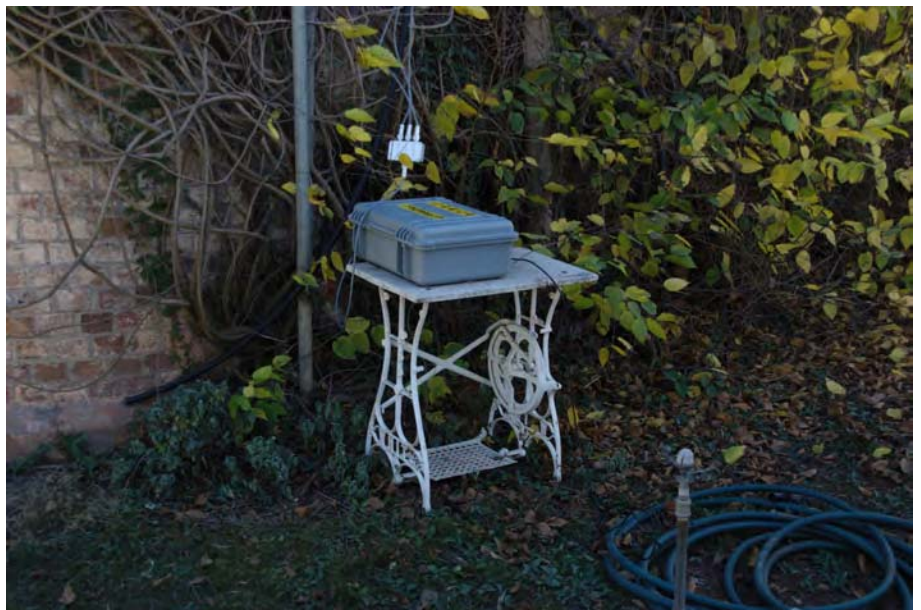
*Figure 4: The recorder at the base of the tank stand had a wireless Internet link to the Datamasters headquarters.*

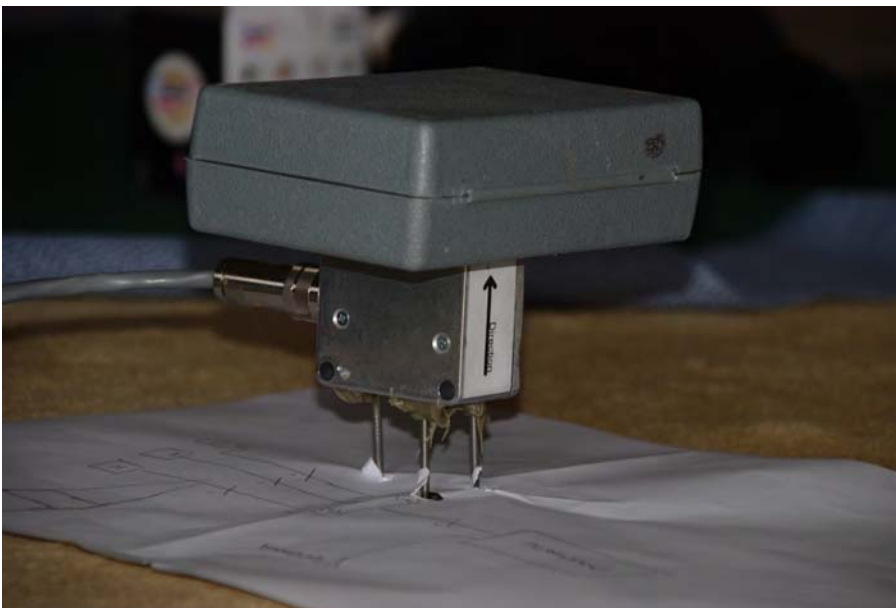
*Figure 5: A vertical sensor was set up in the middle of the floor above the games room, rigidly connected to the timber flooring with large nails (the tool box was placed to help secure it).*

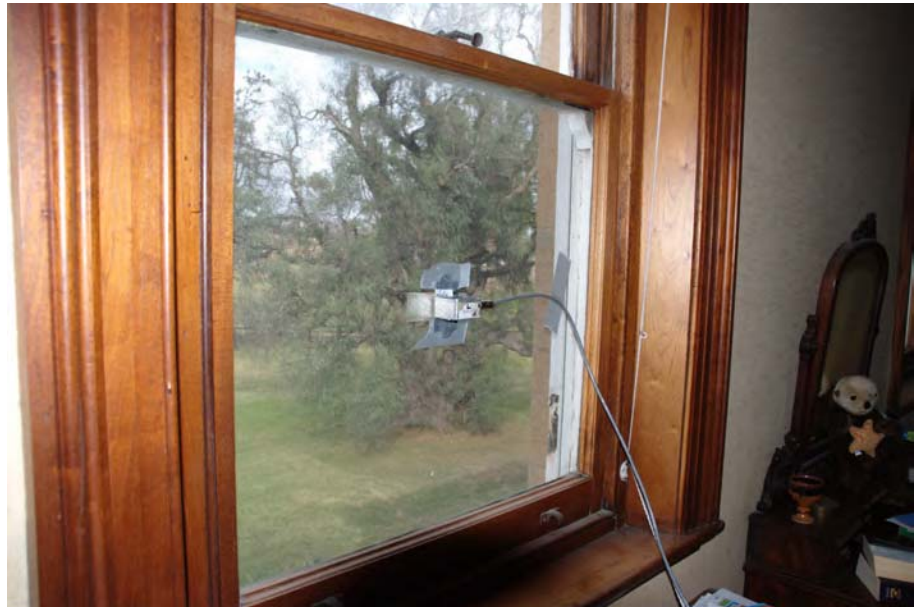
*Figure 6: A horizontally oriented sensor was attached to the middle of a typical window pane facing the blast site.*

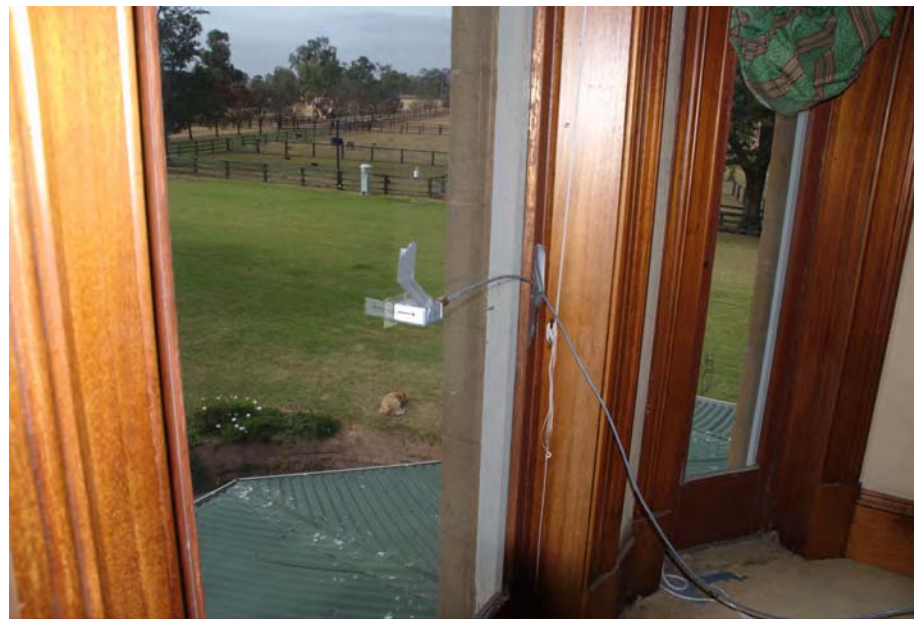
*Figure 7: The second horizontal sensor was attached to the lower pane of a french window facing eastwards.*

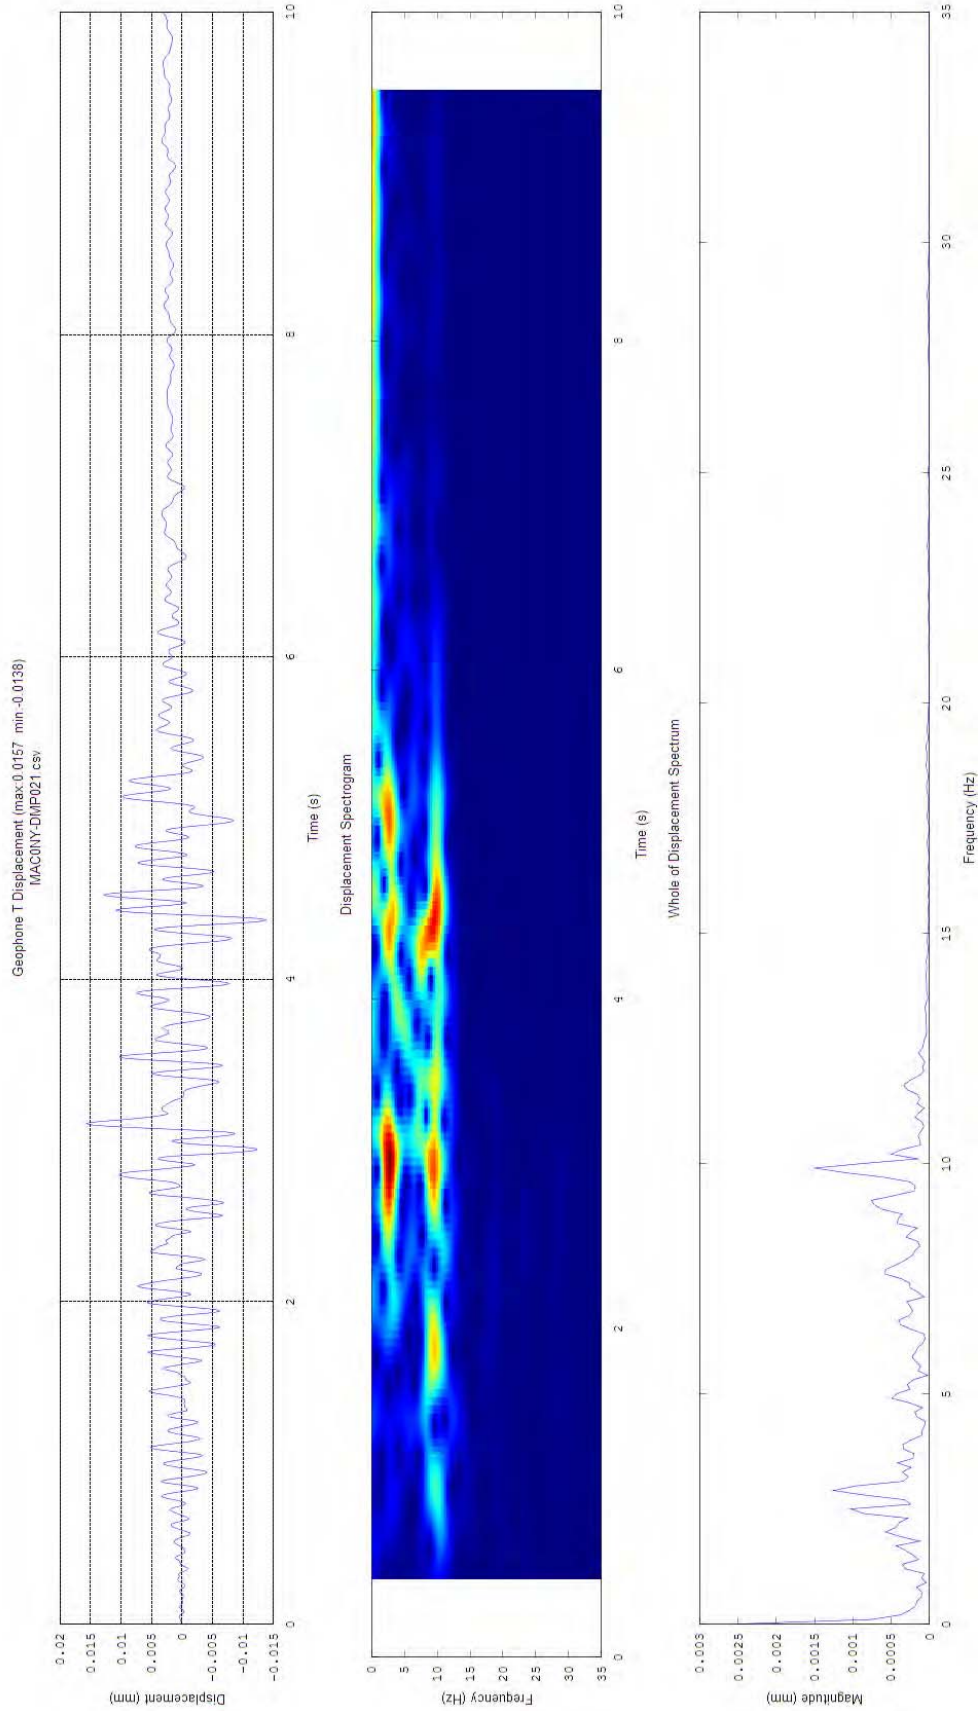
Geophone T Displacement Waveform with no pre-processing of velocity data.
