# **Orchard Hills Waste and Resource Management Facility**

## **Visual Assessment**

**February 2010**

**Specialist Consultant Studies Compendium  
Volume 2, Part 7**

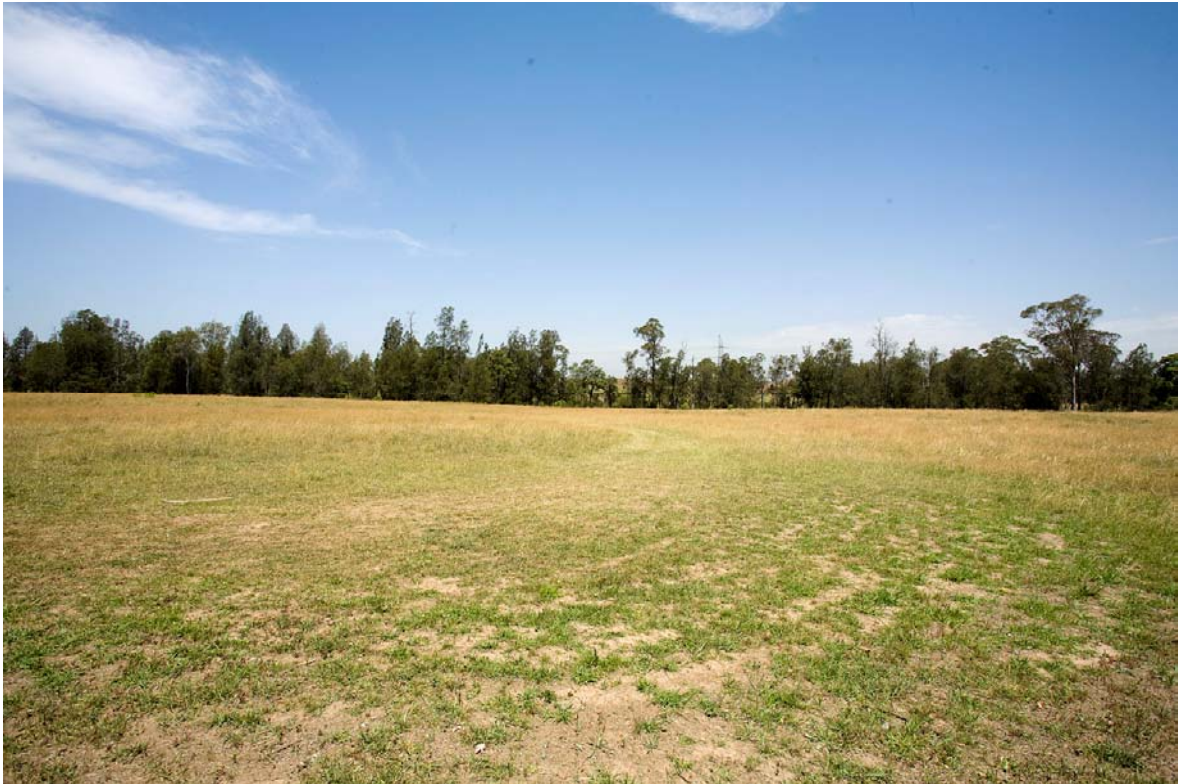
**Plate 1:** View of section of the northwestern bund wall approximately 500m from Cabernet Circuit at “The Vines” estate. As illustrated in the photo, the existing tree canopy located along Blaxland Creek screens the northwestern bund wall on the Project Site from this lower elevation within the estate.

Elevations of residences in Cabernet Circuit are typically approximately 35mAHD in contrast to elevations between 40mAHD and 63mAHD and the Project Site. As illustrated in **Plates 1 and 2**, the tree canopy extends beyond the height of the northern bund wall when viewed from those properties closest to the Project Site.

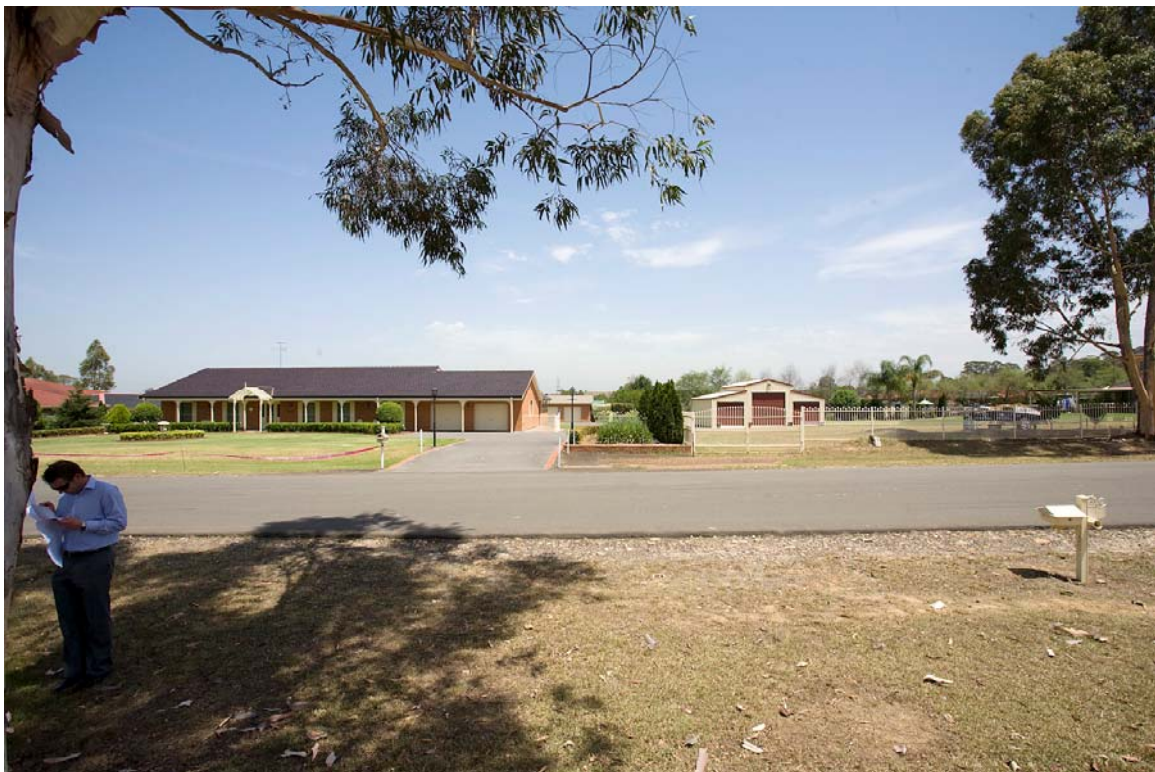
**Plate 2:** View southwards of the Project Site approximately from Bordeaux Place at “The Vines” estate. Only the top of part of the northeastern bund wall is able to be viewed from those residences at the lower elevations within the estate.

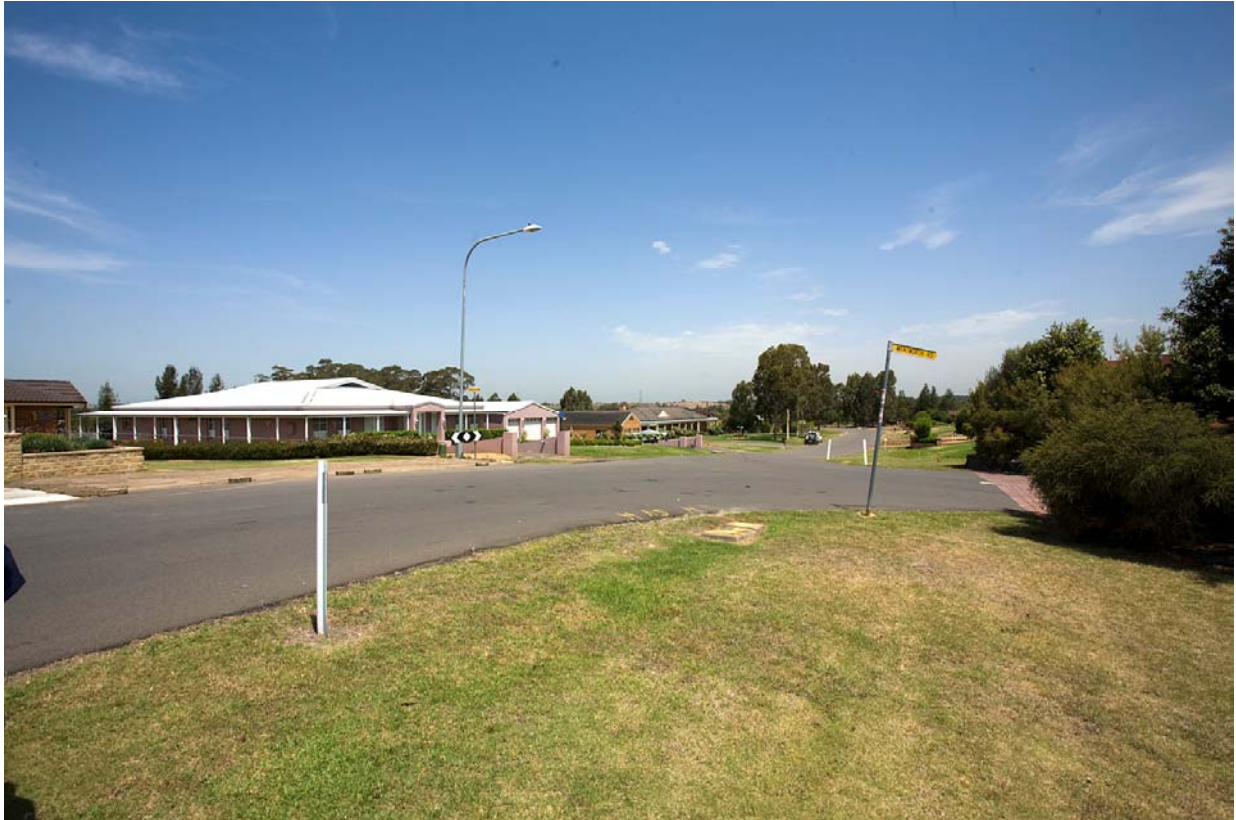
**Plate 3:** View southwards towards the Project Site from approximately 1km away in Verdelho Way at “The Vines” estate. The exposed northern face of the northwestern bund wall and the stockpile of previously extracted clay/shale material on the Project Site becomes more prominent at the higher levels within the estate as the line of sight is projected over the top of those trees along Blaxland Creek.

For those residences within “The Vines” estate located at higher elevations to the north, views of the Project Site’s bund walls become more prominent as the eye line is above the Blaxland Creek tree canopy as illustrates in **Plate 3** below.

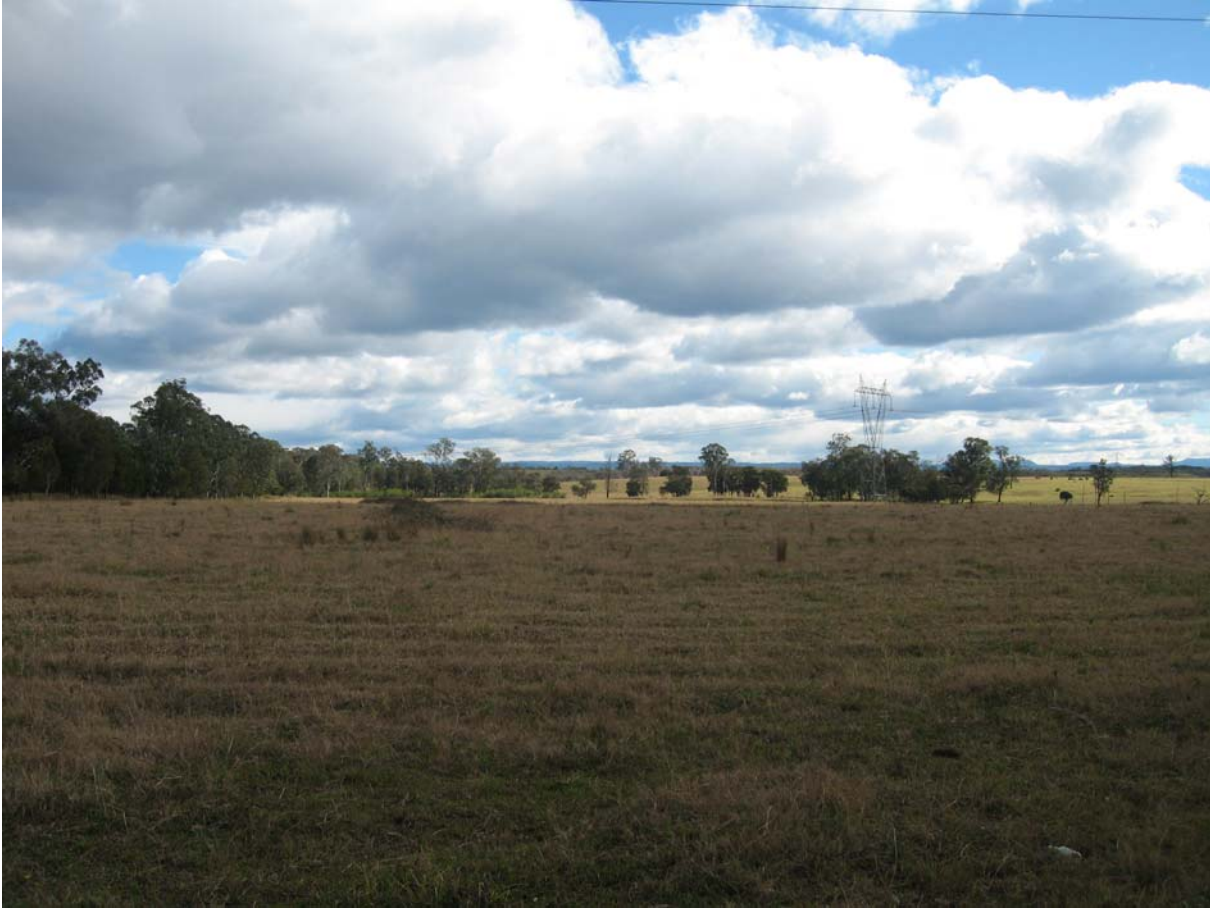
**Plate 4: View of the eastern bund wall of the Project Site approximately 1km away from Luddenham Road. The bund wall is difficult to differentiate from the natural undulating topography of the landscape surrounding it.**

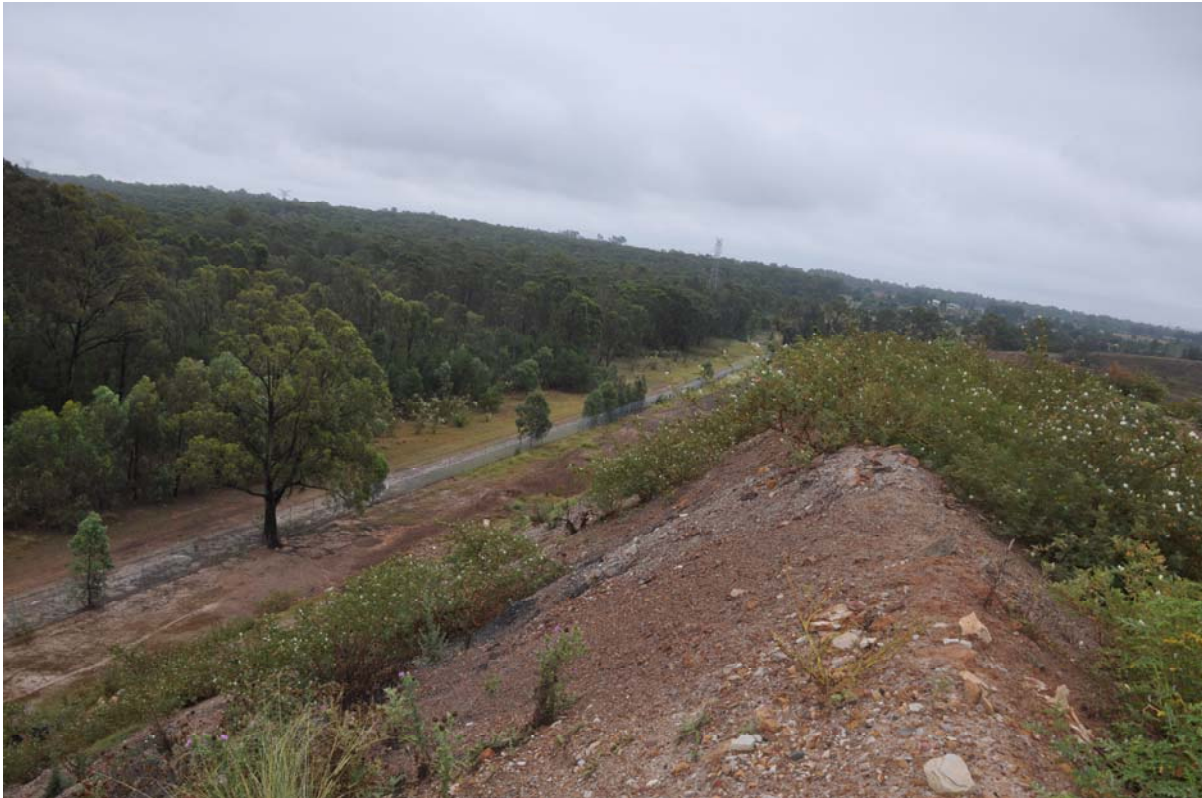
**Plate 6:** Views to the west and northwest from the top of the western bund wall on the Project Site. The land to the west of the Project Site is owned by the Commonwealth and access to that area was unavailable. As illustrated however, the land to the west comprises dense vegetation that would significantly screen the western bund walls on the Project Site from more distant locations.

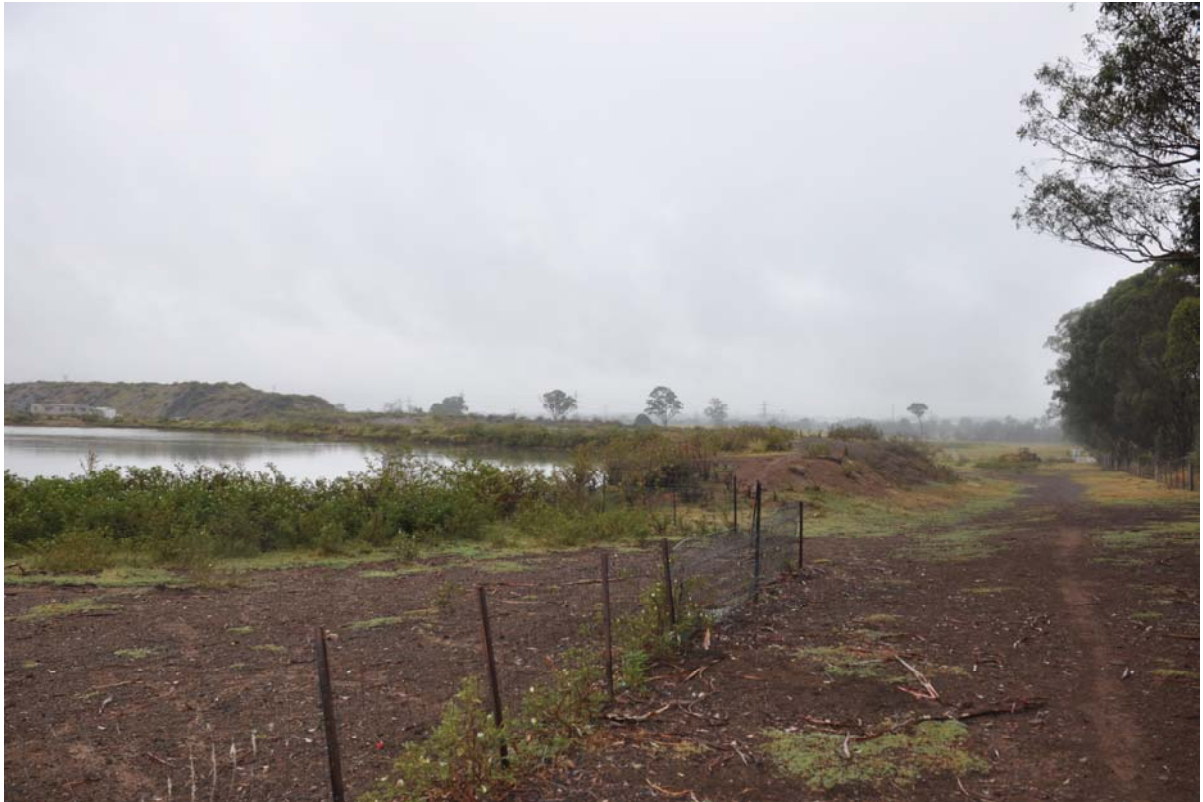
**Plate 7:** View along the Project Site's southern boundary from the west. This photo illustrates that the southeastern corner of the Project Site is generally flat and unaltered except for the small dam wall.

The topography of approximately half of the Project Site's southern boundary is generally unaltered (see **Plate 7** below). For the remaining half, a bund wall approximately 10m high exists (see **Plate 8** below).

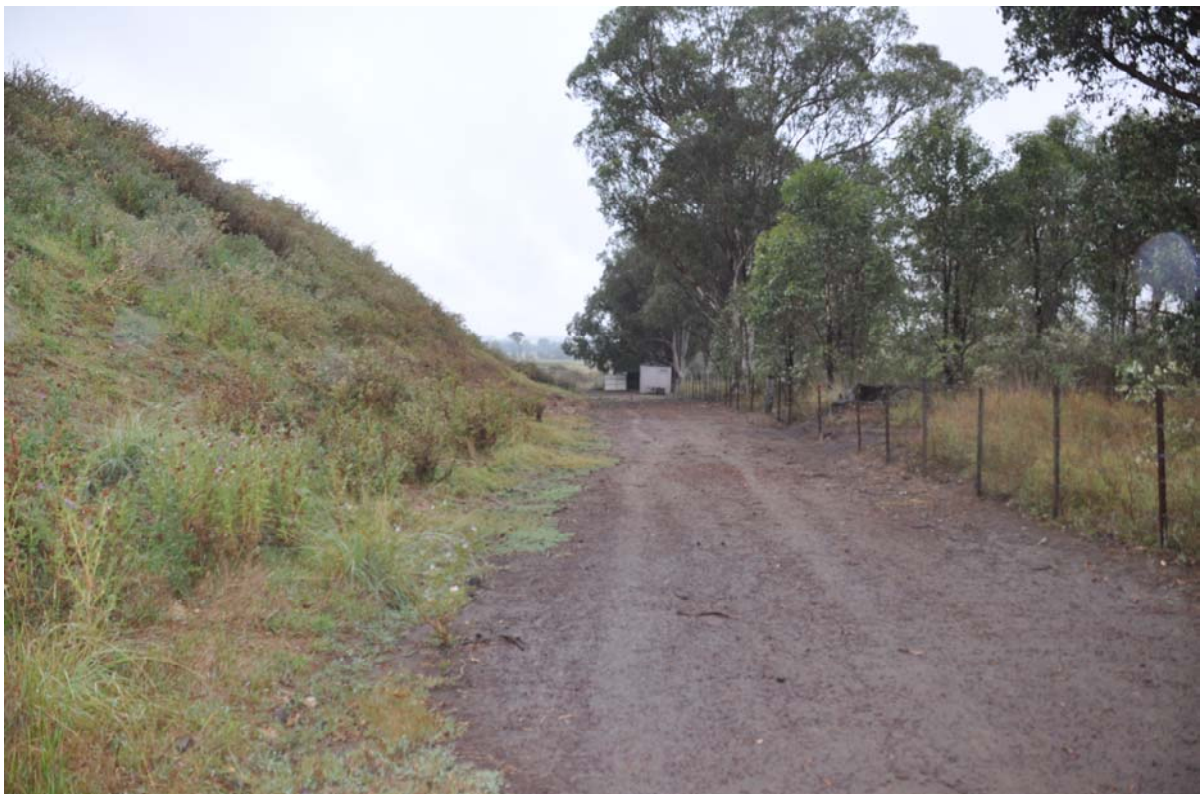
**Plate 8:** A view along the southern boundary Project Site at the western end where the bund walls are in place.

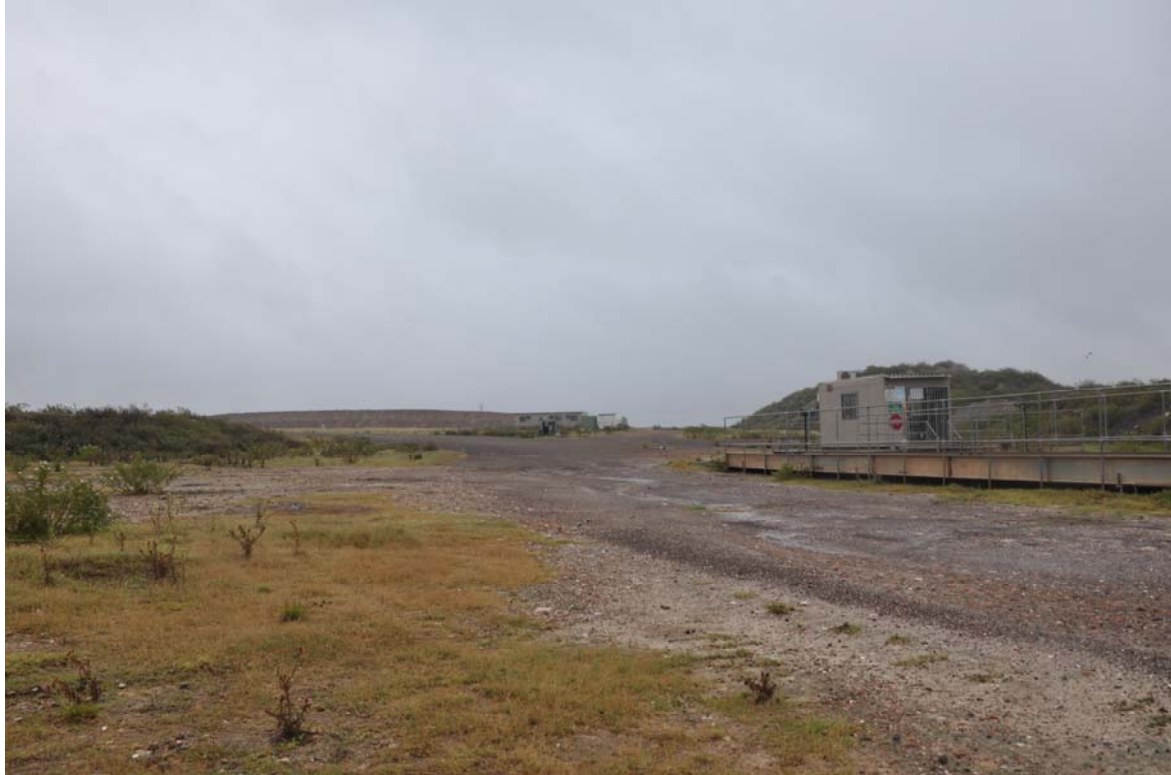
**Plate 9:** View from the southern boundary at the entry to the Project Site from Patons Lane to the north and/or centre of the Project Site. The photo illustrates clay stockpiles in the centre and the eastern bund wall on the right hand side.

Glimpses of the southern portion of the Project Site would only be viewed from all of the above-mentioned privately owned land from approximately 500m away as a result of the existing tree canopy, particularly, on Patons Lane. Within 100m of the Project Site, some of the internal bund walls and remaining material stockpiles can also be viewed from private land and the public domain (see **Plate 9** below).

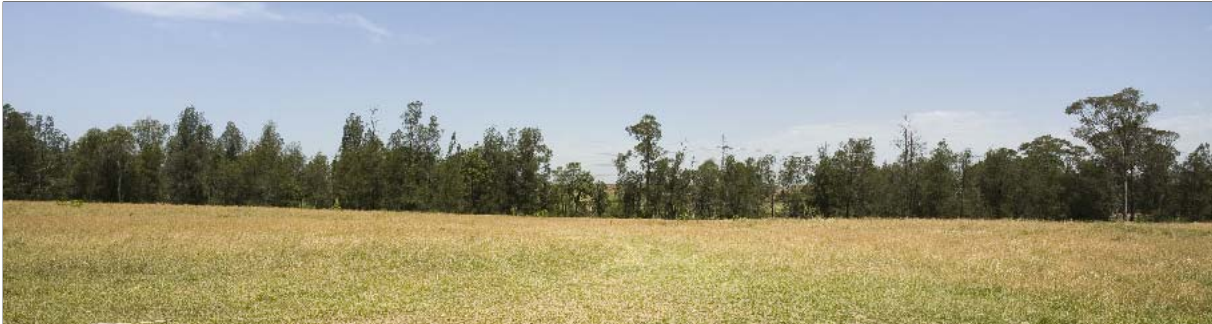
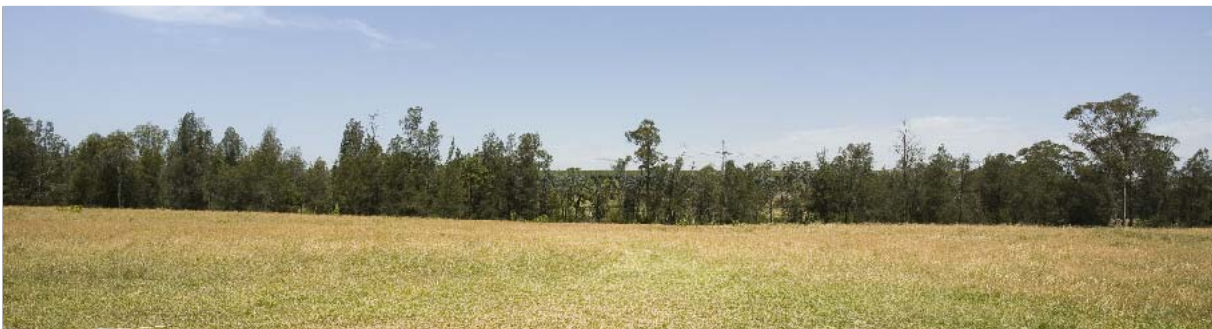
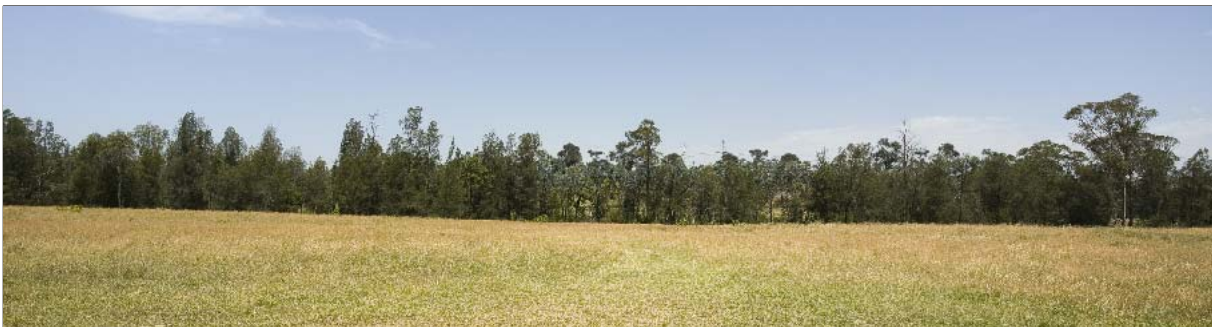
Photomontage 1

Existing View

View after Construction of Visual Bund

View of the Final Landform

The appearance of the northern bund wall in the early operational stages from within “The Vines” at approximately 500m, 800m and 1km from the Project Site is illustrated in the “View after Construction of Visual Bund” presentations in **Photomontages 1, 2 and 3**.

**Photomontages 1, 2 and 3** also illustrate the final landform when viewed from the north within “The Vines” estate from the same locations as the early operations photomontages above mentioned. As illustrated in the photomontages, the views of the site would be consistent with the surrounding rural landscape and represent a significant improvement from those locations, particularly within “The Vines”, where the bund walls can currently be seen. Some of the key points to note in these photomontages are the removal of the acoustic timber fence and mobile acoustic barrier and the mature vegetation screening that would be provided by the landscaping implemented in the early operational stages.

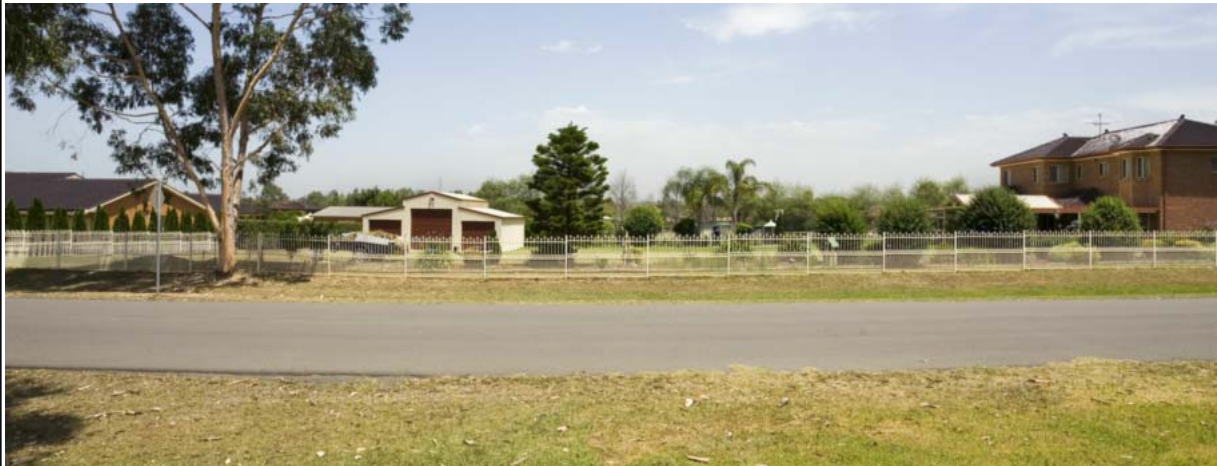
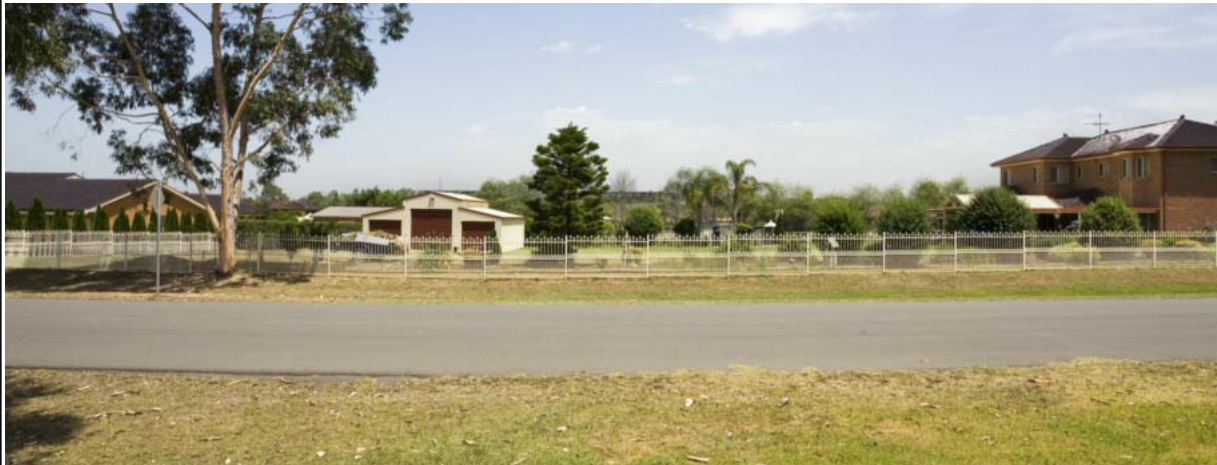
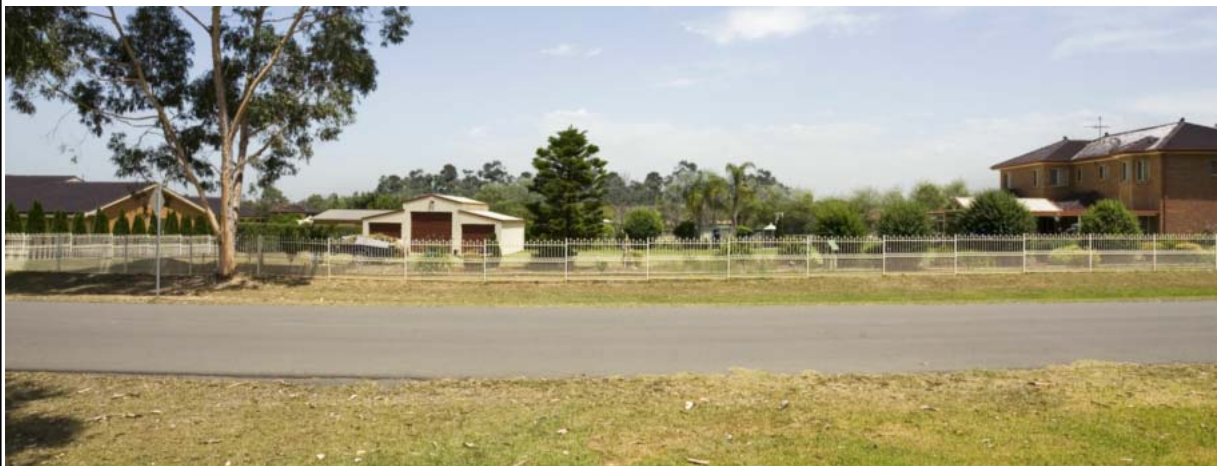
Photomontage 2

Existing View

View after Construction of Visual Bund

View of the Final Landform

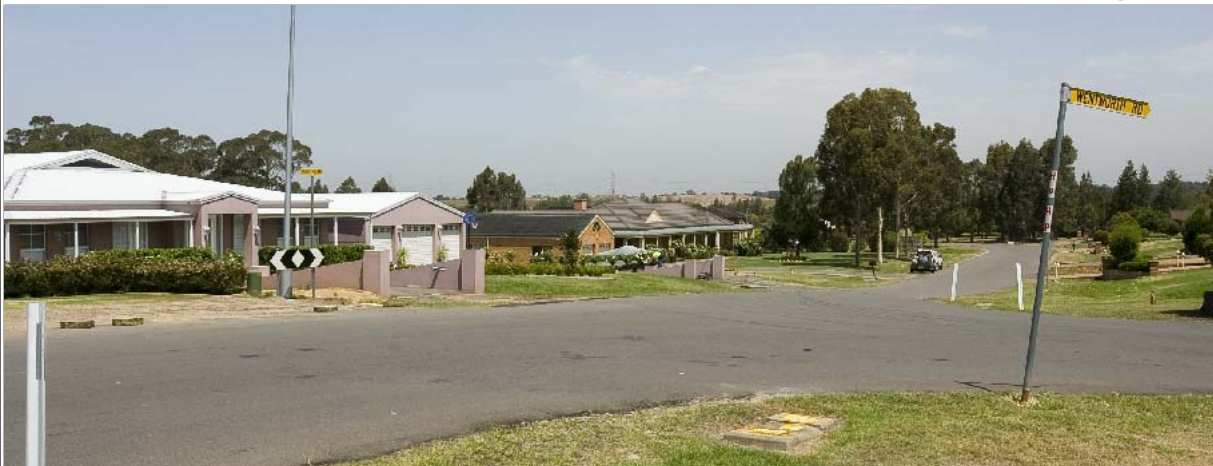
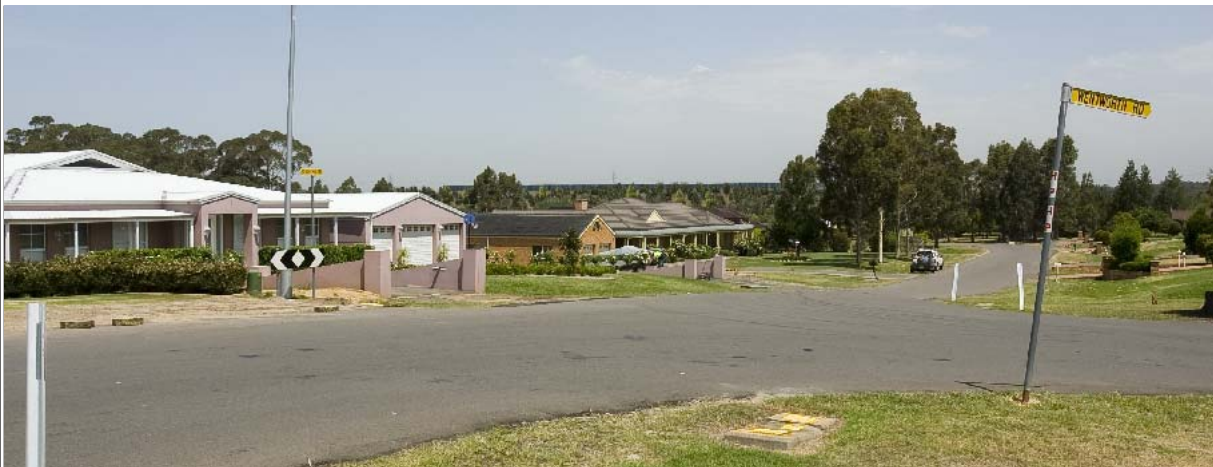
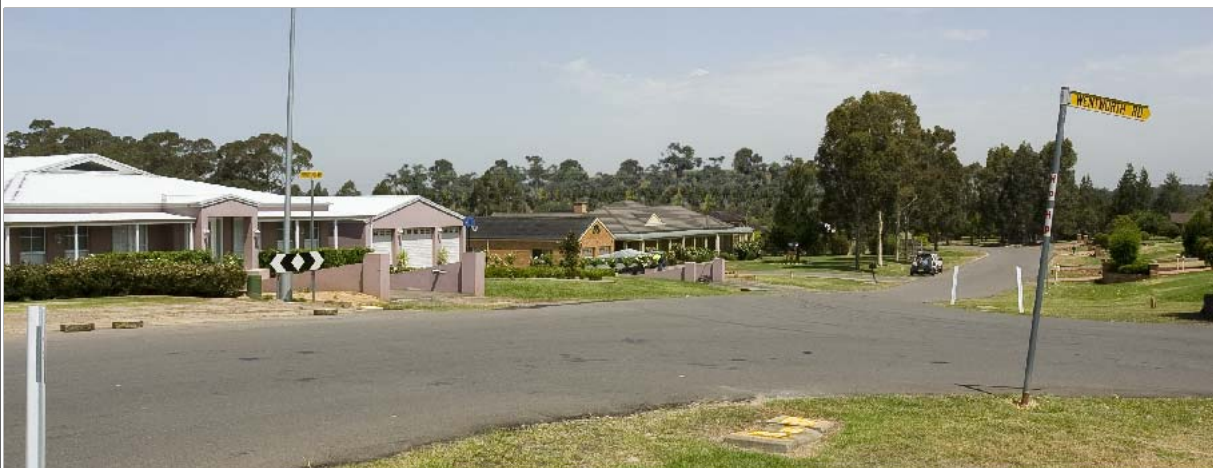
Photomontage 3

Existing View

View after Construction of Visual Bund

View of the Final Landform

An indicative location of the 4m-high acoustic barrier when operating at the higher levels has been provided corresponding with the view from the location of **Photomontage 3**. A close up view of a typical acoustic barrier that would be used is shown in **Figure 8**. The mobile acoustic barrier itself would be painted in a mottle green hue to limit its visibility. The ends of the barrier would be noticeable providing a contrast to the skyline.

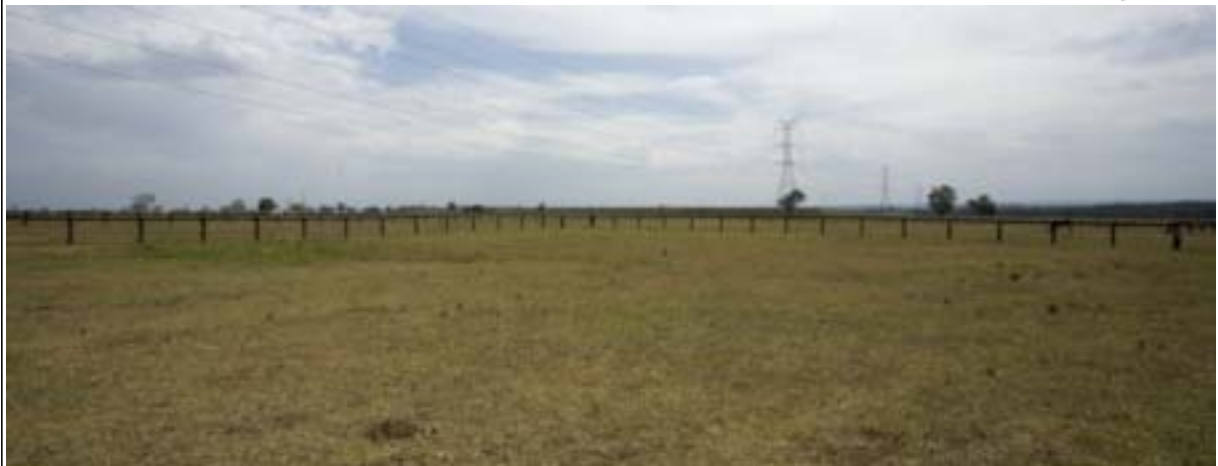
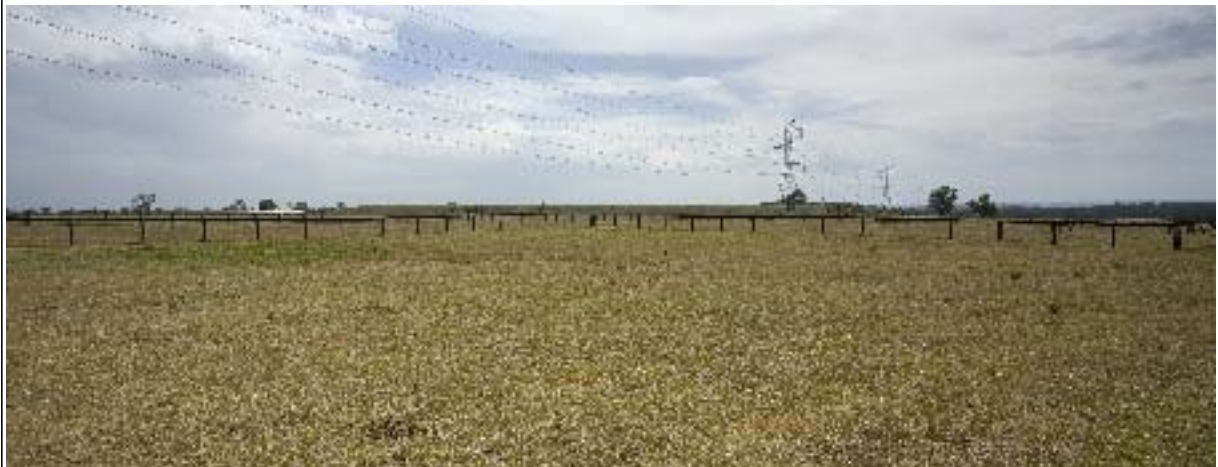
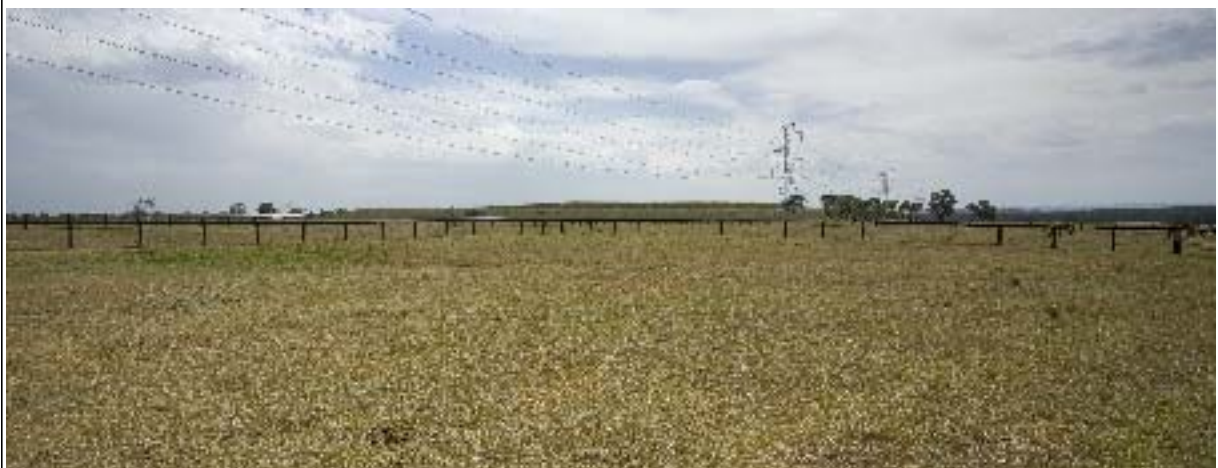
Photomontage 4

Existing View

View after Construction of Visual Bund

View of the Final Landform

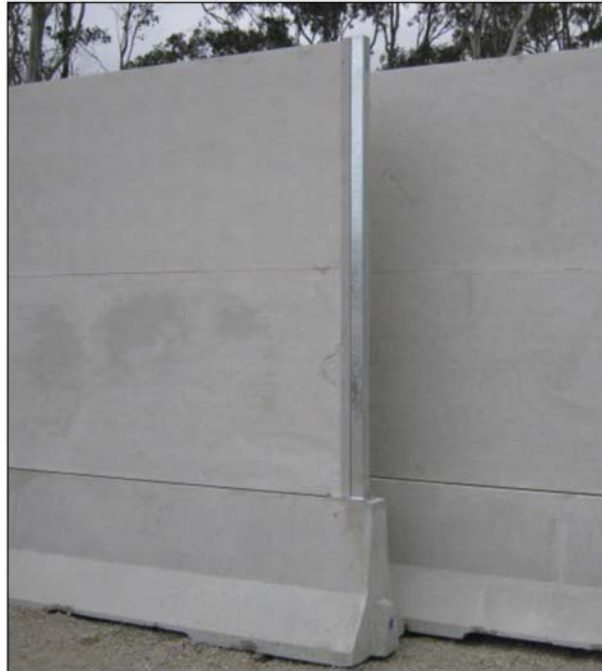
**FIGURE 8**

Typical Acoustic Barrier

**Close up view of proposed relocatable 4m acoustic barrier to be moved around the face of the northern bund wall depending on the location of which will be dictated by where work is being undertaken**

Some of the key features to note in the early operation photomontages include the 2m high timber acoustic fence on top of the reshaped northern bund wall. Also, a 4m high mobile acoustic barrier will be located along different positions of the northern bund wall to reduce noise from machinery operating in this area during the construction phase. The mobile barrier would also be used when undertaking earthworks on the final landform above the 55m level of the northern bund wall (and the 58m level of the eastern bund wall).
