**REPORT  
on  
GEOTECHNICAL INVESTIGATION**

**PROPOSED WALLACE WURTH REDEVELOPMENT  
CORNER OF HIGH STREET AND BOTANY STREET  
UNSW, KENSINGTON**

**Prepared for  
BOVIS LEND LEASE**

**Project 71543  
March 2010**

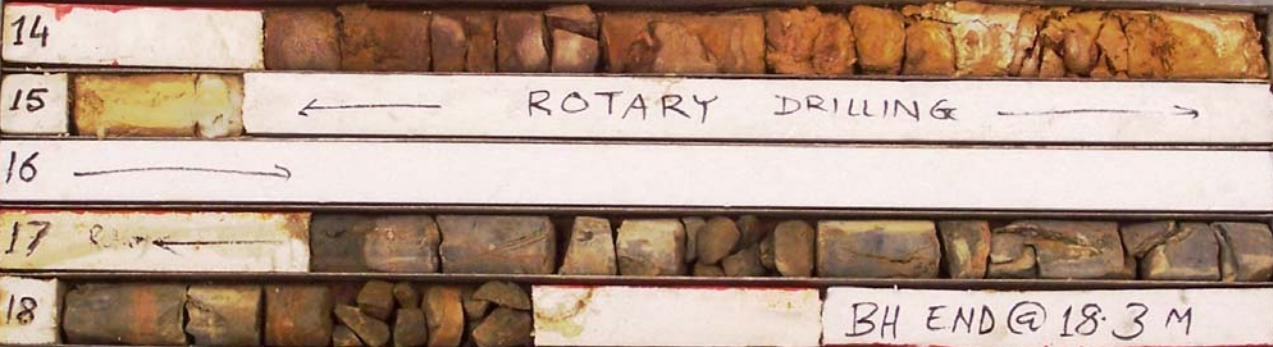
DOUGLAS PARTNERS PTY LTD  
WALLACE WURTH BUILDING UPGRADE, UNSW – KENSINGTON  
BORE 3 PROJECT 71543 FEB 2010

9.50 - 13.00M

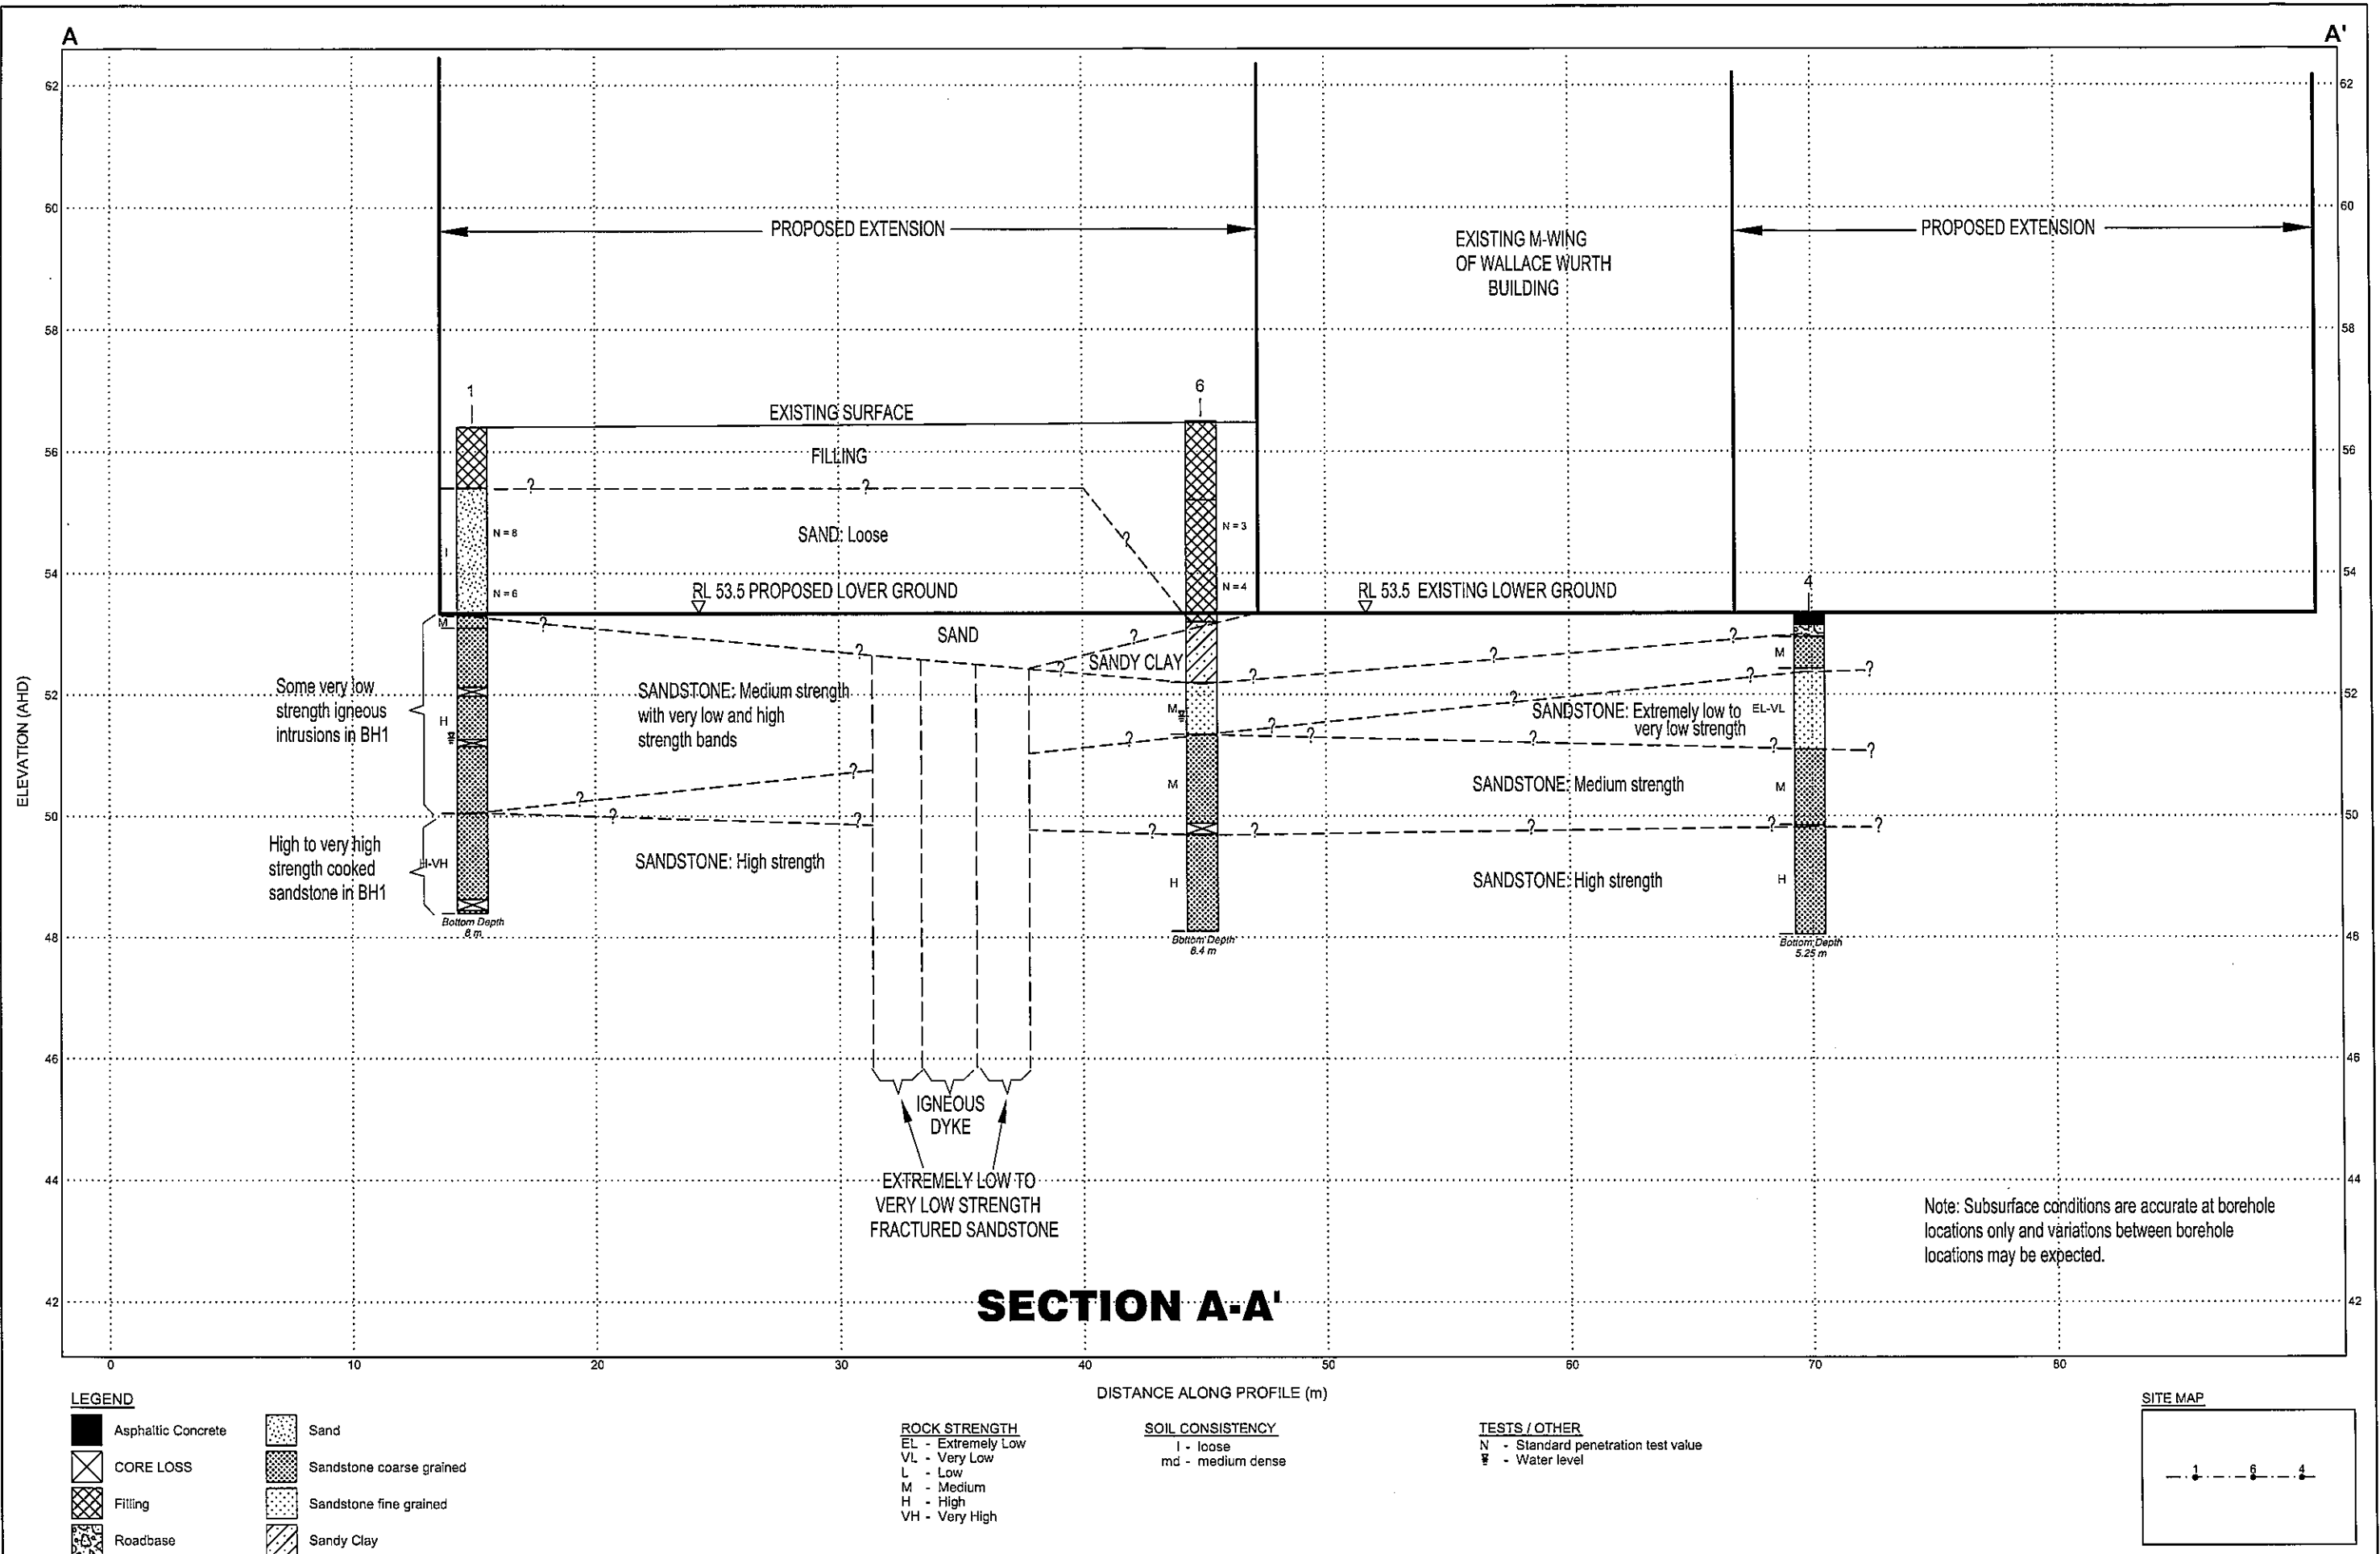
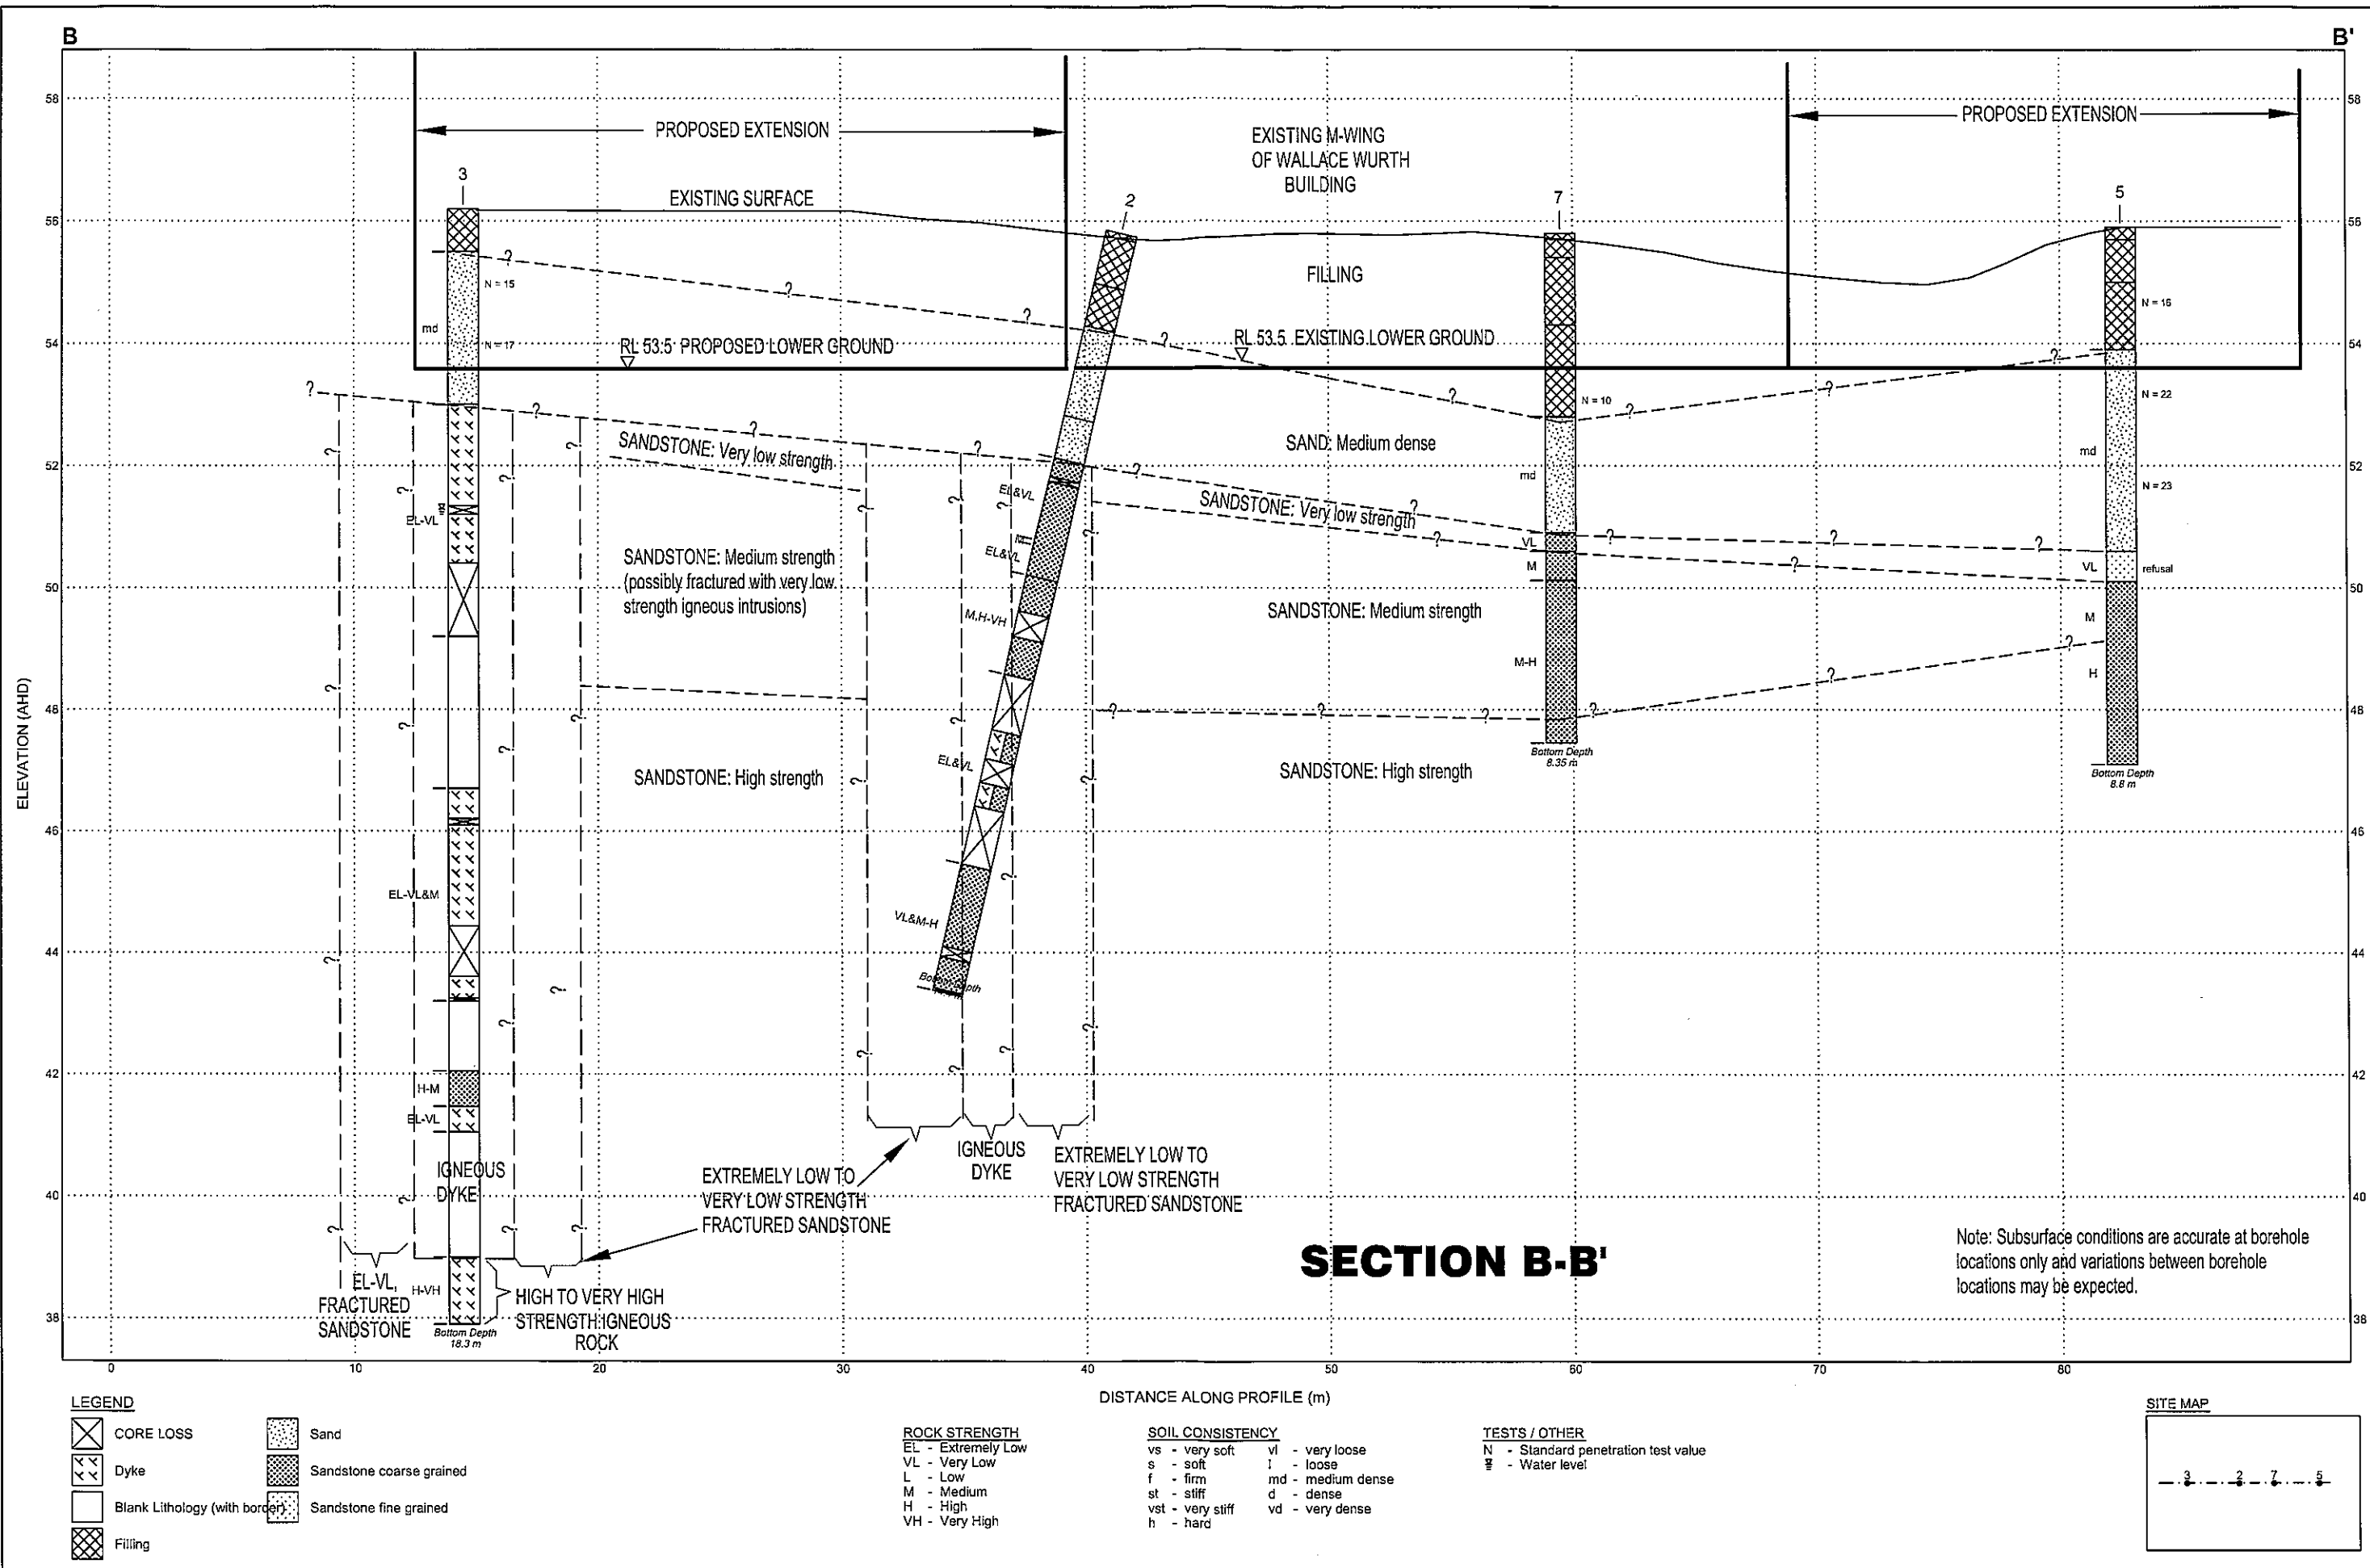
DRAWING No: 1

POSSIBLE LOCATION OF DYKE BASED ON BORES 1 AND 3 (ASSUMED ONLY AND MAY NOT BE CORRECT)

Details of the conditions encountered in the boreholes are given in Appendix A, together with colour photographs of the rock core samples and notes defining classification methods and descriptive terms. The borehole locations are shown on Drawing 1 in Appendix B.
