RICHMOND QUARRY

**Annual Review 2019
Calendar Year**

IMS-COMP-G-0875-RQ

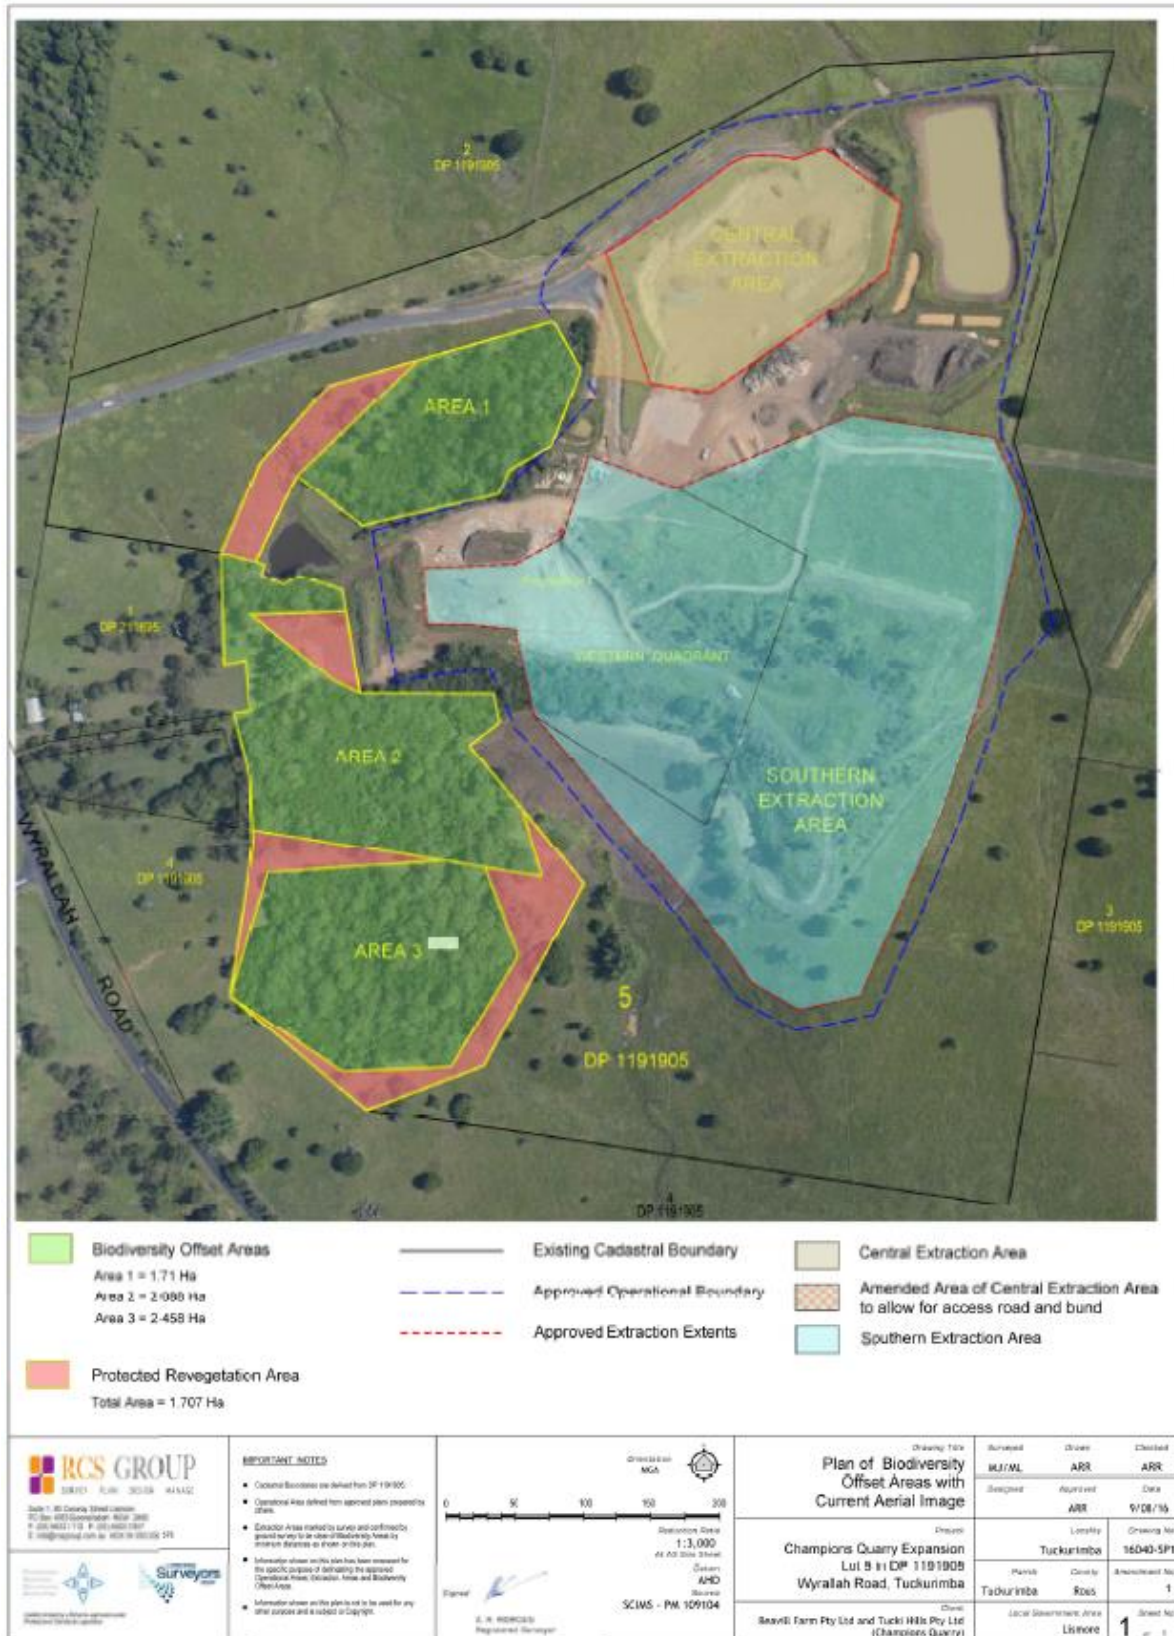
Figure 2: Project Layout (extract from Appendix 6 of Project Approval 09_0080)

The project layout, showing the following is provided as Figure 2 of Appendix A. The project layout includes:

- Approved operational boundary.
- Approved extraction extent.
- Biodiversity Offset Areas.
- Protected Revegetation Area.

Heritage management conditions are covered under Conditions 34, 35 and 36 of Project Approval 09_0080. Throughout 2019, site activities operated within the operational footprint shown in Figure 2 in Appendix A. No Aboriginal or non-aboriginal heritage items were detected throughout site operations in 2019. Previous cultural heritage investigations on-site have not detected any Aboriginal or non-aboriginals heritage items in the area.

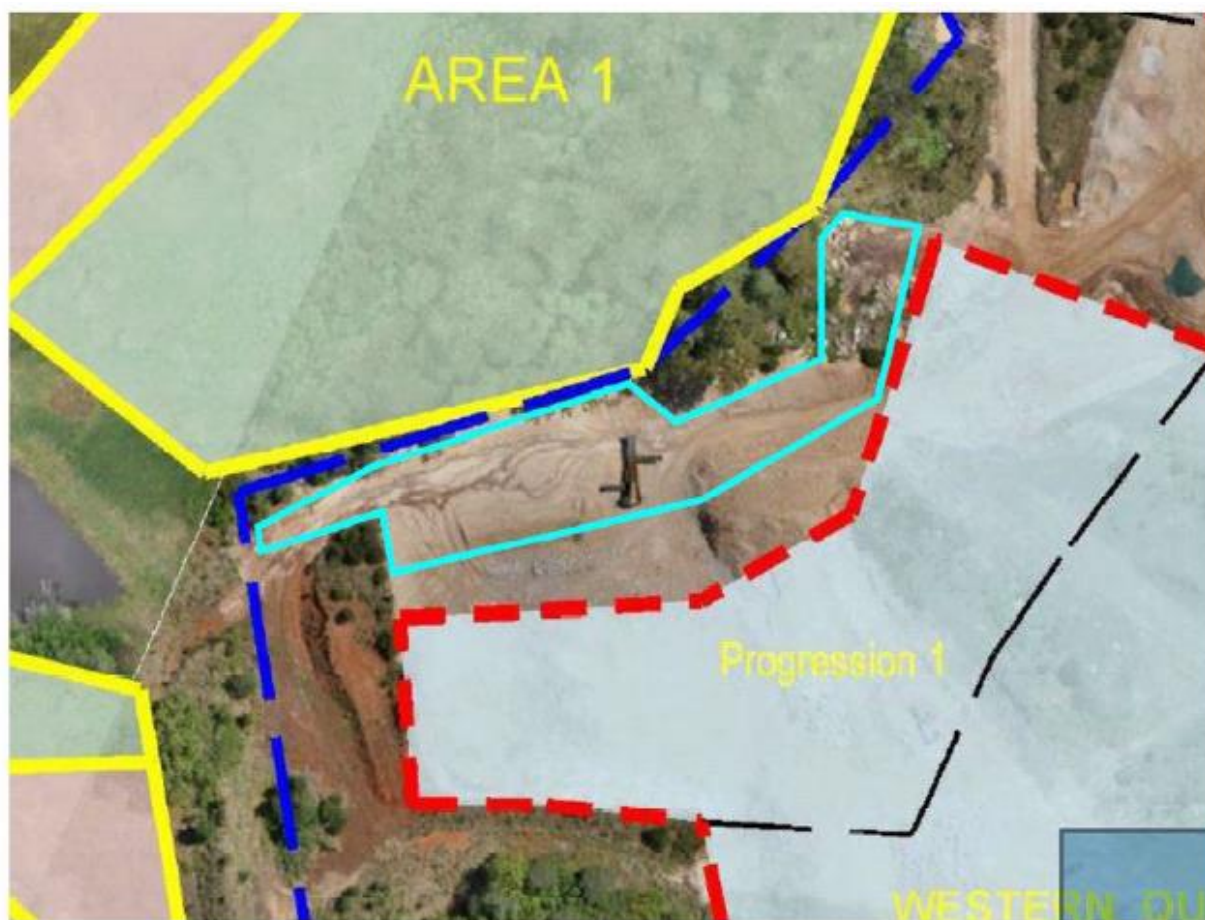
Figure 5: Indicative Rehabilitation Area 2018/2019

Indicative Rehabilitation Area 2018/2019

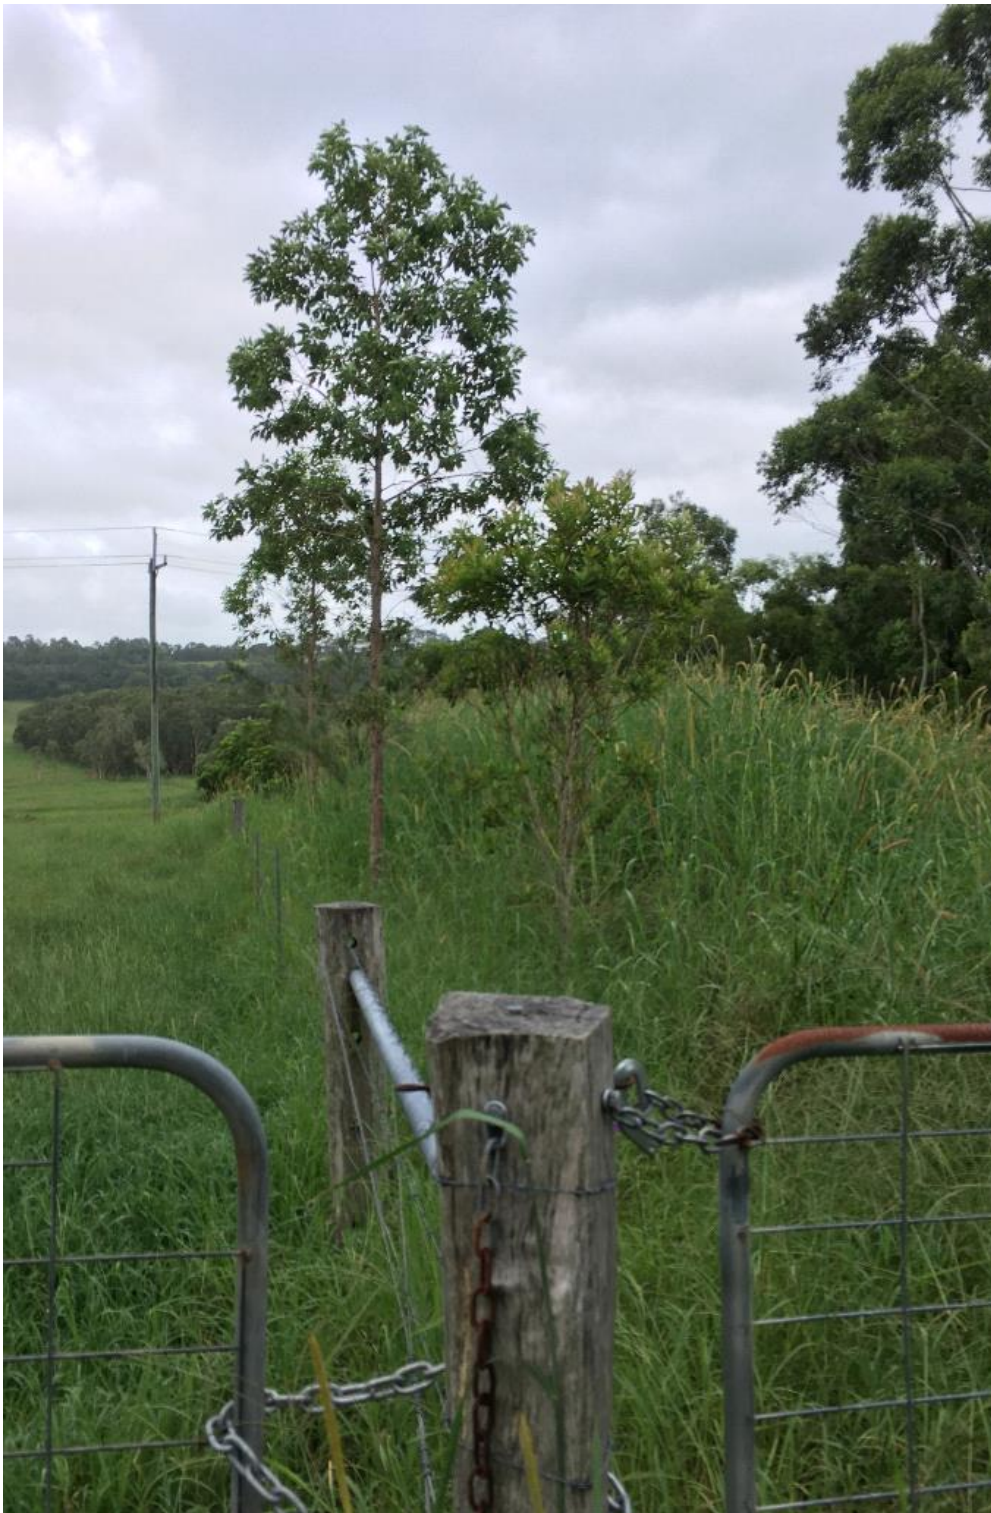
BUND A

View of Bund A from the eastern end, trees planted to the north of the Bund and a single row of non-koala habitat trees on the south-western side of the Bund. Photo March 2020.

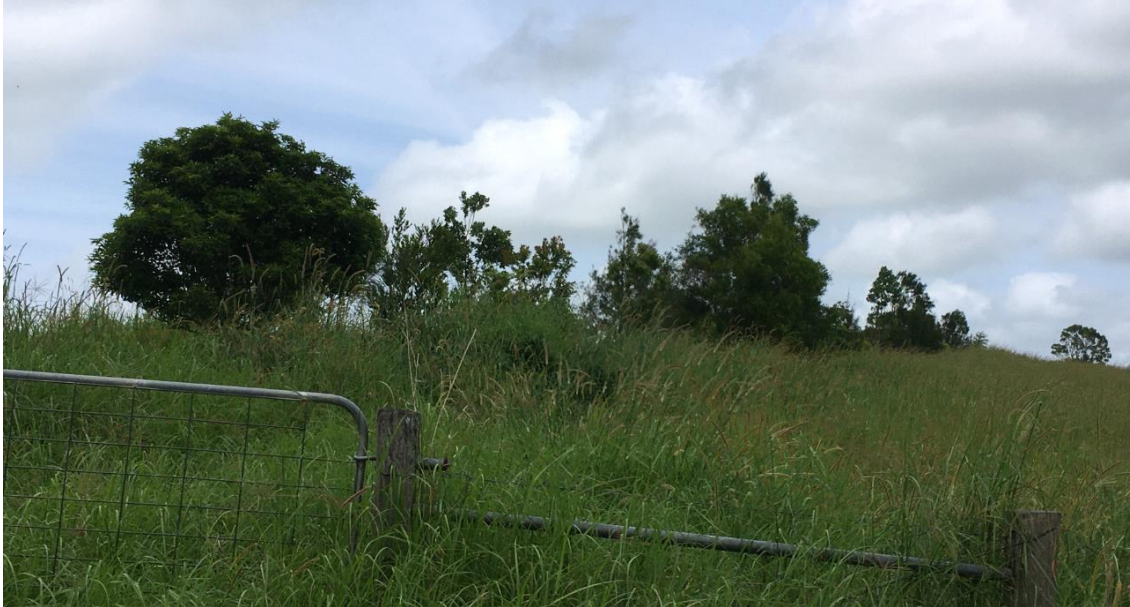
BUND B

Bund B – Low earth mound 10 metres wide. Established and grassed and planted with 2 rows of non-koala habitat trees/shrubs. Photo March 2020.

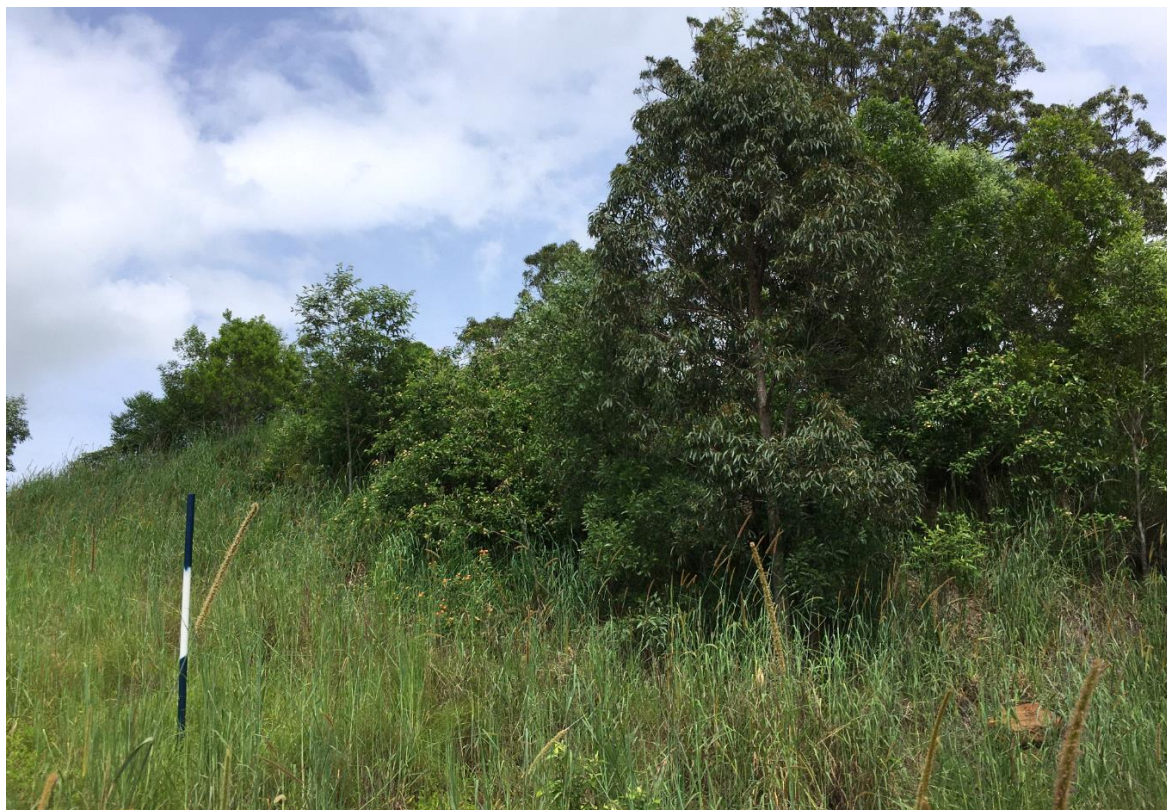
BUND D

10 metre wide bund. Established and grassed. Photo March 2020.

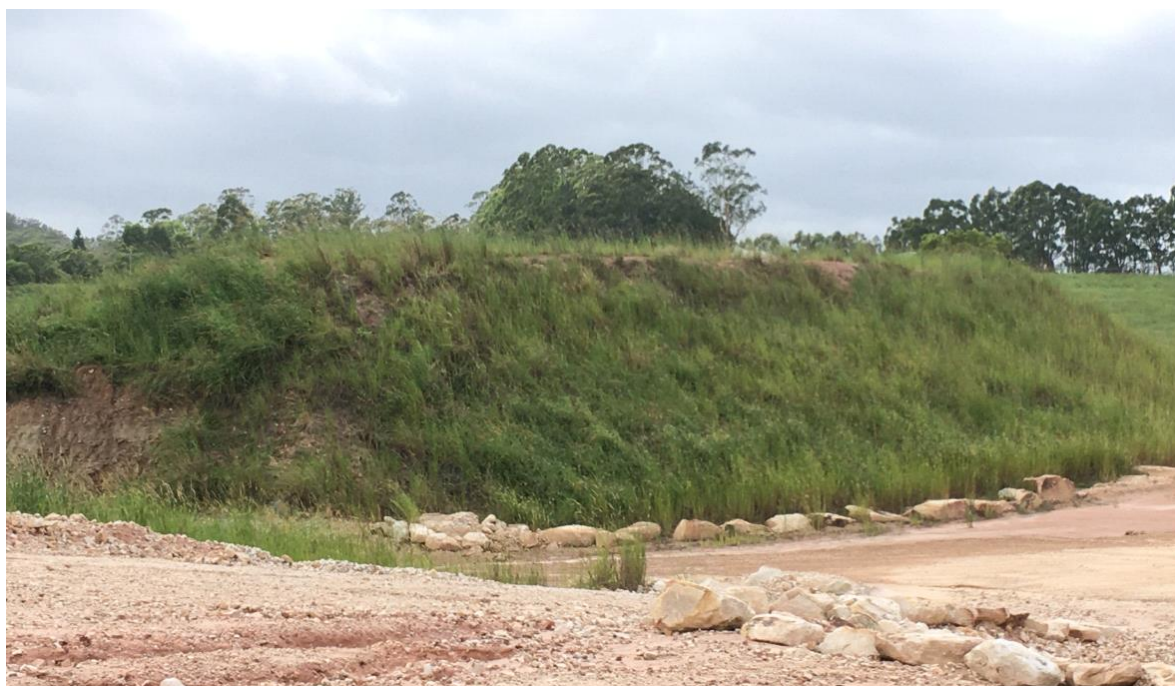
BUND E

Low sacrificial bund 10 metres wide. Established and grassed. Photo March 2020.

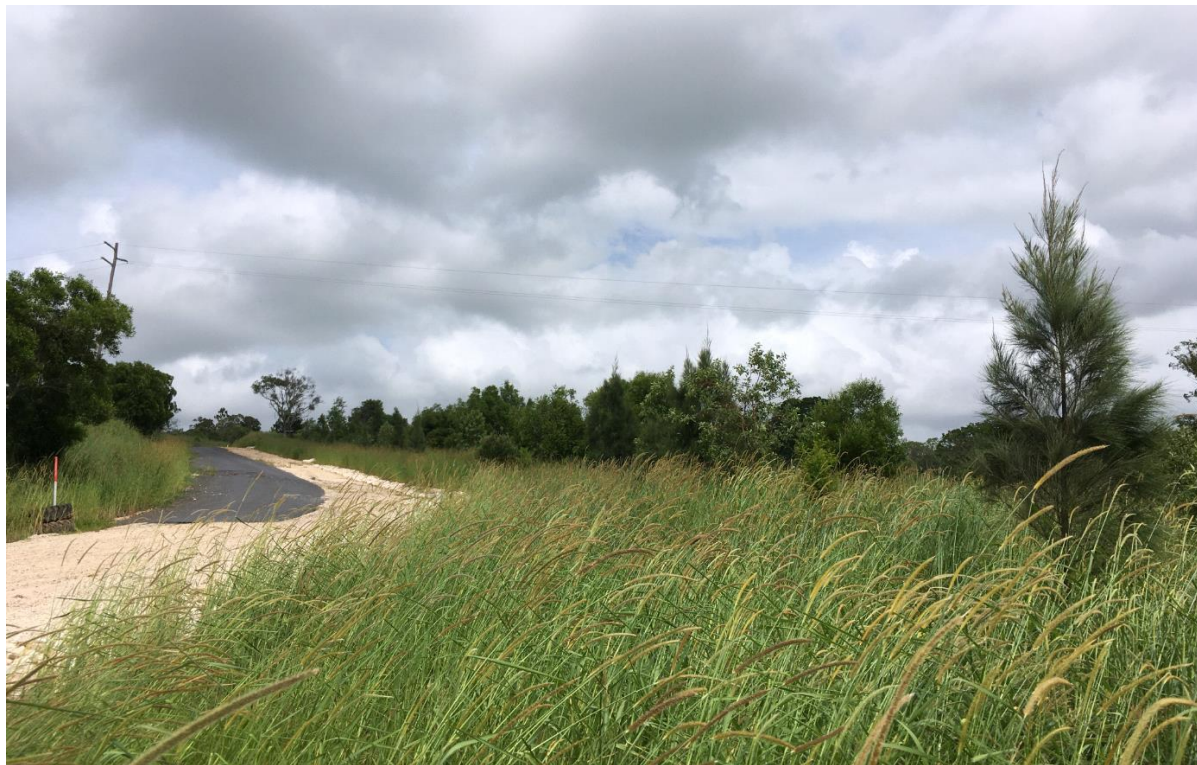
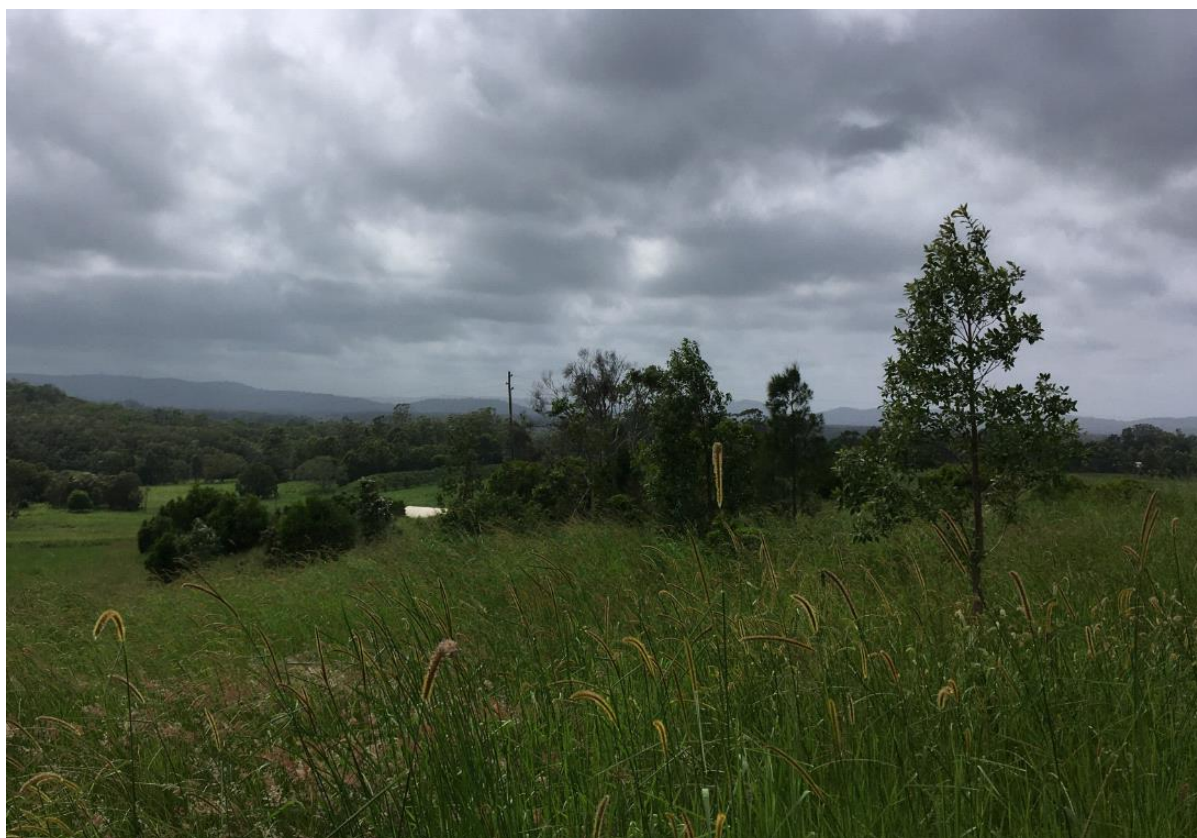
AREA TO THE NORTH OF THE MAIN ACCESS ROAD

Established, grassed and planted with 2 rows of non-koala habitat trees/shrubs. Photo March 2020.
