# **Sydney Opera House Trust**

## **Bennelong Drain Diversion Project**

### **Aquatic Ecology Assessment**

January 2010

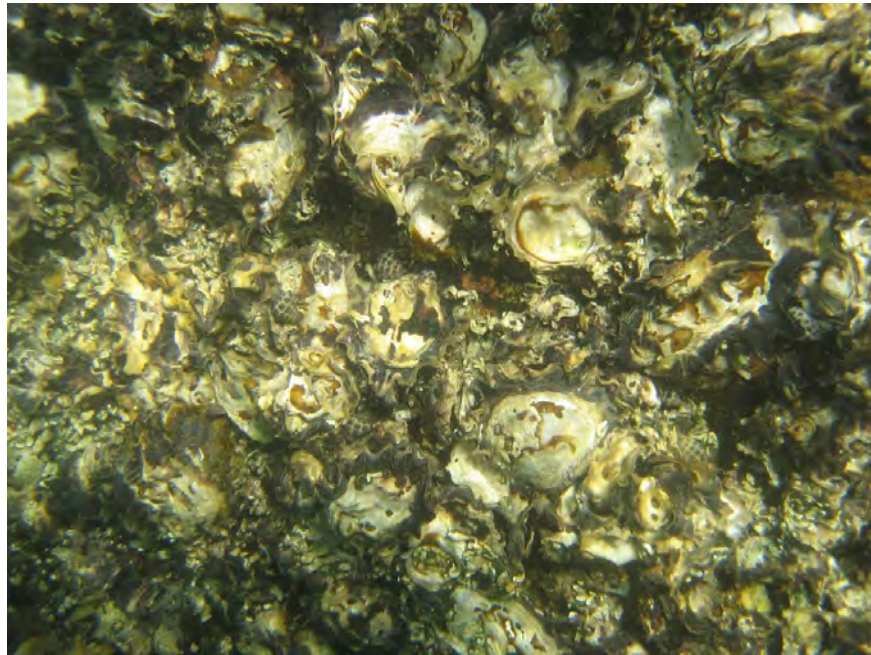
Dominant species observed on the seawall included the Sydney Rock Oyster (*Saccostrea glomerata*), limpets (*Cellana tramoserica* and *Patella* sp.), Murex shell (*Morula marginalba*) and an unidentified species of Chiton (see Figure 4-1). Sydney Rock Oysters are common throughout sheltered, rocky, intertidal environments in NSW and beyond due to their natural abundance, as are the other invertebrate species recorded during this survey (Edgar, 2000). *M. marginalba* plays an important role in structuring intertidal communities as a dominant predator upon other intertidal invertebrates.

These species were observed as common throughout all seawall areas surveyed and are typical of the many rocky, intertidal habitats within NSW coastal waters. Due to the relative abundance of these species and the relatively limited extent of intertidal habitat included within the study area there is little risk of this environment being adversely impacted by the project.

**Figure 4-1 *Saccostrea glomerata* with *Morula marginalba***

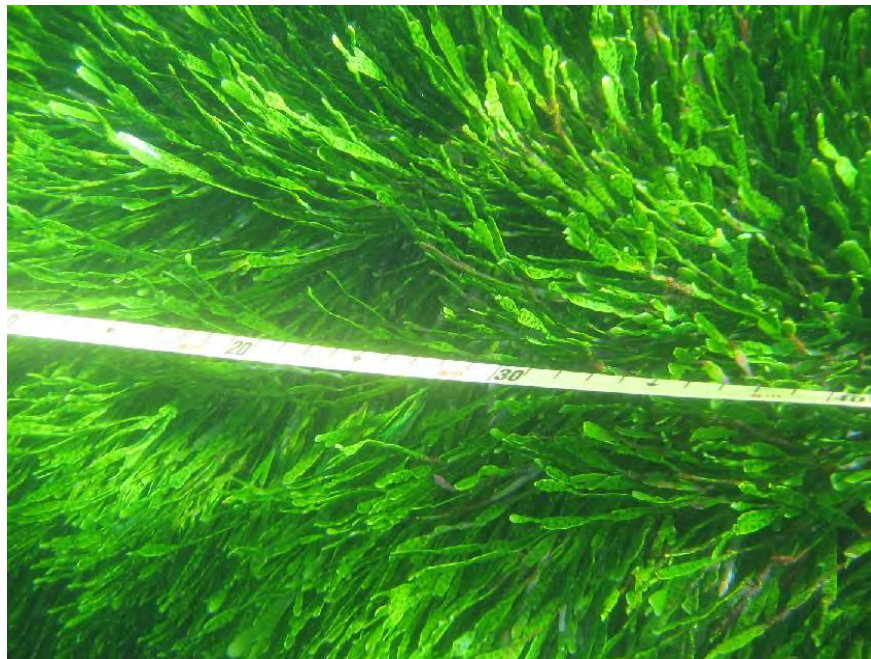
**Figure 4-2** *Caulerpa filiformis* observed on hard substrate in the vicinity of the proposed discharge

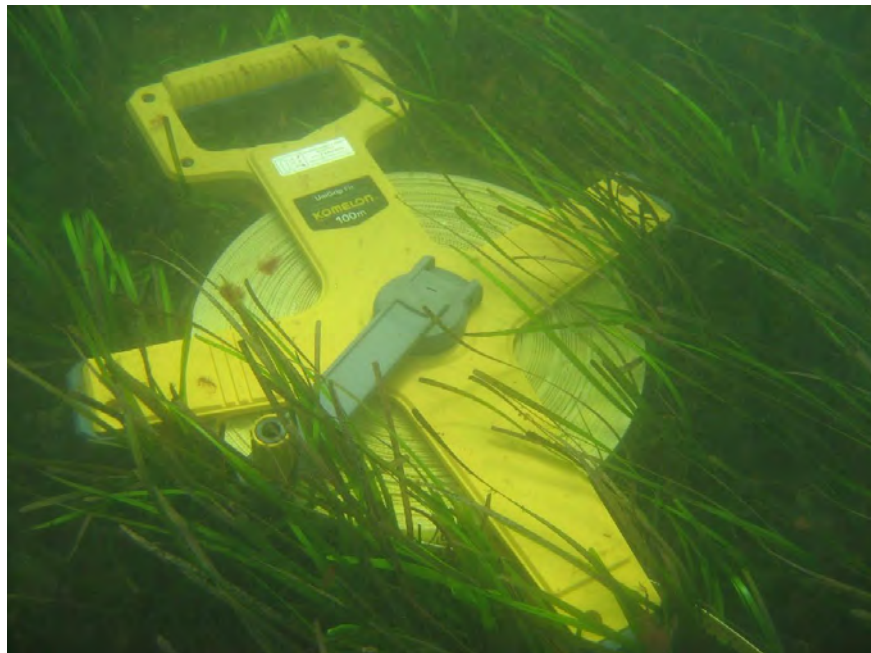
**Figure 4-6** *Zostera* seagrass and tape measure at the end of Transect 1

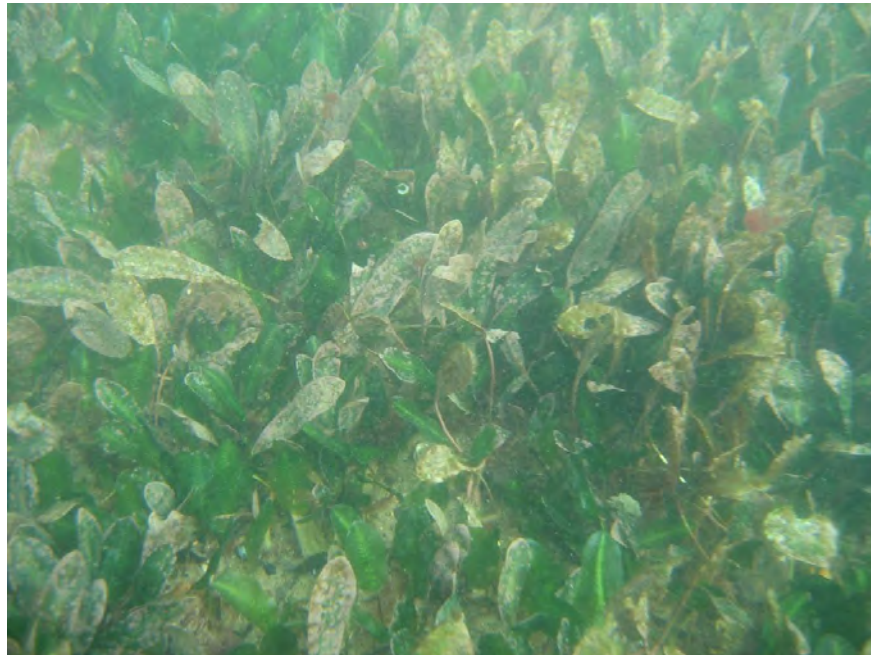
A small area of seagrass was identified at the base of the existing outlet. Transect 7 ran from the outlet directly out towards the shipping channel. The seagrass *Halophila australis* (Figure 4-7) was recorded from 0 – 3.0 m and *Z. capricorni* from 3.0 – 6.2 m where depth limited further survey. Both seagrass species provided approximately 80 % cover. These results indicate that either these two species are largely tolerant of stormwater discharge at this location or that mixing within this region is sufficient to adequately disperse stormwater inputs.

**Figure 4-7** *Halophila australis* at the base of the existing discharge
