### 9.3.3 Orange Section

Survey in the Orange section was carried out over five days [15-19 February]. Two vehicles were used to facilitate movement during survey. One open site and two scarred trees were recorded in the Orange section of the field survey. These are described below.

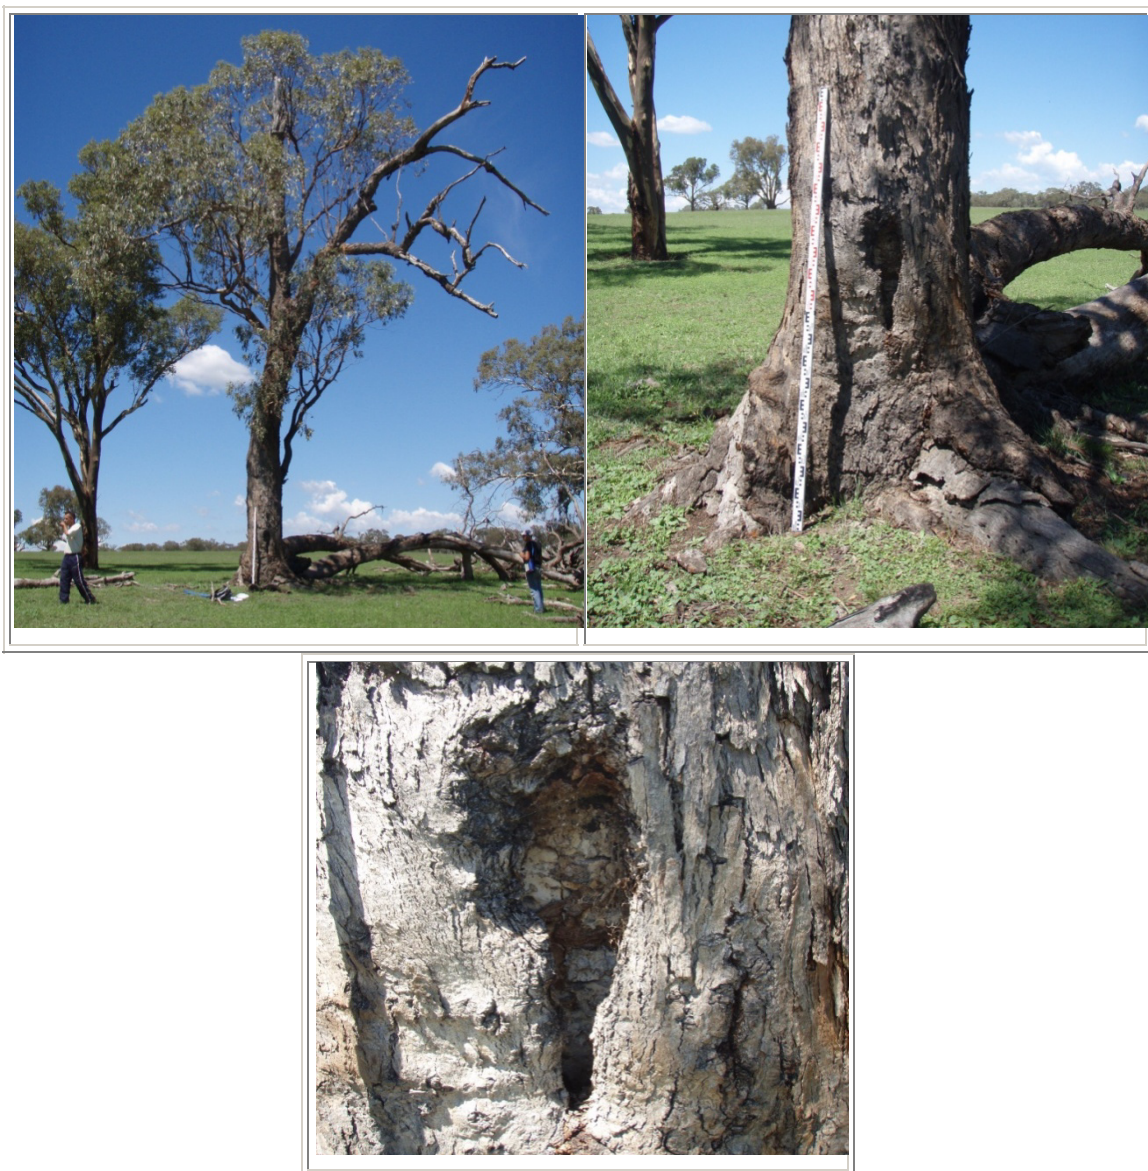
The site is a scarred tree. The tree is more than 300 m from the proposed alignment along Dora Creek. It was investigated because a wider footprint along larger creek crossings is examined as standard procedure. The scar is rated as probable. There is not the definitive combination of features, but it is a reasonable shape given regrowth; it is on an older tree; it is the correct height range and location on the tree. It is on the edge of a creek near places that would be likely residential sites.

Figure 44 Dora Creek CMT 1, setting [upper left], Ian Bell, Blair Fuller; close-up of scar [upper right]; detail of scar [lower centre].

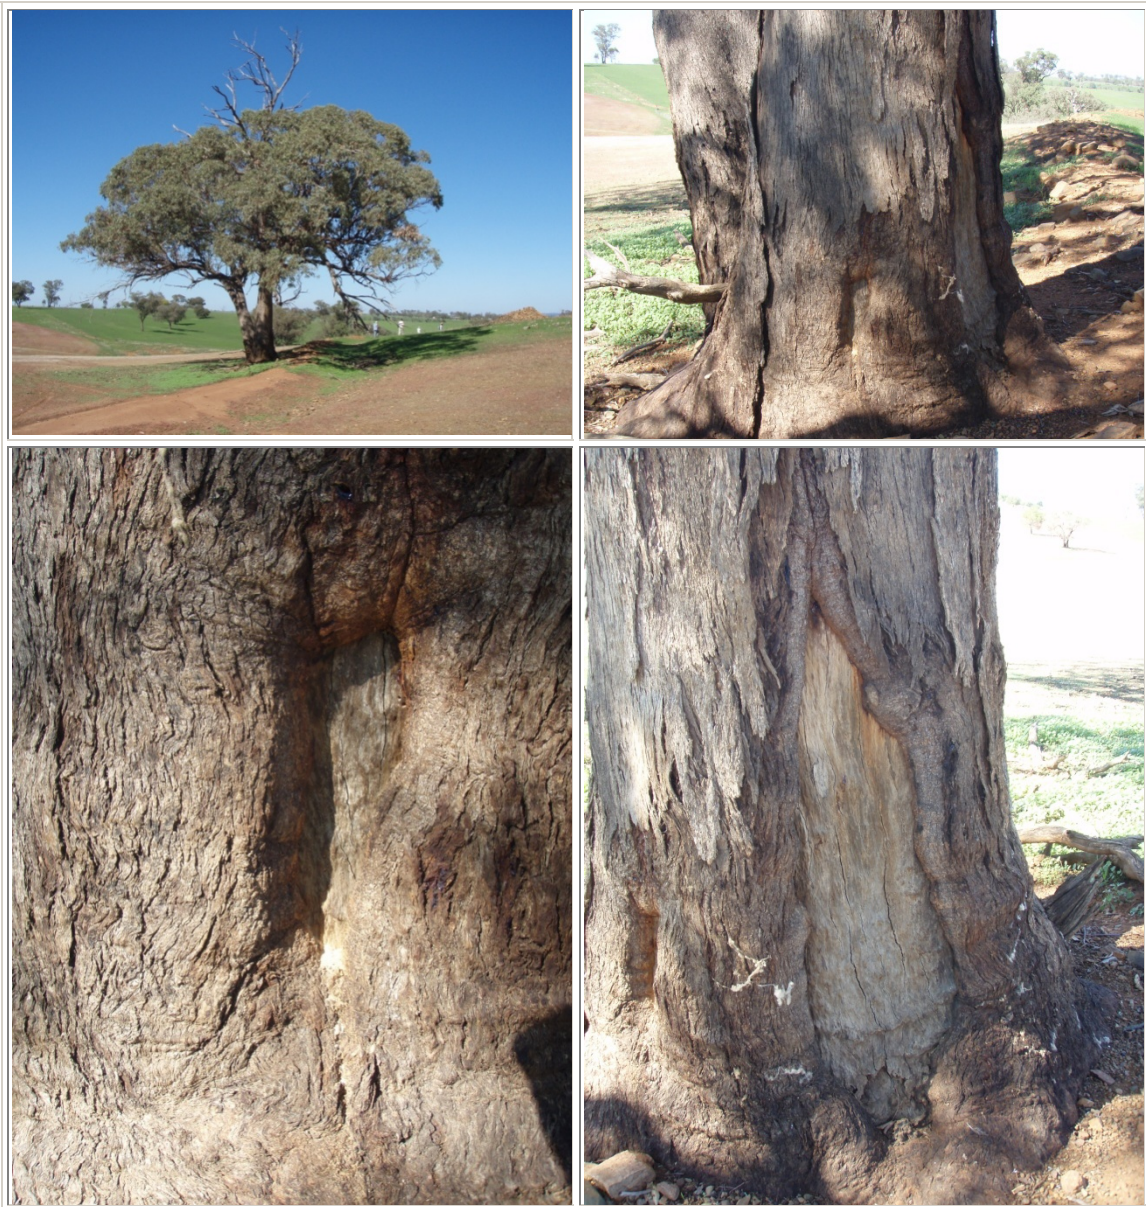
This is a probable scarred tree. The scar is clear and well formed, with even regrowth. It was not possible to observe axe marks, given the amount of regrowth. In the picture it appears close to the ground, but is 420 mm above ground. There is a natural scar beside the cultural one.

Figure 45      Scenic Road CMT 1, setting [upper left]; scar on trunk [upper right]; detail of scar [lower left]; natural scar [lower right].

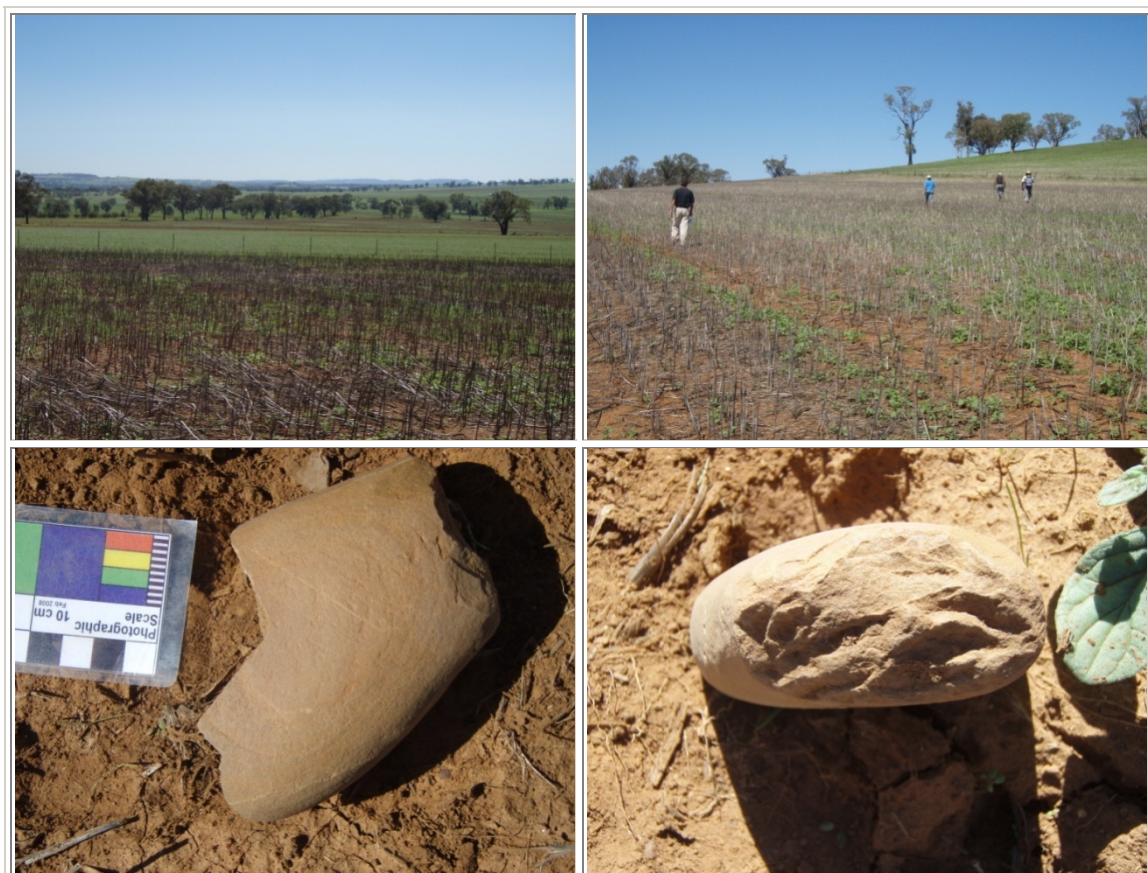
The site is a large open site defined by a concentration of stone artefacts. The site measures approximately 110 m x 65 m. with an estimated area of 6,000 m<sup>2</sup>. The site is south of Bourimbla Creek and immediately south of the next [unnamed] creek south which also drains into Boree Creek just to the west. There is a small swamp directly east of the site, created by a small rocky outcrop. There is a smaller drainage line joining here [the creek runs north].

Items seen at the site include a broken hammer (anciently broken, not by the plough), cores, flakes and debitage. Several cores were bifacially flaked from 'producer' cores or larger flakes. One core was unifacially flaked from a larger flake. Three materials were seen, all of which are local in origin. Of the larger pieces, the grey/black siliceous volcanic was most common, followed by an unidentified coarse-grained volcanic. White quartz from river cobbles was the most common material of the smaller pieces [<3 cm]. The quartz was typically flaked using bipolar technique. A typical pattern was seen of broken hammer [being used as an anvil], polyhedral quartz cores with anvil/bashing damage at both ends, quartz flakes, and one instance of a small crescentic microlith. The latter would have been used as barb or part of composite knife.

Figure 46      Location of site [left] and aspect; broken hammer [lower].
