RailCorp Environmental Projects  
Unit

**Macdonaldtown Triangle (Former  
Cleaning Sheds)**

Delineation and Classification Sampling

Report

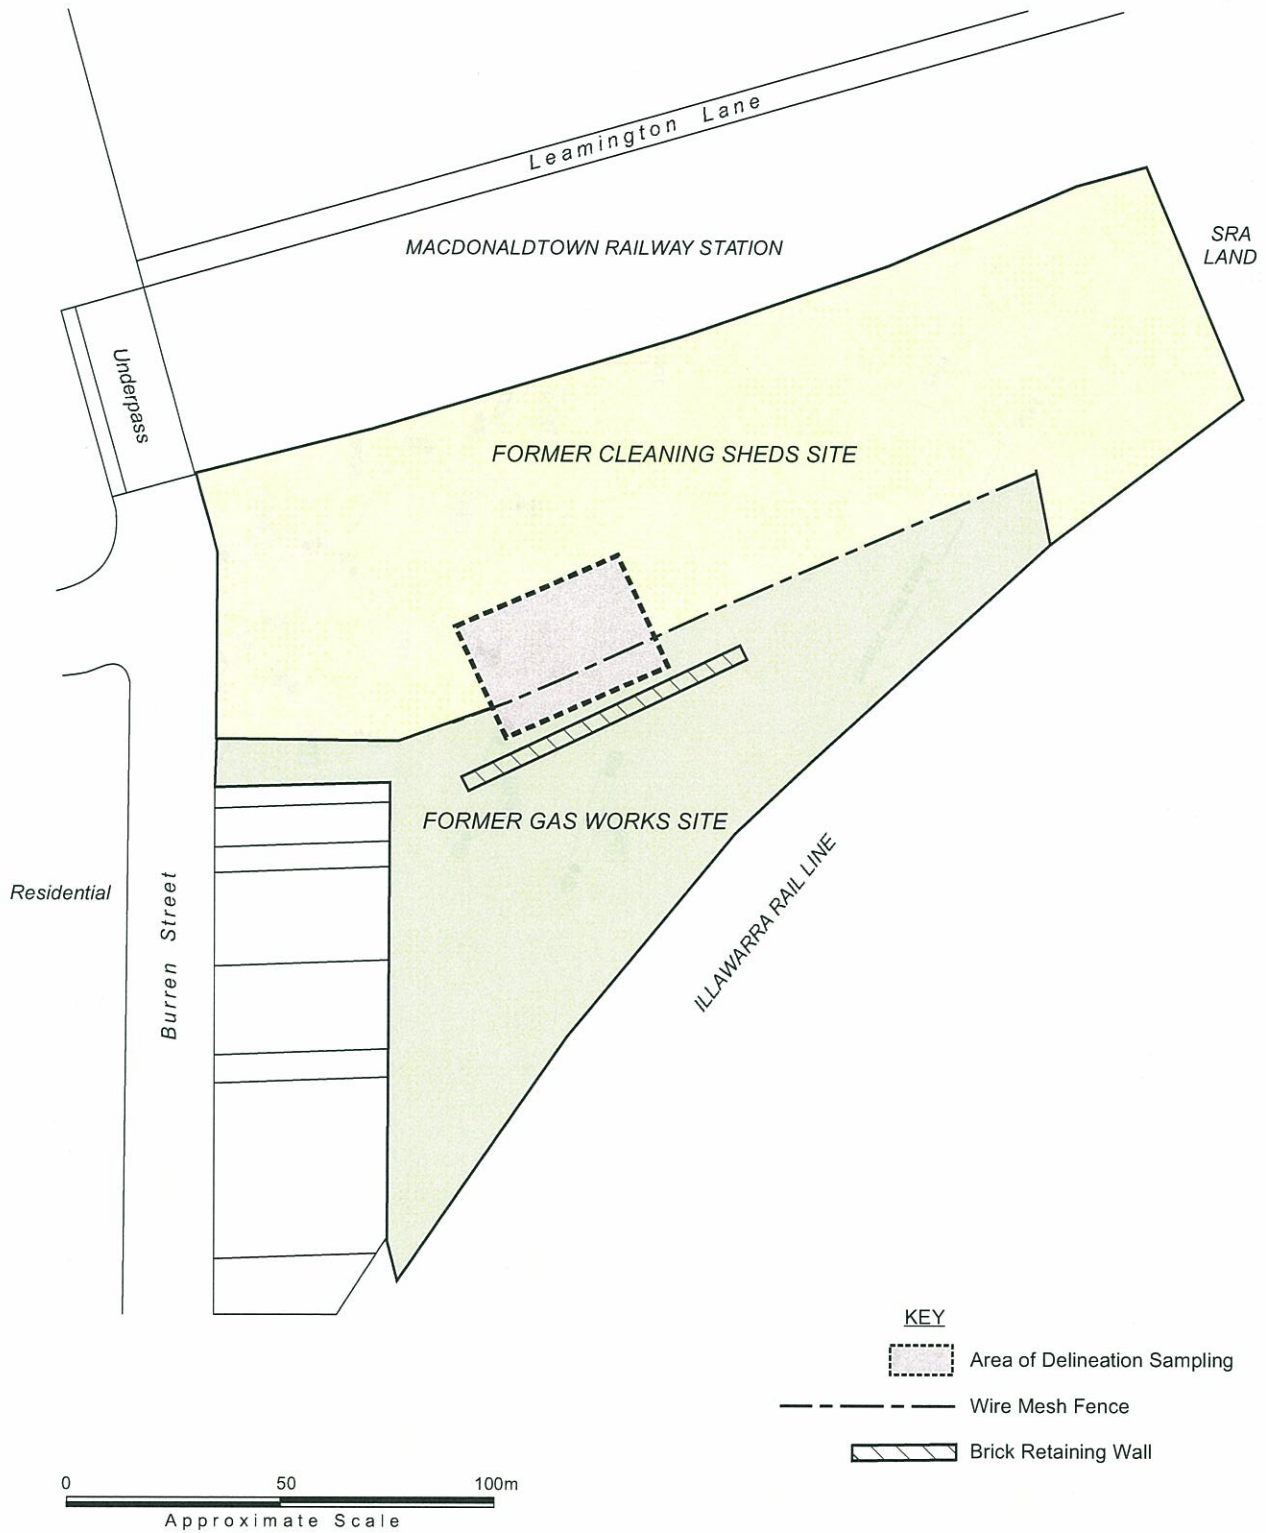
# SITE LAYOUT

It should be noted that previous investigations (see **Section 3** below) were conducted over a larger area of the greater Macdonaldtown Triangle comprising 23,000m<sup>2</sup> (**Figure 2**). The focus of the current investigation, the 'delineation area' (hereinafter referred to as the 'site'), occupies an area of approximately 900 m<sup>2</sup>. The site is part of Lot 50 in Deposited Plan (DP) 1001467 and is currently used by RailCorp for railway purposes.
