## **3.2 TEST TRENCH METHODOLOGY**

### 3.7 THE TEST TRENCHES

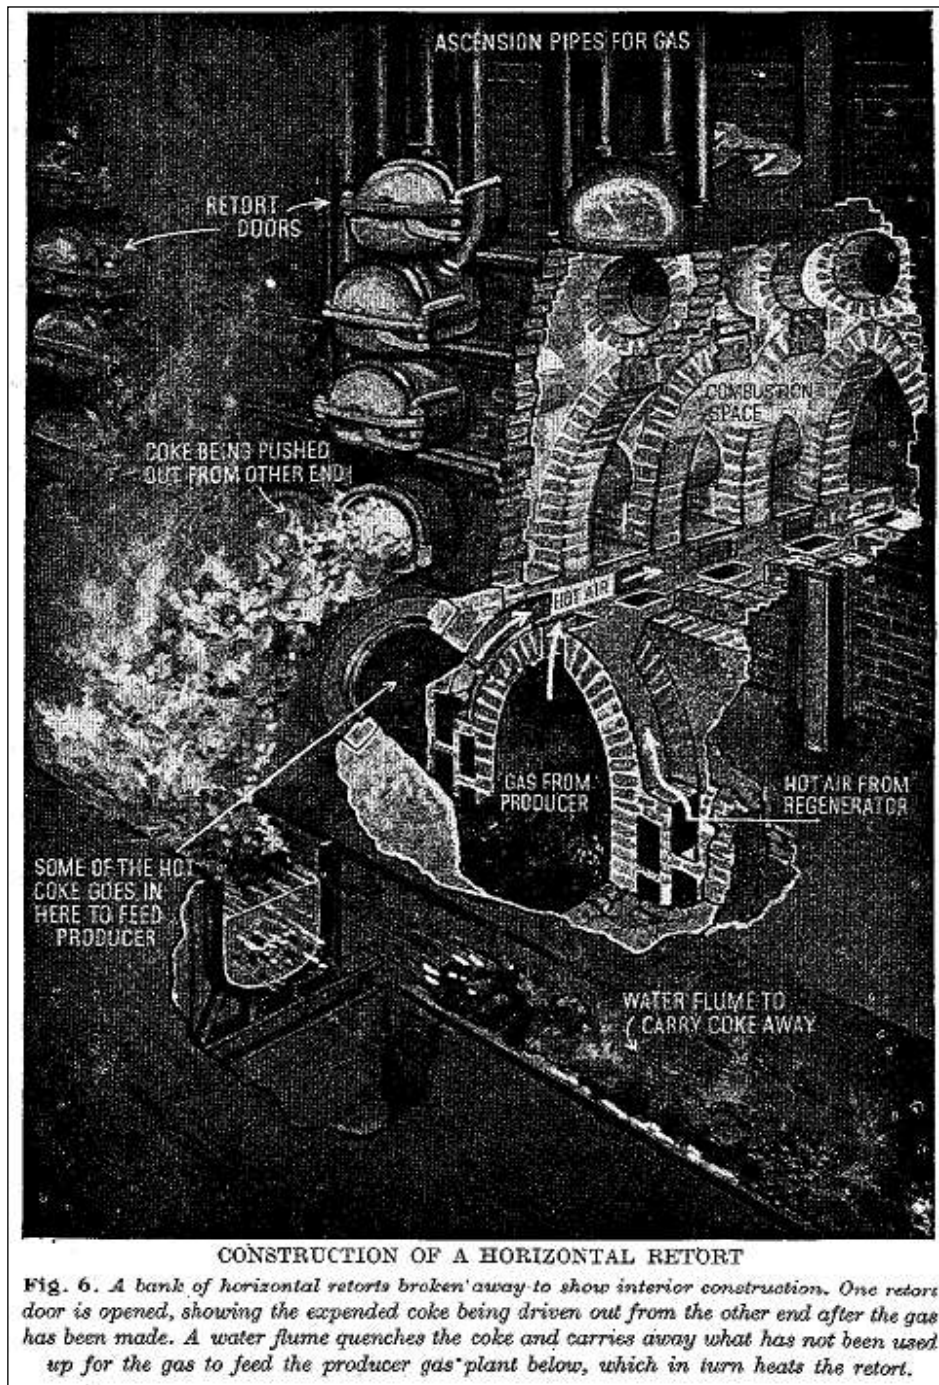
**Figure 13: Generic diagram of a cut-away horizontal retort.**

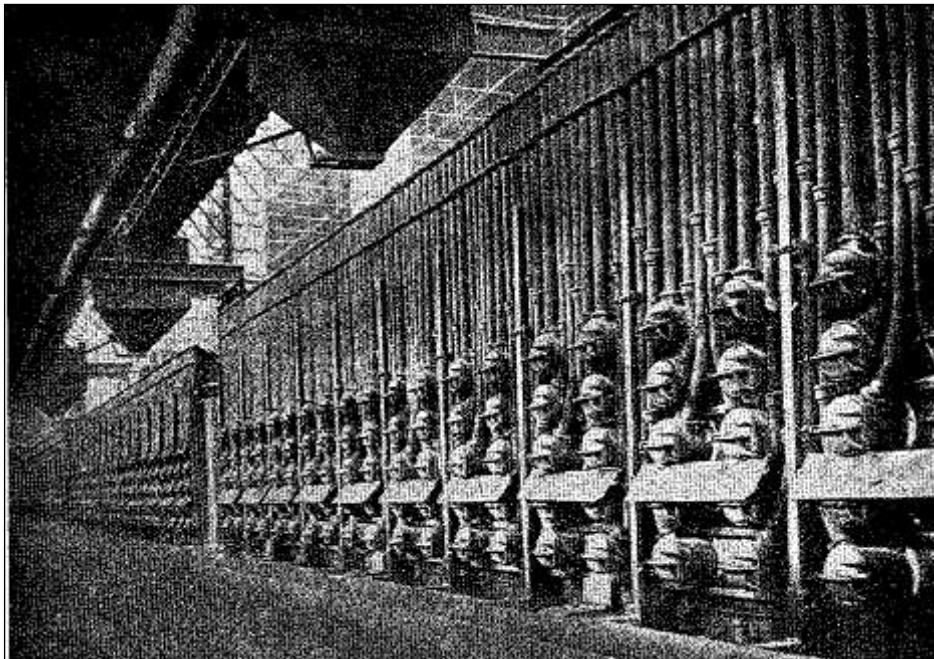
**Figure 14: Photographic view of a horizontal retort house, shows how the retorts are stacked here in groups of ten.**

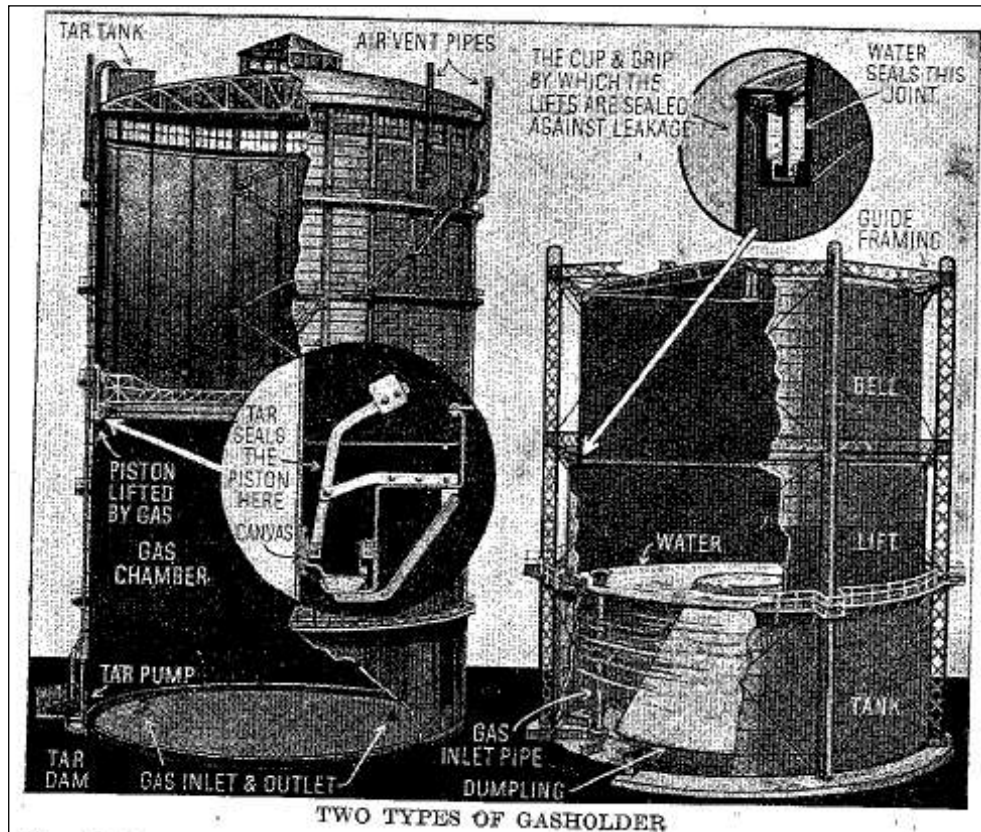
**Figure 15: The gasholder on the left has a fixed cylinder with a piston sealed by gas tar. The holder on the right – of similar type to the subject site – has a series of lifts with a top bell sealed by water.**

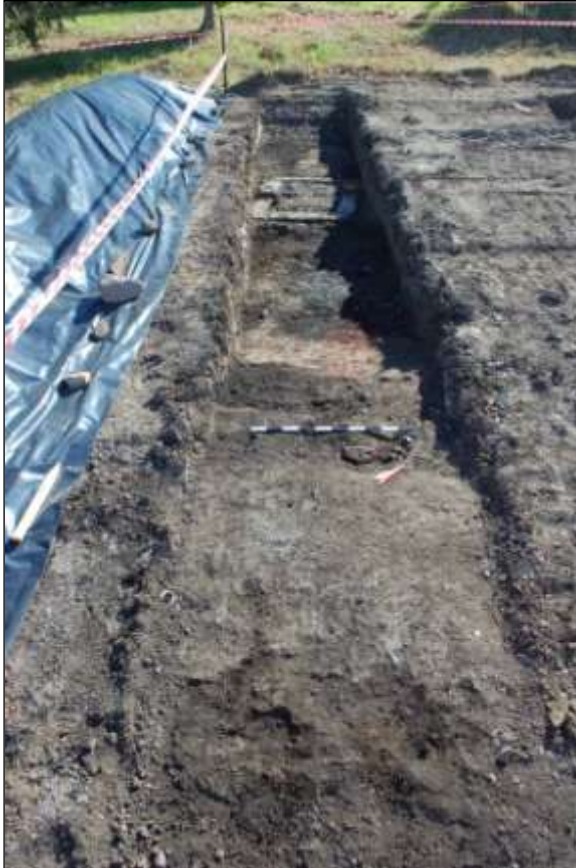
The defining context in this trench was a rectangular brick feature made of machine made clay bricks bonded with cement mortar. There were no marks or frogs (technical term for the depression on a brick) visible on the bricks. The internal measurements of the feature were 1020mm by 840mm and the walls were of a standard 230mm width. There was a coke ash surface present in the southeast end of the trench about 100mm under the current surface. The layer of coke residue which made up the surface slopes down towards the brick feature. The survey data places the brick feature in the centre just in the northwest half of the Purifying Shed.

**Figure 18: Trench 1, looking northwest, with coke ash surface in the foreground and rectangular brick structure in the background.**

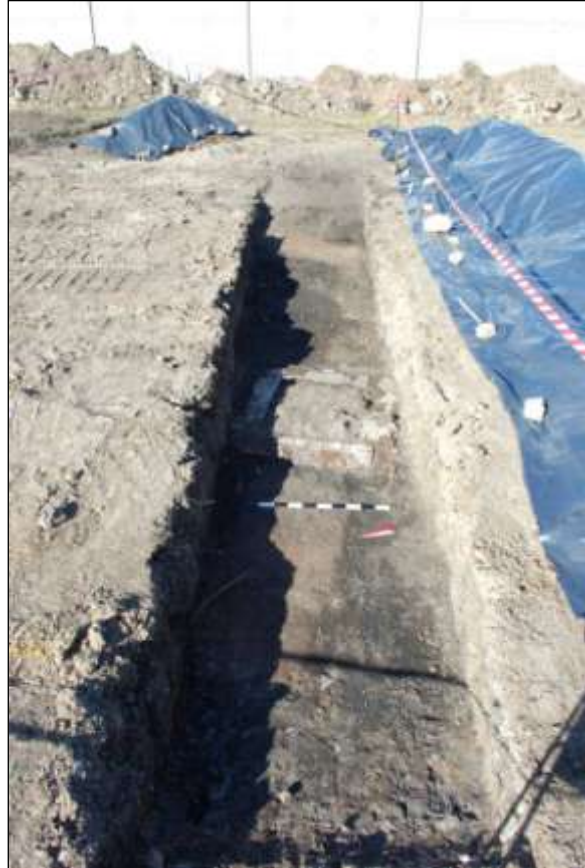
**Figure 19: Trench 1, looking southeast, with rectangular brick structure in the centre**

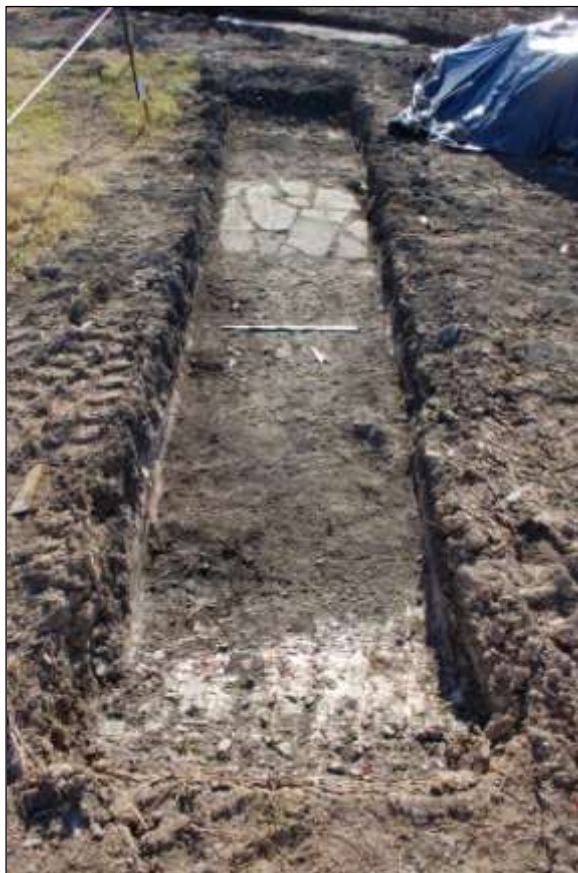
After the removal of the fill layers, which consisted mainly of clay, a coke ash surface was uncovered, which was most likely the surface within the Purifying Shed. The northeast perimeter of the Purifying Shed was marked by a cracked concrete path oriented southeast to northwest in the centre of the test trench. This path was running parallel to the northeast edge of the shed and represented a clear demarcation between the inside and the outside of the shed.

*Figure 20, above: Trench 2, looking east, cracked concrete path along north perimeter of Purifying Shed*

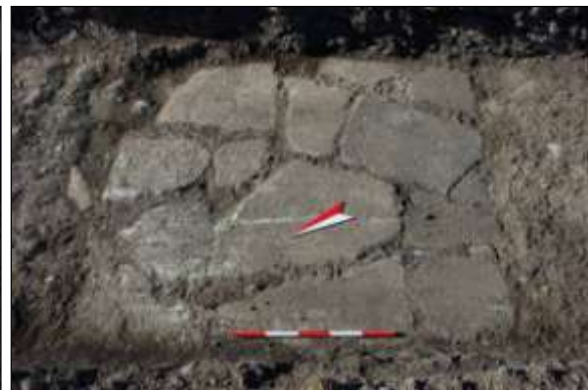
*Figure 21, left: Trench 2, looking north, coal tar surfacing and cracked concrete path in background*

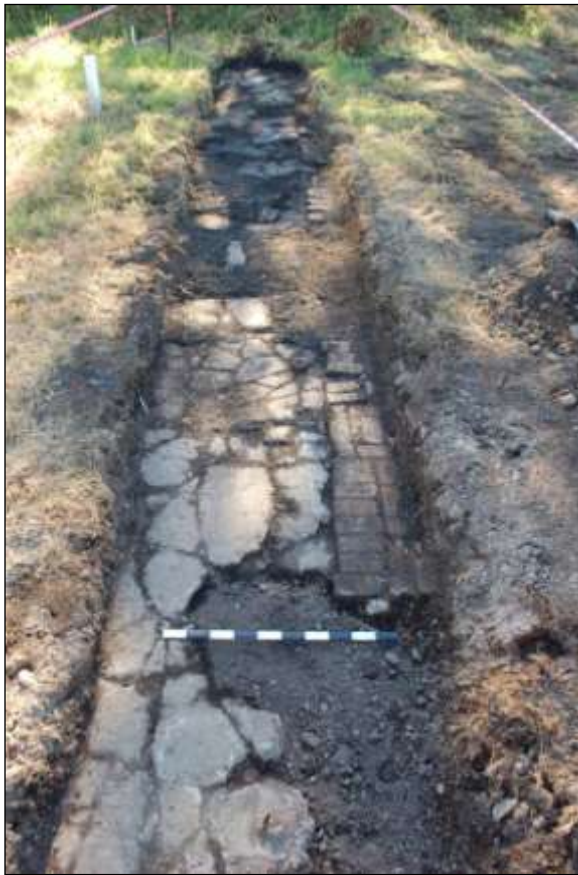
The interior of the Retort House within the test trench was entirely covered by a cracked concrete slab. The southeast boundary was marked by a clay filled trench with a lump of concrete in the centre which could have been the footing for a metal post. In parts the concrete visible in the trench was overlayed by a coke ash surface. The concrete slab continues south for about two thirds of the trench. There are various gaps within the slab. The condition of the concrete varies and there are two diagonal joints towards the southern end. The concrete used for the flooring was generally aggregate rich with aggregate sizes of around 30mm and there was no form of metal reinforcement present.

Also at the north end of Trench 3 there were segments of a brick wall or paving against the eastern side of the trench, with the total length remaining about 7m. Two of the segments appeared to be cut by a later trench. The bricks were machine made clay bricks, some stamped 'IFP' and others stamped 'GRIT'; or 'GRITA'. Slightly further south there was also a segment of dry pressed brick wall bonded with cement mortar. This could however just be floating within the fill. In the far north corner there was a rectangular metal grate with a width of 300mm. The length could not be determined as the feature was protruding into the east section.

**Figure 22: Trench 3, looking northwest towards end of trench with cracked concrete surface in foreground, overlaying coke/ash surface in background and brick wall or paving to the right.**

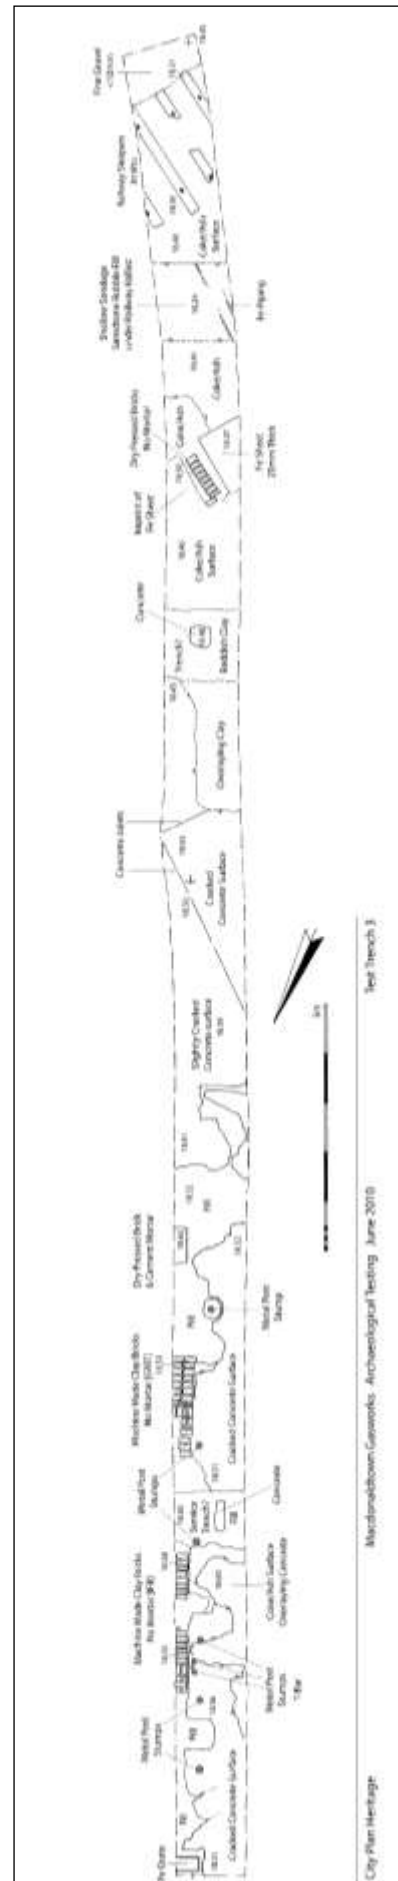
Trench 3 was designed to transect the Retort House on its long axis. It was oriented southeast to northwest to pick up internal structures and the southeast perimeter. The trench was continued to the southeast to determine if any evidence of the train lines connected with the Gasworks was still present. In total the trench was 37m long and 1.5m wide and up to 200mm deep - with the exception of a small sondage at the southeast end of the trench which was about 450mm deep.

**Figure 23: Detailed plan of Trench 3, a bigger version of this plan in scale 1:100 is attached as appendix**

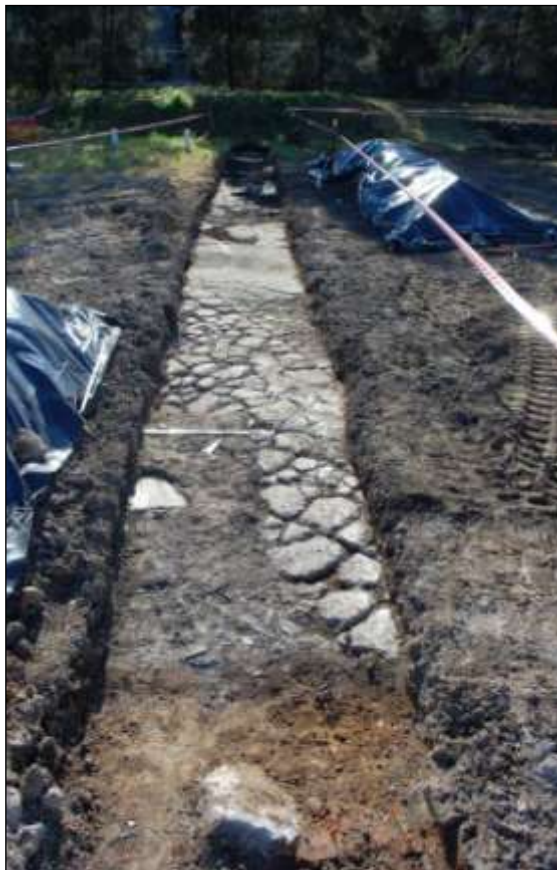
**Figure 25: Trench 3, looking northwest showing the entire concrete surface seen from southern edge of the Retort House marked by the clay filled trench in the foreground**

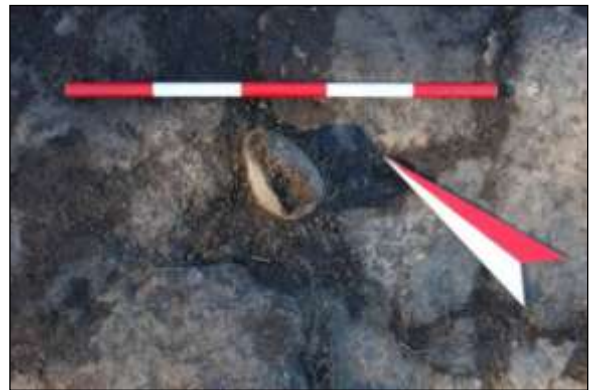
There were a total of eight metal posts, cut off at the level of the concrete visible at the north end of the trench. Six of them were in alignment with varying distances between them, of between 1.2m to 2.8m. The remaining two posts were about 250mm from each other with a vertically buried metal T-bar between them.

**Figure 24, above: Trench 3, detail of the cut off metal pole**

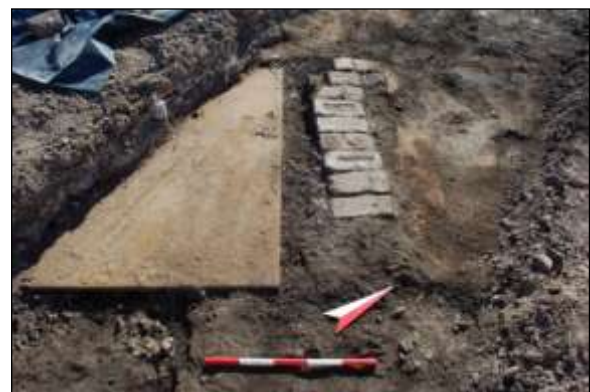
A coke ash surface started to the south of the aforementioned trench at the end of the concrete slab. After about two metres there was a line of dry laid (unmortared) bricks about a metre long diagonal set in the centre of the trench, with a 20mm thick and 1.3m wide square or rectangular metal plate on the southern side and the imprint of a similar metal plate on the northern side of this brick feature. The trench plan is shown overleaf.

**Figure 26: Trench 3, detail of brick line with metal plate on either side located towards southern end of the trench.**

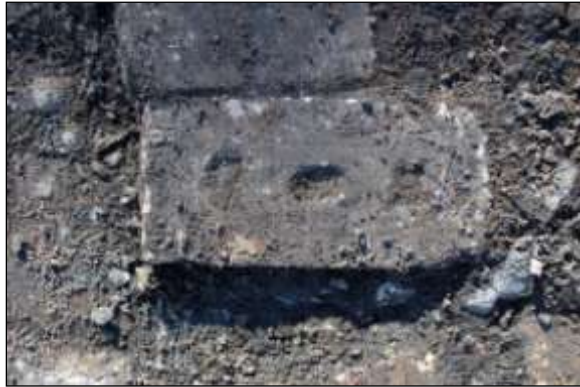
**Figure 27: Trench 3, detail of brick**

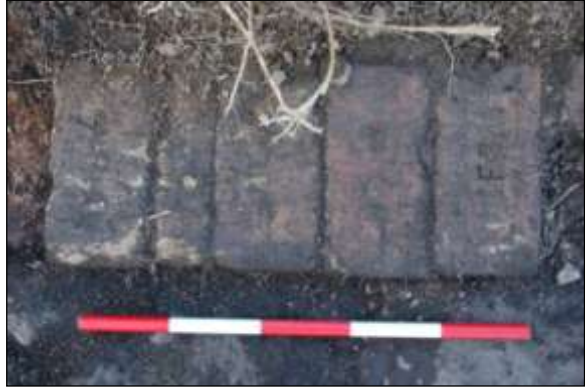
**Figure 28: Trench 3, detail of row of bricks, the brick to the right is stamped 'IFB'**

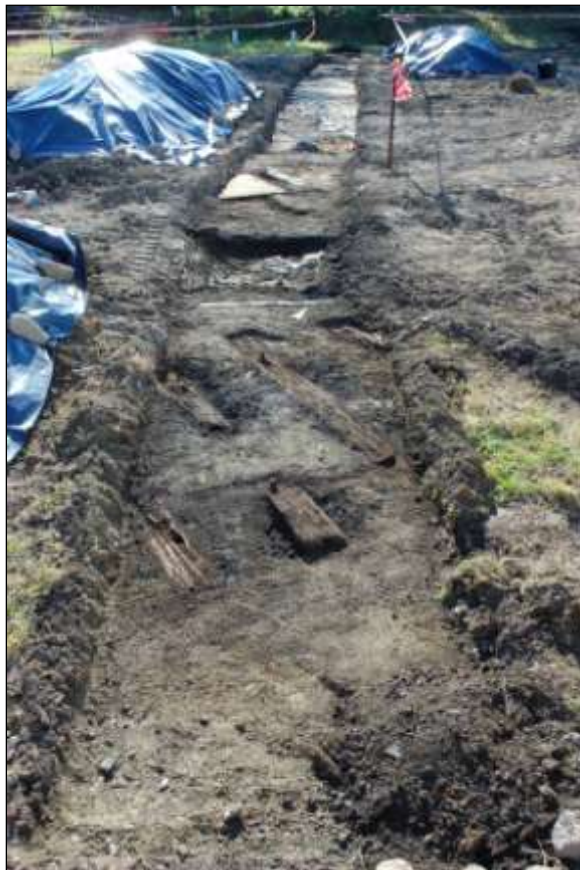
About 4m towards the south there were four railway sleepers in situ diagonally to the trench with some metal spikes still attached to the timber. The sleepers were sitting in coke residue and there was fine gravel of less than 10mm in size immediately to the south. The fill over the sleepers was made up mainly of railway ballast.

**Figure 29: Trench 3, looking northeast, southern end of trench with in situ railway sleepers in foreground and concrete slab of Retort House in background**

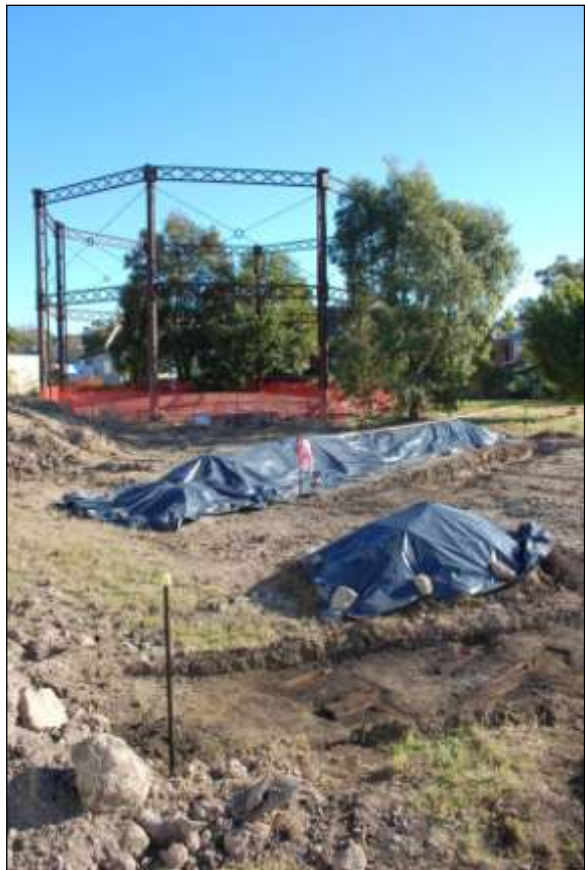
**Figure 30: Railway sleepers in Trench 3 with the Southern Gasholder in background and Trench 1 in centre right.**

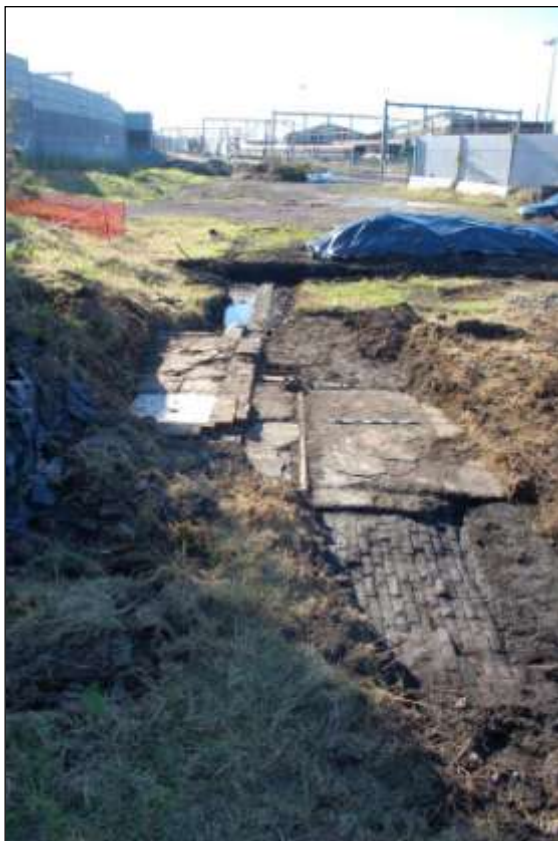
The western end of the trench contained a brick paving which was partly overlaid by a layer of coke residue with a coke ash surface which in turn was overlaid by a concrete surface. The paving was made of bricks sitting on their long edges and it extended for about 5.5m from the west end of the trench towards the east. The concrete covered only the east half of the paving but continued south beyond the edge of the paving. The paving slopes slightly down towards the south and appears to end in a straight line. The fill abutting the bricks was the same coke residue as the fill overlaying the paving. The paving's east extent coincides with the eastern perimeter of the Retort House. Towards the north the paving and the concrete slab was cut by an east west running pipe trench with a metal pipe about 2.7m in length and about 70mm in diameter contained in the trench fill.

On the north side of the wall there was a room which most likely served as a bathroom of about 3.8m internal length with the remains of an 1150mm by 950mm shower recess in the southwest corner. The recess was tiled with white square tiles measuring 25mm by 25mm and there was what appears to be a chrome plated floor waste in the centre of the recess. To the east of the recess was a cracked concrete floor with another chrome plated floor waste in the west half. The wall bordering this room at the east end was made of machine made clay bricks and was 230mm wide. Immediately west of this wall, sitting on the east west running wall, was a sandstone block, about 1.2m long, which was probably a threshold marking the doorway to the bathroom. To the west of the bathroom was a room of about 4.5m length with a smooth concrete floor about 300mm lower than the floor of the bathroom. It had a concrete step in the southwest corner and the east side of the room was marked by a 350mm wide dry pressed brick wall tying into the east west wall.

**Figure 32: Trench 4, looking northeast towards Redfern with Illawarra Line in background. Brick paving in foreground overlaid by concrete in centre and dry pressed brick wall with shower recess and concrete slabs to the left**

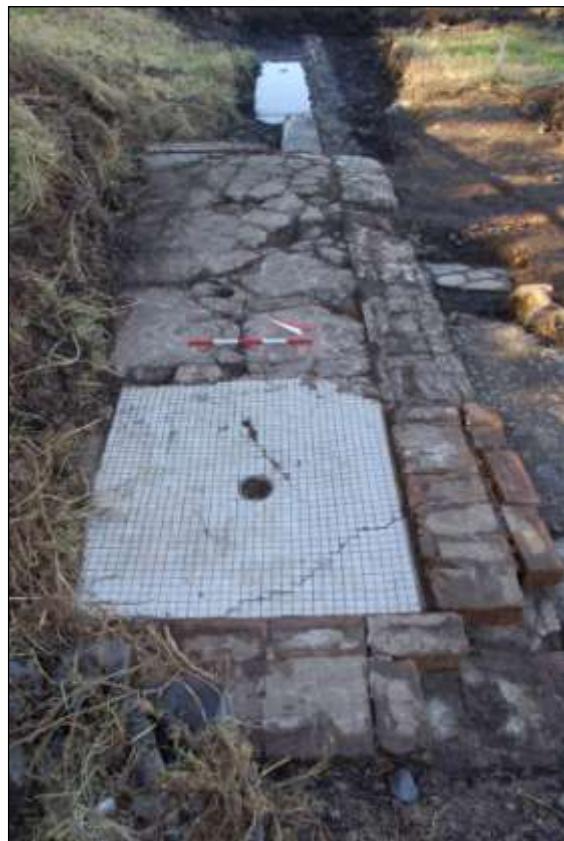
North of the pipe a patched section of concrete slab of varying quality extended north for about 500mm. It then abutted an east west oriented dry pressed brick wall with a corner turning north about 3m from the west end of the trench. The wall, which continues east for the entirety of the trench, was 350mm wide and the bricks were bonded with cement mortar.

**Figure 33: Trench 4, looking northeast with corner of dry pressed brick wall and shower recess in foreground and concrete slabs in centre and background to the left of the wall**

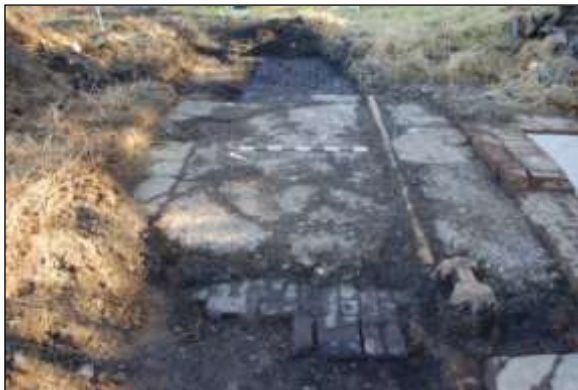
***Figure 34: Trench 4, looking southwest with concrete slab over coal tar and brick paving***

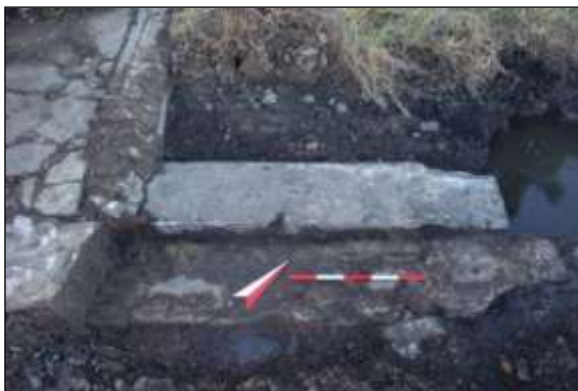
***Figure 35: Trench 4, looking northwest, concrete step into lower room with concrete floor***

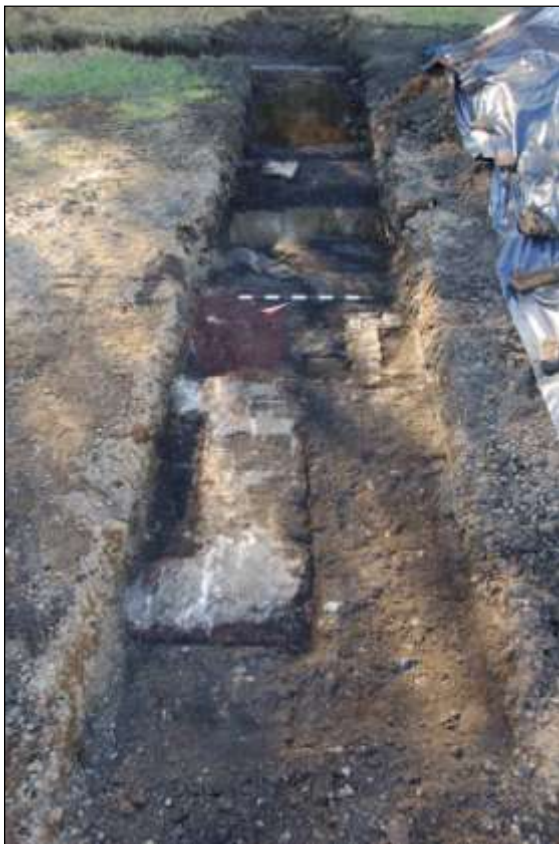
Another 2m to the south was a row of dry pressed bricks without mortar bonding oriented diagonally within the trench. It started in the centre of the trench and disappeared into the west section. It was 230mm wide and a total length of 800mm of this wall was visible.

Another segment of wall was visible about 1m further south at the east section, possibly the corner of a rectangular or square pit, the function of which is unknown. It was also constructed of dry pressed brick and cement mortar. It was 230mm wide, ran south for about 800mm and was then obscured by an overlaying fill of coke residue which formed the base for a higher coke ash surface to the south. This surface bordered a solid dry pressed brick and cement foundation of a probably rectangular or square structure about 2m wide, which covers about half of the trench and disappears into the west section. The east wall of this structure is 550mm wide and the north and south walls closer to 450mm wide.

**Figure 36: Trench 5, view northeast, solid brick structure in foreground, two brick structures in centre, brick pier in background**

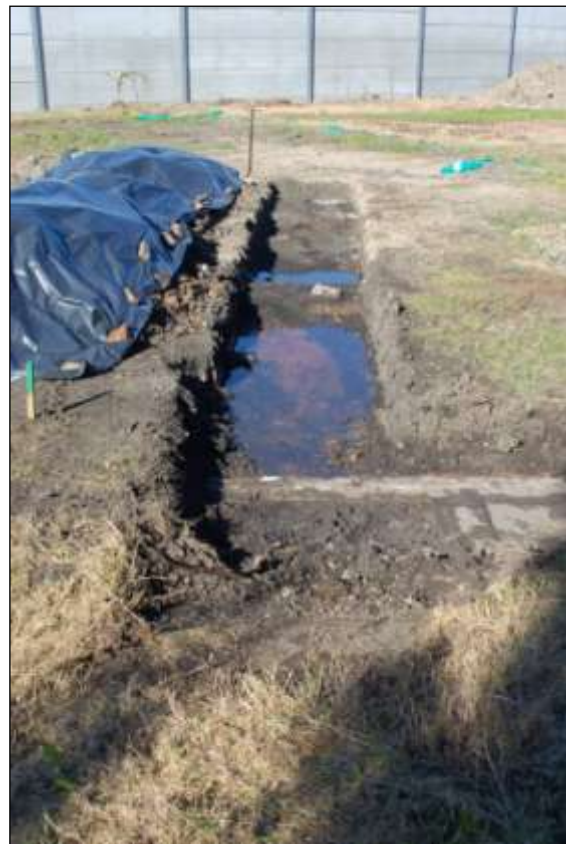
This trench was about 12.5m long, 1.5m wide and oriented roughly north south. It joined Trench 4 at the east end of that trench which contains the aforementioned east west running dry pressed brick wall. Trench 5 is between 50mm and 500mm deep. Located about 5m to the south of the east west wall was a pier or pad made from dry pressed brick and cement mortar. This pier is in line with the expected southern wall of the Compressor and Tea Room.

**Figure 37: Trench 5, view south east, dry pressed brick wall from Trench 4 in foreground, brick pier in centre. Ground water was seeping in over what appeared to be natural clay.**
