CHULLORA
HERITAGE ASSESSMENT, 1990

GODDEN MACKAY PTY. LTD.

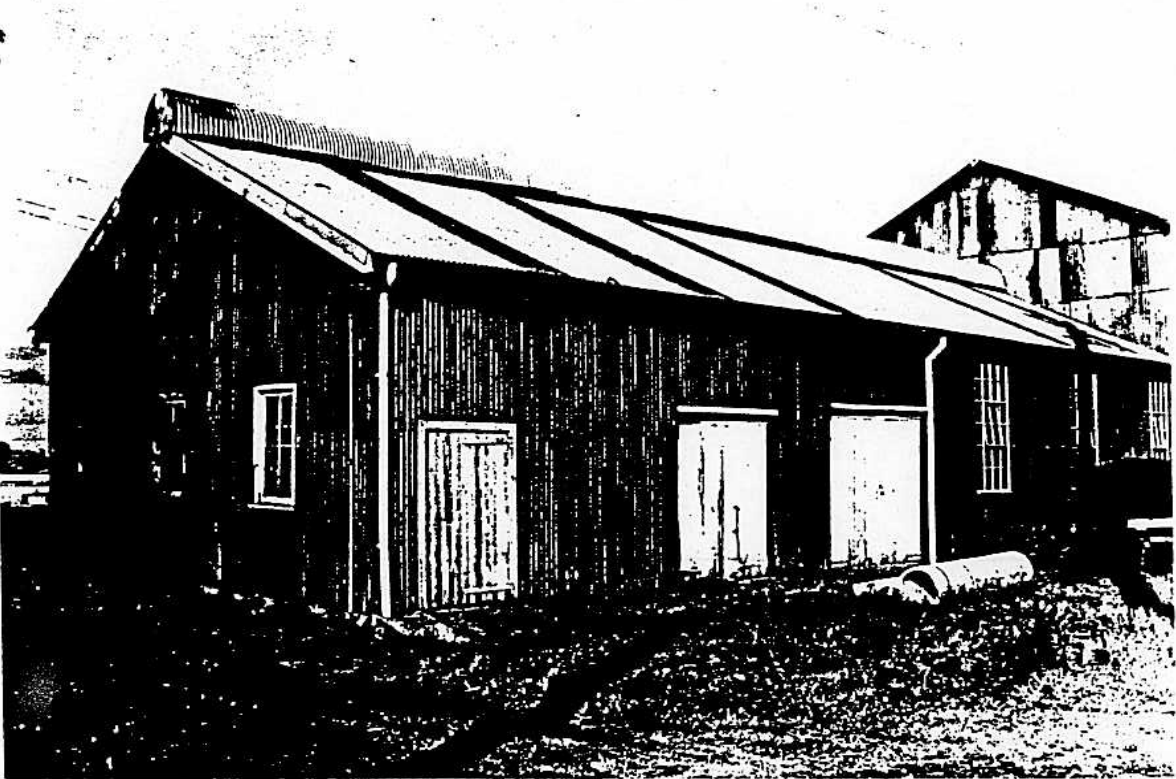
NAME OF ITEM: Carpenters Shop														
No. B42	Map Ref:													
Location: North/west section Per Way No. 2		Precinct E												
Condition:														
Associated Items:														
<p>Description: A corrugated iron clad, single bay timber framed shed. On the eastern wall the shed has two large, multiframed (not matching) windows and 2 small 4 pane wooden framed windows. The front elevation consists of 3 cast iron frame windows 6x4 panels, the middle 4 being casement opening and three doors, (Two of which are sliding). There is a barrel shaped monitor running the length of the roof and five panels of corrugated fibre glass have been inserted to provide daylighting to the interior.</p>														
<p>SIGNIFICANCE ASSESSMENT</p>

Aesthetic Value	2/5	Historic Association	4/5	Technological Importance	2/5	Structural Integrity	3/5	Interpretive Ability	2/5	Social Significance	1/5	<p>INFORMANTS:</p> <p>REFERENCES:</p>
Aesthetic Value	2/5													
Historic Association	4/5													
Technological Importance	2/5													
Structural Integrity	3/5													
Interpretive Ability	2/5													
Social Significance	1/5													
RECOMMENDATION: Record		<p>PHOTOGRAPHS:</p> <p>B & W: 90-038-4-22</p> <p>Slides:</p>

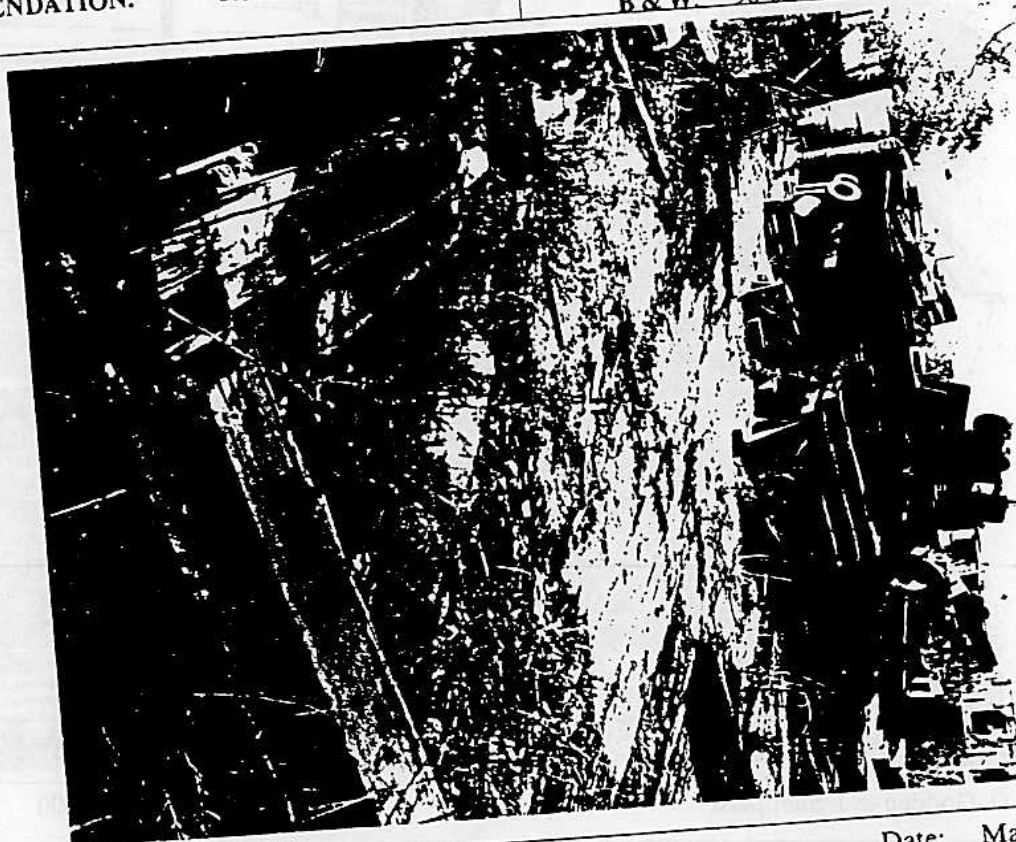
NAME OF ITEM: Saddlers Store		Map Ref:												
No. B43	Precinct E													
Location:														
Condition:														
Associated Items:														
<p>Description: The saddlers store was used to store and repair harness and saddles for the working horses which were used on the site shortly after it opened. The only remnants of the building are the timber covered concrete floor and the bottom wall plate.</p>														
<p>SIGNIFICANCE ASSESSMENT</p>

Aesthetic Value	2/5	Historic Association	1/5	Technological Importance	4/5	Structural Integrity	2/5	Interpretive Ability	1/5	Social Significance	2/5	<p>INFORMANTS:</p> <p>REFERENCES:</p>
Aesthetic Value	2/5													
Historic Association	1/5													
Technological Importance	4/5													
Structural Integrity	2/5													
Interpretive Ability	1/5													
Social Significance	2/5													
RECOMMENDATION:	Record	<p>PHOTOGRAPHS:</p> <p>B & W: 90-038-4-26 Slides:</p>
