PRECINCT G

CHULLORA HERITAGE ASSESSMENT, 1990

MACHINERY/PLANT

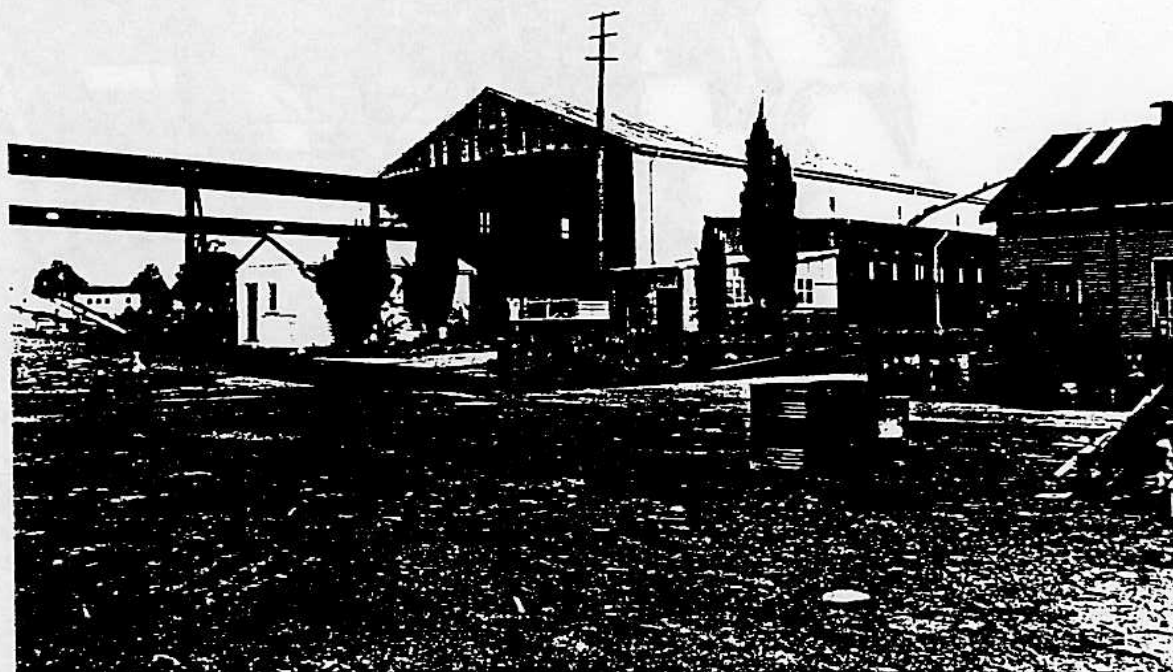
CHULLORA**HERITAGE ASSESSMENT, 1990****BUILDING/STRUCTURE****NAME OF ITEM:** Carpenters/Sawmill shop**No.** B26**Map Ref:****Location:** South/west portion of site near the centre of per way No. 2

Condition:**Associated Items:** Timber rack B64, OH Crane M26, Sawdust hopper M34, Furnace Room & Chimney M27, M27A.

Description: Large steel framed shed-clad in corrugated iron, recently refurbished. The shed has a single gable running its length. The windows are located at second storey level. The windows on each side of the shed have been sheathed in corrugated iron, but the end windows remain as 20 pane windows. This shed has skillion roofed additions on each side. There are timber racks to the west and store and sawdust rooms to the east. The sawmill has crane rail guides which run the length of the building and project some 80m into the yard. The crane was used to bring timber from the breakdown saw bench to the breast bench in the mill

INFORMANTS:**REFERENCES:****RECOMMENDATION:** Record**PHOTOGRAPHS:**

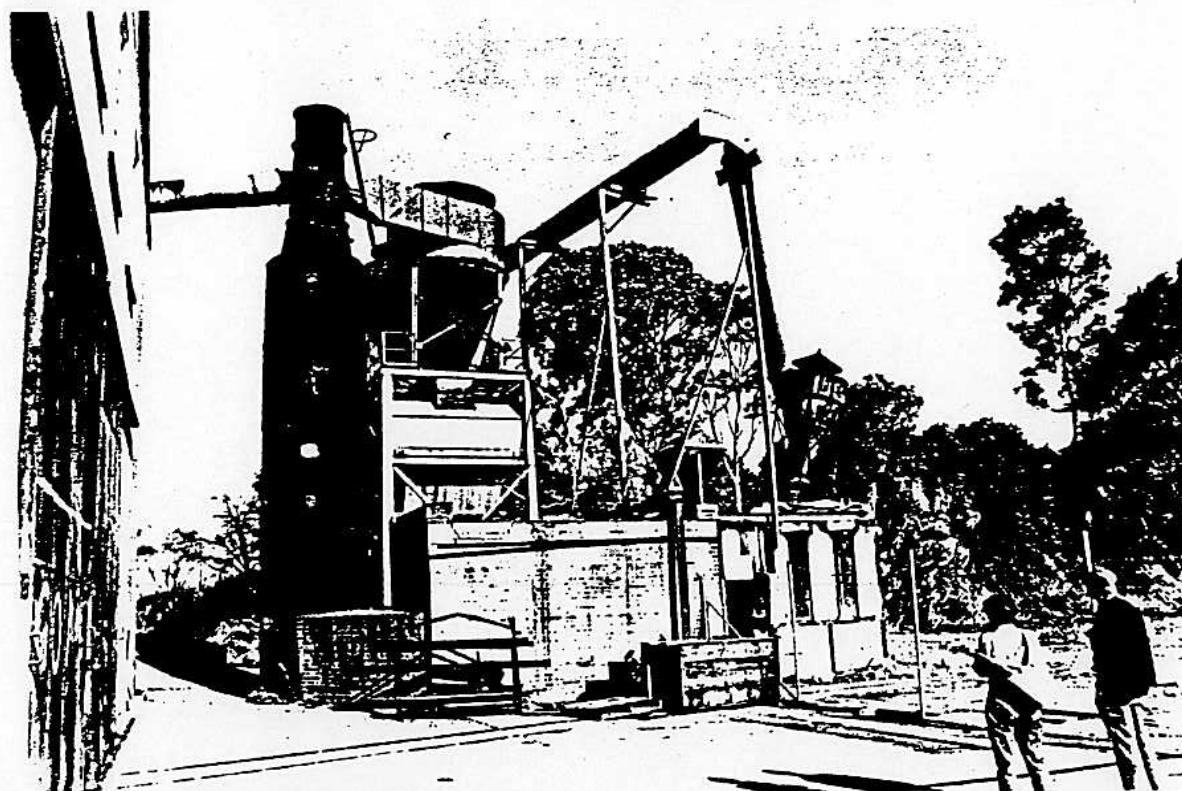
NAME OF ITEM: Furnace Room													
No. M27A	Map Ref:												
Location: South/west of carpenters shop	Precinct G												
Condition: Poor													
Associated Items: Timber Rack B64, OH Crane in shed M26, Sawdust Hopper M34, Carpenters/Sawmill shop B26, Original furnace chimney													
<p>Description: The furnace room recieved wood shavings from the timber mill and sawdust shop. The sawdust cyclone hopper is now at an angle. The furnace room itself is a brick structure which had a barrel vault brick roof which has recently been demolished. The hopper released sawdust into bags for use on station floors etc.</p>													
<p>SIGNIFICANCE ASSESSMENT</p>

Historic Association	2/5	Technological Importance	3/5	Structural Integrity	2/5	Interpretive Ability	/5	Relative Rarity	2/5	Operational Ability	2/5	<p>INFORMANTS:</p> <p>REFERENCES:</p>
Historic Association	2/5												
Technological Importance	3/5												
Structural Integrity	2/5												
Interpretive Ability	/5												
Relative Rarity	2/5												
Operational Ability	2/5												
RECOMMENDATION: Record	<p>PHOTOGRAPHS:</p> <p>B & W: 90-038-3 Slides:</p>
