PRECINCT H

CHULLORA

HERITAGE ASSESSMENT, 1990

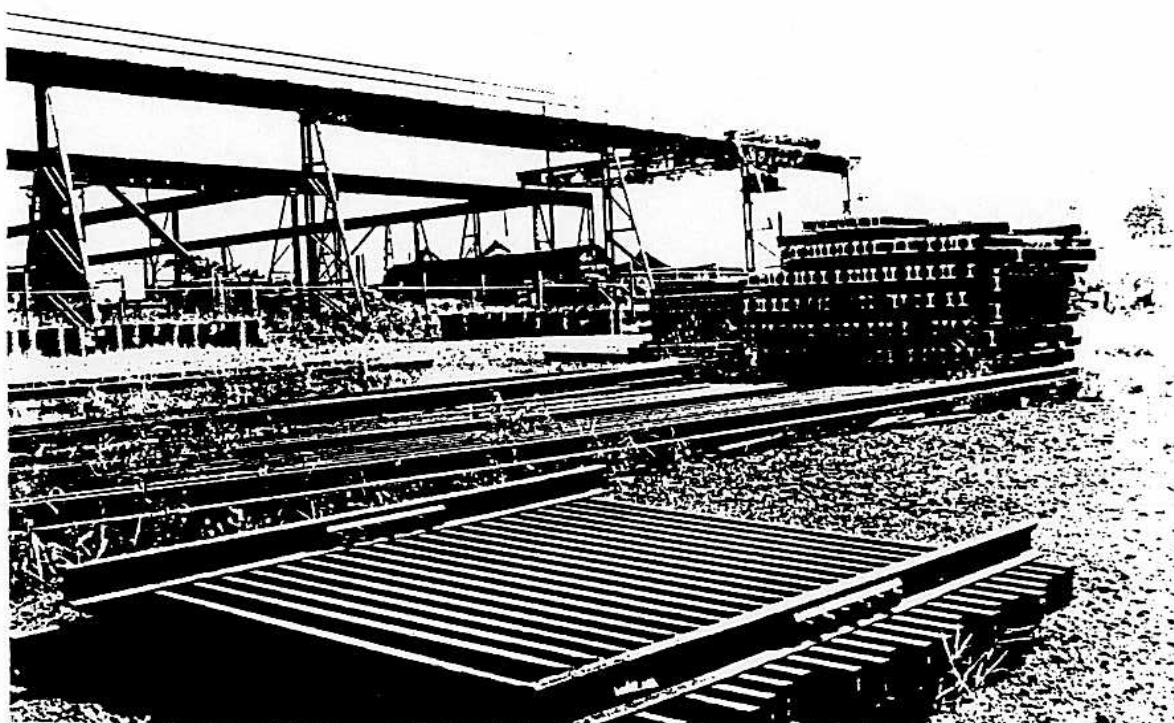
NAME OF ITEM: Overhead Crane Upper Yard													
No. M21 C8	Map Ref:												
Location: Upper Yard.	Precinct H												
Condition:													
Associated Items:													
<p>Description: The maker's plate is inscribed as follows: "W A Hogkinson & Co Ltd, Crane Makers, Sydney, NSW, 5.24, Load not to exceed 3 tons". This crane runs on overhead rails on rivetted section plate girders supported on welded channel and angle section steel members. It is obviously of an earlier vintage than the workshop crane. It is supported on A frames except for the supports about 12m, 3rd section from the northern end. This section spans 20m. The depth of beam over this section is almost twice that over rest of the beams length. This crane was used to move timber from the timber yard to the workshop or to the band saw shed.</p>													
<p>SIGNIFICANCE ASSESSMENT</p>

Historic Association	3/5	Technological Importance	2/5	Structural Integrity	3/5	Relative Rarity	3/5	Operational Ability	3/5	Interpretive Ability	3/5	<p>INFORMANTS:</p> <p>REFERENCES:</p>
Historic Association	3/5												
Technological Importance	2/5												
Structural Integrity	3/5												
Relative Rarity	3/5												
Operational Ability	3/5												
Interpretive Ability	3/5												
<p>RECOMMENDATION: Consider for conservation</p>	<p>PHOTOGRAPHS:</p> <p>B & W: 90-038-7</p>

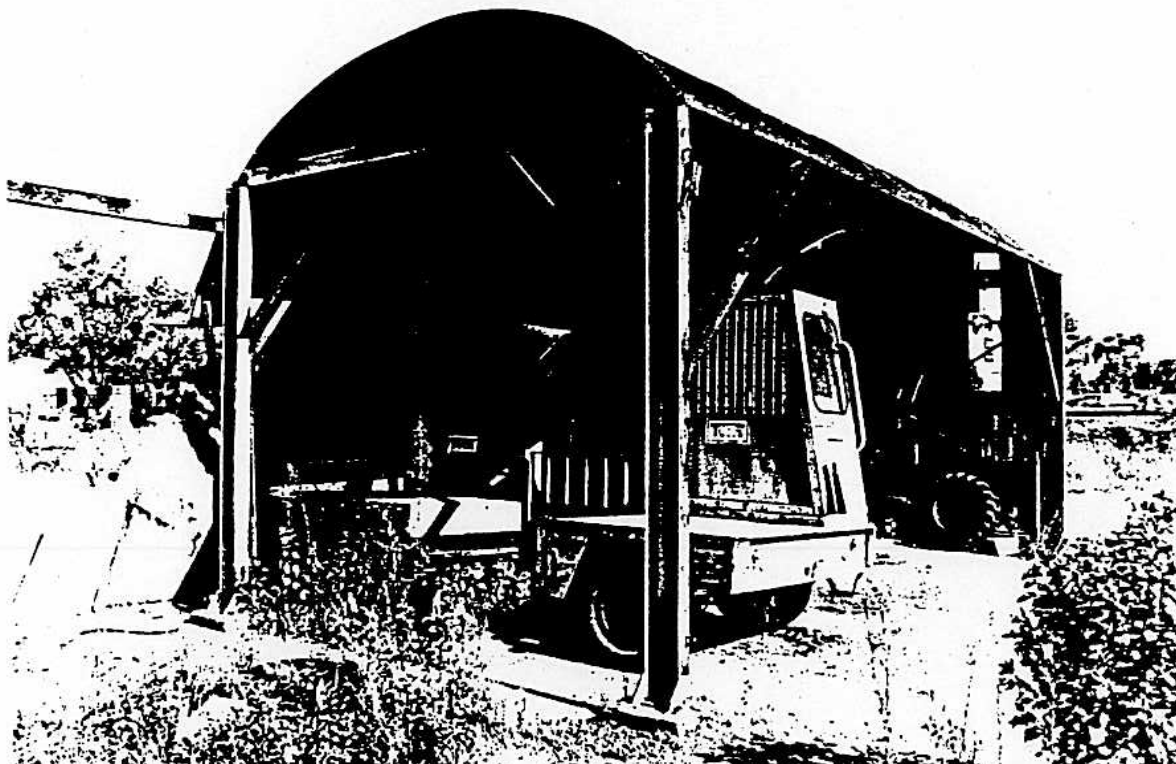
NAME OF ITEM: Shed (Band Saw Building)		
No. B23	Map Ref:	
Location: Upper Yard, west of crane.	Precinct H	
Condition: Poor		
Associated Items:		
<p>Description: This building is steel and timber framed with welded sections and a cambered sheet iron roof. The buildings were possibly sheathed on 3 sides in corrugated iron. This shed originally housed a band saw. It is presently used for storage of machinery and equipment.</p>		
SIGNIFICANCE ASSESSMENT Aesthetic Value 2/5 Historic Association 1/5 Technological Importance 3/5 Structural Integrity 2/5 Interpretive Ability 2/5 Social Significance 2/5	INFORMANTS: REFERENCES:	
RECOMMENDATION: Record	PHOTOGRAPHS: B & W: 90-038-7	Slides:
