Eastlakes Shopping Centre (North)

Arboricultural Impact Assessment

Prepared for
Crown Group

7 July 2017

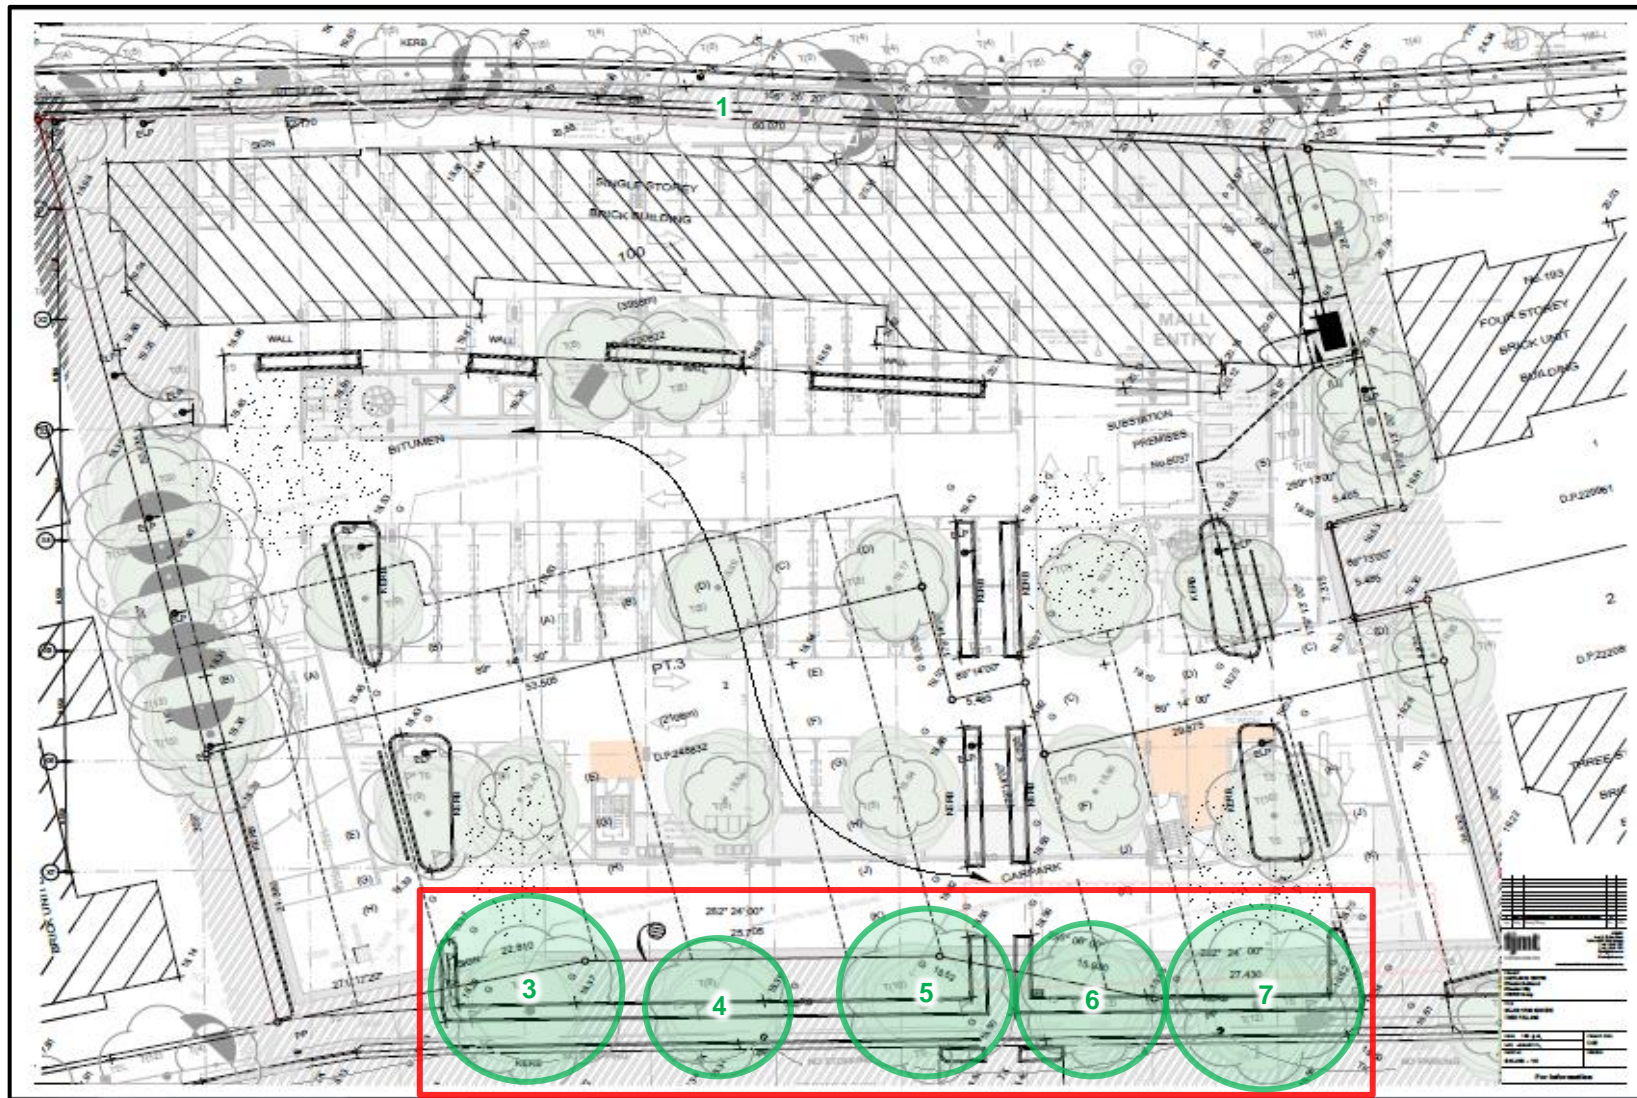
Appendix A: The study area, the subject trees

- **Tree 3, 4, 5, 6, 7:** Tree crown has been lopped to maintain powerline clearances, root system is being confined by carpark and footpath, and tree roots are lifting footpath.

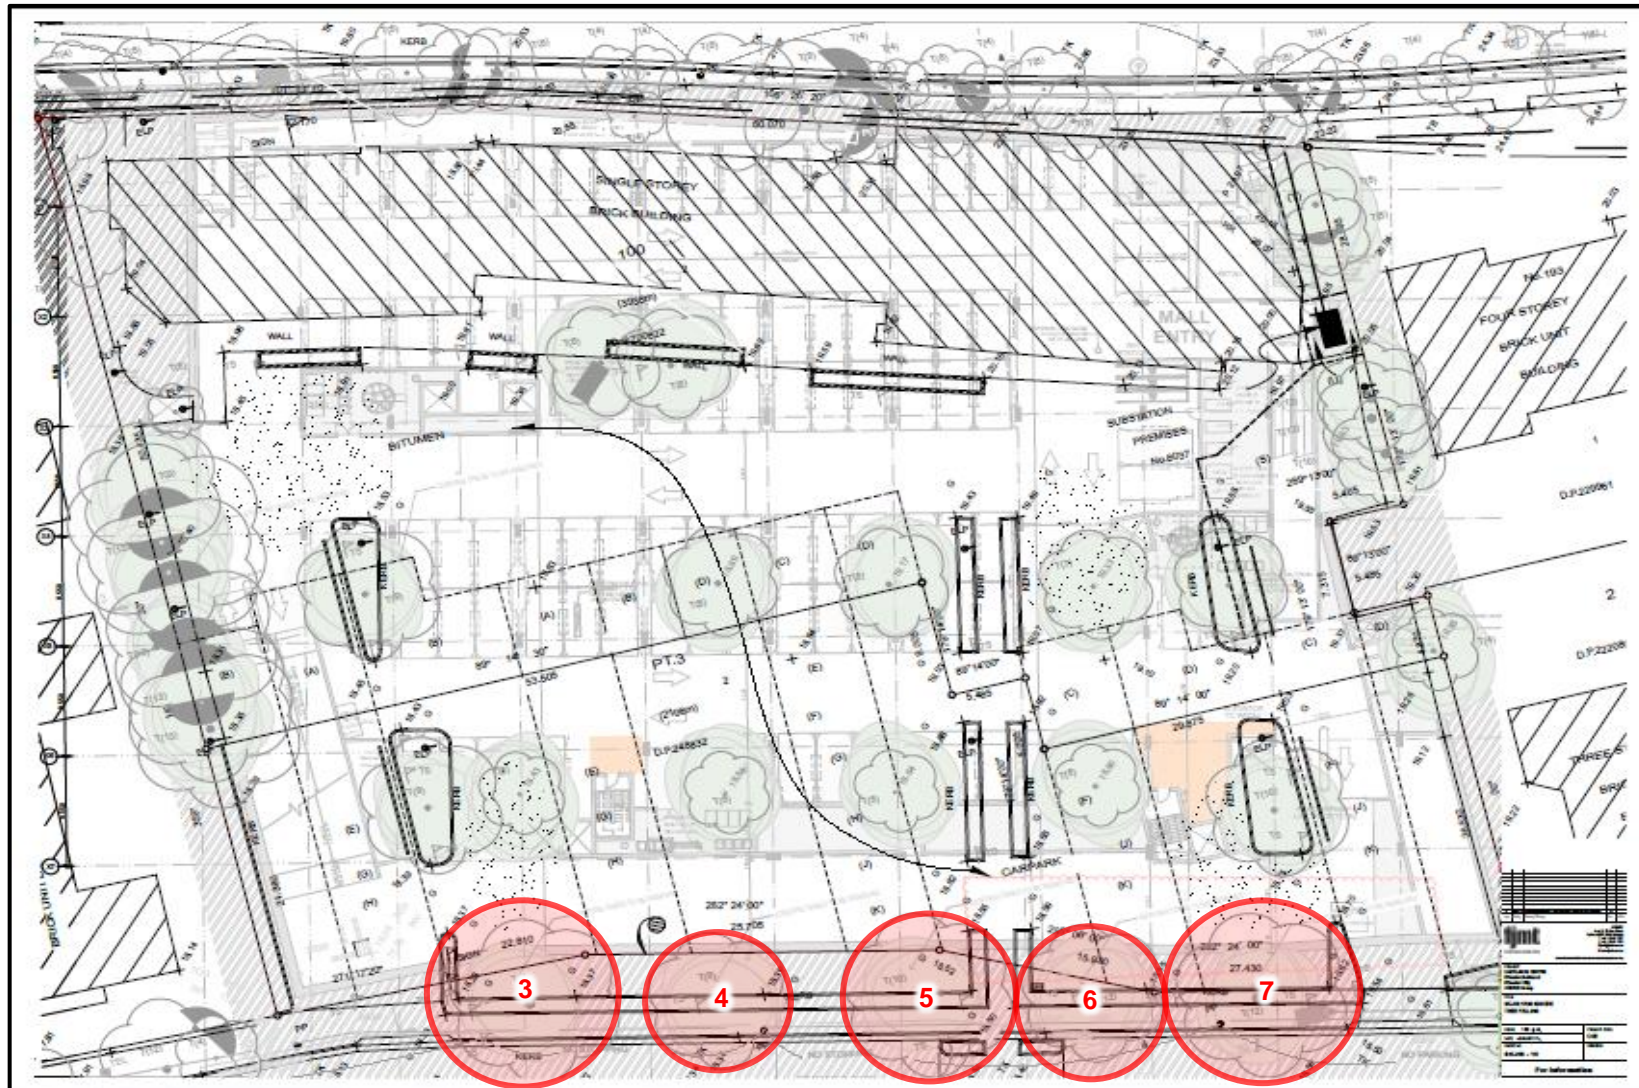
Appendix B: Major encroachment (>40%)

- **Major encroachment (>25%):** 5 trees will be subject to a major encroachment (>25%) within the TPZ. Under the current proposal, none of these subject trees will be retained. Trees proposed for removal have the following retention values:
 - 5 trees with a medium retention value.

No.	Botanical Name	Height (m)	Spread (m)	Health	Structure	Retention value	DBH (mm)	TPZ (m)	SRZ (m)	Encroachment into TPZ		Cause of encroachment	Proposal
3	<i>Platanus x acerifolia</i>	13	10	Good	Fair	Medium	600	7.2	2.7	Major	100%	Excavation for basement levels and installation of underground services.	Remove
4	<i>Platanus x acerifolia</i>	12	7	Fair	Fair	Medium	450	5.4	2.4	Major	100%	Excavation for basement levels and installation of underground services.	Remove
5	<i>Platanus x acerifolia</i>	15	7	Fair	Fair	Medium	550	6.6	2.6	Major	100%	Excavation for basement levels and installation of underground services.	Remove
6	<i>Platanus x acerifolia</i>	12	7	Fair	Fair	Medium	650	7.8	2.8	Major	100%	Excavation for basement levels and installation of underground services.	Remove
7	<i>Platanus x acerifolia</i>	13	9	Fair	Fair	Medium	600	7.2	2.7	Major	100%	Excavation for basement levels and installation of underground services.	Remove
