Aboriginal Heritage Due Diligence Report

# UTS 14–28 Ultimo Rd

## Aboriginal Heritage Due Diligence Report

Report prepared for University of Technology Sydney  
February 2011

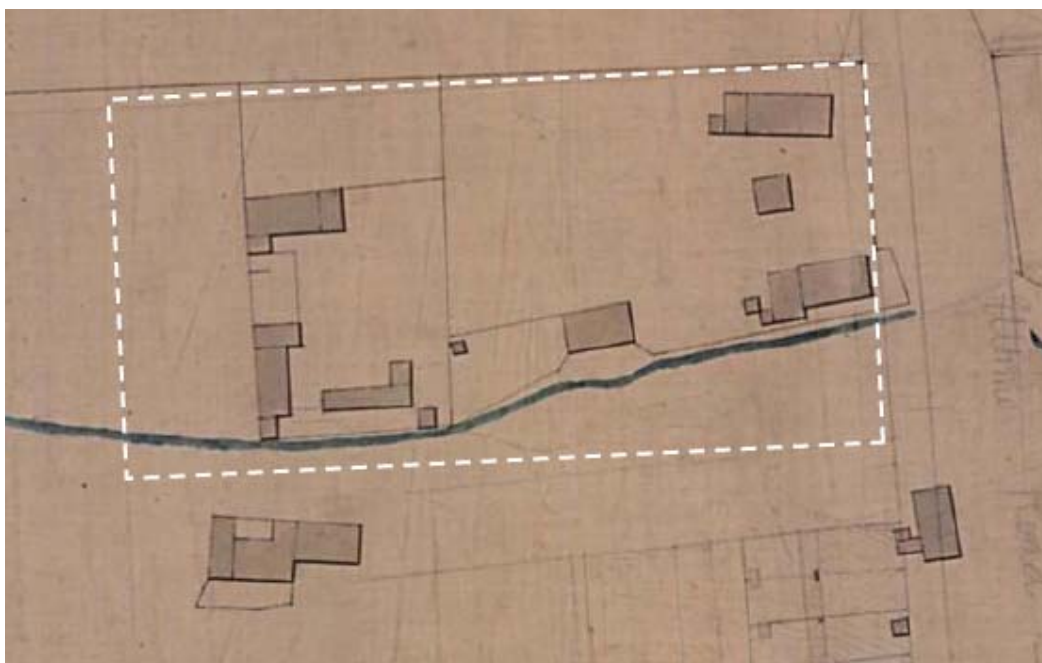
Figure 2.3 Portion of Block V of the Trigonometrical Survey of Sydney 1855-65. Note the creek running beneath Ultimo Road. (Source: Taken from Casey and Lowe 2010<sup>12</sup>. Original Historical Atlas of Sydney, CCS Archives.)

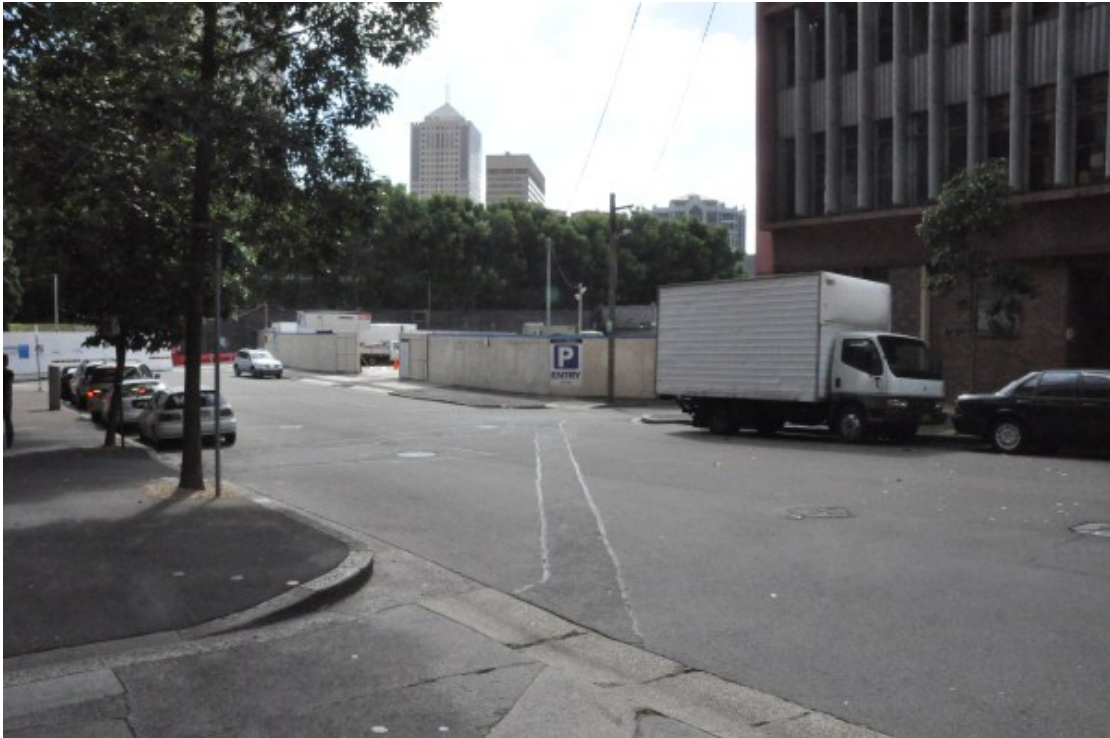
Figure 4.1 View to the subject site from the northwest, from intersection of Mary Ann Street and Systrum Street. Note the relatively low-lying nature of the subject site.

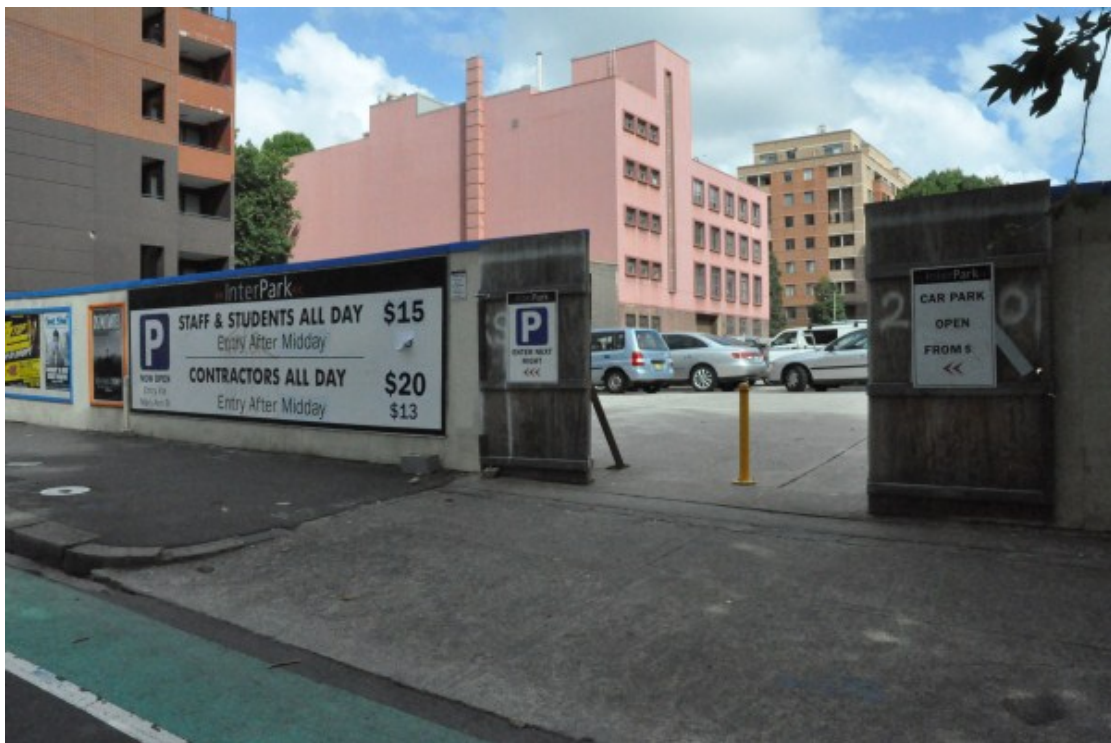
Figure 4.2 View to the southern entrance of the subject site from Ultimo Road. Note the difference in elevation between street level and the carpark.

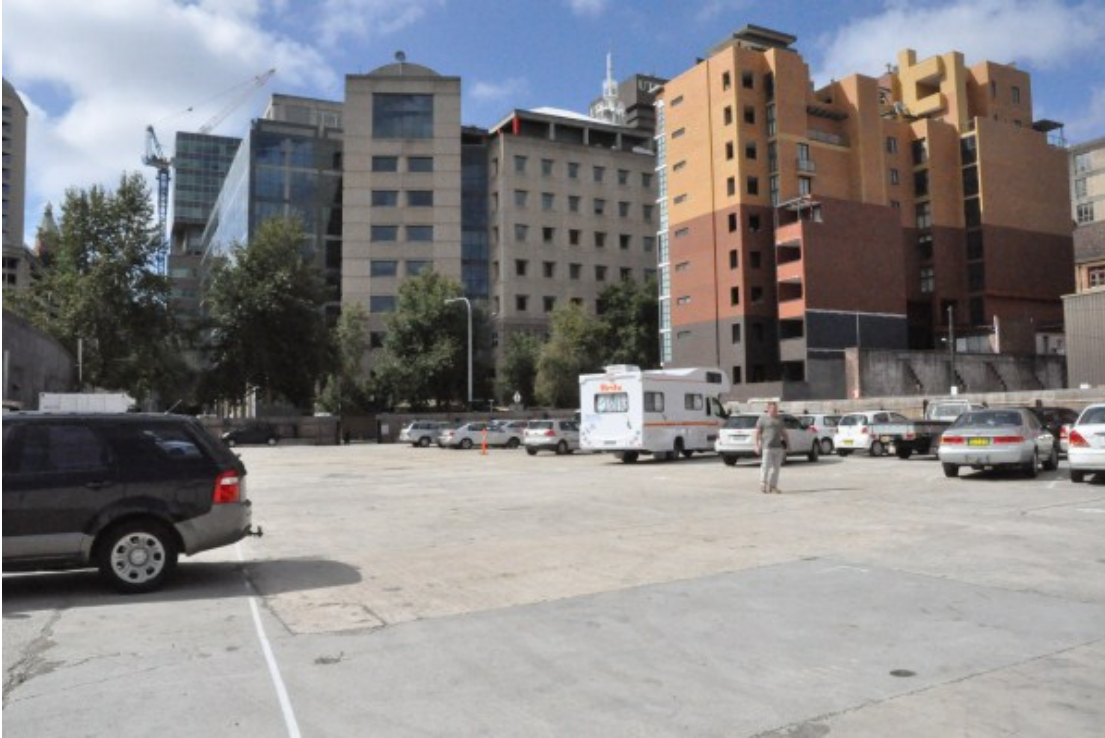
Figure 4.3 View across the subject site's concrete slab, from the northeast corner.
