Archaeological Conservation and Heritage Interpretation Plan  
MP 09\_0167

Crown Landmark Pty Ltd

45 Macquarie Street  
Parramatta

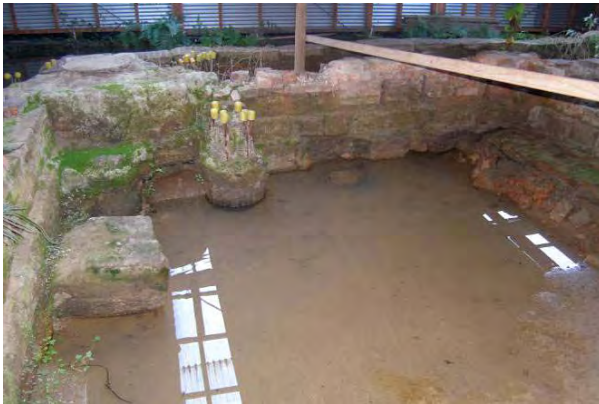
*2008 flooding of the site caused some damage to the archaeology, especially the collapse of the sides of excavation trenches and the partial undermining of the foundation material below remnant brick walls*

In 2008 the site was flooded and some damage inflicted on the archaeological excavations and exposed trench walls, including partial collapse of the sides of archaeological trenches. Some stabilisation work was undertaken by Edward Higginbotham and Associates at that time.

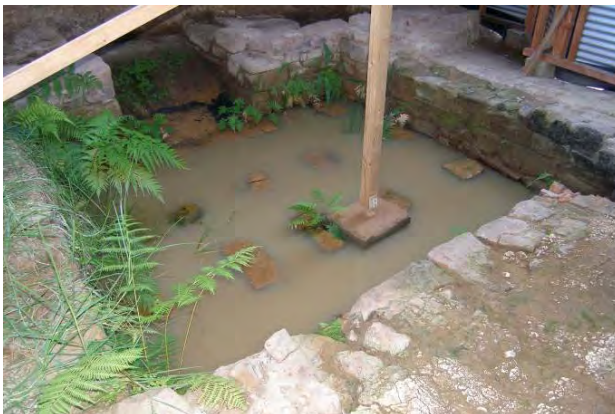
*Flooding of the cellar of the former hotel at the north east corner of the site.*

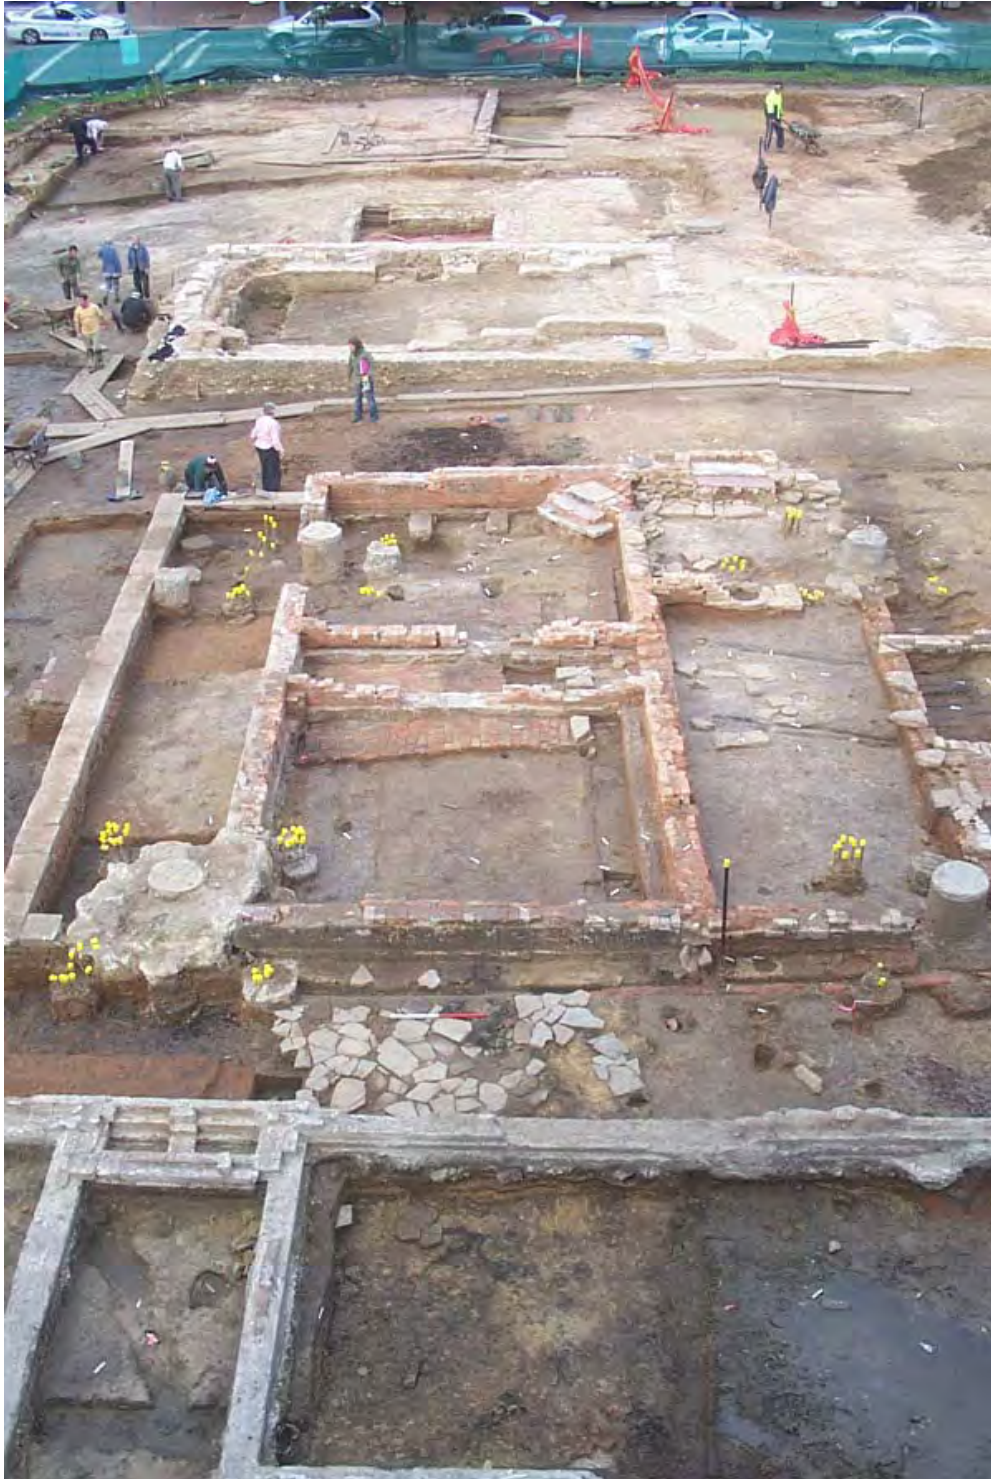
*Elevated photo looking east over the revealed archaeology during the 2005 excavations. The 'convict hut' lies within the brick footings of the 1830s house, while the hotel cellar is in the background*

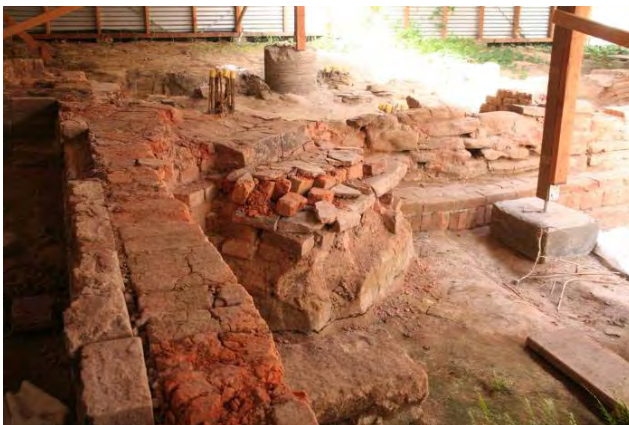
*Layers of history revealed in the excavation included later alterations to the early 19<sup>th</sup> century buildings and reinforced concrete footings from a failed 1970s office development on the site.*

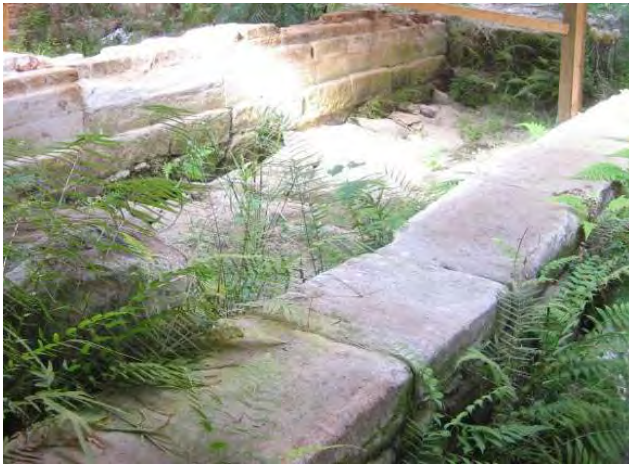
*Sandstone elements in the 1830s cottage are used mostly in conjunction with brick wall construction.*

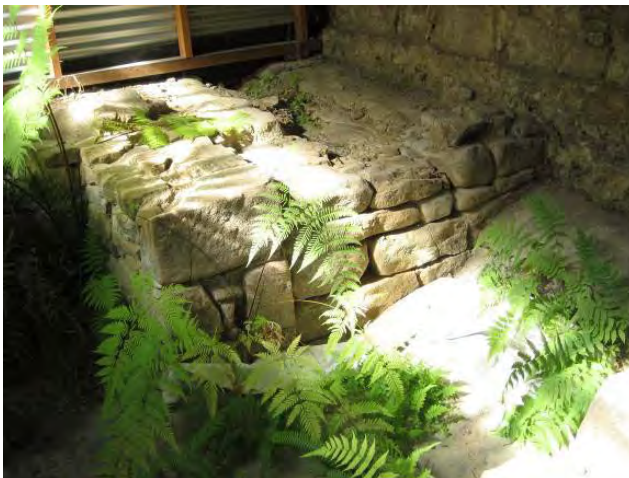
*Sandstone has also been used as foundation walls within the below-grade cellar.*

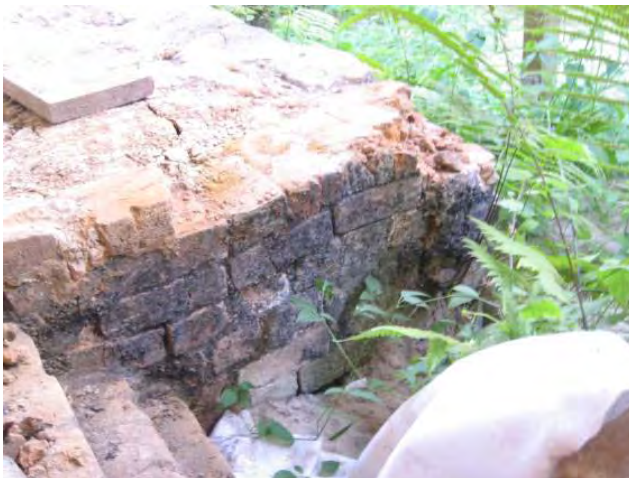
*In the cellar archaeological site, brick remains are found in the stairs leading into the sub-ground cellar.*

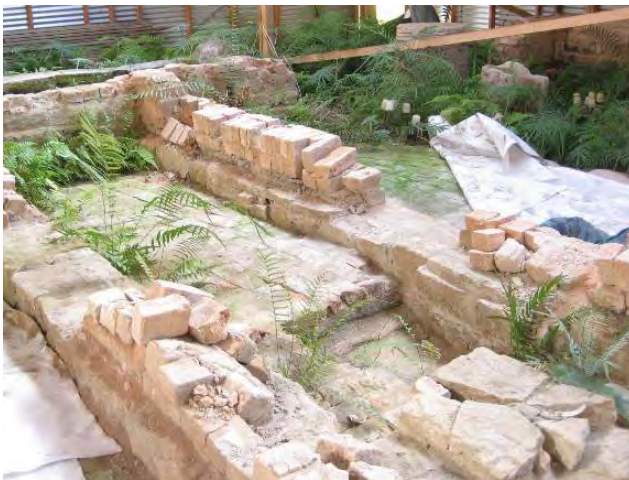
*Brick paving is found only within the boundary of the original convict hut.*

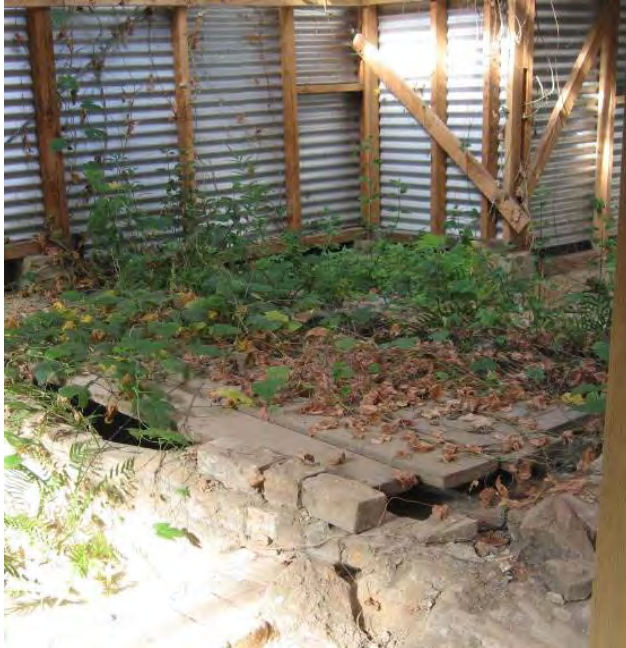
*The well for the 1830s cottage has been temporarily boarded over as a safety measure.*

*It is lined with brick and has only been partially excavated.*

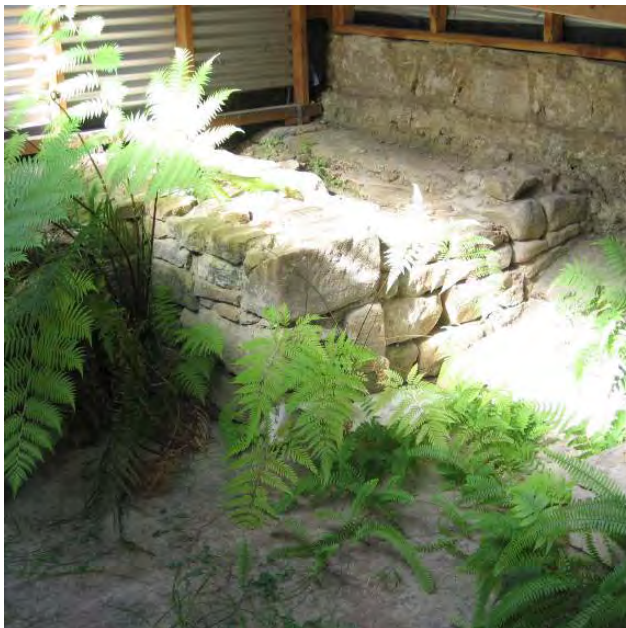
*The cellar is also a below grade feature. Is it lined with sandstone with two access points; stairs in the northeast corner, and a ramped access point halfway along the western side.*

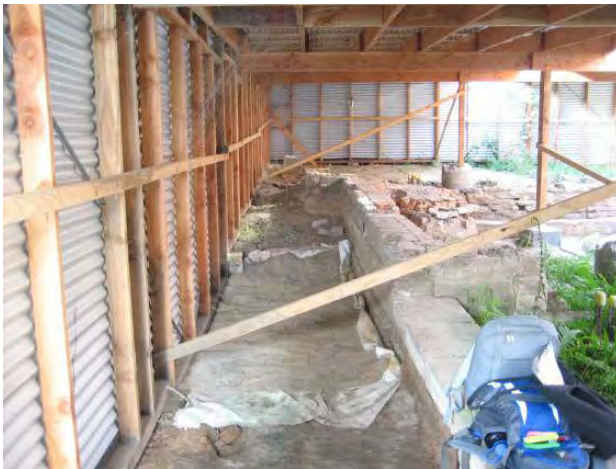
The fill matter is mostly sand, with some areas layered with a geotextile.

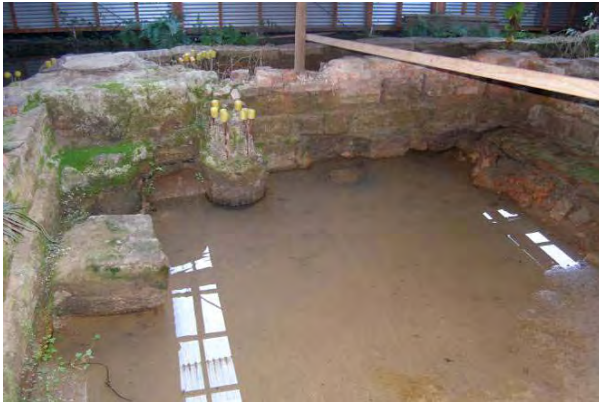
*2008 flooding of the site caused some damage to the archaeology, especially the collapse of the sides of excavation trenches and the partial undermining of the foundation material below remnant brick walls*

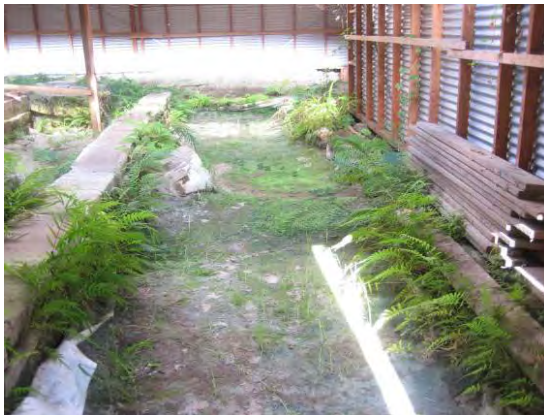
*Most noticeably prevalent along the northern side of the Convict Hut*

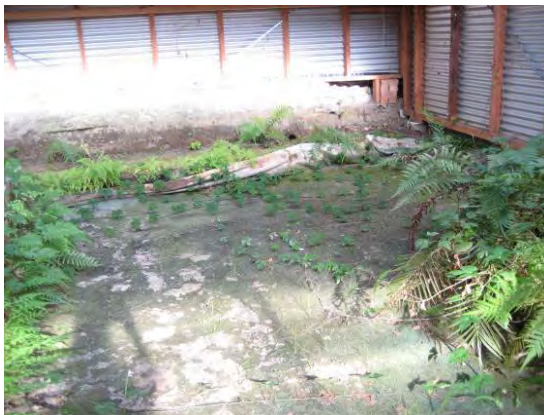
*Also noted along the north side of the overall site (outside of the sheds) along Macquarie Street.*

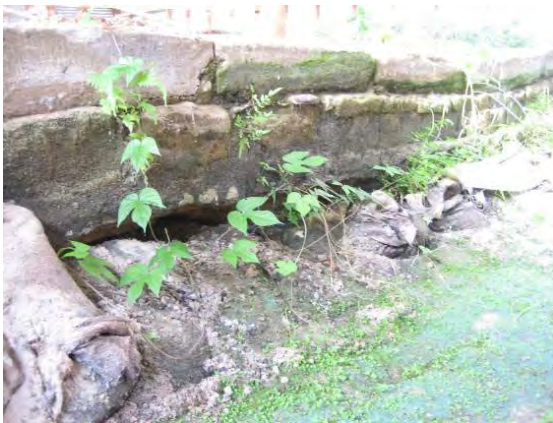
*Evident along the wall on the north side of the Convict Hut*

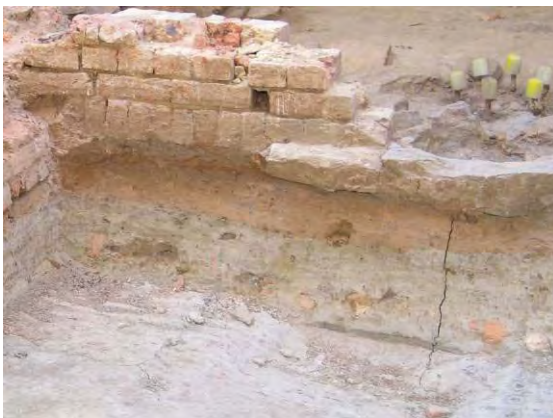
*Erosion has caused an undercut of a brick wall on the south side of the site*

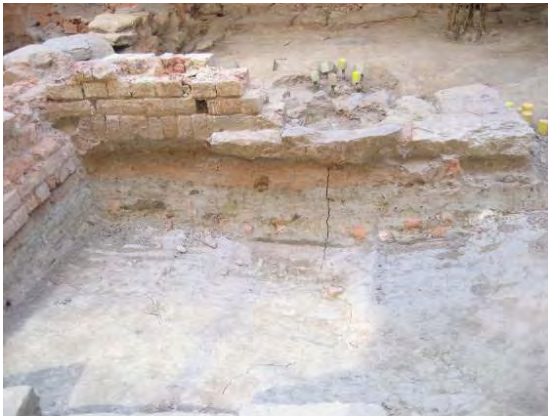
*Prevalent on the south side of the site.*

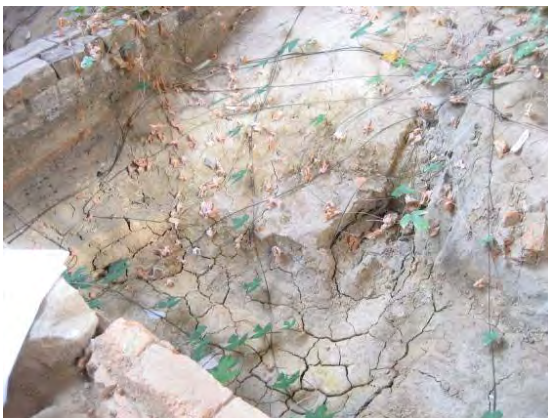
*Soil cracking is evident as the ground dries out*

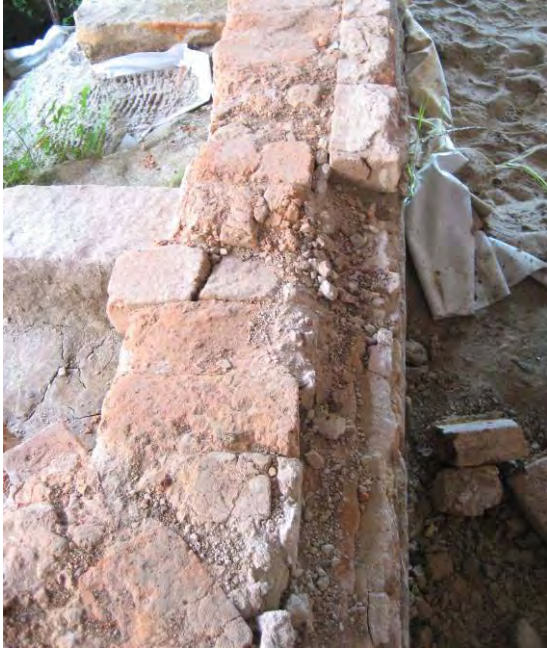
*Evident along most brick wall features.*

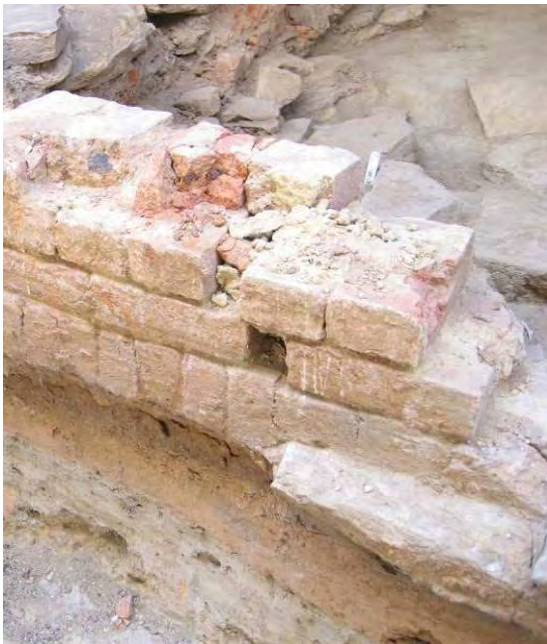
*Degree of crumbling varies from large cracks through brick remnants, to very small fine particles.*

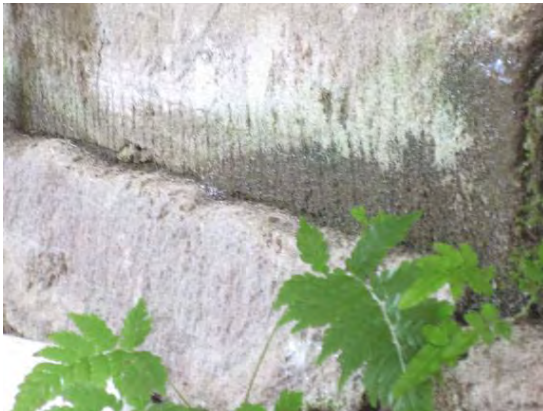
*Efflorescence evident on vertical faces on most brick and stone wall features.*

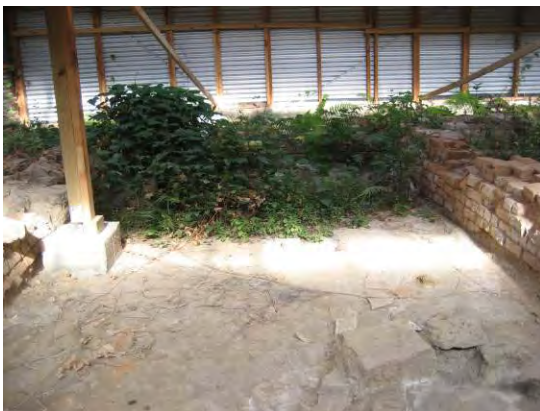
*Plant growth is greatest where the sun penetrates through glazed panels in the roof of the timber framed sheds.*

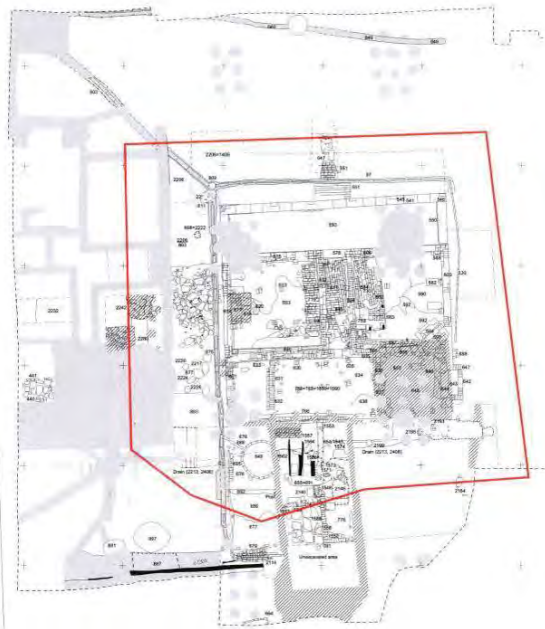
*The proposed protection zone around the 1830s cottage and convict hut on the western side of the Macquarie Street frontage*

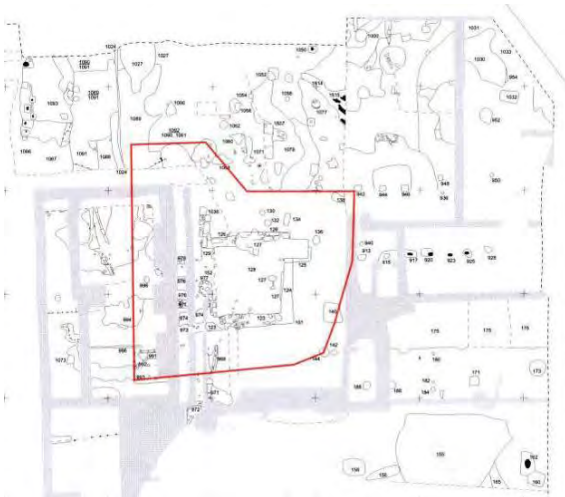
*The protection zone around the remains of the hotel cellar at the eastern end of the Macquarie Street frontage*
