## D3 Bore census forms

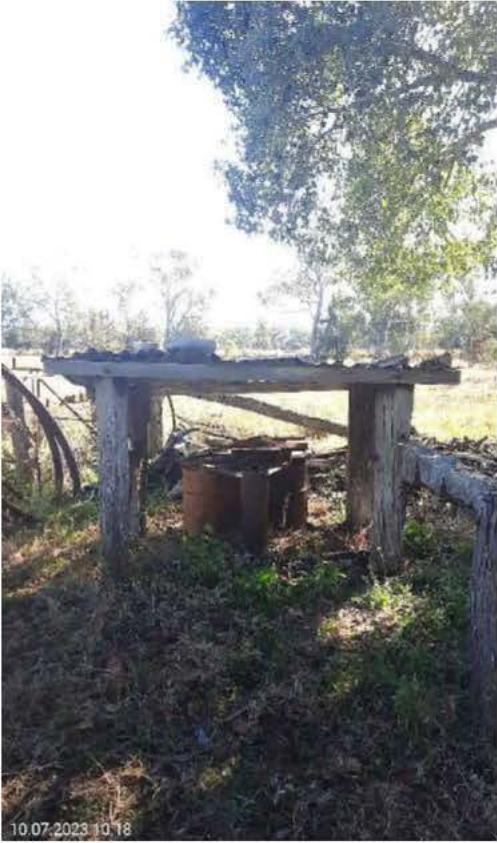
| Bore Image | Bore ID: | GW062771 |

| Bore Image | Bore ID: | GW062771 |
|---|---|---|
| | Bore Status (existing/abandoned) | Existing - Disused |
| | Total Drilled Depth (m) | 12.29 |
| | Casing Type (steel/pvc) | Steel |
| | Water Depth (mTOC) | 6.87 |

| Bore Image | Bore ID: | GW062771 |
|---|---|---|
| | Comments / Landholder notes | Landowner reported that the borehole ran dry during the drought, so drilled a new one ±5m away. |
| | Sampling notes | *Sampled, manually bailed, sample has suspended sediment. |

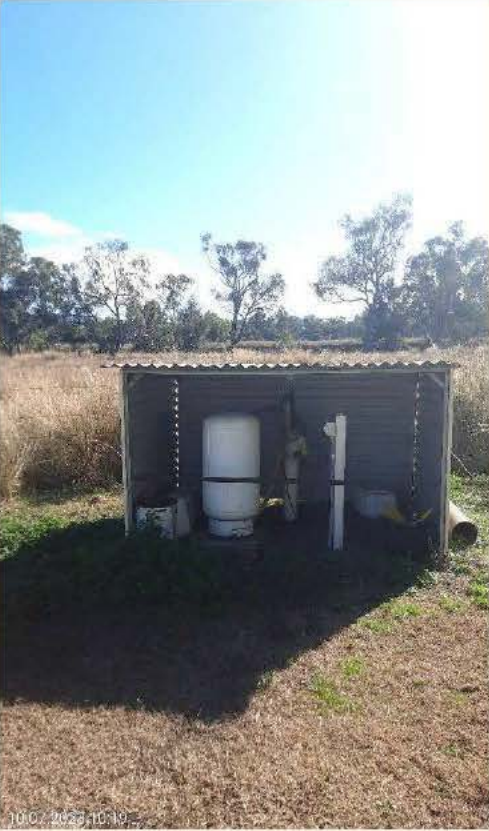
| Bore Image | Bore ID: | Old Glenelg 2 |

| Bore Image | Bore ID: | Old Glenelg 2 |
|---|---|---|
| | Bore Status (existing/abandoned) | Existing |
| | Casing Type (steel/pvc) | PVC |
| | Pumping Equipment (submersible pump, jet pump) | Submersible |

| Bore Image | Bore ID: | Old Glenelg 2 |
|---|---|---|
| | Comments / Landholder<br>notes | Has been registered but doesn't show<br>on map.<br>Landowner drilled after GW062771<br>went dry. |
| | Sampling notes | *Sampled from tap |

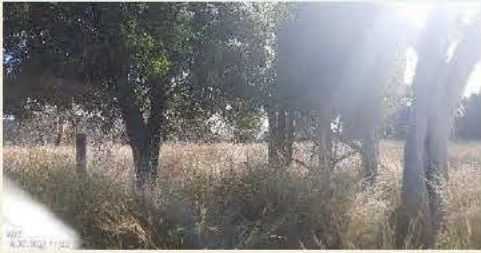
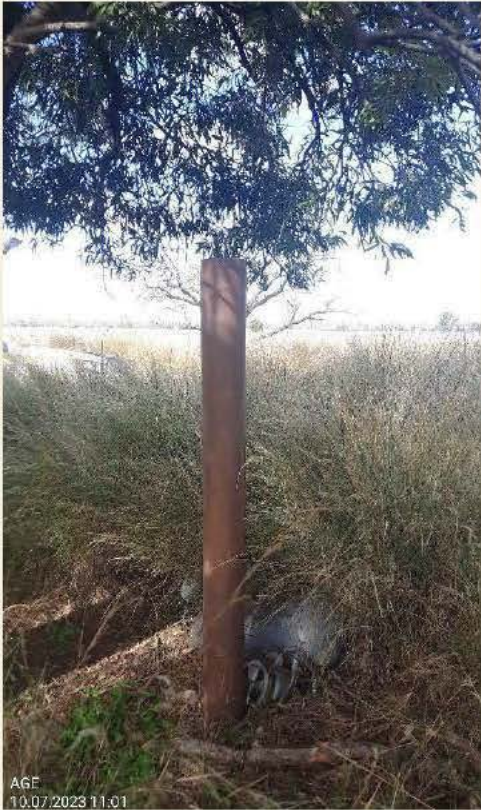
| Bore Image | Bore ID: | GW062770 |

| Bore Image | Bore ID: | GW062770 |
|---|---|---|
| | Bore Status (existing/abandoned) | Existing - Disused |
| | Water Depth (mTOC) | 7.49 |

| Bore Image | Bore ID: | GW062770 |
|---|---|---|
| | Comments / Landholder<br>notes | Well dug by hand, used to have a<br>windmill.<br>Next to old tank. |
| | Sampling notes | *Sampled, manually bailed, sample was<br>clear. |

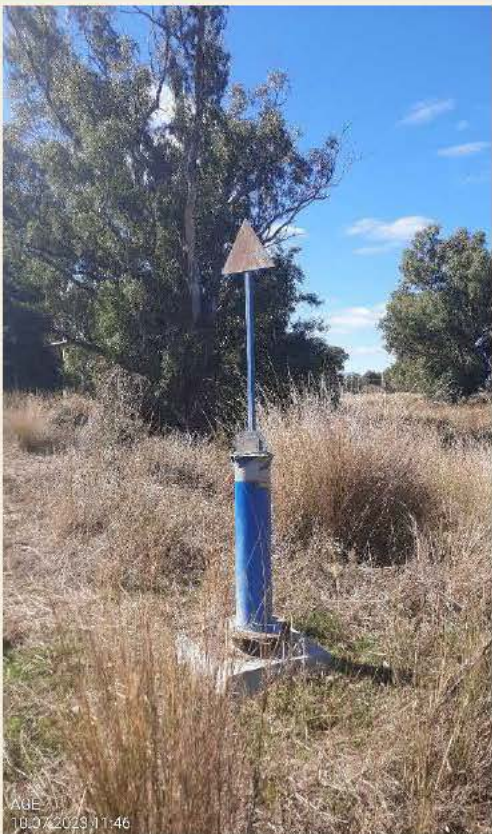
| Bore Image | Bore ID: | GW273267 |

| Bore Image | Bore ID: | GW273267 |
|---|---|---|
| | Bore Status (existing/abandoned) | NSW University monitoring borehole |

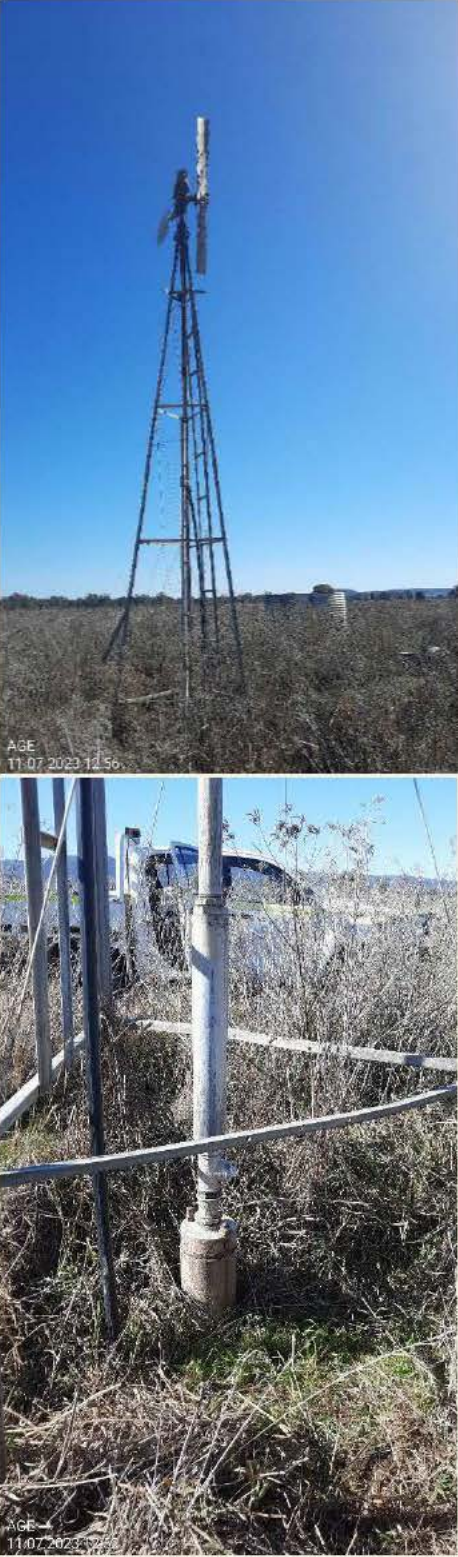
| Bore Image | Bore ID: | GW062784 |

| Bore Image | Bore ID: | GW062784 |
|---|---|---|
| | Comments / Landholder<br>notes | Appears to have broken down.<br>Landowner not present.<br>Tank not in use but present.<br>Not accessible, pump fitted. |

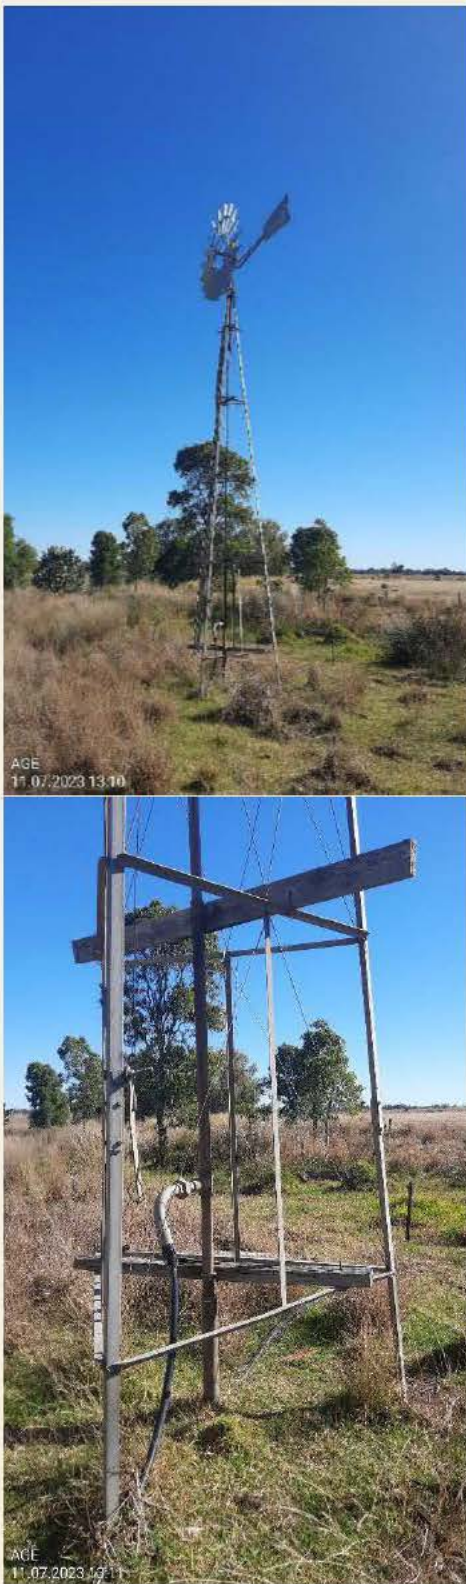
| Bore Image | Bore ID: | GW062782 |

| Bore Image | Bore ID: | GW062782 |
|---|---|---|
| | Comments / Landholder<br>notes | No casing visible.<br>Pipe connection to windmill broken. |

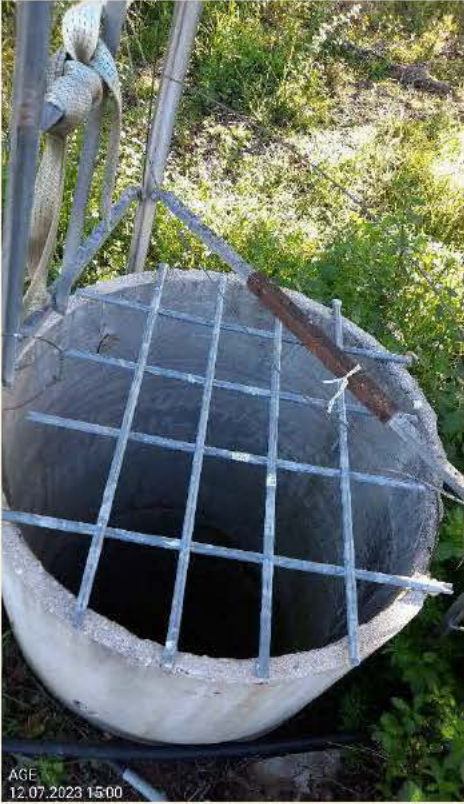
| Bore Image | Bore ID: | GW026017 |

| Bore Image | Bore ID: | GW026017 |
|---|---|---|
| | Casing Type (steel/pvc) | Concrete well |
| | Bore Inner Diameter (cm) | 94 |

| Bore Image | Bore ID: | GW026017 |
|---|---|---|
| | Comments / Landholder<br>notes | Large diameter dug well with windmill<br>over. Assumed for supply to house but<br>clearly abandoned. |

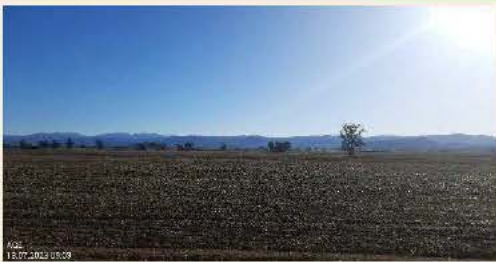
| Bore Image | Bore ID: | GW008238 |
|---|---|---|
| | Bore Status (existing/abandoned) | Not found |
| | Comments / Landholder notes | Landowners son did not show us this boreholes when directing us to the BHs on the Finlay properties. I went back and looked for it but the whole area has been planted. No borehole visible. Assumed destroyed. |

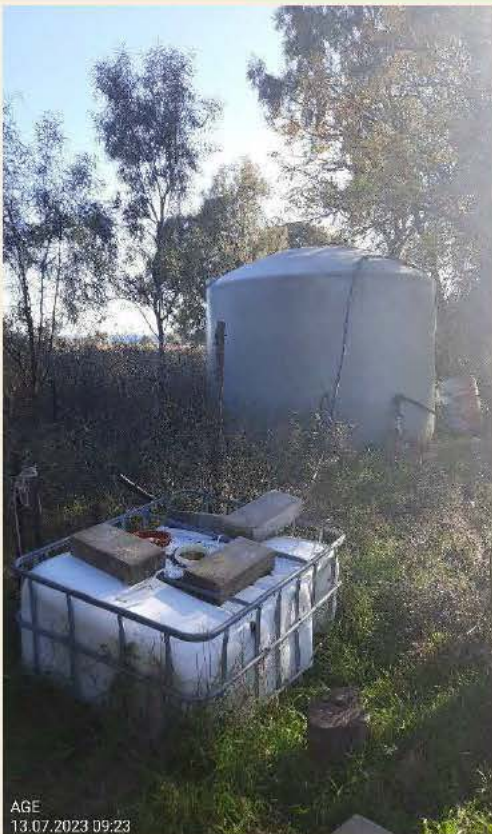
| Bore Image | Bore ID: | GW062790 |

| Bore Image | Bore ID: | GW062790 |
|---|---|---|
| | Bore Location (description) | House bore |
| | Casing Type (steel/pvc) | Concrete well |
| | Bore Inner Diameter (cm) | ~100 |
| | Pumping Equipment (submersible pump, jet pump) | Pressure pump |

| Bore Image | Bore ID: | GW062790 |
|---|---|---|
| | Comments / Landholder<br>notes | Landowner not present.<br>Covered in plastic tub- can't measure<br>cement diameter. |

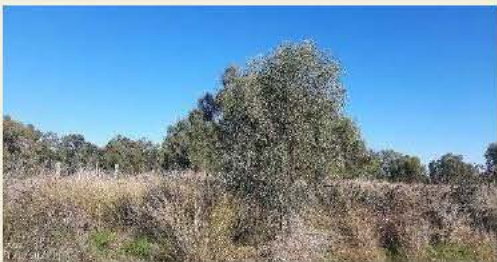
| Bore Image | Bore ID: | GW901937 |

| Bore Image | Bore ID: | GW901937 |
|---|---|---|
| | Bore Status (existing/abandoned) | Not found |
| | Comments / Landholder notes | Could not locate, possible destroyed. Seems to have been located at old abandoned vineyard. Very overgrown. |

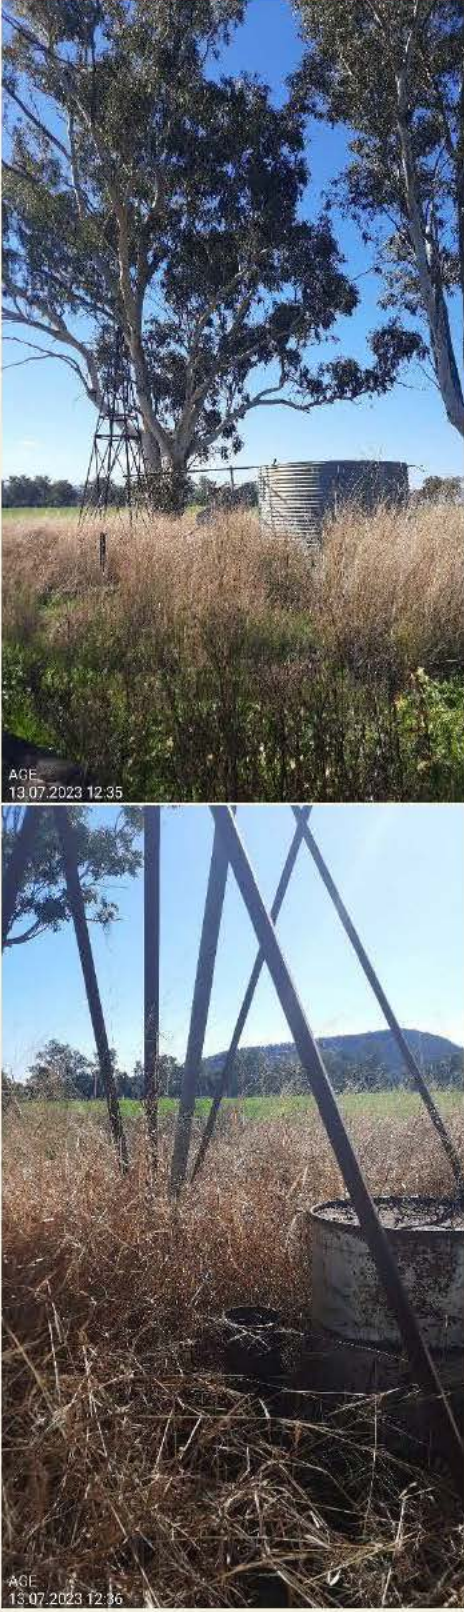
| Bore Image | Bore ID: | GW062763 |

| Bore Image | Bore ID: | GW062763 |
|---|---|---|
| | Comments / Landholder<br>notes | Windmill base present but blades<br>missing.<br>Two troughs nearby but discarded. |

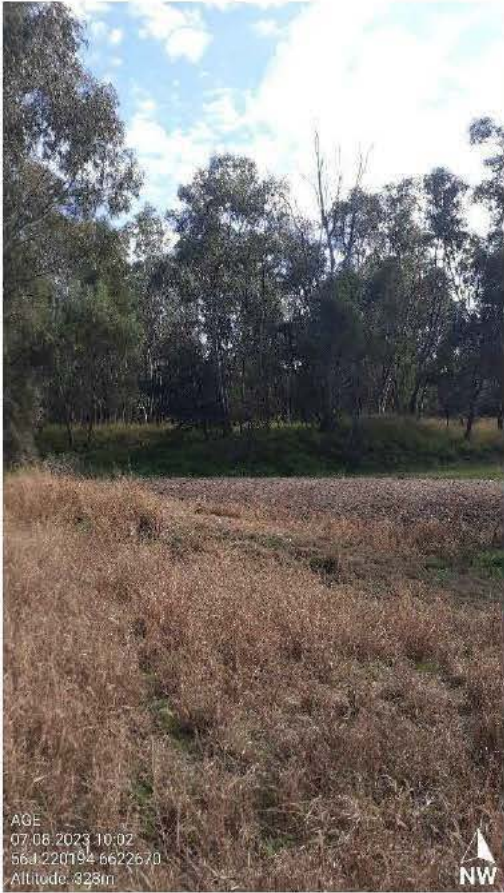
| Bore Image | Bore ID: | GW900068 |
|---|---|---|
| | Comments / Landholder notes | Could not locate. Plots adjacent to Creek. Most likely covered by soil from intermittent flooding. Creek was dry at location but water was observed further up the Creek when driving around the property. |

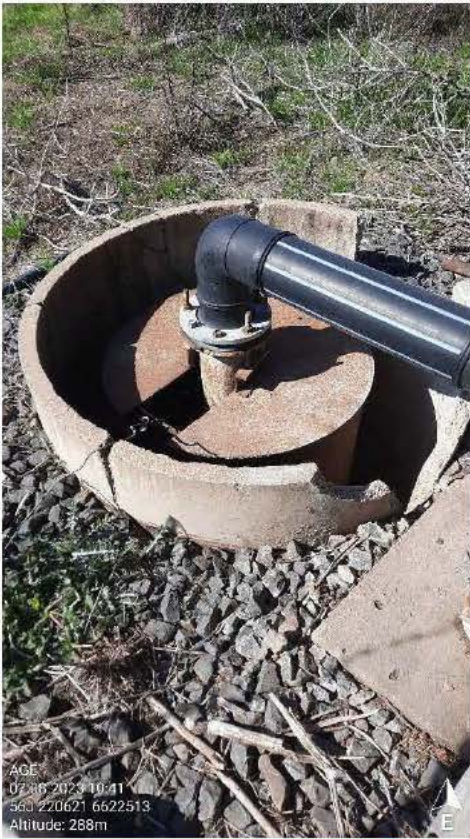
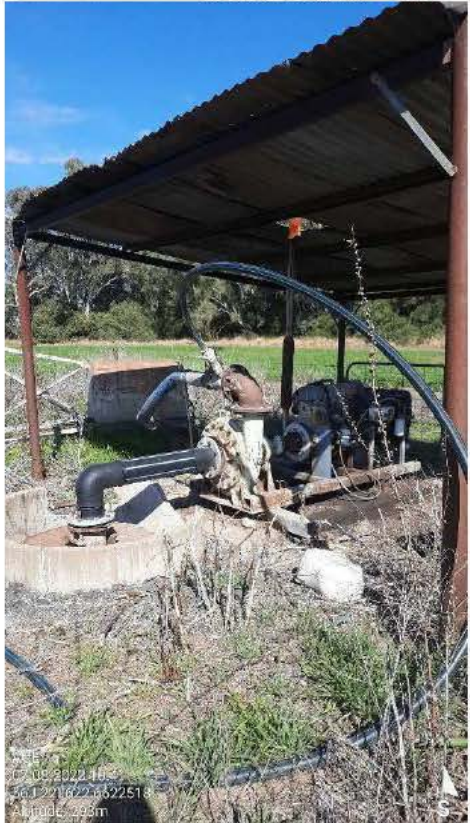
| Bore Image | Bore ID: | GW037338 |

| Bore Image | Bore ID: | GW037338 |
|---|---|---|
| | Total Drilled Depth (m) | 8.4 |
| <p>AGE<br/>07/08/2023 10:41<br/>563 220621 6622513<br/>Altitude: 268m</p> | Casing Type (steel/pvc) | Steel bore inside concrete well |

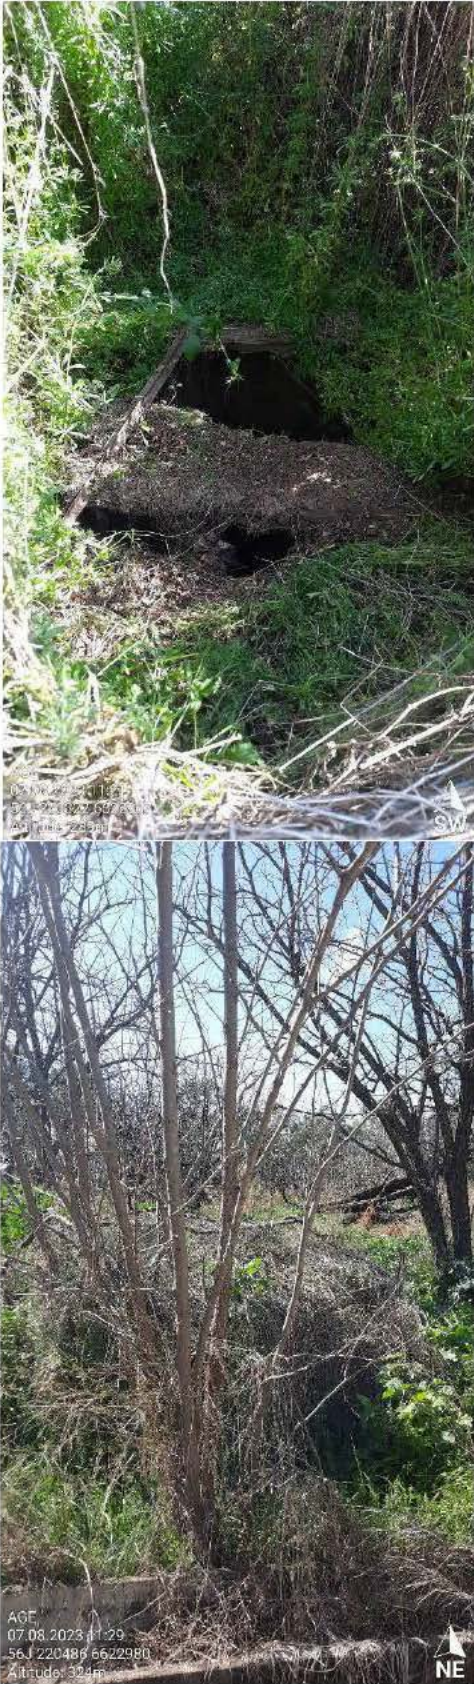
| Bore Image | Bore ID: | GW037705 |

| Bore Image | Bore ID: | GW037705 |
|---|---|---|
| | Bore Location (description) | Wheat field |
| | Bore Status (existing/abandoned) | Abandoned |
| | Total Drilled Depth (m) | 5.5 |
| | Casing Type (steel/pvc) | Concrete |
| | Water Depth (mTOC) | 3.56 |

| Bore Image | Bore ID:<br>PROPERTY INFORMATION | GW037705 |
|---|---|---|
| | Comments / Landholder<br>notes | Large diameter well, located between<br>Creeks. Very overgrown. |
| | Sampling notes | Sampled (grab sample), sample was<br>clear. |

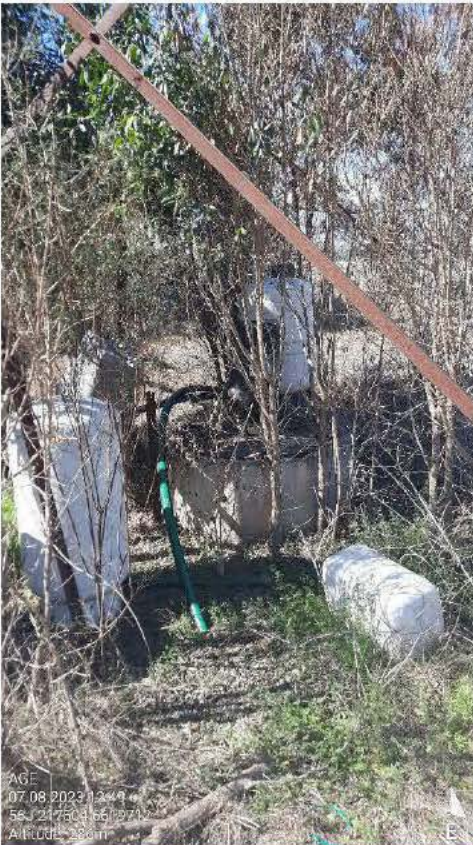
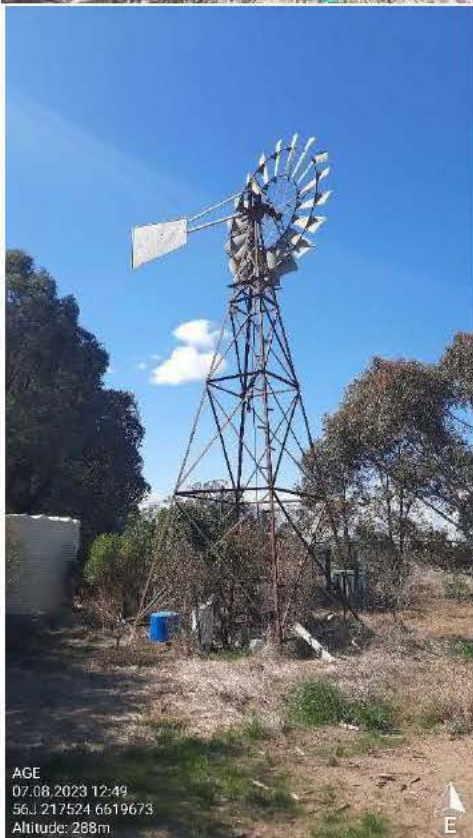
| Bore Image | Bore ID:<br>PROPERTY INFORMATION | GW062749 |

| Bore Image | Bore ID:<br>PROPERTY INFORMATION | GW062749 |
|---|---|---|
| | Bore Location (description) | Near old house |
| | Bore Status (existing/abandoned) | Existing |
| | Total Drilled Depth (m) | 9.35 |
| | Casing Type (steel/pvc) | Concrete |
| | Water Depth (mTOC) | 5 |
| | Pumping Equipment (submersible pump, jet pump) | Submersible pump |

| Bore Image | Bore ID:<br>PROPERTY INFORMATION | GW062749 |
|---|---|---|
| | Comments / Landholder<br>notes | Large diameter well. Windmill over bore<br>but not connected.<br>Usage uncertain. Pump inside bore, so<br>it is assumed that the borehole is used. |

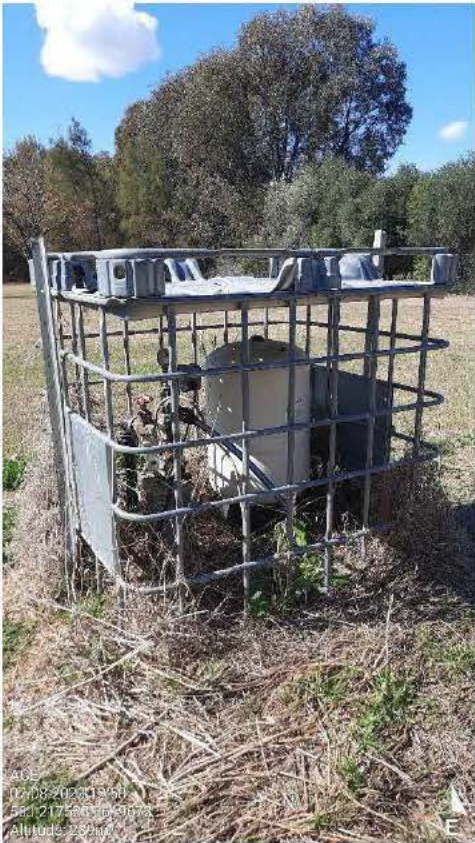
| Bore Image | Bore ID:<br>PROPERTY INFORMATION | Marlow Downs Cottage |

| Bore Image | Bore ID:<br>PROPERTY INFORMATION | Marlow Downs Cottage |
|---|---|---|
| | Bore Location (description) | Marlow Downs Cottage |
| | Bore Status (existing/abandoned) | Existing |
| | Casing Type (steel/pvc) | Steel |
| | Pumping Equipment (submersible pump, jet pump) | Submersible pump |

| Bore Image | Bore ID:<br>PROPERTY INFORMATION | Marlow Downs Cottage |
|---|---|---|
| | Comments / Landholder<br>notes | Close to windmill bore GW062749.<br>Information on bore states drill depth<br>and pump depth (13.7m).<br>Probably drilled in 2018 (based on<br>pressure tank installation date) as a<br>response to the drought. |

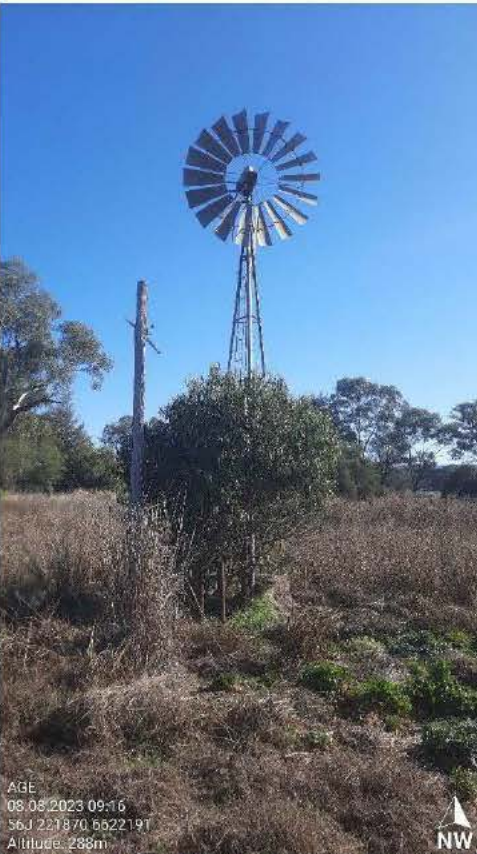
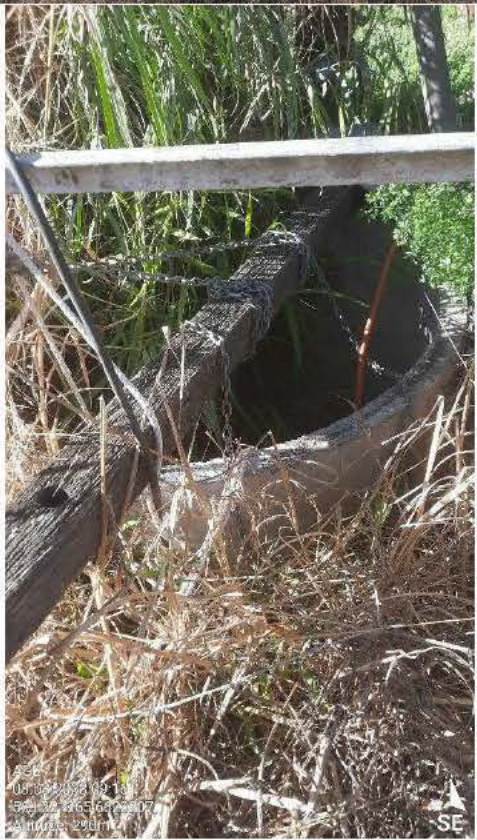
| Bore Image | Bore ID:<br>PROPERTY INFORMATION | GW062752 |

| Bore Image | Bore ID:<br>PROPERTY INFORMATION | GW062752 |
|---|---|---|
| | Total Drilled Depth (m) | 3.99 |
| | Casing Type (steel/pvc) | Concrete |

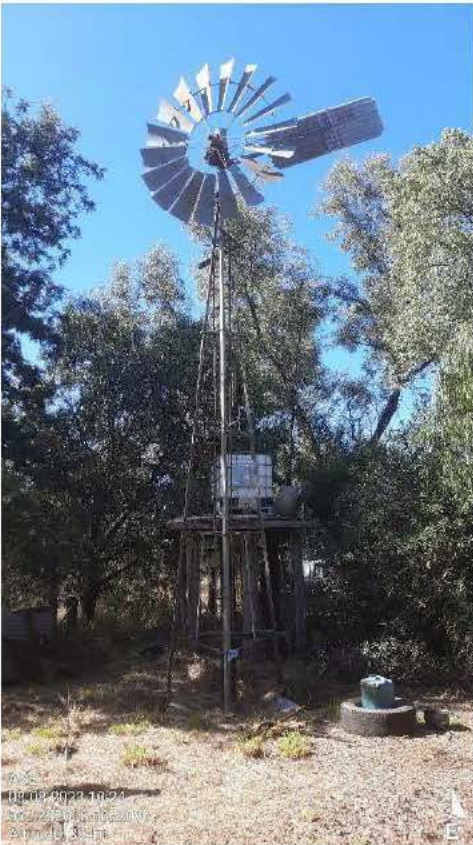
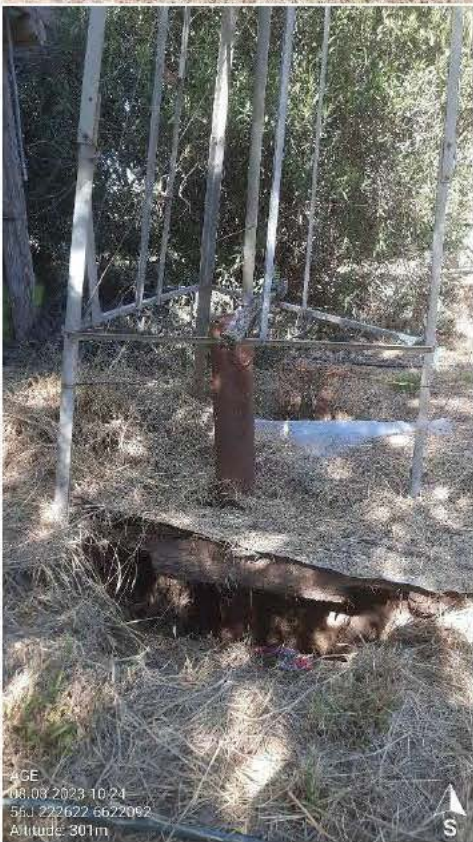
| Bore Image | Bore ID: | Ashton House Unreg |

| Bore Image | Bore ID: | Ashton House Unreg |
|---|---|---|
| | Casing Type (steel/pvc) | Steel |

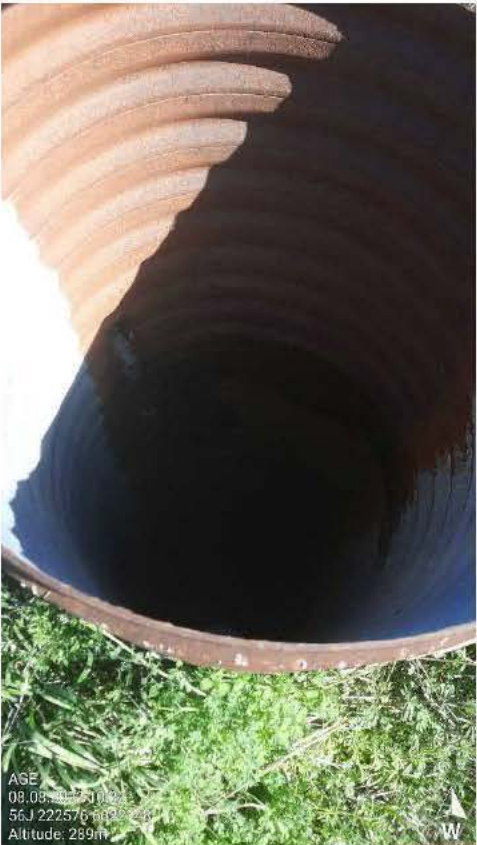
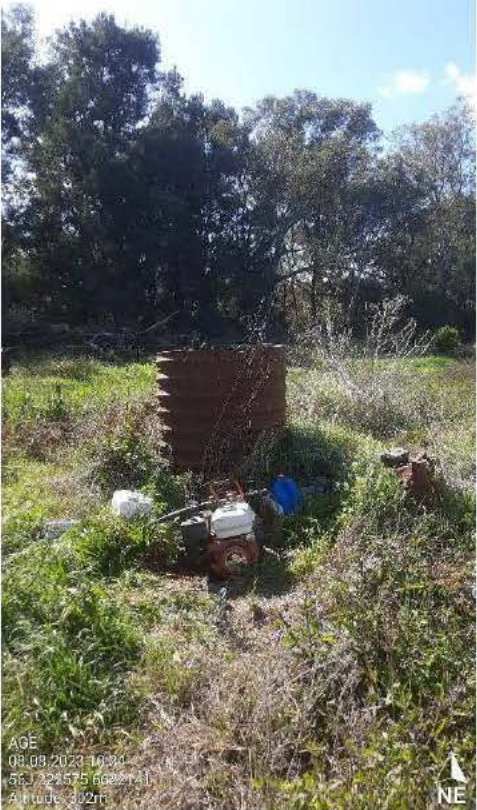
| Bore Image | Bore ID:<br>PROPERTY INFORMATION | GW062756 |

| Bore Image | Bore ID:<br>PROPERTY INFORMATION | GW062756 |
|---|---|---|
| | Total Drilled Depth (m) | 6.3 |
| | Casing Type (steel/pvc) | Steel |

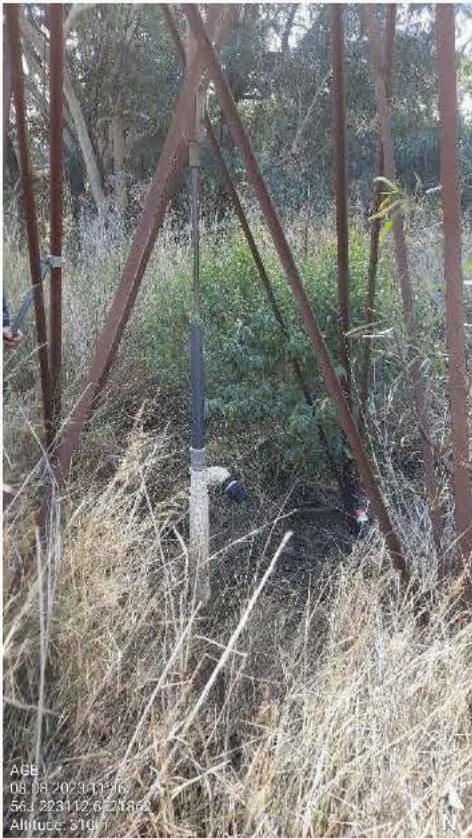
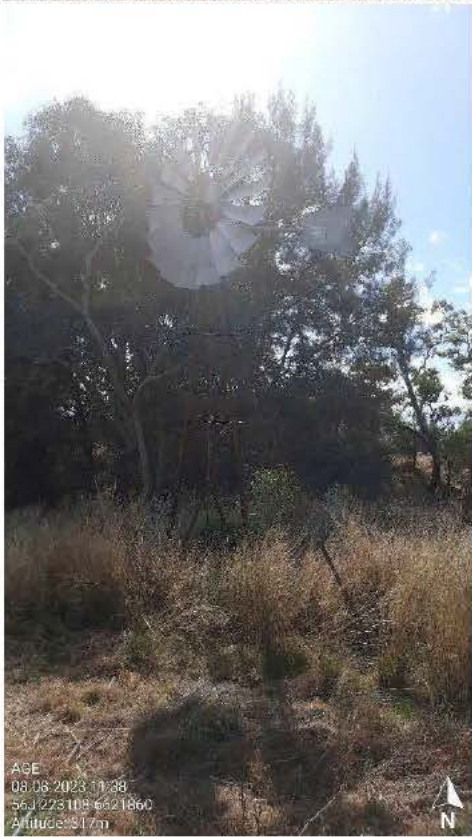
| Bore Image | Bore ID: | GW062758 |

| Bore Image | Bore ID: | GW062758 |
|---|---|---|
| | Casing Type (steel/pvc) | Steel |

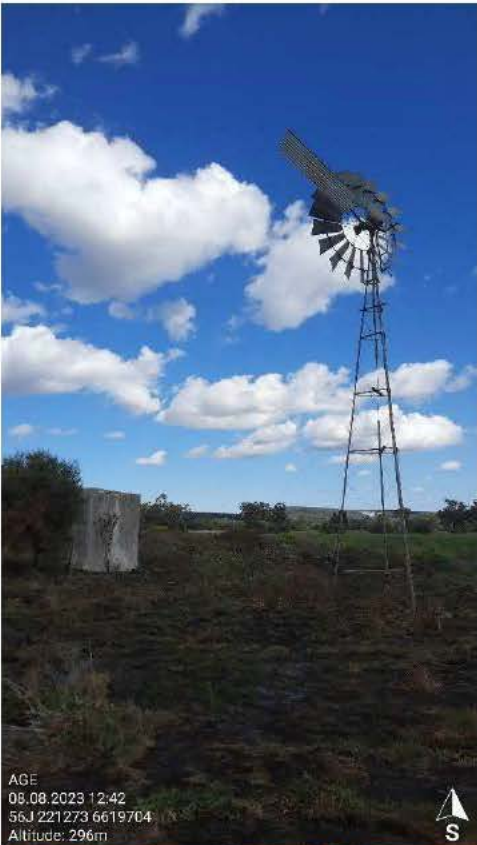
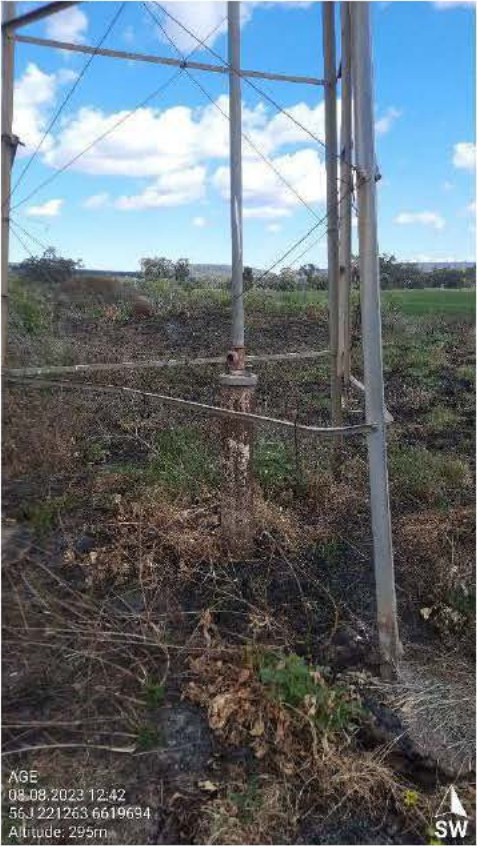
| Bore Image | Bore ID: | GW002831 |

| Bore Image | Bore ID: | GW002831 |
|---|---|---|
| | Casing Type (steel/pvc) | Steel |

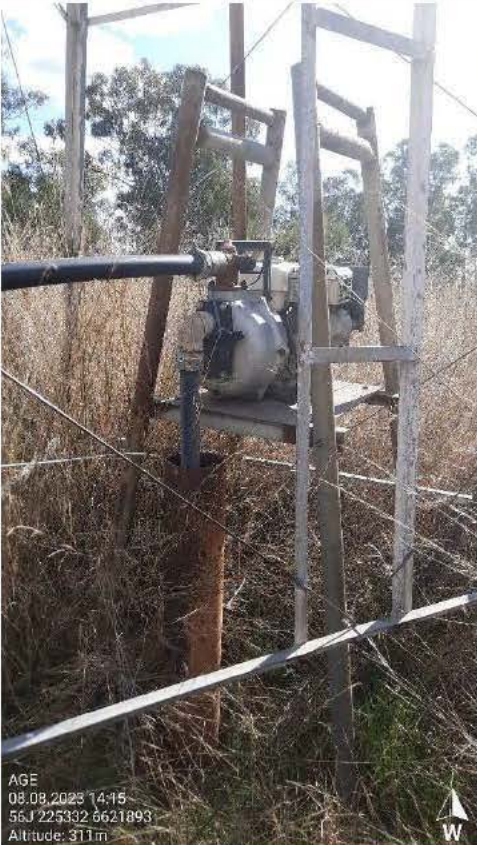
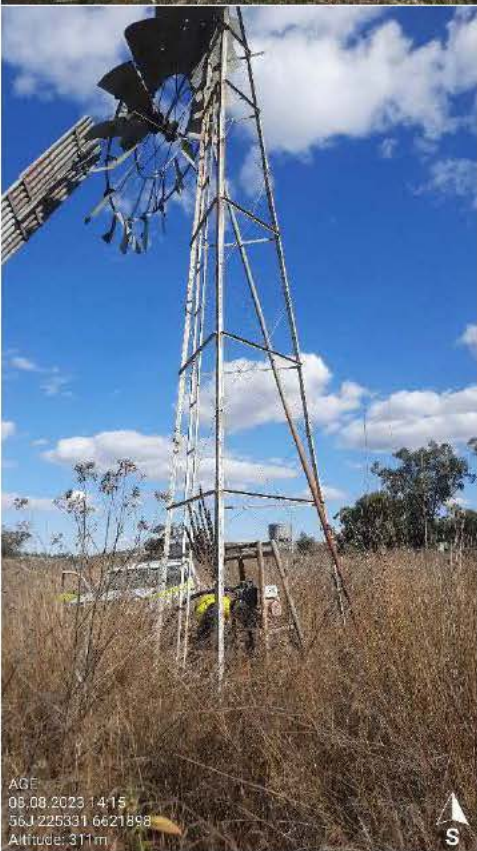
| Bore Image | Bore ID: | GW062779 |

| Bore Image | Bore ID: | GW062779 |
|---|---|---|
| | Total Drilled Depth (m) | 4.15 |
