# Cultural heritage report

# Highlands Source Project

## Cultural Heritage Assessment: Addendum Report

August 2010

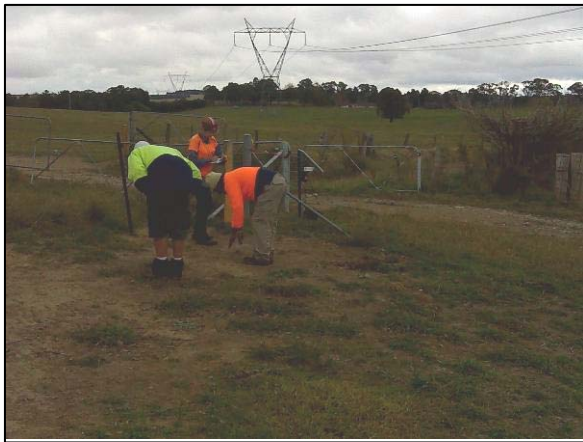
**Figure 4.1** Isolated find HSP19, looking southwest

This site was originally recorded as an isolated find situated on a moderate gradient upper slope with a westerly aspect. A single silcrete flake was observed eroding out of a skeletal sandy loam in a small area of sheet erosion just below an access track in Lot 157 DP 751298; it was immediately east of the existing gas and telecommunications pipelines (Figures 4.24). During the 2010 survey this site was revisited and an additional quartz artefact was observed approximately 80 m to the southwest of the original recording. HSP18 is approximately equidistant from Paddys River and Uringalla Creek, which flow one kilometre to the northeast and southwest respectively.

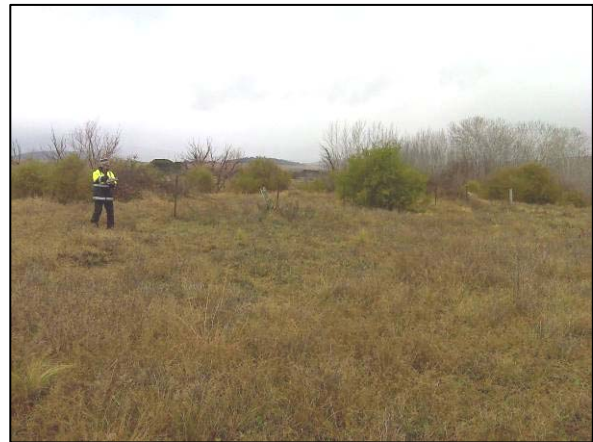
**Figure 4.2** Artefact scatter and PAD at HSP20, looking south

This site comprises a scatter of at least 12 artefacts eroding out of a relatively deep sandy deposit situated on a low gradient spur crest in a basal slope context, approximately 120 m northeast of Kenmore Creek (Figures 4.2 and 4.19). The artefacts observed at the time of recording included

Exposure incidence in this location was 70% and surface visibility averaged 80%. Exposure incidence across the broader area of the spur crest averaged 30%. Ground exposures across the site included the existing gas easement, rabbit burrows and sheet erosion. The highest concentration of artefacts (seven items in an area of about 100 m<sup>2</sup>) was observed adjacent a fence, on top of the proposed pipeline route.

Soil deposits at this site appear to be relatively deep (>30 cm) and, while there has been moderate disturbance from vegetation clearance, farming, rabbits and the existing service easement in the north, there is a high potential for subsurface artefacts across the spur crest. It is likely that the density of artefacts would increase in the south, towards Kenmore Creek. It is predicted that there is a low to moderate potential for *in situ* archaeological deposits

The identified area of PAD extends south from the location of the proposed pipeline to approximately 25m south of the visible artefacts. This PAD is approximately 30 m by 50 m in area.

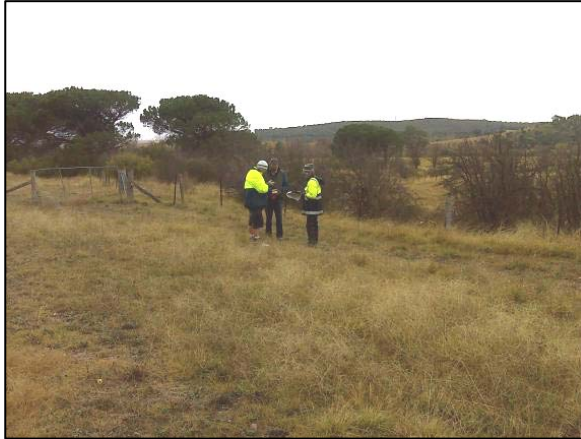
**Figure 4.3** Isolated find HSP21, looking east

This site consists of a single quartz flake situated in a disturbed context on a gentle gradient basal slope with a southerly aspect (Figures 4.3 and 4.19). The observed artefact was located along a vehicle track on the southern side of the gas pipeline.

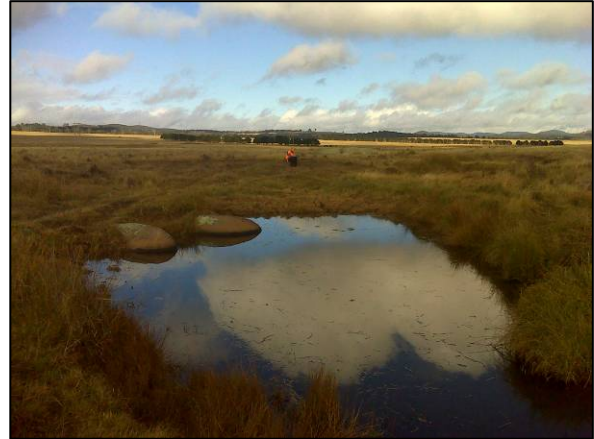
**Figure 4.4** Artefact scatter HSP22, looking south

While there is a high potential for additional artefacts to be present in a subsurface context along the south side of the creek, the topographic context: upper catchment of an ephemeral creek, is such that artefact densities are likely to be low.

This artefact scatter is located approximately 80 m south of the proposed HSP.

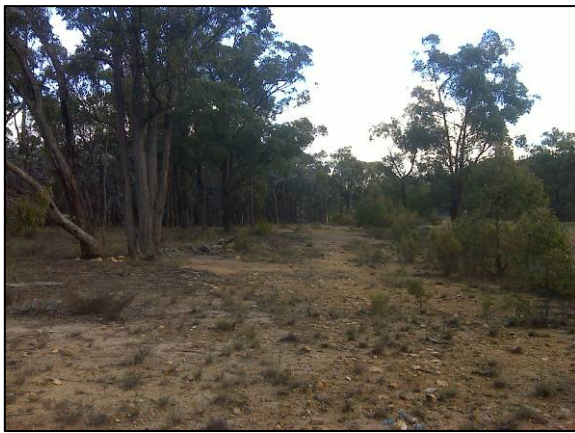
**Figure 4.5** Artefact scatter and PAD at HSP23, looking southwest

The site HSP23 comprises a relatively extensive surface scatter of an estimated 50+ stone artefacts over an area of 180 m by 30 m (Figures 4.5 and 4.22). The site is located on a low gradient ridge crest and associated upper slopes approximately 2.0 km north of Jaorimin Creek. However, a number of natural springs were observed on this ridge, providing a relatively reliable water source within 200 m of the observed artefacts.

The artefacts were visible eroding out of a relatively shallow, sandy, gravelly loam disturbed by vegetation clearance, ant activity, sheet erosion and earth works for existing easements. Artefacts were observed across four locales and comprised silcrete, quartz, chert and volcanic flakes, flaked pieces and cores. Areal density of surface artefacts varied from as low as one per 20 m<sup>2</sup> to greater than one per m<sup>2</sup>.

Exposure incidence across the visible site averaged 70% and visibility within those exposures was around 80%. While many of the exposures corresponded to areas of disturbed ground along the existing service easements, the majority of the recorded artefacts were observed on undisturbed ground to the south. Taking into consideration the broader topography of the site, on a ridge crest with views over valleys to the east and the west and a relatively reliable water source immediately adjacent, the location is likely to have been utilised for sporadic short term activities such as overnight camps. Artefact density is likely to be low to moderate. The potential for subsurface artefacts is high; an area of PAD has been identified in association with the surface artefacts, it extends across for approximately 340 m along the proposed HSP alignment and is up to 100 m wide. The archaeological potential of the site is however lowered somewhat by the shallow nature of deposits and the extent of disturbance along the existing easements.

Given the shallow nature of the soil deposits and the low number of artefacts observed in areas of good visibility, the archaeological potential at this site is low. It is predicted that any additional artefacts will be present at low to very low density only.

This site is located within the proposed HSP easement.

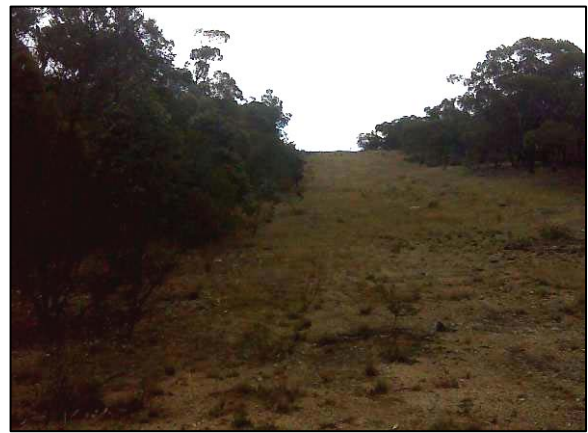
**Figure 4.6** Artefact scatter HSP24, looking southwest

This recording comprises two stone artefacts located within eight metres of one another on a spur shoulder less than 200 m to the northeast of HSP23 that is approximately 1.3km north of Jaorimin Creek (Figures 4.6 and 4.22). The crest of the spur is essentially level and has an easterly aspect; it is located immediately adjacent a spring fed stream that flows down the southern slopes of the ridge.

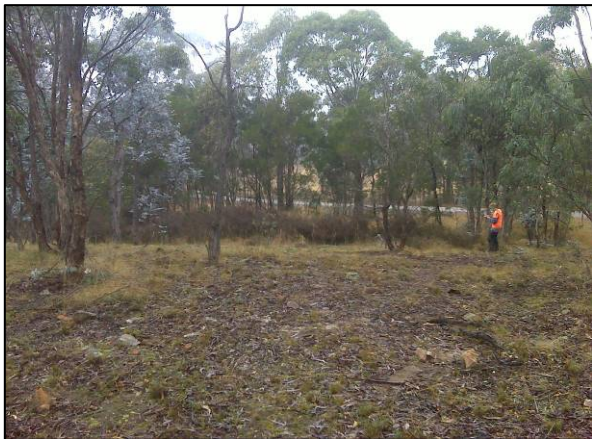
**Figure 4.7** Artefact scatter at HSP25, east side of Brayton road looking south

The observed artefact scatter and associated PAD at HSP25 will be directly impacted by the proposed HSP easement.

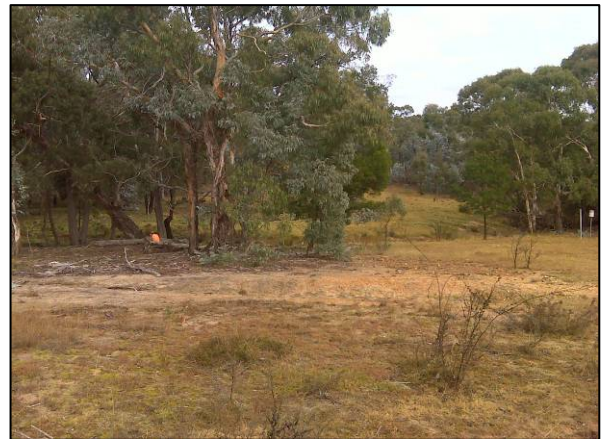
**Figure 4.8** Artefact scatter and PAD at HSP26, eastern side of Jaorimin Creek, looking west

This recording comprises a relatively disperse artefact scatter across the previously identified HSP PAD4 which is located along basal slopes and creek margins at Jaorimin Creek (NOHC 2010). The area was revisited in order to check potential impacts at the PAD and, due to changes in surface visibility encountered during the 2010 field survey, a number of artefacts were observed on both the eastern and western sides of the creek.

A total of at least 15 artefacts were observed across five locales either side of Jaorimin Creek. Three artefacts were recorded along a 100 m section of the old road cutting to the south of the proposed pipeline, while an isolated flake was located 15 m south of the proposed easement. The remaining artefacts were recorded adjacent to the proposed pipeline, in an area of sheet erosion measuring approximately 10 m by 1 m on the eastern side of the creek. The majority of artefacts were flakes and flaked pieces, however four cores were also observed. Silcrete was the dominant material and a number of quartz artefacts were also present.

There is moderate to high potential for additional artefacts to be present in a subsurface context at HSP26. The basal slopes along this section of the creek are of relatively low gradient and would have provided a suitable camping location for Aboriginal inhabitants. Furthermore, the deep sandy nature of the soil deposits in this location means that there is relatively good potential for subsurface deposits. It should however be noted that disturbance within these deposits varies from moderate to high due to impacts associated with wombat burrows, flooding/erosion and existing service easements.

In light of the additional information recorded at this site during the 2010 survey, the extent of the PAD at this location has been revised to incorporate the basal slopes on both sides of the creek. The total area of PAD at this location is now estimated to be 125 m by 155 m.

The proposed HSP alignment cuts through the northern portion of this site and the associated PAD; it traverses a 125 m section of the PAD.

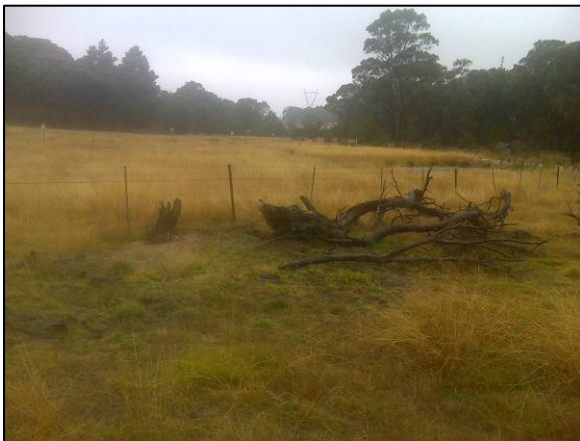
**Figure 4.9** Artefact scatter HSP27, looking northeast

Site HSP27 comprises a scatter of two stone artefacts located within 5 m of each other on a gentle gradient basal slope on the western margin of Osborne Creek. The site has an easterly aspect and is located immediately south of a fence line (Figures 4.9 and 4.21). Disturbance levels at the site are moderate to high due to earth works associated with adjacent dams and bioturbation from wombats.

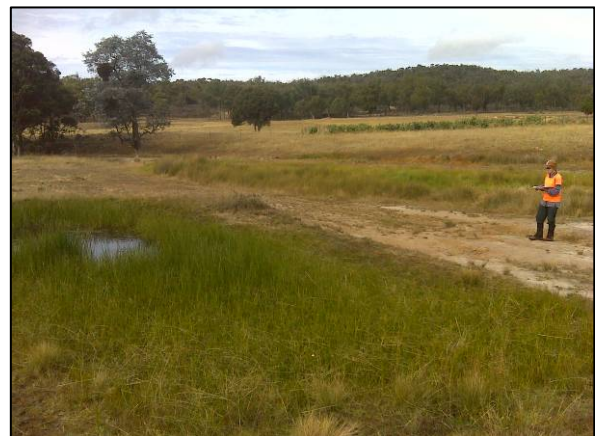
**Figure 4.10** Artefact scatter HSP28, looking south

This recording consists of a small low density artefact scatter situated on a basal slope with a southerly aspect, adjacent to a tributary of Jaorimin Creek (Figures 4.10 and 4.22). The site is located approximately 350 m southwest of HSP25 and a similar distance northeast of HSP17. Four artefacts were observed in a heavily eroded area adjacent a natural spring. The exposure in which the artefacts were found extended for approximately 40 m by 10 m; exposure incidence in this area was 90% and surface visibility also averaged 90%. Much of the exposure was eroded down to the clay subsoil.

Given that only four artefacts were observed over an area of 400 m<sup>2</sup> with excellent exposure incidence and archaeological visibility, the site is considered to be representative of opportunistic use resulting in very low levels of artefact discard. It is predicted that, the potential for additional artefacts to be present in a subsurface context is low.

HSP28 is located approximately 50 m south of the HSP easement.

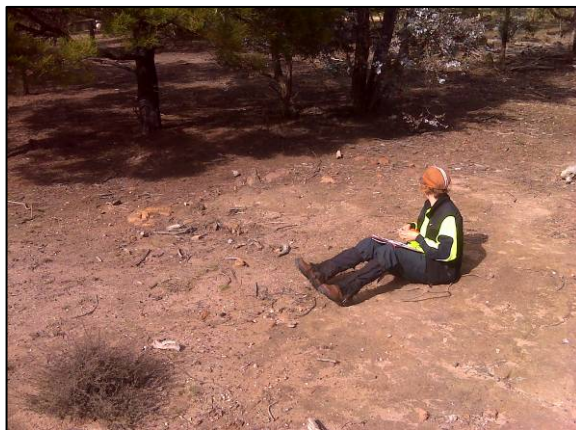
**Figure 4.11** Artefact scatter HSP29, looking south

This site comprises a dispersed low density artefact scatter on a gentle mid slope/saddle with a northerly aspect (Figures 4.11 and 4.23). Five stone artefacts were observed in an area of sheet erosion located immediately south of the existing services pipelines with three of the artefacts located along the pipeline itself. The artefacts were located in a sandy, gravelly loam and were all quartz flakes with the exception being one quartz blade.

Relatively good levels of visibility were encountered at the site and only a small number of artefacts were observed in a discrete location. The broader landscape context is such that there are no reliable water sources or other resource zones that are likely to have been focus of Aboriginal activity. These factors, together with the shallow nature of the soils and the relatively high levels of prior disturbance, indicate that the archaeological potential at this site is low.

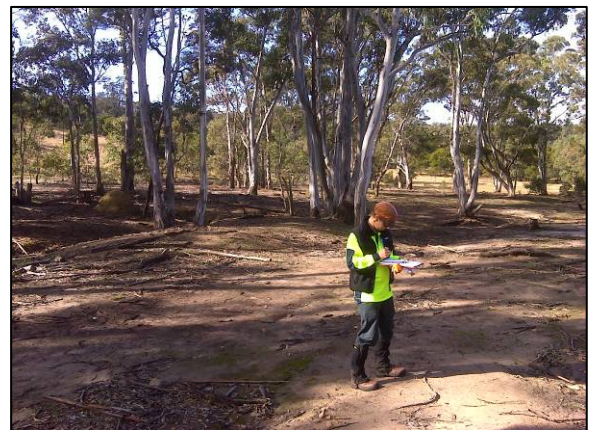
**Figure 4.12** Northern extent of artefact scatter HSP30, looking southeast

This site comprises a dispersed low density scatter of stone artefacts along the basal slopes and margins of an ephemeral creek line (Figures 4.12 and 4.23). Artefacts were observed over an area of approximately 100 m by 200 m, eroding out of a sandy loam exposed by sheet and rill erosion. At least eight artefacts were observed at the site; however the recording of the site was curtailed by a request from a local resident to leave the area.

Artefacts observed at the site included quartz flakes and flaked pieces and a silcrete core. Exposure incidence across the site averaged 50-75% with 80% surface visibility within exposures. Prior disturbance at the site is moderate and includes vegetation clearance, fencing, grazing and erosion. Given the reasonably good visibility levels at the site and the limited number of artefacts observed, it is predicted that any additional artefacts will be present at low density only.

The proposed HSP alignment runs through the middle of the artefact scatter at HSP30.

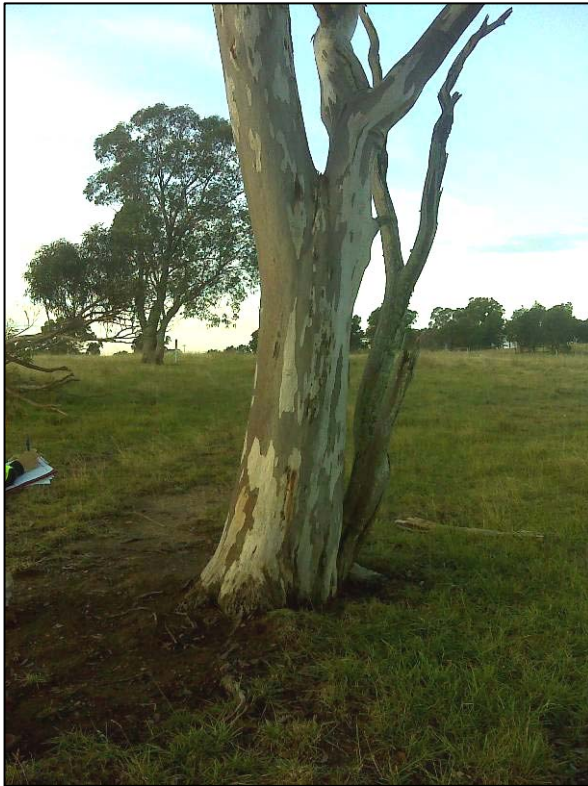
**Figure 4.13** Isolated find HSP31, looking southeast

A single silcrete flake was observed in an area of surface erosion measuring 8 m by 2 m. Ground exposure in this area was 80% and visibility averaged 90%. Exposure incidence in surrounding areas was just 5%. Prior disturbance at the site is moderate to high and includes vegetation clearance, grazing, ripping and fencing.

Given the distance to suitable water sources and the broader context of exposed, amorphous spur crests, the artefact recorded at HSP31 is predicted to be representative of low to very low density artefact distribution resultant from opportunistic landuse such as foraging and/or movement through country.

The site HSP31 is situated within the proposed pipeline easement.

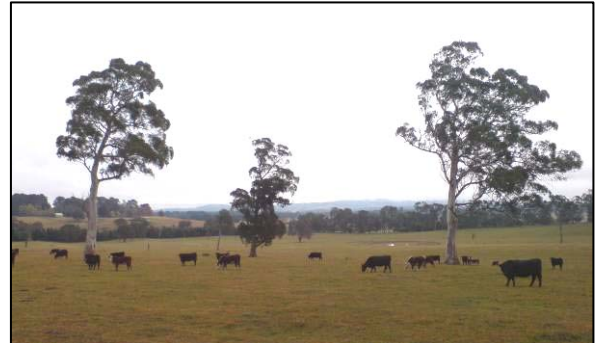
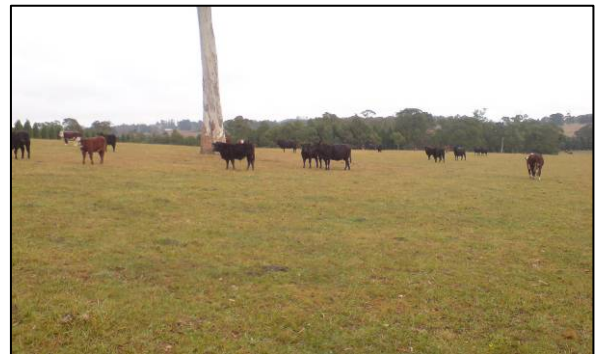
**Figure 4.14** Possible Aboriginal site, looking north: general view of location at top, possible ephemeral platform at bottom

while no absolute physical evidence was observed for such a site it was noted that there are some apparent rectilinear features between the trees in question that may be the remains of tent or hut sites (Figure 4.14).

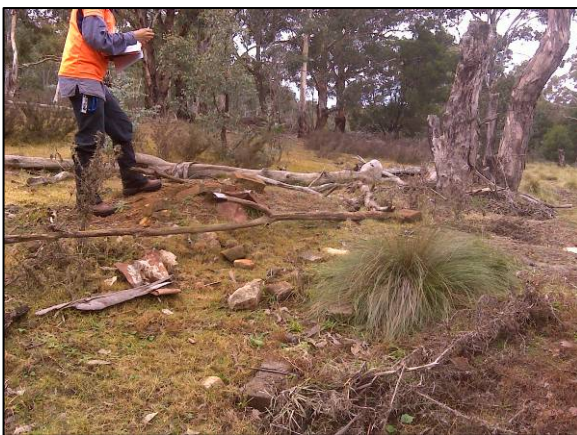
**Figure 4.15** Chimney mound at HSPH4, looking north

The building ruins at HSPH4 are situated in an isolated location on a gentle slope adjacent to Jaorimin Creek. This site is in poor condition. On the basis of available information it cannot be demonstrated to be of importance in terms of local history, individuals or communities. It is a relatively common site type and does not display significant potential to yield additional information. This site is not assessed to be of sufficient value against any of the significance criteria to warrant heritage listing.

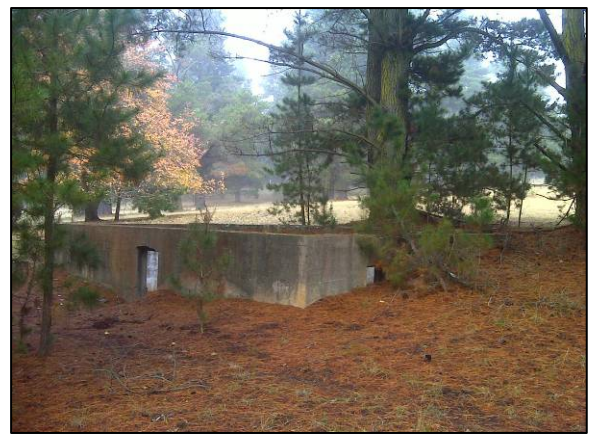
**Figure 4.16** View of concrete cellar at HSPH5, looking south

Site HSPH5 consists of the concrete foundations/basement of a structure that has since been removed. The site is located about 15 m west of a vehicle access track on a gentle basal slope (Figure 4.16 and 4.25). There is a small doorway on the eastern side of the site, leading into a concrete walled room that may have been used as a cellar. A variety of glass bottles were recorded within the foundations. Manufacturer's markings on the bottles indicate that they were produced around the mid-twentieth century. This structure is located among pine tree plantings and the remains of a wooden fence are visible on the eastern side.

According to local sources, this site is perhaps the location of a log cabin which was relocated around 30 years ago. This site has very limited research potential.

Site HSPH5 is located about 15 m from the proposed location of the HSP.

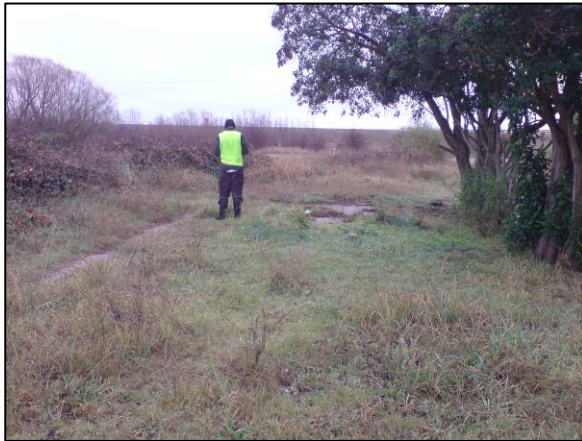
**Figure 4.17** Building remains at HSPH6, looking west

The building remains include fragments of a concrete slab and brick footings that form a rectilinear platform. Sandstock bricks are scattered across the site and a circular depression adjacent to the building platform may indicate the location of a cellar or toilet pit. There are a number of introduced trees in the area and blackberries are growing adjacent to the concrete slab. Located 20 m to the southeast of the building ruins there are what appear to be artificial terraces that may have been constructed as part of an associated garden.

There is good potential for subsurface archaeological deposits at the site, however due to the extent of vegetation cover it is unclear how far such potential may extend. The proposed HSP alignment cuts through part of the garden terraces in this area and runs within 5 m of the building remains.

The only sites that will potentially be directly impacted by the Project are HSPH6 and the Veteran's Allotments. However, it should be noted that the impacts proposed within the Veteran's Allotments would be restricted to a narrow corridor between two existing easements (the gas pipeline to the north and the railway to the south). Given that impacts would be within an already disturbed portion of these allotments and that impacts would be similar to those already sustained by the neighbouring easements, the overall impact on the heritage value of these allotments is assessed to be negligible.

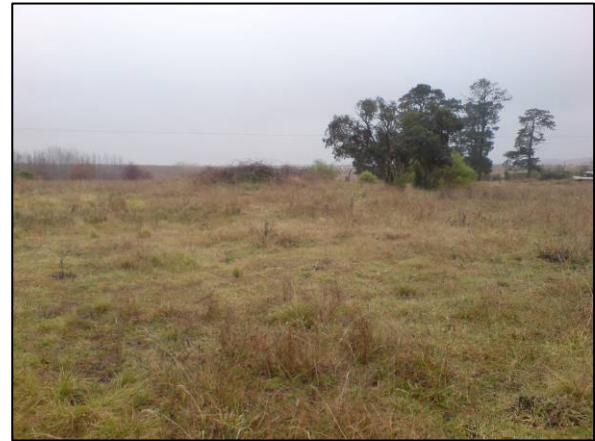
**Figure 4.18** General view of HSPH6, looking northwest

This site consists of tree plantings and building remains that appear to be remnants of a house and gardens located about 30 m south of a gas meter station to the east of Taralga Road (Figures 4.17,
