**GEOTECHNICAL INVESTIGATION**

**PROPOSED PACIFIC NATIONAL DEPOT**

**MANSFIELD STREET, GRETA**

**Project 39129.01**

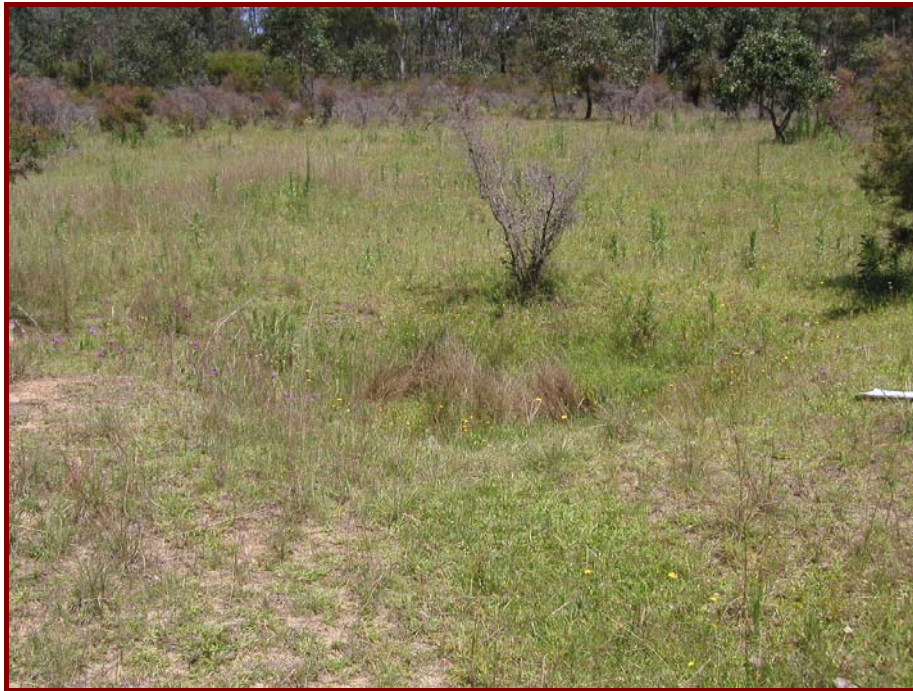
A number of the alleged shafts had been identified by the surveyor. These were located, observed and photographed by the senior engineering geologist from DP. These features were generally round holes of about 2 m to 3 m diameter and were generally of shallow depth (Plate 1). The depth of one was obscured by vegetation and some had been partly filled with rubbish. The holes had distinct edges and appeared to have been purposefully excavated. Rock and soil fragments were observed around the top of many of the ‘shafts’. A number of the ‘shafts’ had walls of dry-placed stone (Plate 2). Another ‘shaft’ was excavated adjacent to, or possibly through, medium to high strength sandstone which formed two walls of this feature.

**Plate 1 - Typical "Shaft" Without Lining**

The 'shafts' and associated troughs observed on site are somewhat enigmatic. The number and spacing of these is closer than is normally observed even where collieries were operating at shallow depths. It is extremely unlikely that such a large number of shafts would have been sunk through generally strong sandstone and conglomerate to such depths.

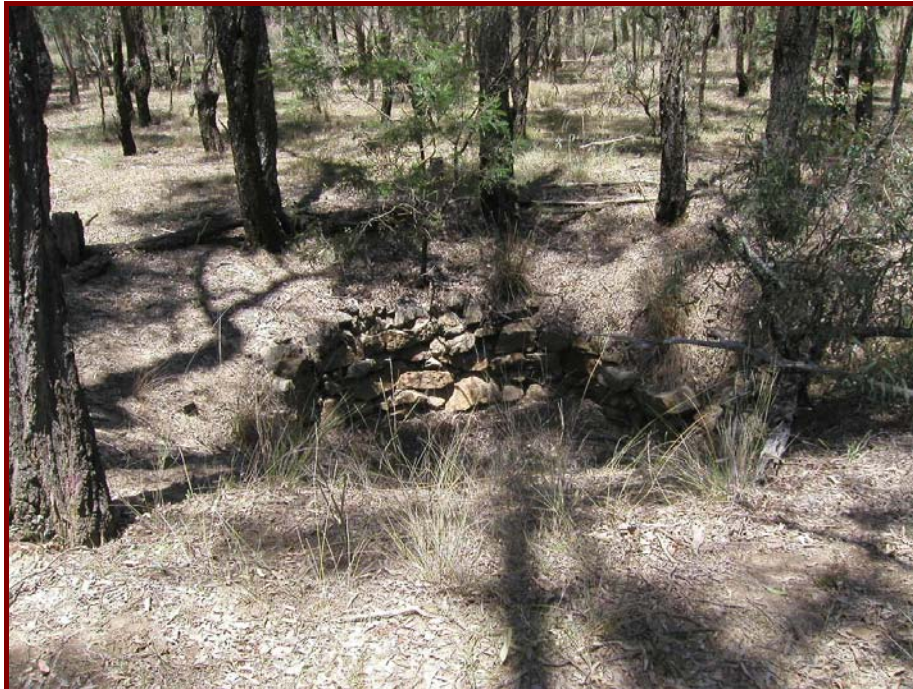
**Plate 2 - "Shaft" with Dry Stone Lining**

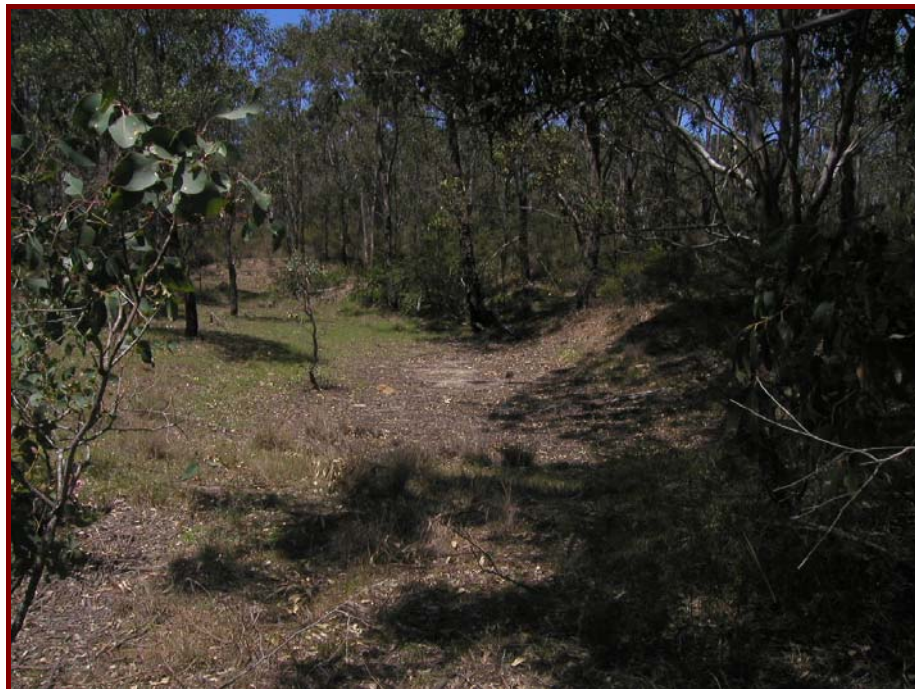
In addition to the 'shafts', two elongated shallow trough features were observed. These correspond to the 'subsidence' indicated on the plan provided by SKM. These features had their long axis aligned in a north south direction. The southernmost of these, at approximate Chainage 212 090 was about 8 m wide and 50 m in length (Plate 3). Approximately 7 m from the northern end of this trough, a circular 'shaft' of about 3.4 m diameter had been excavated through or adjacent to a sandstone outcrop.

**Plate 3 - North South Trending "Trough"**

The elongated troughs observed during the site inspection appear, to the writer, to have the form of purposeful excavation rather than subsidence. In view of the large depth of cover in these areas, mine subsidence would not be expected to have such a localised expression.

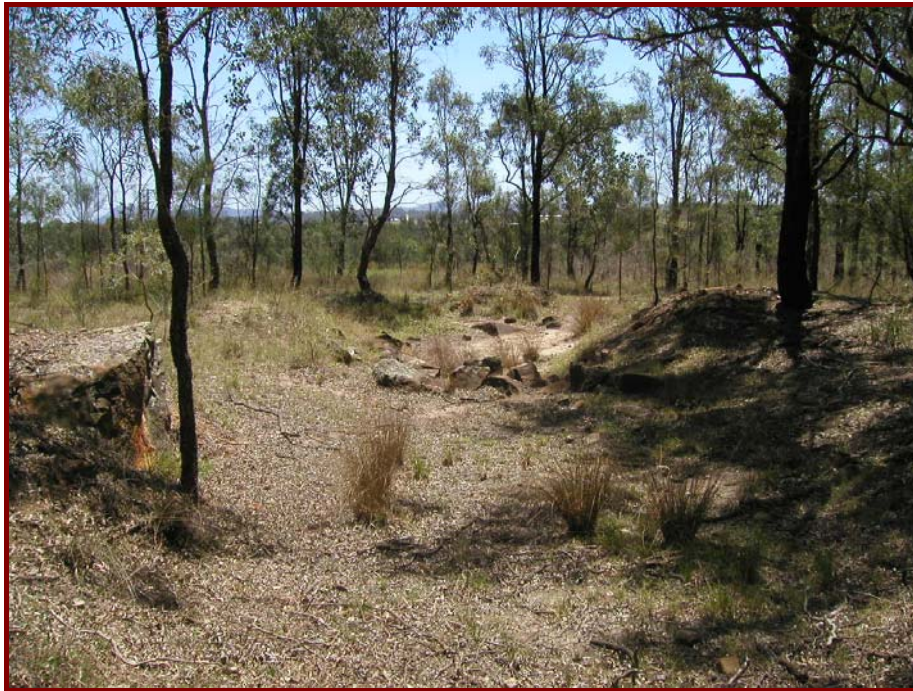
The second of these features, at approximate Chainage 212 120 was about 4 m in width, 31 m in length and about 1.5 m deep (Plate 4). This trough was about 21 m north-west of a rock lined 'shaft', and also had a 3 m to 4 m diameter 'shaft' approximately 20 m from the northern end of the trough and on the projection of this feature. A number of stones had been placed to form a wall like structure on part of the western side of this feature. In the floor of the trough an old dead tree trunk was observed with a severe lean to the vertical. The tree did not appear to be in its growth position and was suggestive of possible filling in the base of the trough.

**Plate 4 - Second North South Trending Trough**

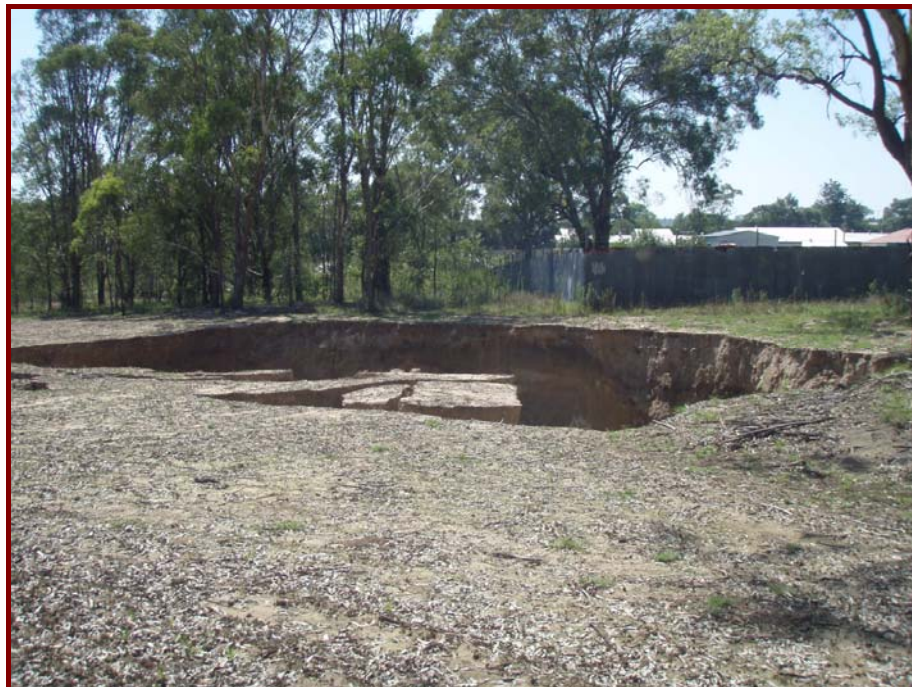
Information provided by the MSB indicated that a large pothole developed towards the southern end of the site, near the north western boundary of Lot 3 in DP 882276, in February 2009. As well as the large hole there were also four other smaller holes running south away from the large hole. It is understood that the MSB backfilled the pothole without undertaking survey to establish its exact location or dimensions. However the district officer of the MSB indicates that the hole was probably about 30 m long by 15m wide by 3 m to 4 m deep at the shallow end sloping down to 10m deep at the deep end. A photo of the large pothole provided by the MSB is reproduced as Plate 5. The District Officer also indicated “There have been two previous issues in the same immediate area as the big February pothole, in 2005 and 2008, making a total of four claims. I can’t explain why the subsidence history only started in 2005 but the board (MSB) was formed in 1961. Surface water running back towards the shallower areas seems to play a big role in the problems in this area. Maybe any previous subsidence was repaired by the colliery or a previous owner.”

**Plate 5 - Large pothole towards southern end of the site, February 2009**  
**Photo provided by the MSB**

It is understood that a large pothole with plan dimensions of about 15 m by 30 m and a depth of up to 10 m was observed on the site near the north west corner of Lot 3 in DP 8822276 in February 2009. The location of this pothole is shown on Drawing 1. Reference to this drawing indicates that the pothole is in an area with about 12 to 15 m cover over the seam. The RT indicates that the site is underlain by first workings with a bord width of about 5 m although at some nearby locations bords intersect at an acute angle and form voids of up to 9 m width at the intersection.

In view of the abnormally large dimension of potholes which have occurred on the site, together with the uncertainty as to the extent of pillar damage by underground fires, it is not considered feasible to adopt pothole subsidence design (where structures are designed to span possible potholes) on this site. The large size of the February 2009 pothole and its depth relative to the likely working section also suggests that future pothole subsidence may propagate to a height

It is therefore recommended that buildings, hard stands and fuel storage areas should be restricted to areas of the site with greater than 40 m cover over the coal seam. This is the area to the north west of the 40 m isopach indicated in red on Drawing 1.
