# Site Description Sheet

| Site Name:<br>MINERS' HUT SITES | | Study Area:<br>2x50 <sup>2</sup> m areas | |
| Site Description:<br>Suggested sites of miners' huts, W side of GNR N Greta Rly Stn | | Site Type: | |

Site Recording Sheet -  
Physical Evidence

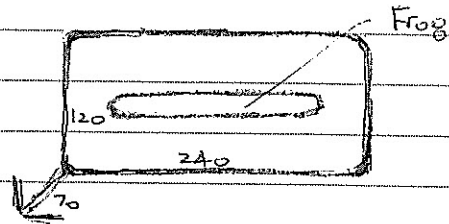
Initial sighting of 2 faced bricks in stretcher  
Exposure revealed footing of fireplace opening S,  
1820 x 850, 2 leaf, stretcher bond, dry-laid in  
2 courses, laid flat on yellow clay substrate  
On SW cor, residue of base course of fireplace  
Structure of 1 brick & 2 bats, with lime mortar bond.

Scatter of bricks/batts W-SW from ~ 1m W  
of footing. Scatter of ceramic, glass, iron, metal,  
slate & shotgun cartridge base

Bricks routinely 240Lv  
120W x 70D, long narrow  
rectangular form frog
