Water Quality Report

Response to Submissions

Prepared for
Veolia Environmental Services

43177749

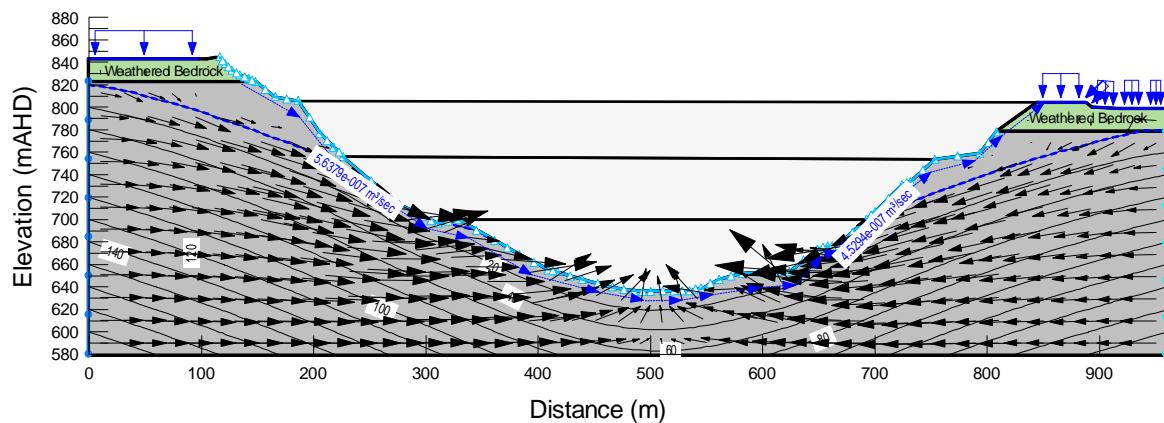
Figure 2-1 Woodlawn Seepage Model - Open Void

The leachate modelling was carried out using the cross-sectional model SEEP which simulates horizontal and vertical fluid movement in the saturated and unsaturated zone. The model is shown in Figure 2-1 below.

A former hydrogeological study of the site indicated, through packer testing, that the hydraulic conductivity of the fractured rock mass is between 1×10^{-8} m/sec and 3×10^{-9} m/sec. Using an average value of 8×10^{-9} m/sec, the model indicates that the groundwater flow into the pit is approximately $60 \text{ m}^3/\text{day}$, or 0.7 L/sec . This is similar to the value observed at the sump of the mine pit prior to filling (c. 1 L/sec).

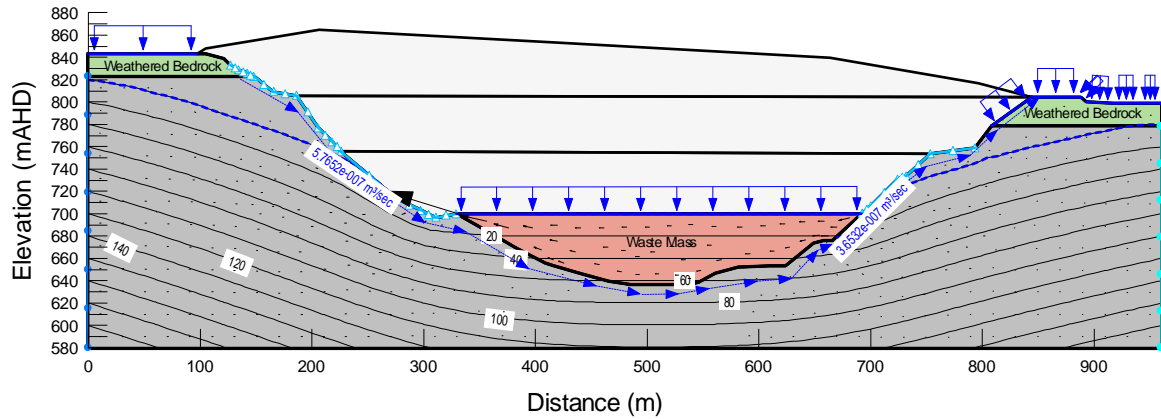
Figure 2-2 Woodlawn Steady-state Seepage Model - Waste Level at 700mAHD.

As the void is progressively filled, groundwater inflow decreases as the hydraulic gradient reduces. The filling sequence is simulated in the following figures. Steady state modelling was used to simulate groundwater conditions at various stages of filling. Figure 2-2 shows the current condition with the waste level at 700 mAHD. Subsequent stages are shown in Figures 2-3 to 2-5.

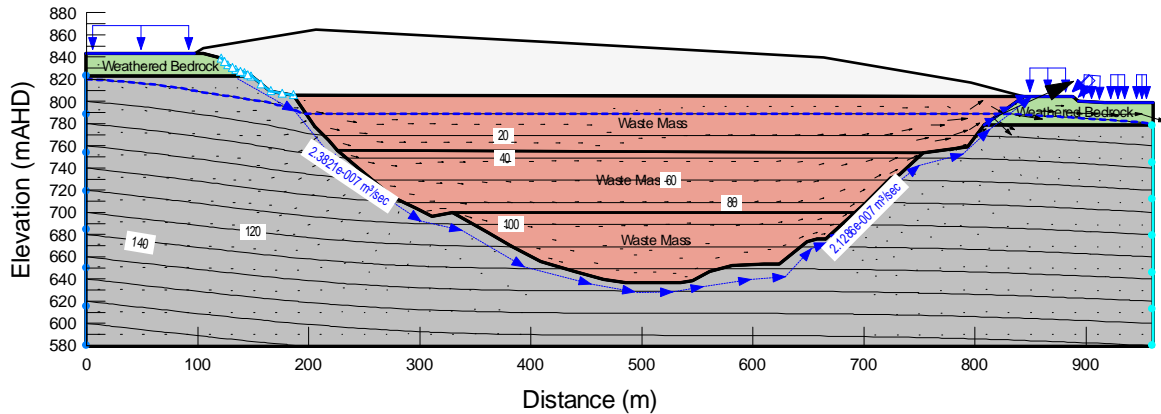
Figure 2-4 Woodlawn Steady-state Seepage Model - Waste Level at 805mAHD

As the waste level rises, the bedrock becomes more weathered, and the SCA has pointed out that the weathered bedrock is more likely to have a higher permeability. To mitigate the potential for leachate migration from this more weathered zone, Veolia will selectively line the rock faces to ensure that the hydraulic conductivity is less than 1×10^{-9} m/sec. Such measures are already being undertaken in selected areas of the wall where higher permeability fracture zones are encountered. The impact of this liner is simulated in the SEEP model on the right hand rock face along the weathered bedrock zone.

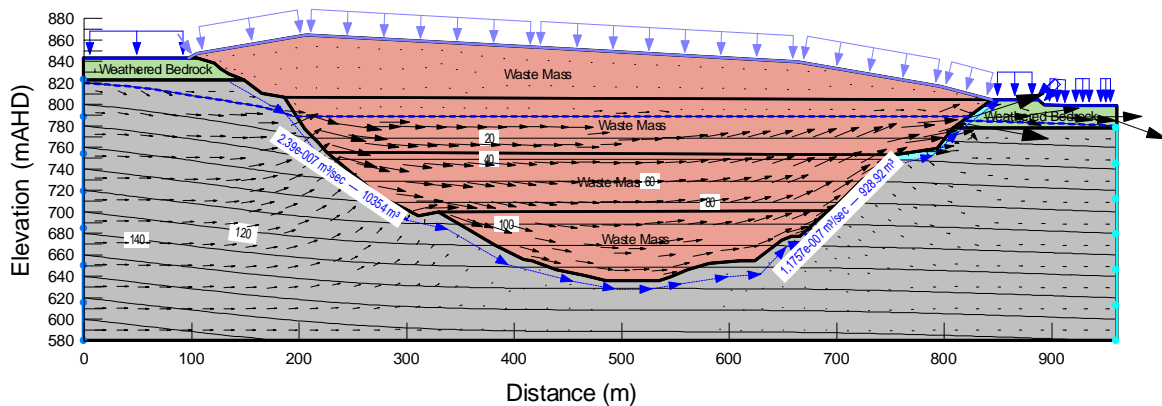
Figure 2-9 Predicted Liquid level 1,000 years after capping - Final Cap with Barrier System

After 1,000 years a leachate mound of approximately 8 m is predicted by the SEEP model. The maximum seepage velocity of liquid occurs along the uppermost right edge of the void (where the longest black arrows are shown on Figure 2-9).

To assess the impact of the elevated leachate level on the surrounding, recovered water table, seepage velocities from the model, as depicted by the flow arrows in the diagrams, have been reviewed. Inspection reveals that a thousand years after the bioreactor is capped, the seepage velocities will be less than 1 m/year. Therefore, the travel time for conservative contaminants to migrate to the nearest offsite receptor (Crisps Creek) would be centuries after the leachate level has rebounded. This does not take into account the influence of dilution from rainfall recharge, which will attenuate the impact further, and the fact that the leachate quality will be more benign as a result of biochemical degradation processes having been exhausted.

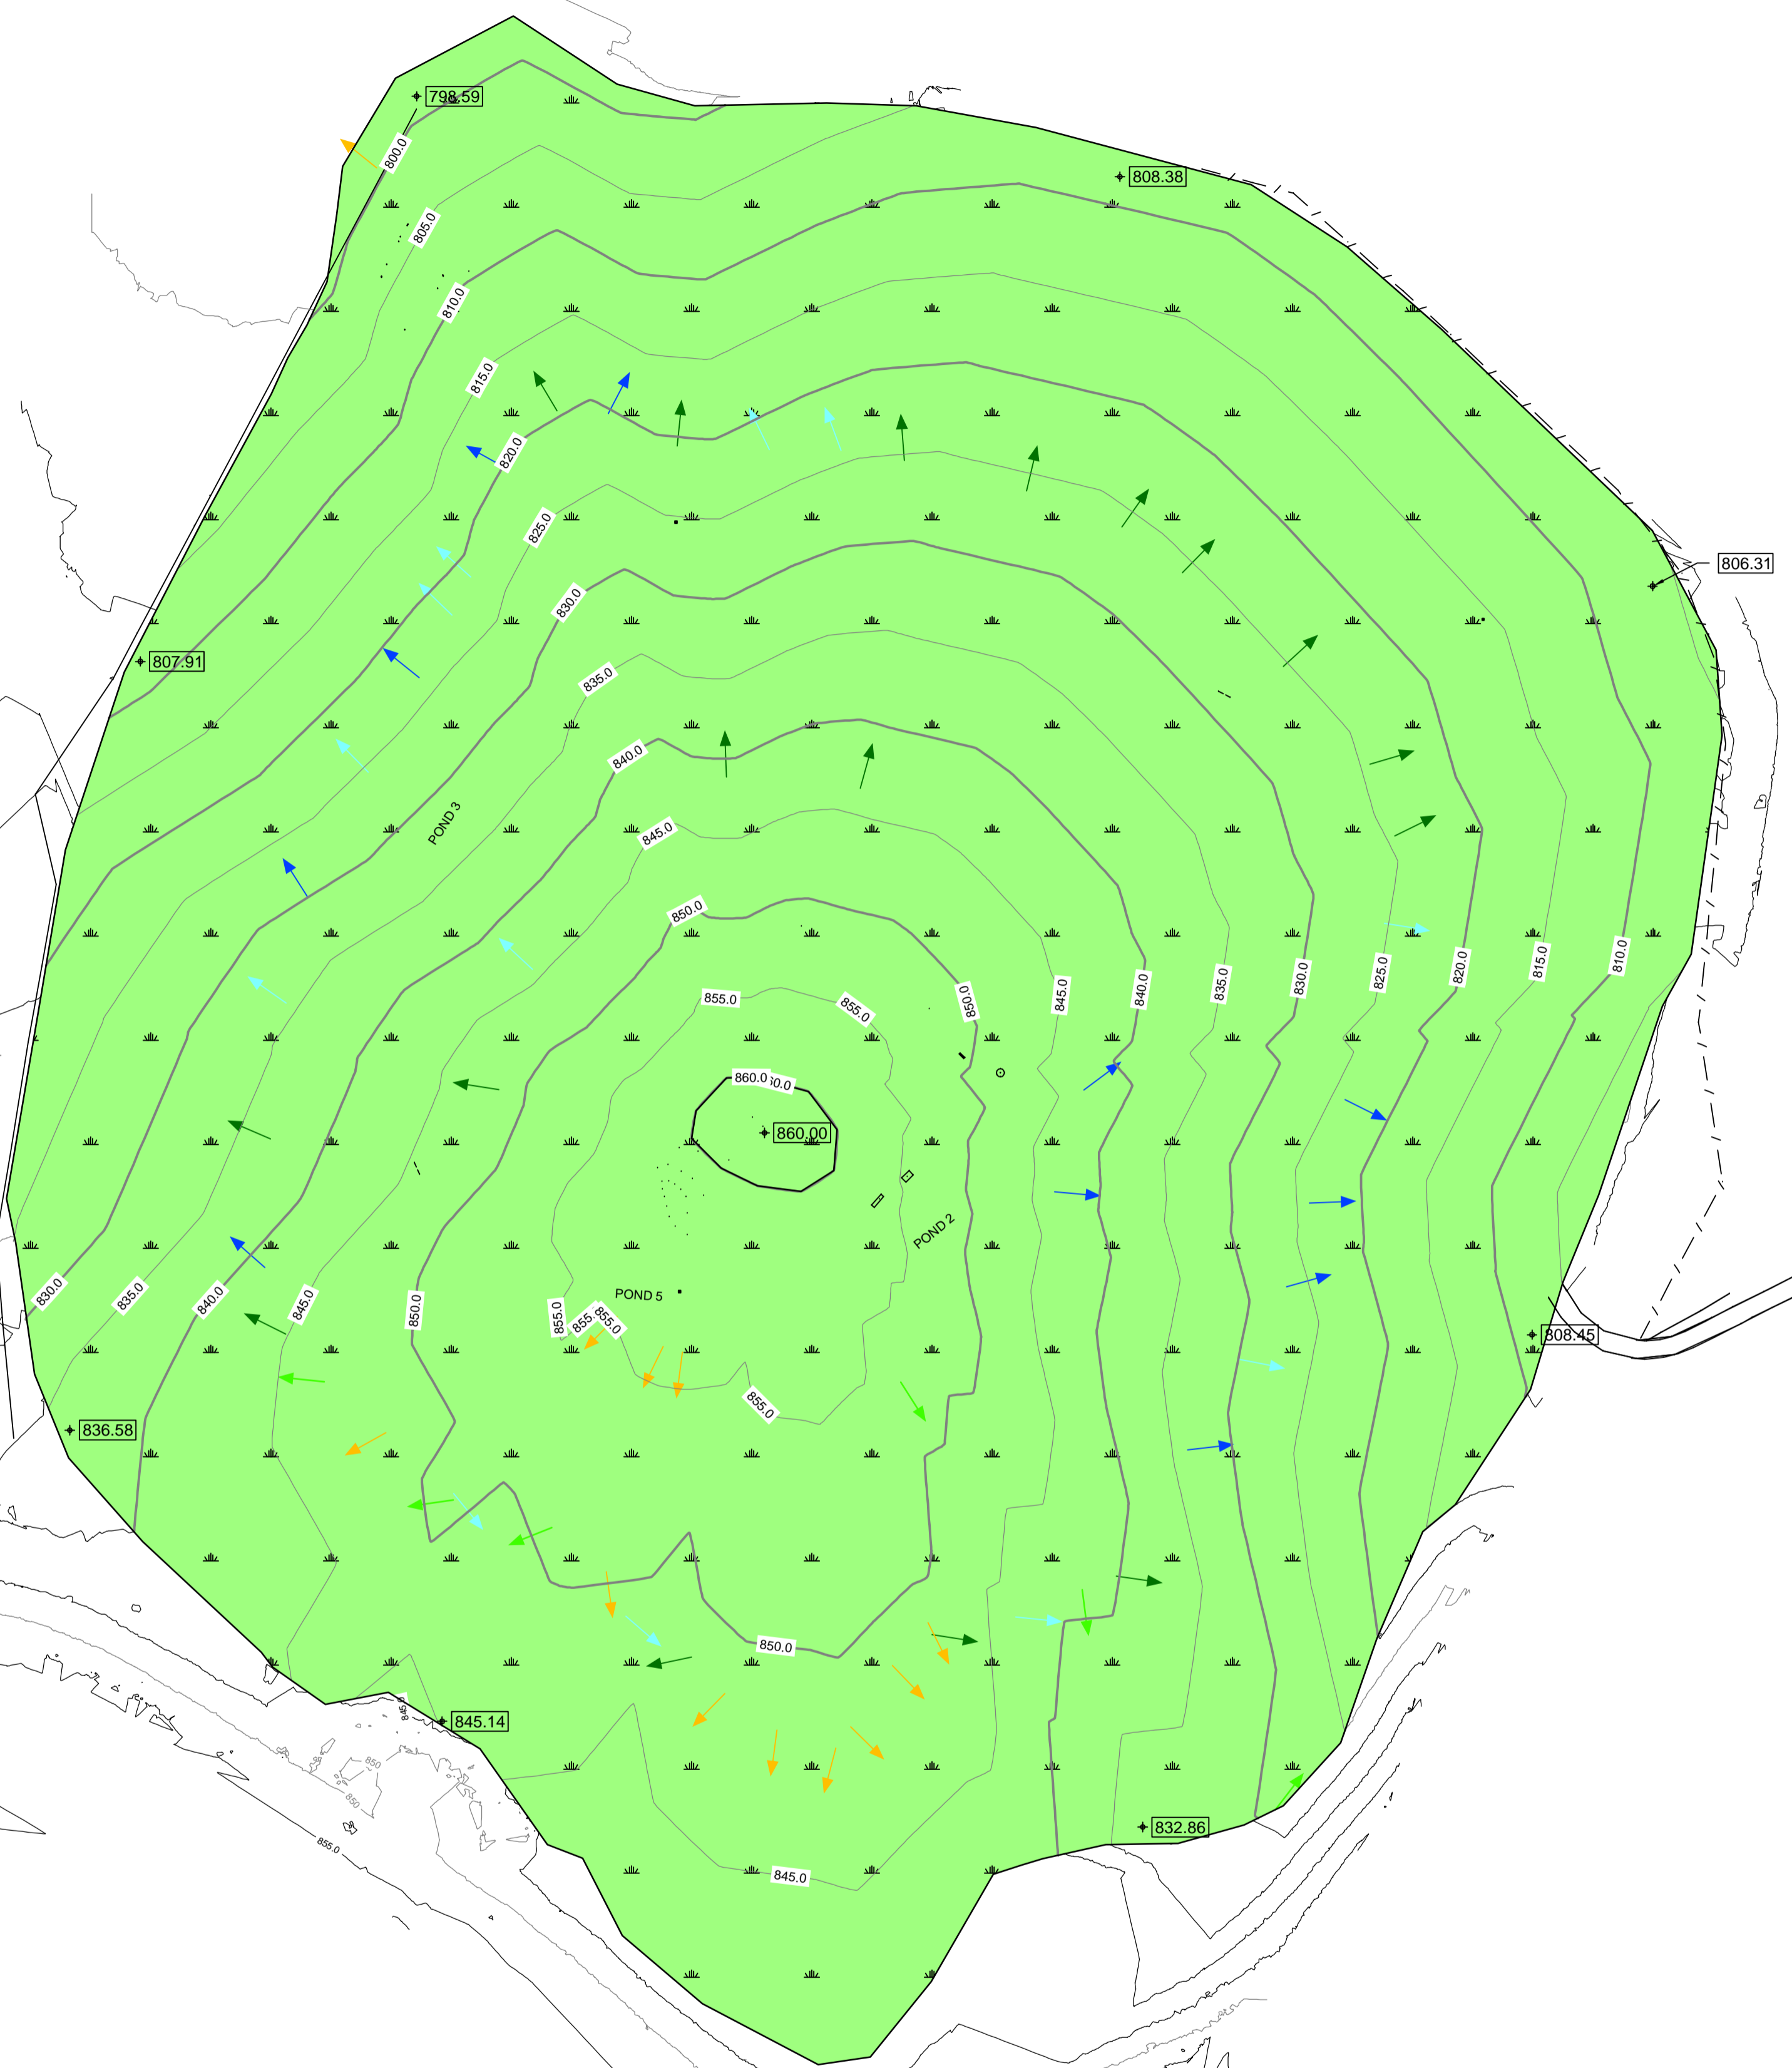
WOODLAWN BIOREACTOR
 COMPLETED REHABILITATION
 SURFACE PLAN

The maximum final post-settlement surface level of the cap is approximately 865 mAHD and the design provides for post-settlement slopes less than 20% and greater than 5% across the whole surface, in accordance with the Environmental Guidelines: Solid Waste Landfills, EPA NSW, 1996.

The final cap contours are shown in Figure and show that the final levels will join back in to the existing levels around the rim of the void.

NOTE:
ARROWS INDICATE DIRECTION OF FALL WHILST ARROW
COLOUR INDICATES GRADE AS SET OUT IN TABLE BELOW.

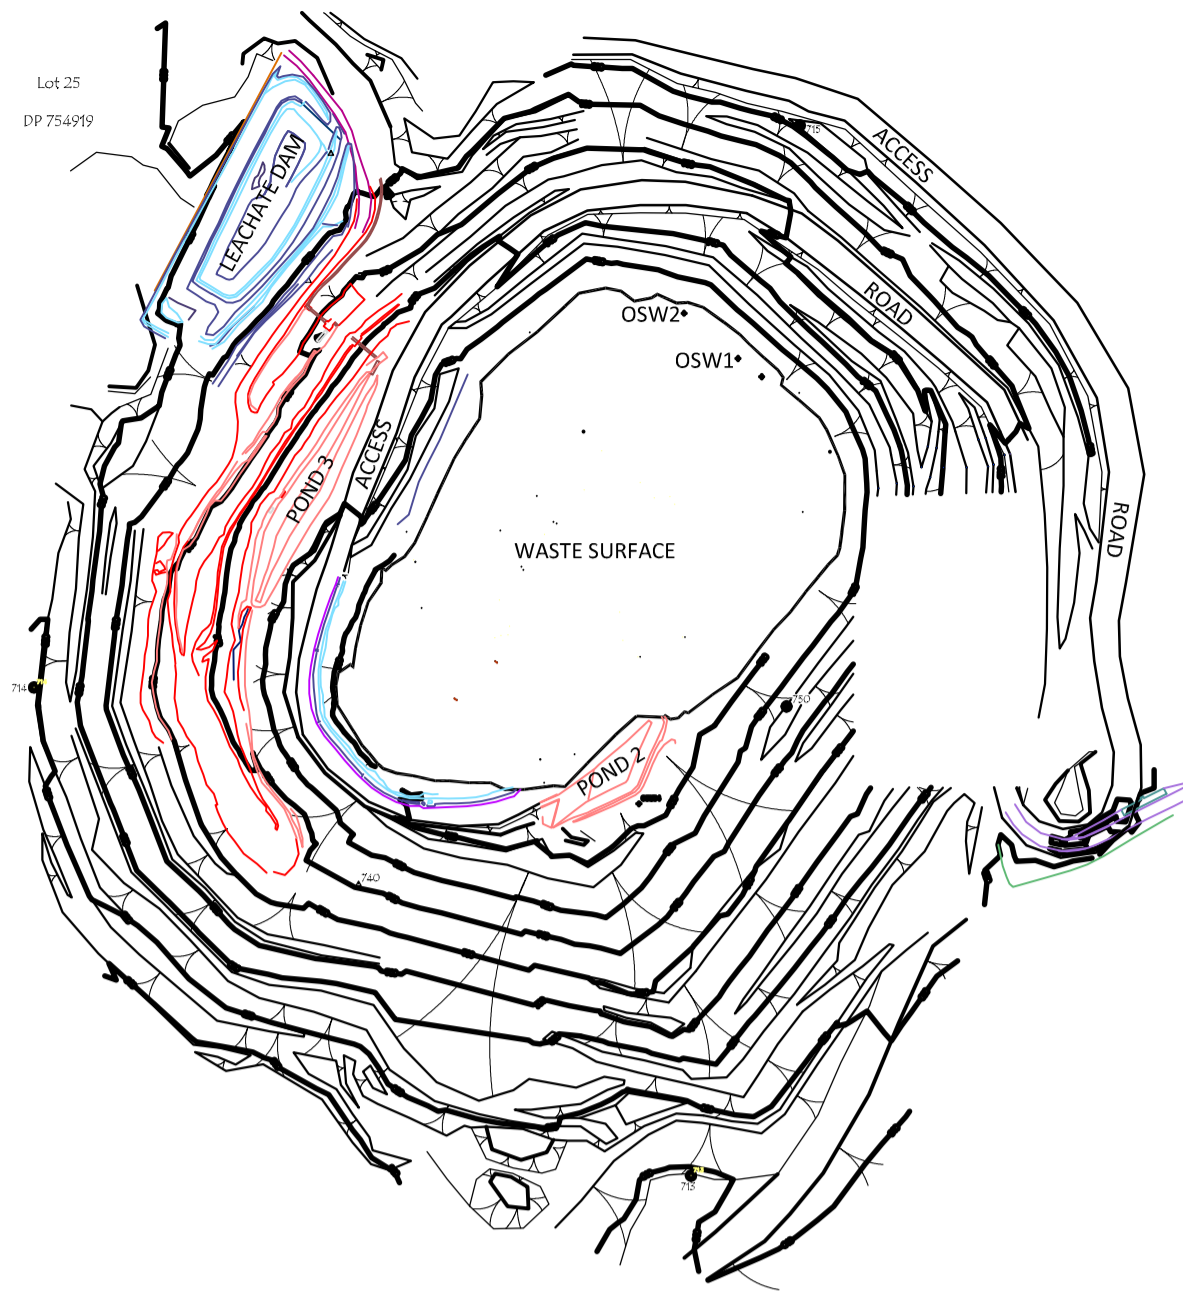
DIAGRAM OF LOCATIONS OF OSW1 & OSW2

The location of the two groundwater dewatering bores (OSW1 and OSW2) is shown in Figure 2-11. The two bores (one operational and one back-up) are used to dewater groundwater from beneath the bioreactor liner, as shown in Figure 2-12.

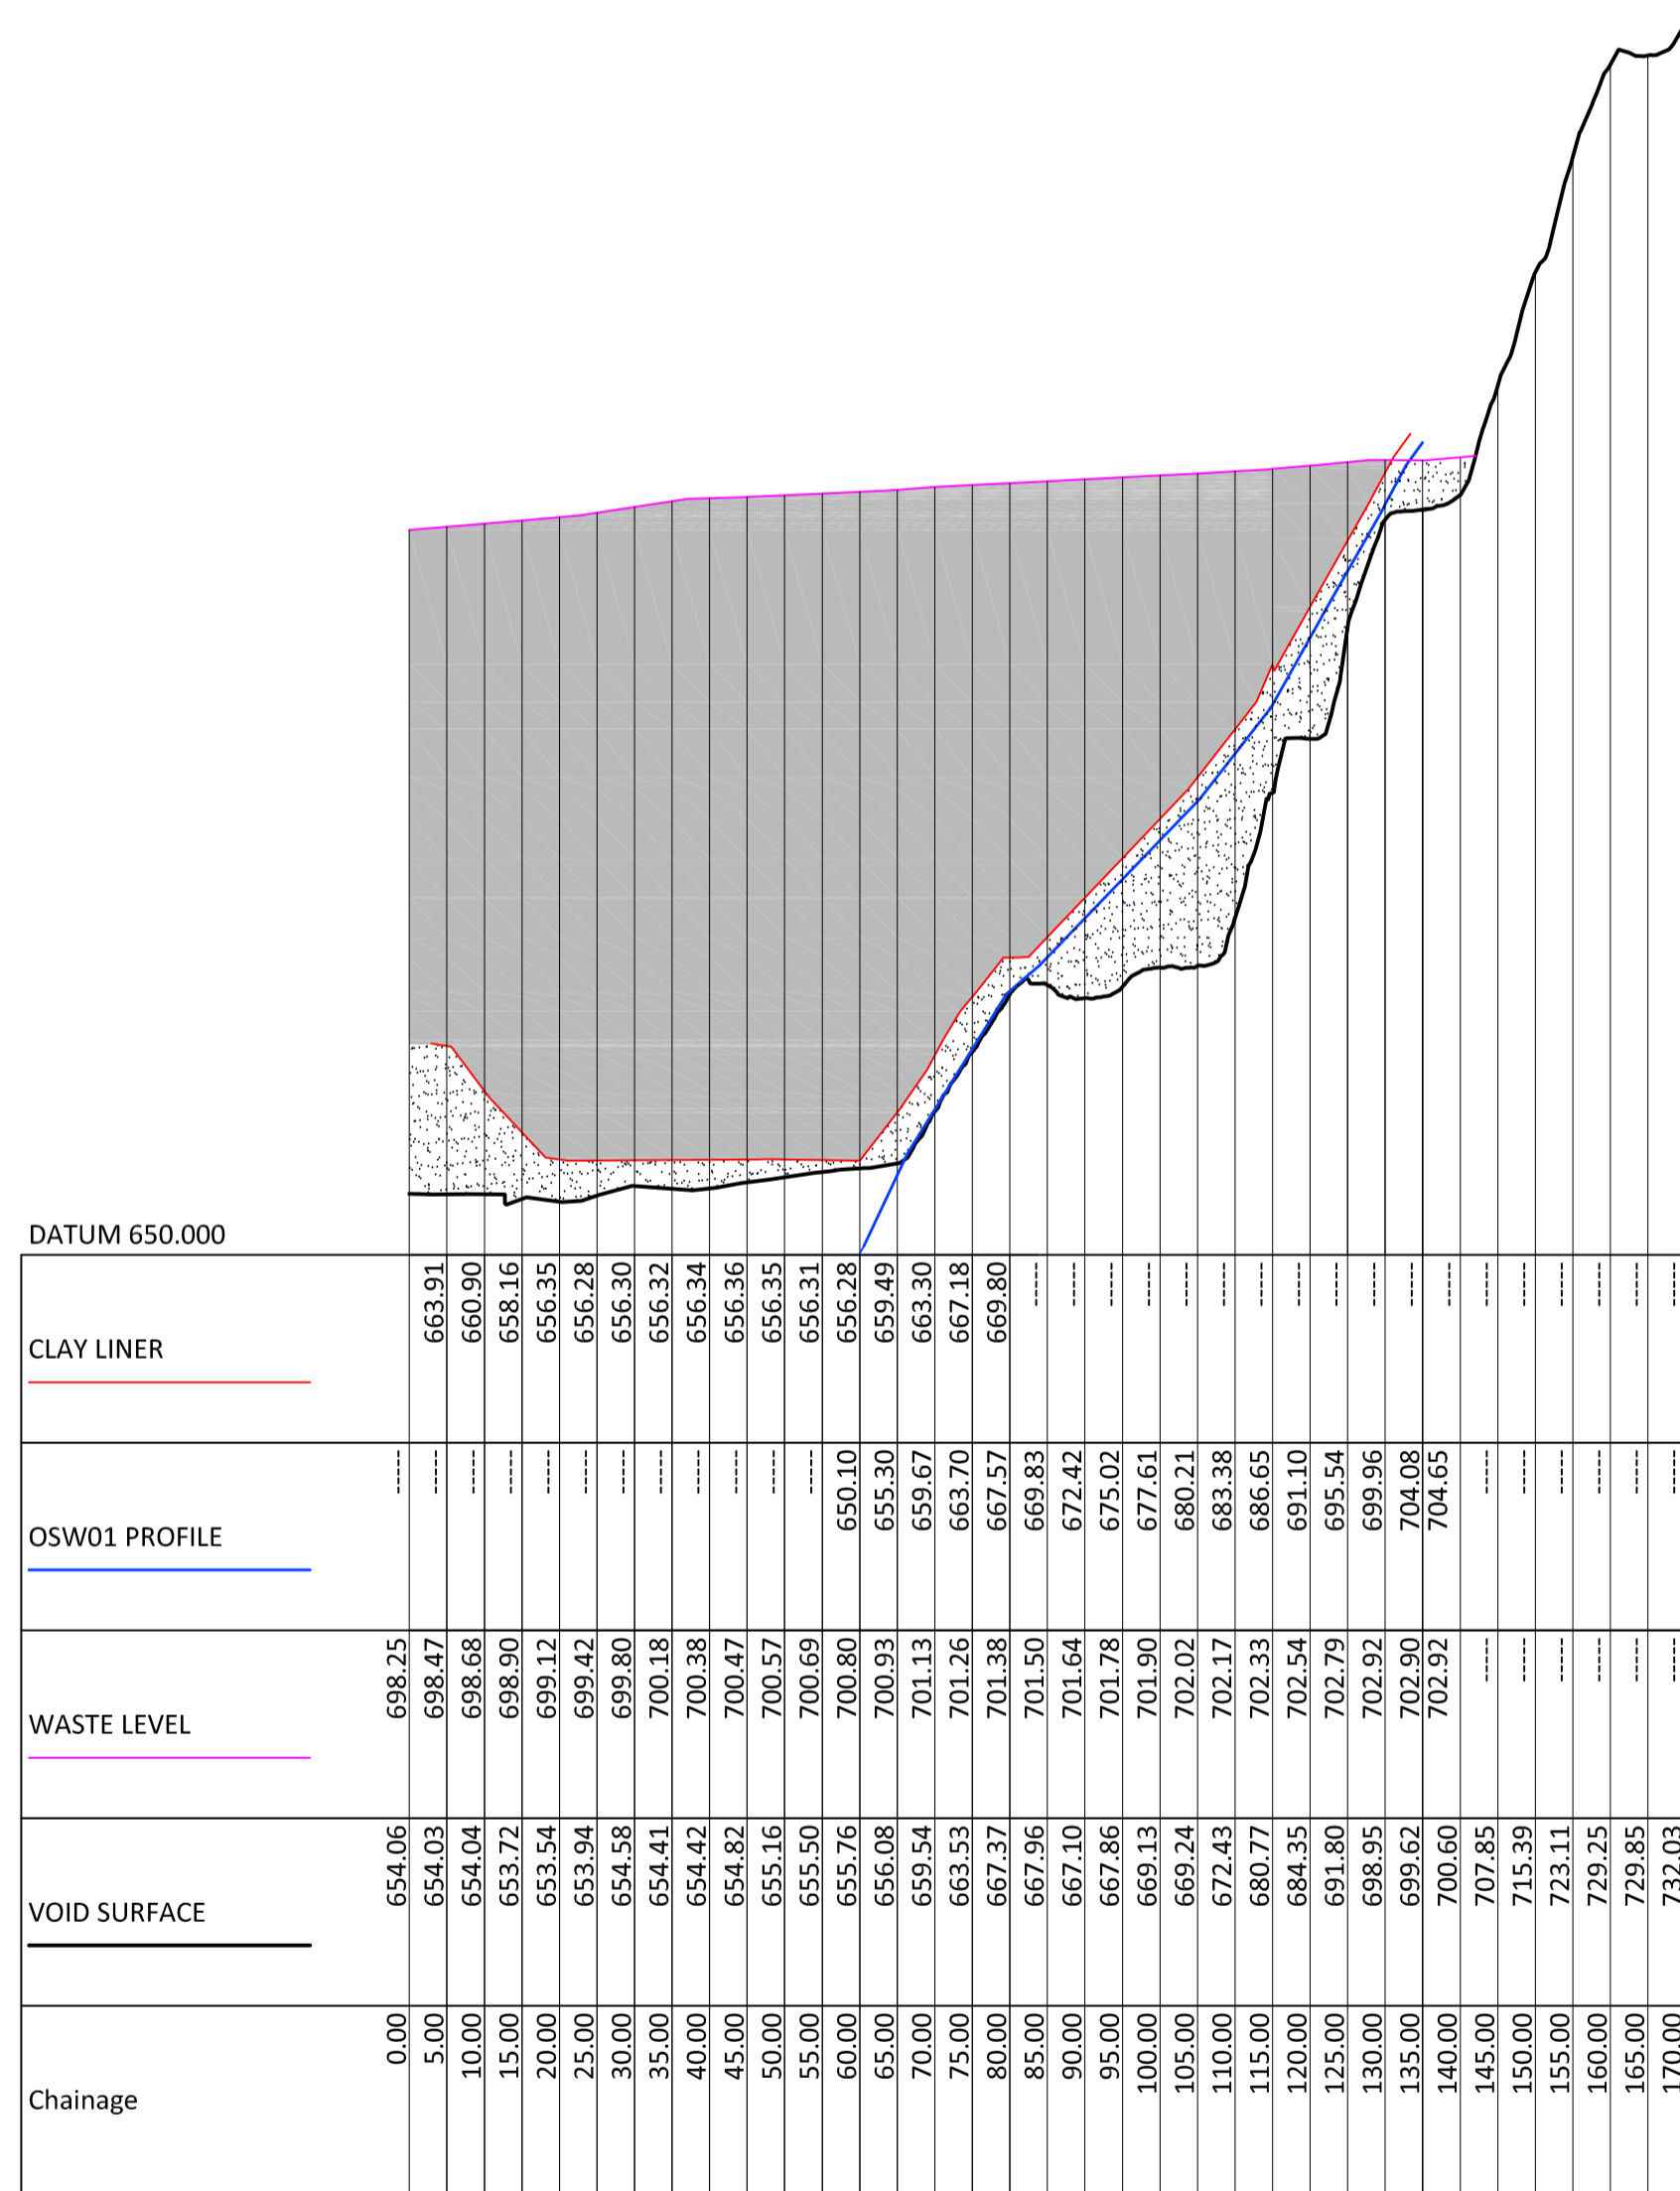
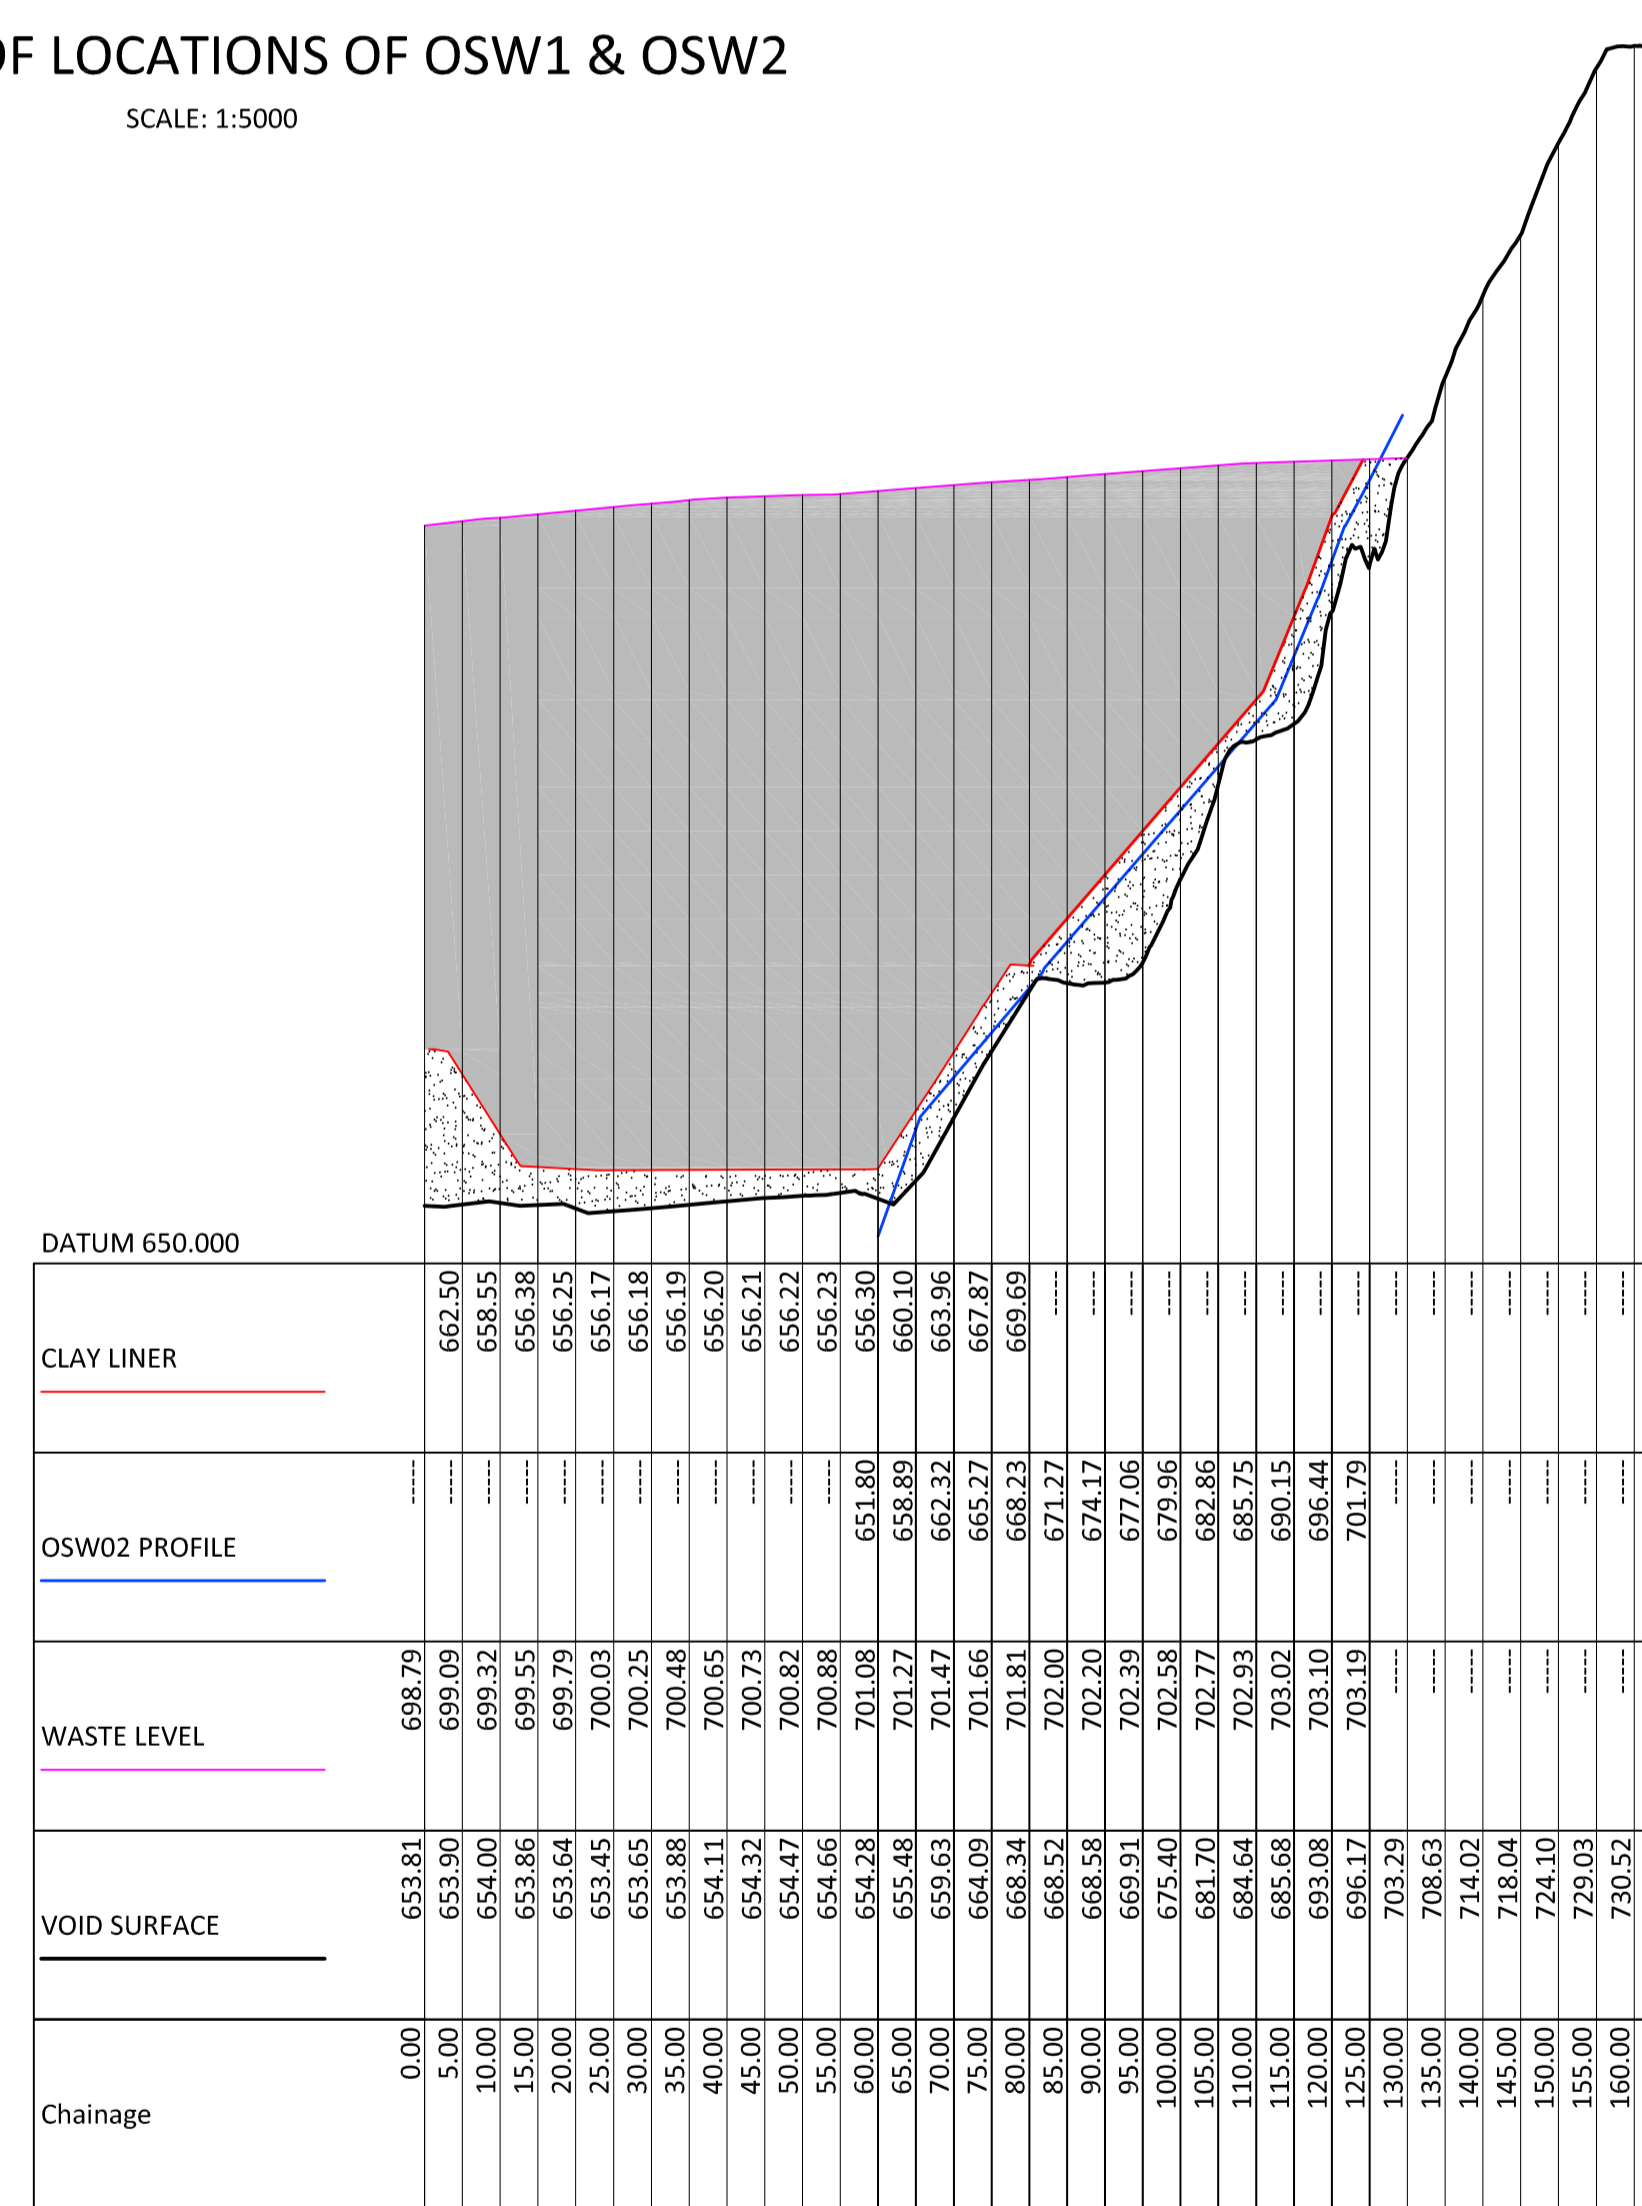
SHOWING CROSS SECTIONS OF OSW01 AND OSW02

OSW1 is equipped with a submersible pump with a 5.5KW motor that is able to pump 1.5 to 2.0 L/sec against a head of 100m. The inclined borehole is extended up the side of the void as the waste level increases. The groundwater bores are used for dewatering of the mine void and the extraction will be licensed under the Water Act, in accordance with the advice of NOW.

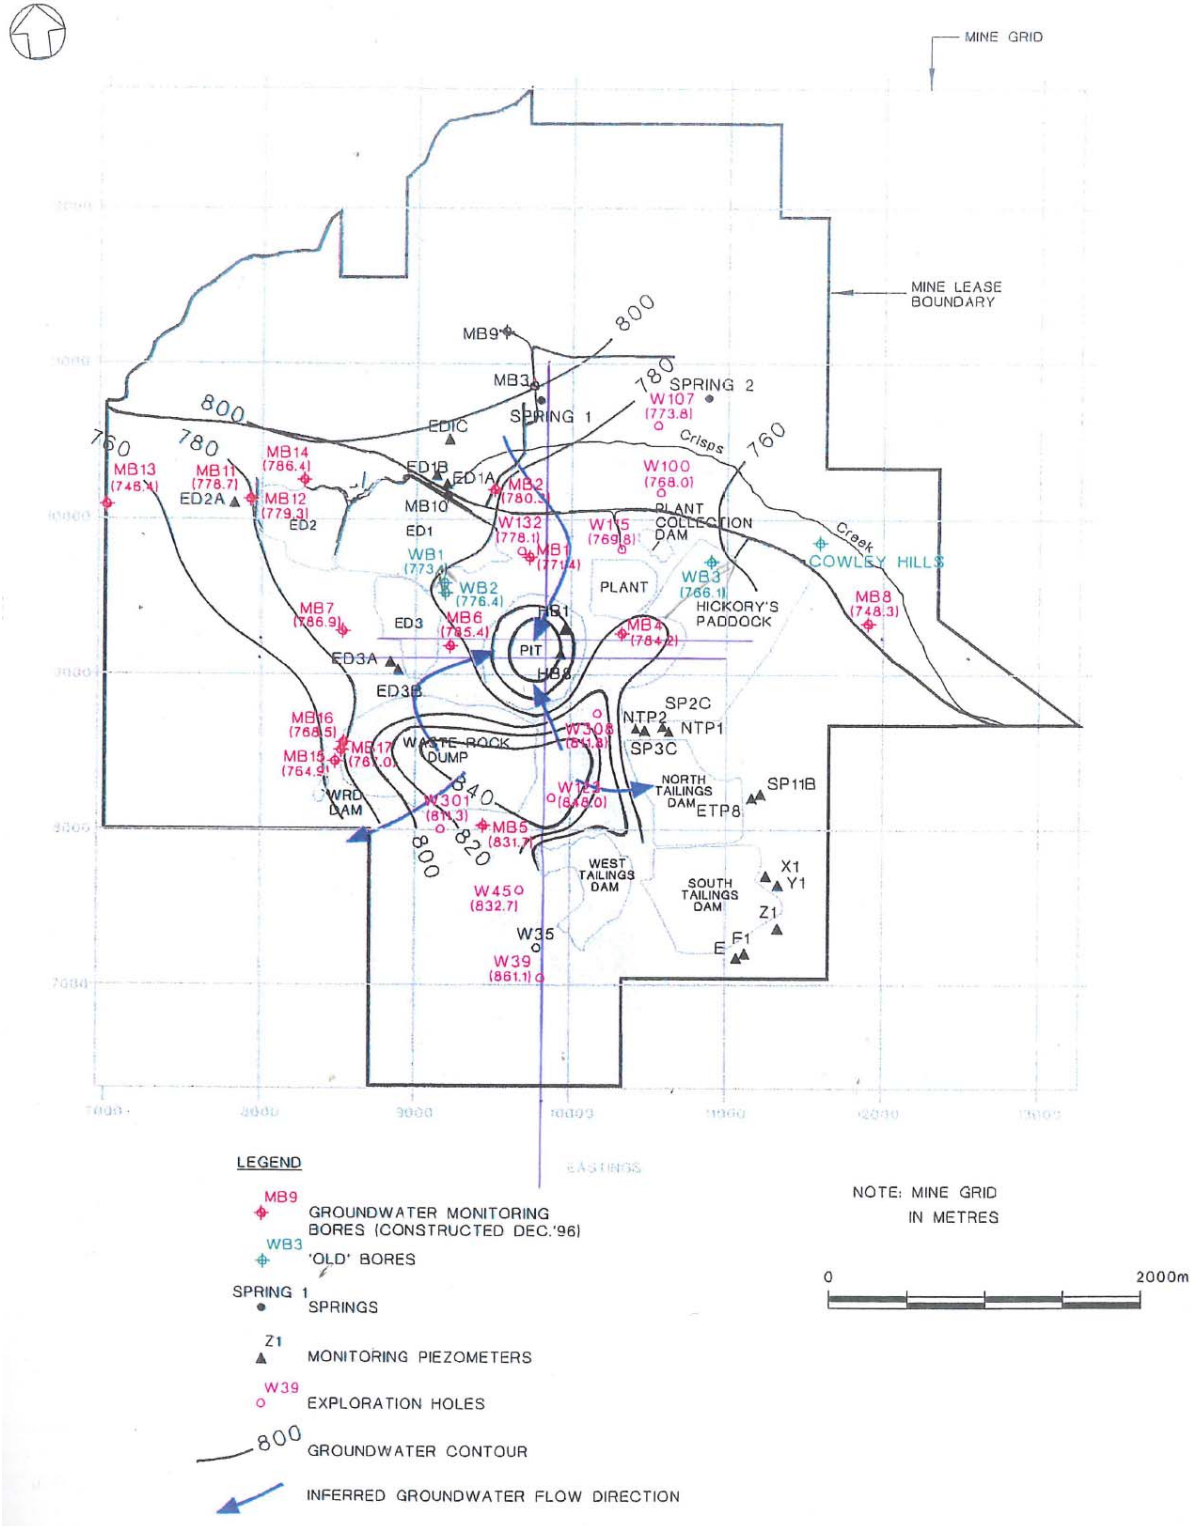
Figure 2-13 Woodlawn Groundwater Contours - 1997

Open cut mining at Woodlawn commenced in 1978 and in 1997 Woodward-Clyde (now URS) plotted groundwater levels in the bedrock around the mine void. These contours, which are reproduced in Figure 2-13 show the cone of depression created by the open cut mine. The groundwater levels range from as high as 840mAHD beneath the waste rock dump on the southern side of the pit to 760mAHD to the east and west of the mine. These groundwater levels are within the bedrock and are a completely separate system from the shallow water table conditions that exist along the Crisps Creek alluvium where spring flows are observed.

The 1997 contours (Figure 2-13) show the impact on groundwater levels in the bedrock after 20 years of depressurisation during open cut mining, when the pumping sump was located about 180m below the regional water table level.

Although pit dewatering has had an impact on groundwater levels, as shown in Figure 2-13, the consistent declining trend that is illustrated in some of the hydrographs between 2002 and 2009 (e.g. MB10, MB12, MB7, MB2 and MB5), is more likely a result of low rainfall conditions and lower than normal recharge rates. This is confirmed by the fact that, in 2010, this trend reversed as wetter conditions began. These hydrographs indicate that the fractured rock aquifer is responsive to vertical fluxes associated with rainfall. Horizontal permeabilities are much lower, however, as noted by the low flow rates into the mine void, and these flows are less susceptible to local climatic variability.
