University Creek

Landscape Rehabilitation Plan
(Incorporating Vegetation Management Plan)

May 2010

Prepared by:
Context Landscape Design

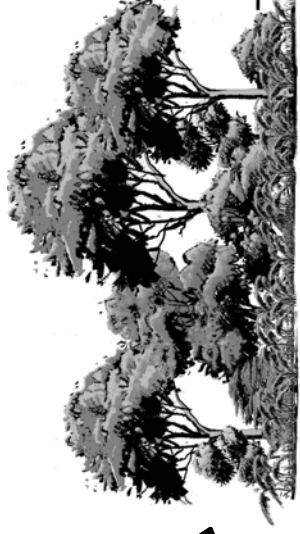
drawing title
existing site habitats

Vegetation Structure	Exotic Biomass %	Weed Scale	Calculated Weed Class
canopy	< 10%	1	canopy weed scale x 0.5 = **
	10% - 30%	2	
	31% - 60%	3	
understorey	< 10%	1	understorey weed scale x 0.2 = **
	10% - 30%	2	
	31% - 60%	3	
ground cover	< 10%	1	ground cover weed scale x 0.3 = **
	10% - 30%	2	
	31% - 60%	3

note: where the canopy is absent use understorey Weed Scale

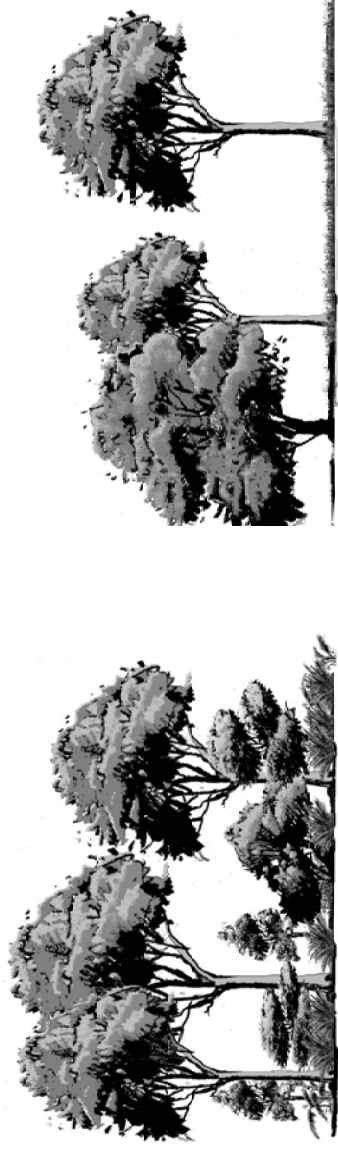
site rehabilitation units

landscaped precincts

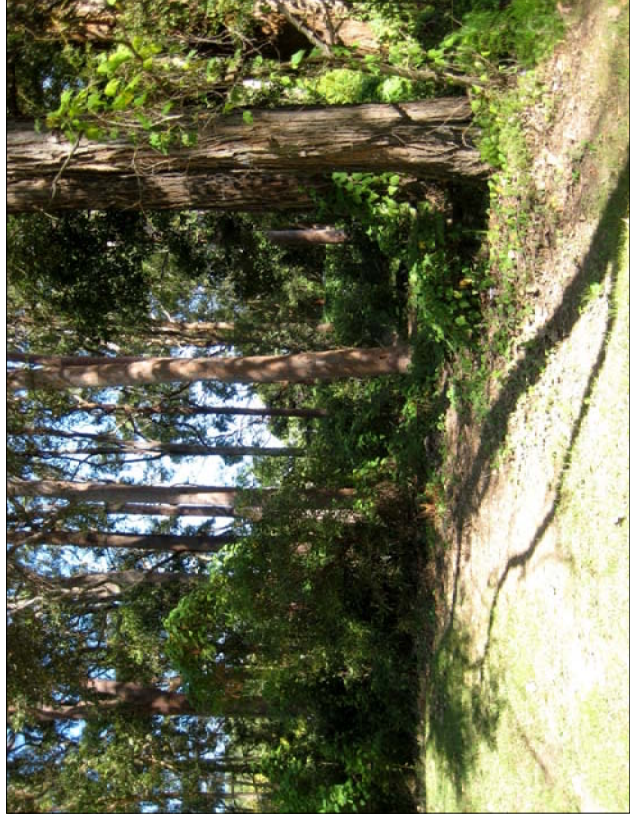
figure 6.1 the regeneration area looking south west along the informal track

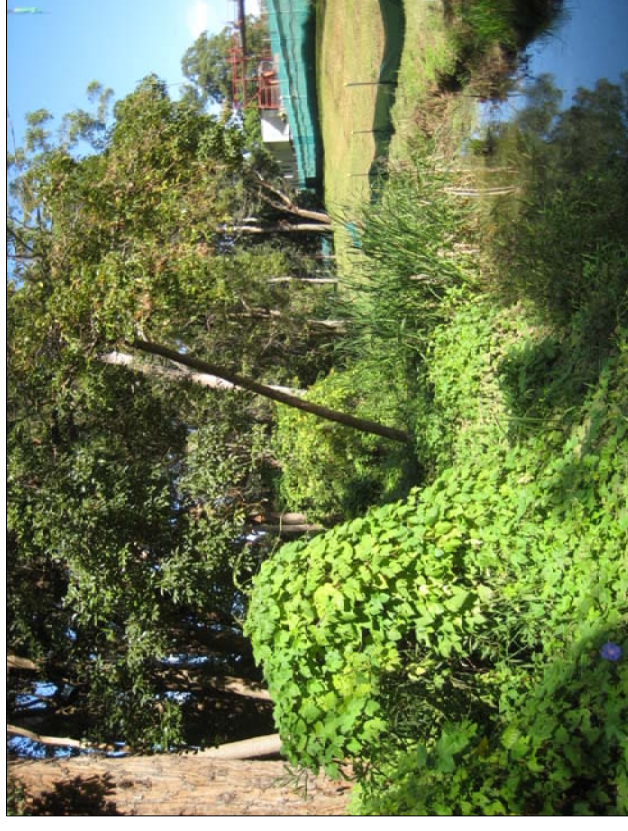
figure 6.2 the regeneration area looking south west along the watercourse

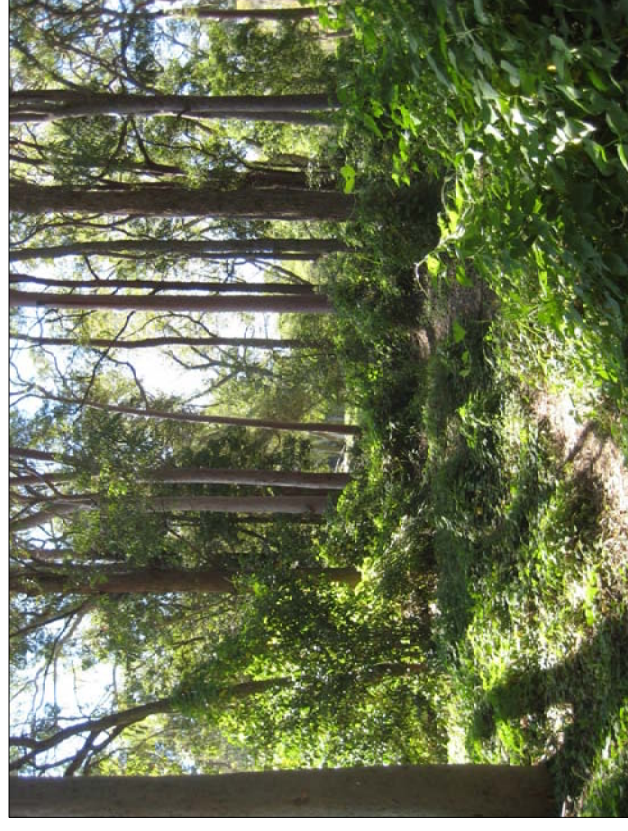
figure 6.3 the regeneration area looking north east along the informal access track

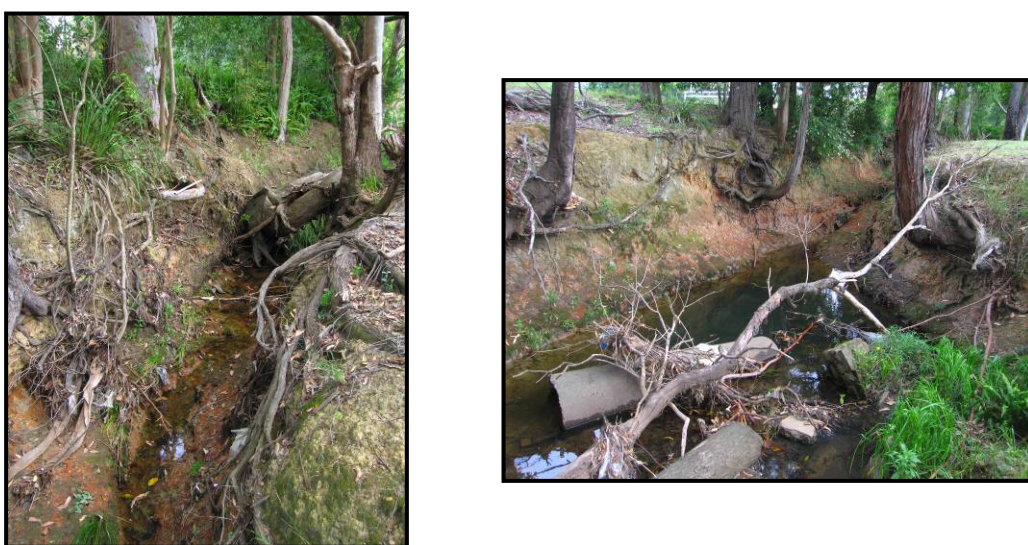
Figure 1 Typical channel characteristics along Reach A

On first appearances, Reach A shows signs of degradation, with exposed tree roots, tree trunks curved at the base and high banks (see Figure 1). However, there is little evidence of recent erosion, other than just below the entrance pipe, around other stormwater/sewage pipes, and just upstream of a tree root width constriction. The banks, although high, are composed largely of stiff to very stiff residual clay that has been eroded near-vertically to over 1.5m in height.

Some material (both artificial and natural) has accumulated on the bed of the channel. Vegetation, including immature trees, has become established. It is, therefore, likely that degradation occurred in response to a past trigger, such as channelisation, and the creek has now adjusted to the contemporary regime.

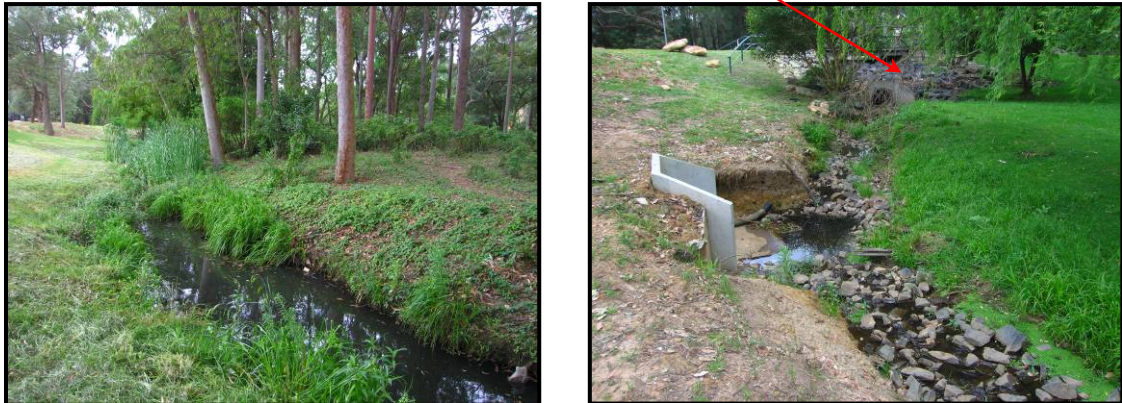
Figure 2 Typical channel characteristics along Reach B

Reach B is the most visually appealing of all those assessed, with low banks, a grassy riparian corridor and in-channel vegetation. There is evidence of minor bed degradation and bank erosion, particularly around pipe inlets.

At the downstream end of Reach B, a large rock armour-faced dam has been constructed, presumably to produce controlled flooding over the park land (i.e. a flood detention dam). As the left bank is higher and steeper than the right, due to the local topography, flows will preferentially flood over the right bank.

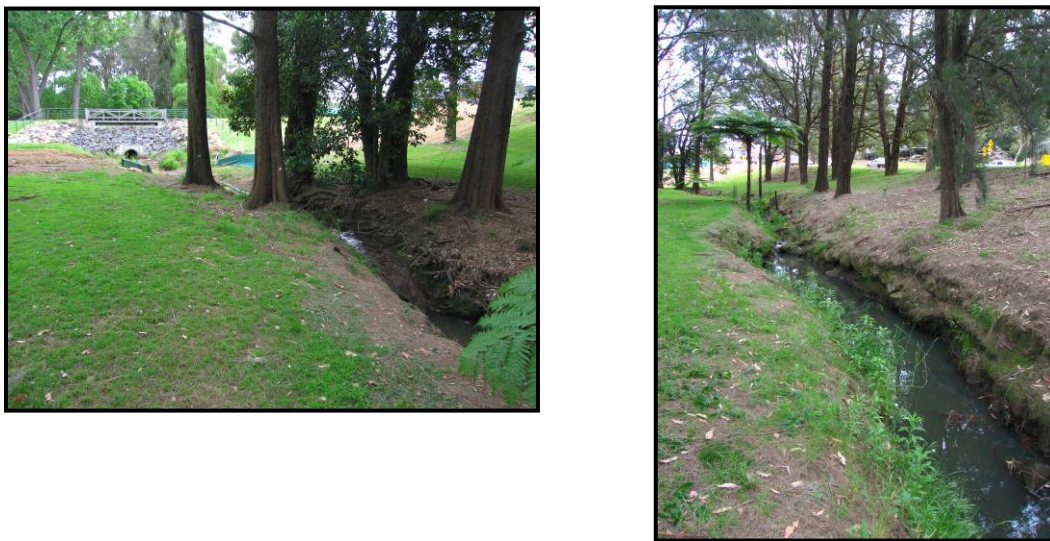
Figure 3 Typical channel characteristics along Reach C

At the upstream end of Reach C, sediment (including rock from the dam) has been deposited just downstream of the piped section, at a wider section of the channel. Reach C shows signs of minor bed degradation, although this has been limited by several small bedrock bed elevation controls. Sandstone cobbles have been eroded from the banks and deposited in the downstream section. All pipes entering the reach were perched approximately 0.3m above the current water level.
