Client	Macquarie University
Project	Geomorphological Assessment University Creek
Title	Location Map and Master Plan of Proposed Development Near to University Creek
Project No.	GEOTLCOV23810AB-AB
Figure No.	DRAWING 1

Client	Macquarie University
Project	Geomorphological Assessment University Creek
Title	Simulation of 1984 Flood (Source: City of Ryde)
Project No.	GEOTLCOV23810AB-AB
Figure No.	DRAWING 2

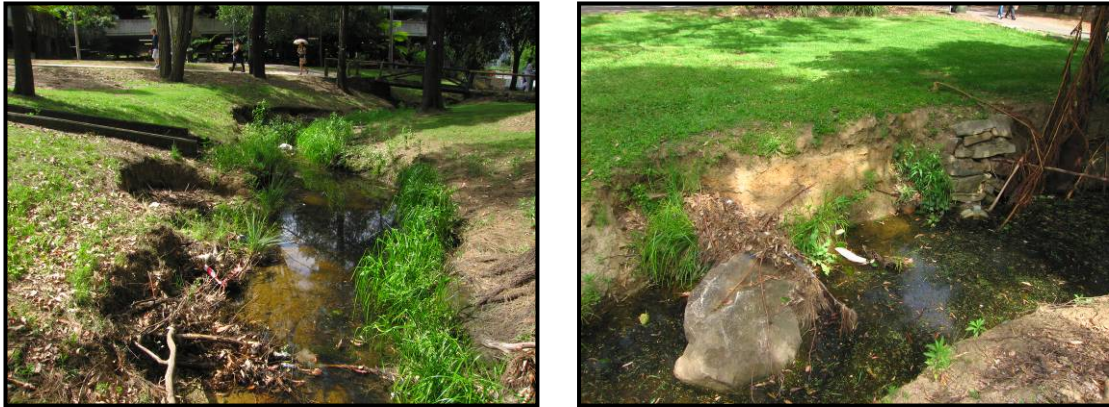
**Figure 4 Typical channel characteristics along Reach D**

Reach D is the most sinuous section of the creek, with erosion occurring along the low outer banks of the bends. Tree roots have formed a small bed elevation control midway along the reach. The majority of bank erosion and bed scour occurs downstream of this control point. Some sandstone boulders were observed in the downstream section of the reach.

The downstream end of the reach is piped beneath Research Park Drive, with the realigned creek forming a very sharp bend. Sediment and flood debris have been deposited upstream of the overflow pipes. The opposite (left) bank is showing signs of recent erosion towards the foundations of the adjacent building.

Flood debris was also observed around tree trunks up to a metre above the current water level. Reach D is relatively well connected to its floodplain. Therefore, relatively frequent overbank flows are likely. The western area of Station Site North, on the east side of Research Park Drive, is at approximately the same elevation as the creek, and possibly represents the original creek alignment. Station Site North is, therefore, at increased risk of flooding.

- Consider realigning all or part of Reach D to the Station Site North side of Research Park Drive. One alternative would be to create a formal overflow channel running from just downstream of Waterloo Road directly to the stormwater overflow within Reach E. A further alternative would be to realign the creek to remove the sharp bend at the road crossing.

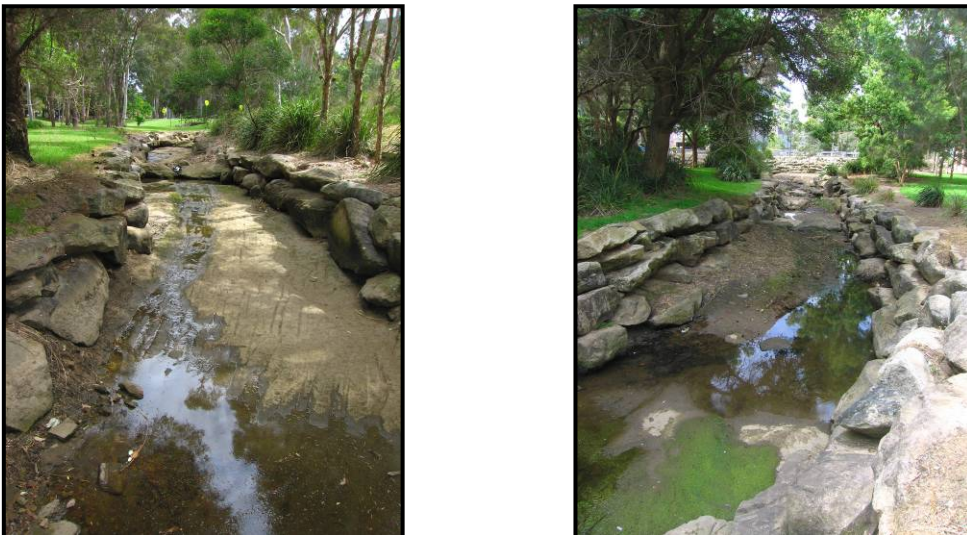
**Figure 5 Typical channel characteristics along Reach E**

Reach E appears to have been artificially constructed, with sandstone bedrock forming the broad, flat channel bed and sandstone block walls forming the banks. In one location, gouges in the rock indicate

that ripping was required to create the channel. Boulders have been placed across the channel at intervals, possibly in an attempt to reduce flow velocities through an otherwise low-friction reach. Sediment has become trapped upstream of these boulder dams.

The blocks lining the banks and within the creek have been placed over geotextile fabric. The geotextile has been exposed in places. The riparian corridor along Reach E has little understorey vegetation, and fine sediment has been washed over and between the boulders lining the banks.

Stormwater overflow channels enter the creek in two places, indicating frequent inundation of west Station Site North.

- Create a channel along Reach E which is more natural in both appearance and process. At the moment, it is likely that sediment is being washed over and through the banks, and there is little opportunity for in-channel vegetation to become established. A multi-level channel could be constructed with an element of self-adjustability. The rock walls could be replaced with planted gabions or geofabric-protected earth banks. A channel which contains sediment bars, and shallow riffles and deeper pools would allow establishment of in-channel and riparian vegetation; increase both the geomorphological and ecological channel condition through creation of flow variability; and reduce sediment inputs. The flood capacity of such a channel would not be reduced if a well-thought-out design is implemented.

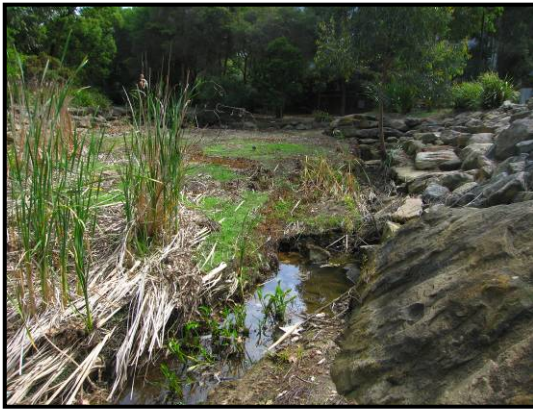
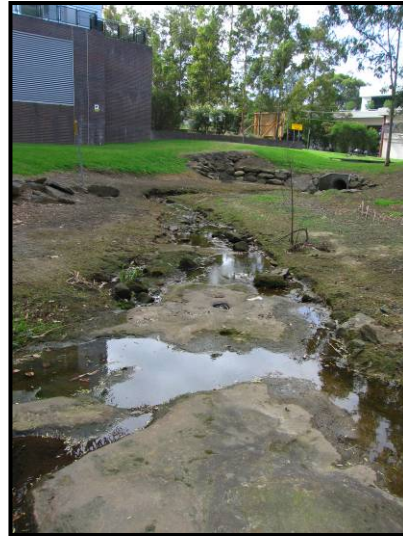
**Figure 6 Typical channel characteristics along Reach F**

Reach F is a sediment storage reach, with large bars covering the channel bed. The bars appear to have formed above artificial boulder dams mid-way down the reach and just above the Talavera Road pipe. Sedimentation has caused near-blockage of a pipe inflow just upstream of the Talavera Road pipe. The low-flow channel has incised approximately 0.2 – 0.3m into these bars. Flattened vegetation on the bars indicates relatively recent inundation. Sandstone bedrock is shallow along this reach, and outcrops within the downstream section.

The floodplain within Reach F has been artificially constricted by office developments, and is now a relatively narrow corridor between steep embankments. Towards the downstream end of the reach, it appears that the channel has been moved towards the left bank to increase development space. The right bank has been replaced by a high (approx 2.5m) sandstone block wall. Lateral erosion and bed degradation has occurred at the base of this wall, especially where the channel has been severely horizontally and vertically constricted by bedrock (see Drawing 5).

The pipe beneath Talavera Road represents a significant and abrupt decrease in channel capacity. Only a short section of small-diameter pipe has been installed, with a larger pipe just downstream. A grate allowing overflow into the larger pipe is only slightly below road level and flooding of the road occurs.

- Relocate the creek to the west of the willow tree at the constriction within Reach F. At the moment, the right bank is being undercut as a result of both bed degradation and lateral erosion. This is likely to be occurring in response to artificial channel realignment and constriction of the channel width (see report GEOTLCOV23810AB-AD for detailed assessment of this issue). Relocation and widening of the creek would allow the constriction to be removed and flow conveyance improved.

- Enlarge the pipe at the downstream end of Reach F. This currently represents a significant reduction in channel capacity. It may be possible to remove the smaller pipe altogether, allowing flows to directly enter the larger pipe just downstream. This will still cause an abrupt reduction in capacity but, since the land beyond this point is out of the jurisdiction of the University, options for further improvement are limited.

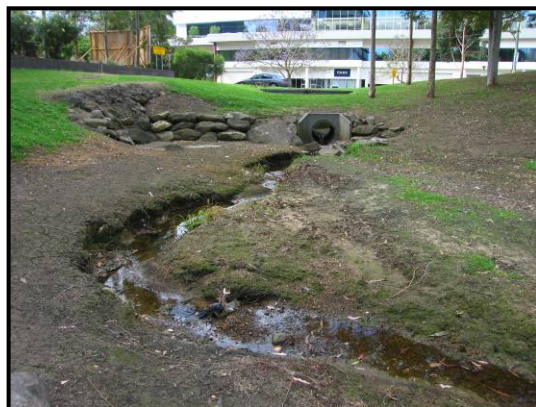
- Resistant bed materials, e.g. bedrock along Reaches C, E and F; residual clay along Reach A; Concrete/pipes at the downstream end of Reaches B, C, D and F (see Figure 7), and within Reach C. Flooding has historically occurred upstream of these constrictions, resulting in uncontrolled surface flows to the west of Station Site South, across Waterloo Road, within the western area of Station Site North; across Research Park Drive; and across Talavera Road;

**Figure 7      Wide culvert mid-way along Reach F and narrow pipe at downstream end of Reach F, demonstrating a significant reduction in flow capacity**

- Resistant bank materials, e.g. bedrock along Reaches E and F; block walls along reaches E and F; and residual clay along Reach A;
  - Tree roots, along Reach A;
  - Narrow piped sections, especially at the downstream end of Reach F (see Figure 7).
- Sharp meander bends can affect flow efficiency, causing rapid flow deceleration and sediment deposition, much in the same way as lateral constrictions. This occurs particularly at the downstream end of Reach D, where the creek is piped below Research Park Drive.
  - High channel banks, through incision, artificial alteration, or due to local topography, can cause dissociation of the channel and its floodplain. This means that, during flood events, flows tend to remain within the incised channel
