APPENDIX F

'Ecological Constraints Report; University and College Creeks Study
Macquarie University' Prepared by Lesryk Environmental Consultants (2009)

ECOLOGICAL CONSTRAINTS REPORT

UNIVERSITY AND COLLEGE CREEKS STUDY MACQUARIE UNIVERSITY

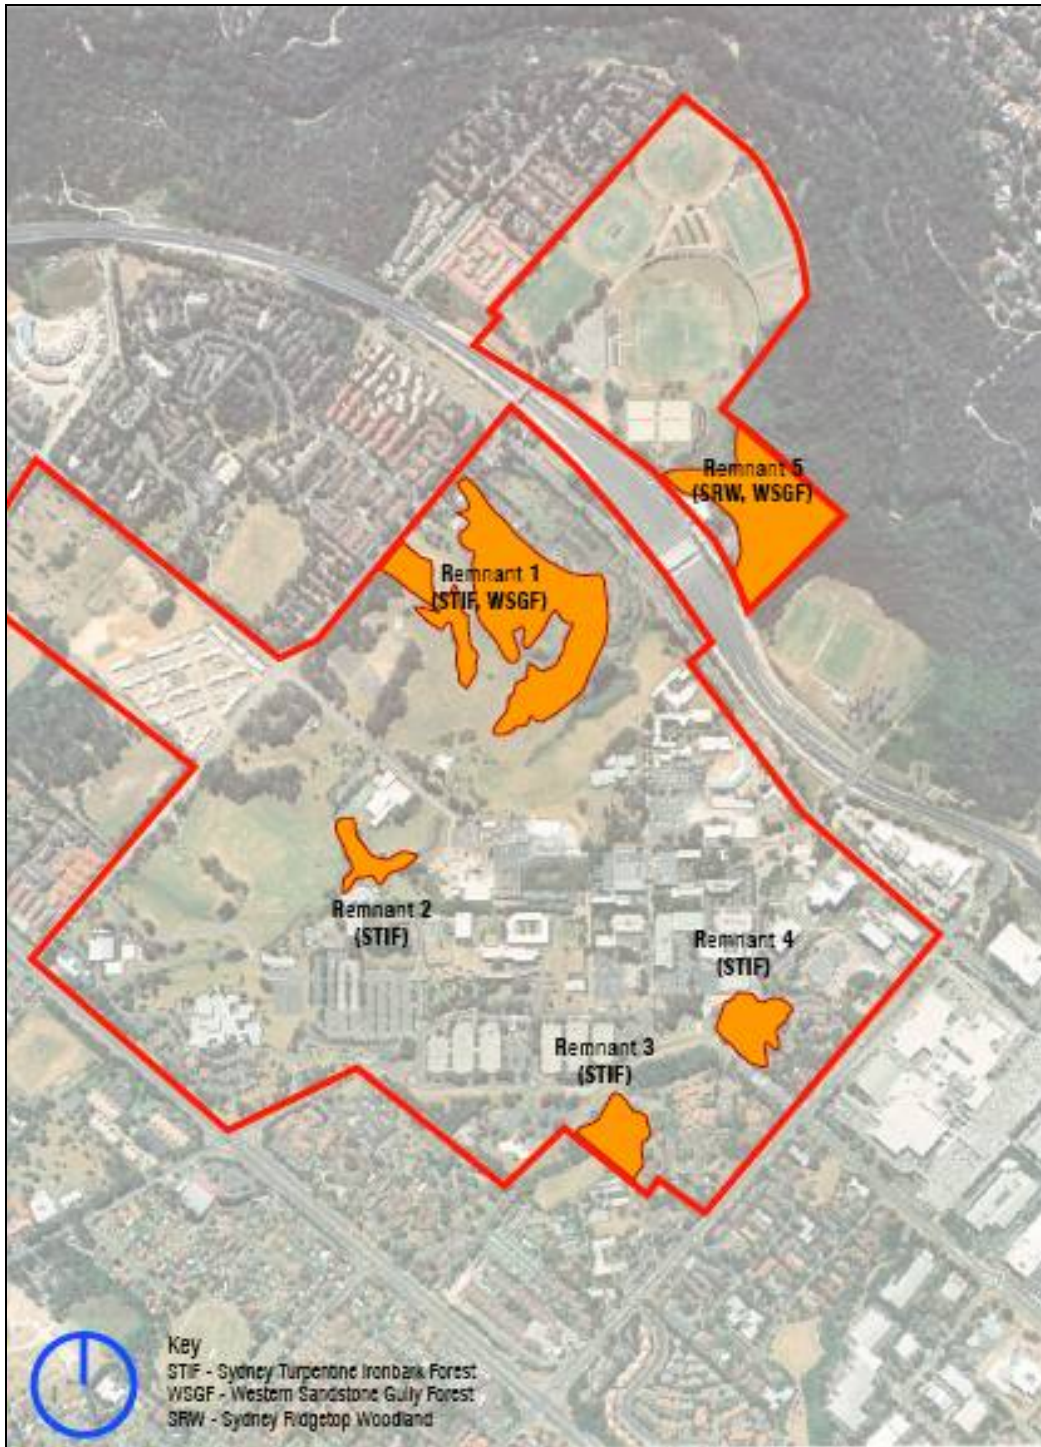
Figure 1. Vegetation Mapping of the University by EDAW (2006)

EDAW undertook a preliminary ecological investigation of the University's grounds in 2006 (EDAW 2006). This was limited to limited to the collation and review of existing, readily accessible information. Using the classification of NPWS (2002), they found three vegetation communities in the university grounds. One vegetation community, Sydney Turpentine Ironbark Forest, was found to occur in two locations within the study area (remnants 3 and 4 on Figure 1). EDAW found that these remnants had very little understorey as they are within a mown park-like setting between the residential colleges and the core of the university. This and their small size limited their ecological value and ongoing viability. Nevertheless, EDAW commented that Sydney Turpentine Ironbark Forest is listed as a critically endangered ecological community under the *EPBC Act* and an endangered ecological community under the *TSC Act*, implying that the remnants within the study area qualified as endangered ecological communities under these Acts.

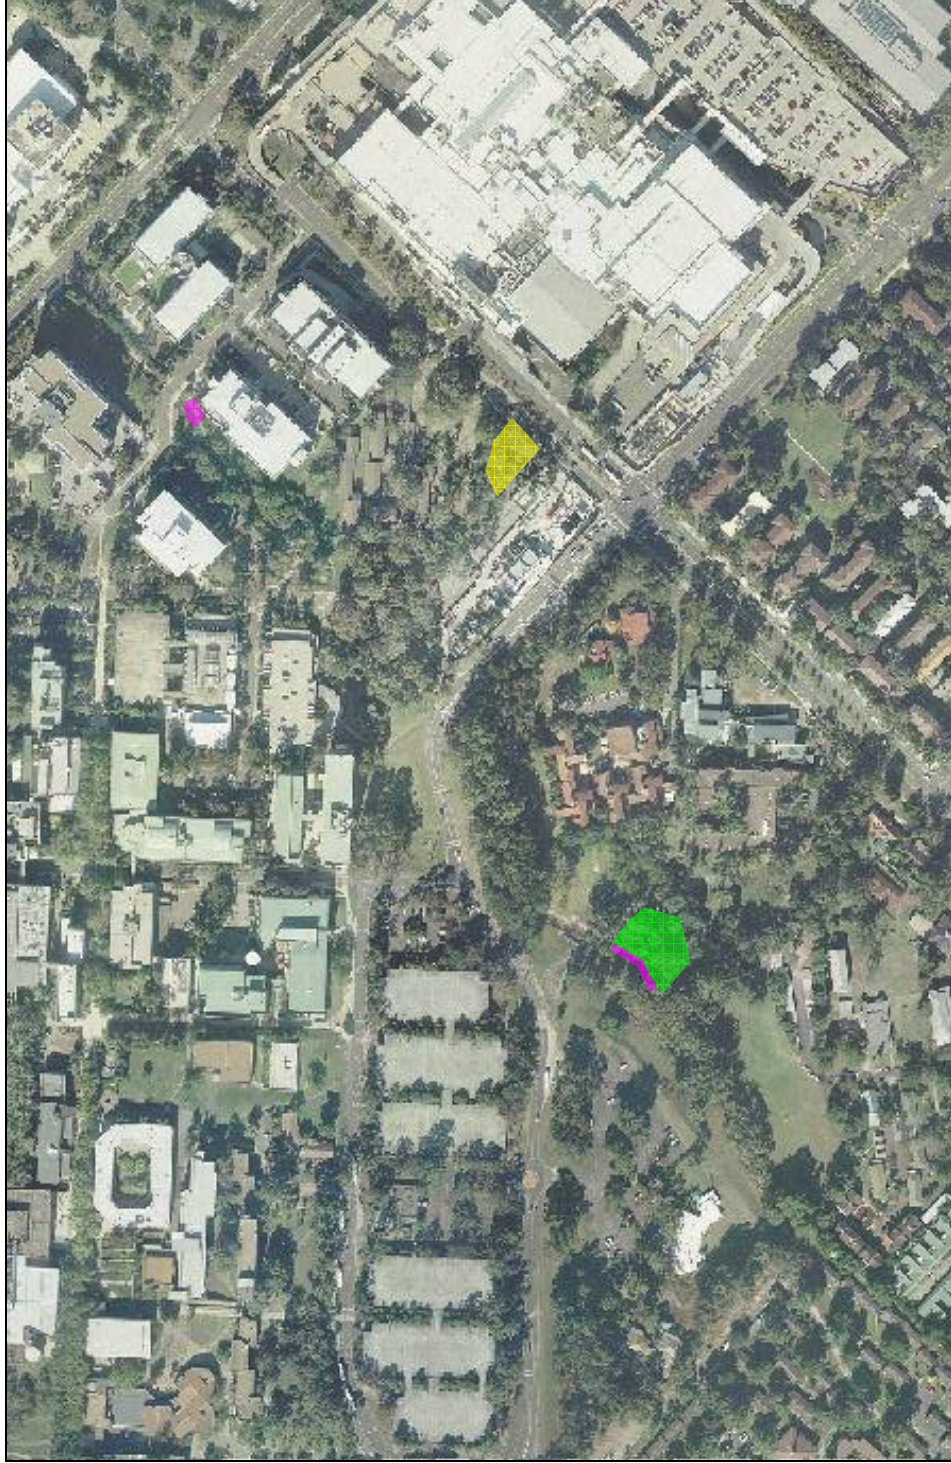
Figure 1. Native Vegetation in the Study Area

Three vegetation communities were identified in the study area. In addition to these, most of the study area consists of remnant or planted trees above lawn or landscape planting. A description of each of the communities and the modified areas is provided below. Figure 2 shows the location of the vegetation communities.

This community occurs on the eastern side of Reach B north of the northern boundary of Morling College. It covers approximately 2000m² is dominated by a canopy of Smooth-barked Apple to 25 metres (m) along with some Blackbutt (*Eucalyptus pilularis*), Turpentine and White Stringybark (*E.globoidea*). There is a sparse to mid-dense shrub layer to 3m of the introduced Lantana (*Lantana camara*) and the native Sweet Pittosporum (*Pittosporum undulatum*), *Ozothamnus diosmifolius* and Sydney Golden Wattle (*Acacia longifolia*). The groundcover is dense and dominated by the introduced Morning Glory (*Ipomoea indica*) and Panic Veldt Grass (*Ehrharta longiflora*) though there is regrowth of native species such Flax-lily (*Dianella caerulea var producta*), Weeping Meadow Grass (*Microlaena stipoides*), Beard-heath (*Leucopogon juniperinus*) and Mat-rushes (*Lomandra* spp). The shrub and groundcover layer strata contain a mix of native and introduced species. Analysis of 1943 aerial photography on the Department of lands Six Viewer website (<http://imagery.maps.nsw.gov.au/>) indicates that this community was at that time restricted to the edge of the creek and has regenerated southward since then.

This community occurs in patches along the creek within Reaches B and E where sediment has dropped. It is composed of dense growth of Cumbungi (*Typha orientalis*) to 1.5m tall fringing, lower growth of Knotweed (*Persicaria lapathifolia*) and Umbrella Sedge (*Cyperus eragrostis*).

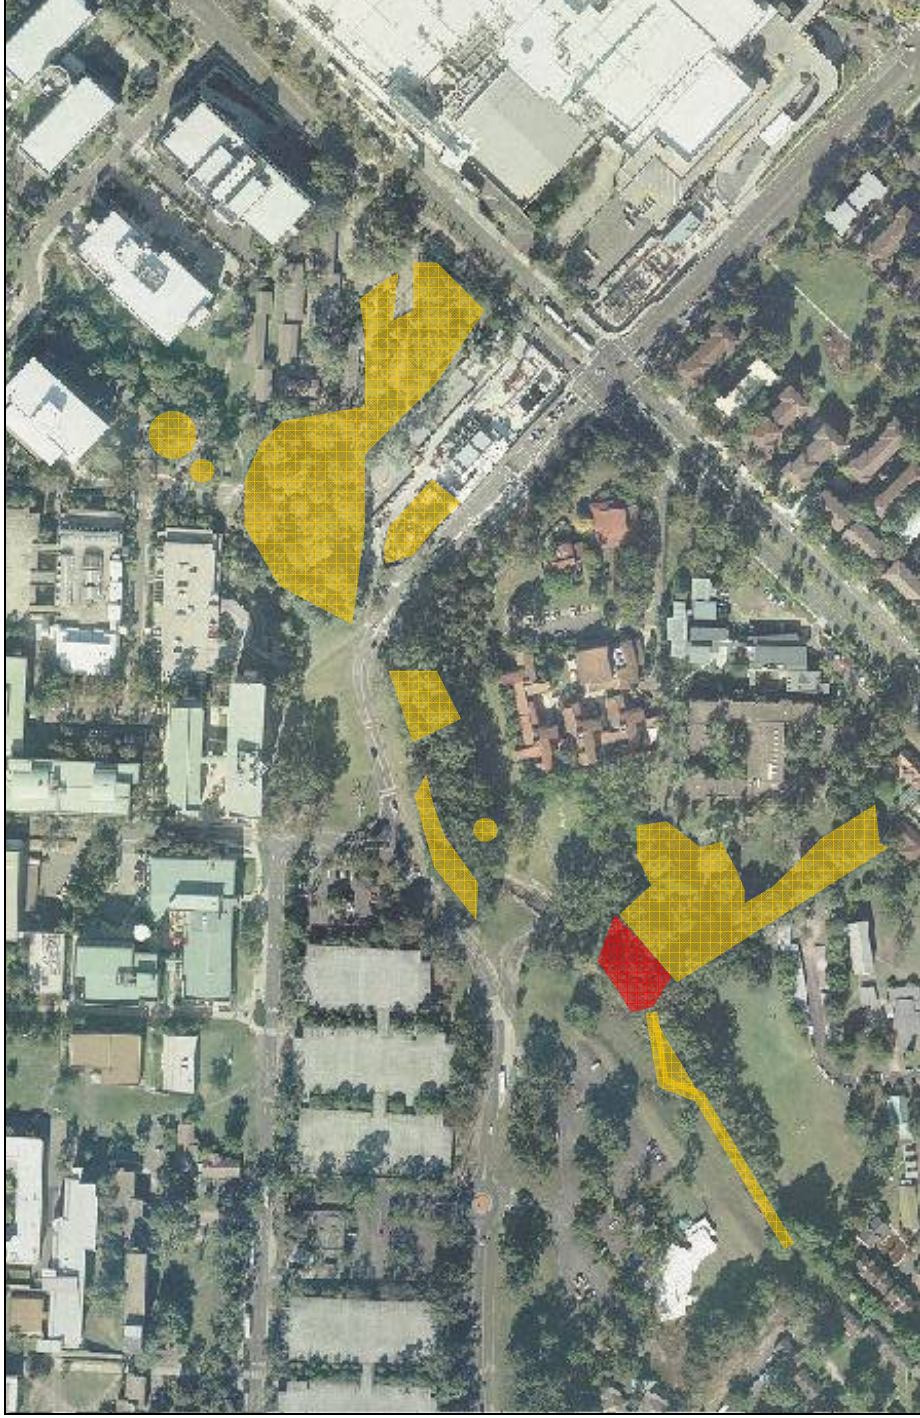
Figure 3. Ecological Constraints

Figure 3 indicates the areas of high and moderate constraint. The balance of the study area is of low ecological constraint.

Areas of low constraint include the remainder of the study area, being the creek, plantings of native and introduced species and associated lawns.
