**PROPOSED DEMOLITION OF HARBOUR CONTROL TOWER,  
BARANGAROO HEADLAND PARK:  
ARCHAEOLOGICAL ASSESSMENT AND  
STATEMENT OF HERITAGE IMPACT**

**Prepared by  
Austral Archaeology Pty Ltd  
Archaeological & Cultural Heritage Consultants  
For  
Barangaroo Delivery Authority  
19 November 2013  
Job No: 1323**

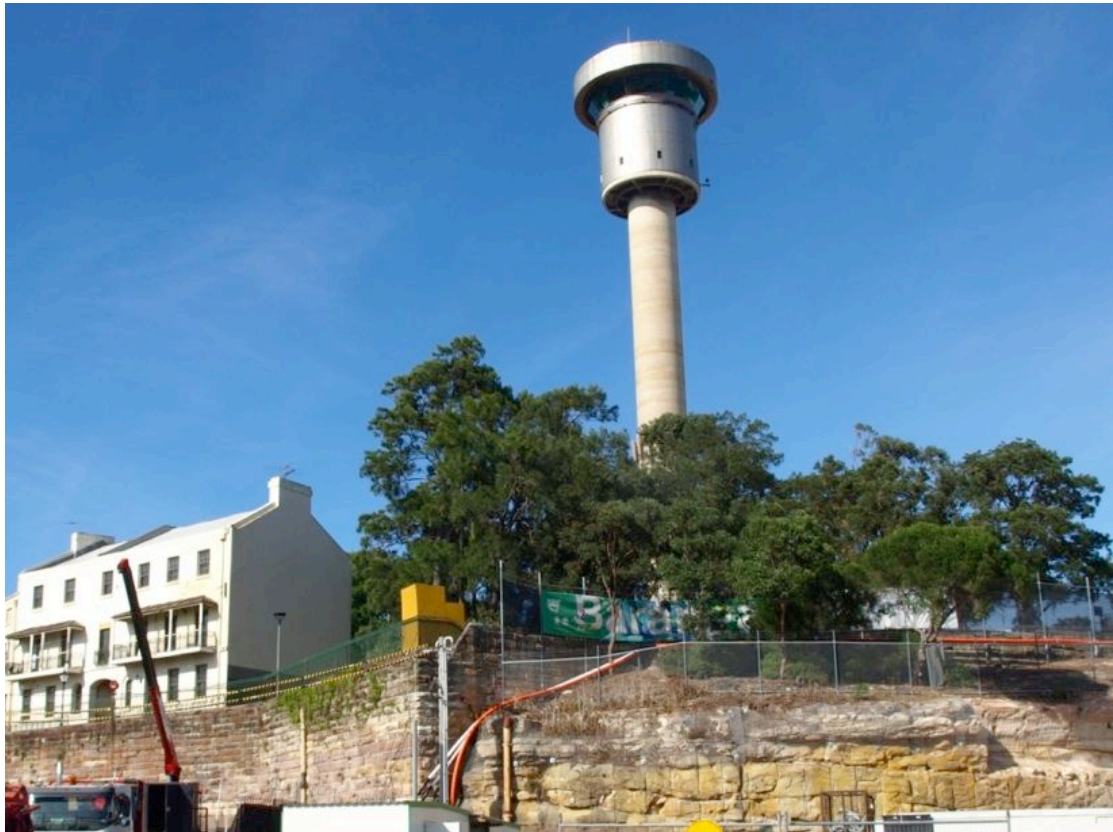
**Figure 3.2. View of the HCT to the south from Moore's Cove with part of Clyne Reserve in the foreground. Victoria Terraces are situated at left. (Photo: Austral Archaeology Pty Ltd)**

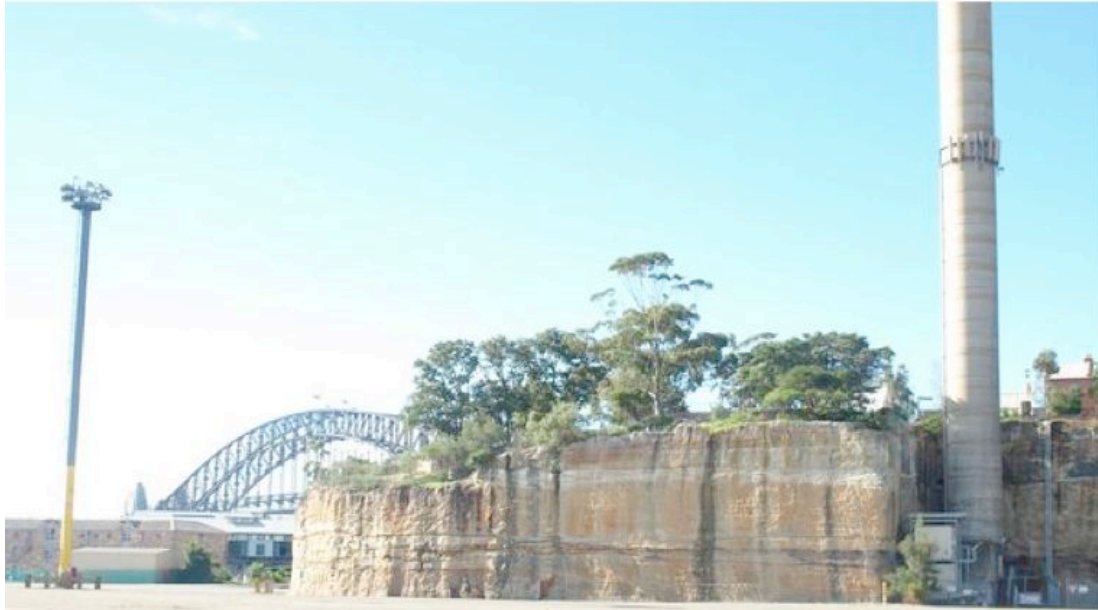
**Figure 4.1. View of base of the tower and the cut back headland prior to works commencing at Barangaroo in 2010. (Photo Austral Archaeology Pty Ltd, June 2010)**

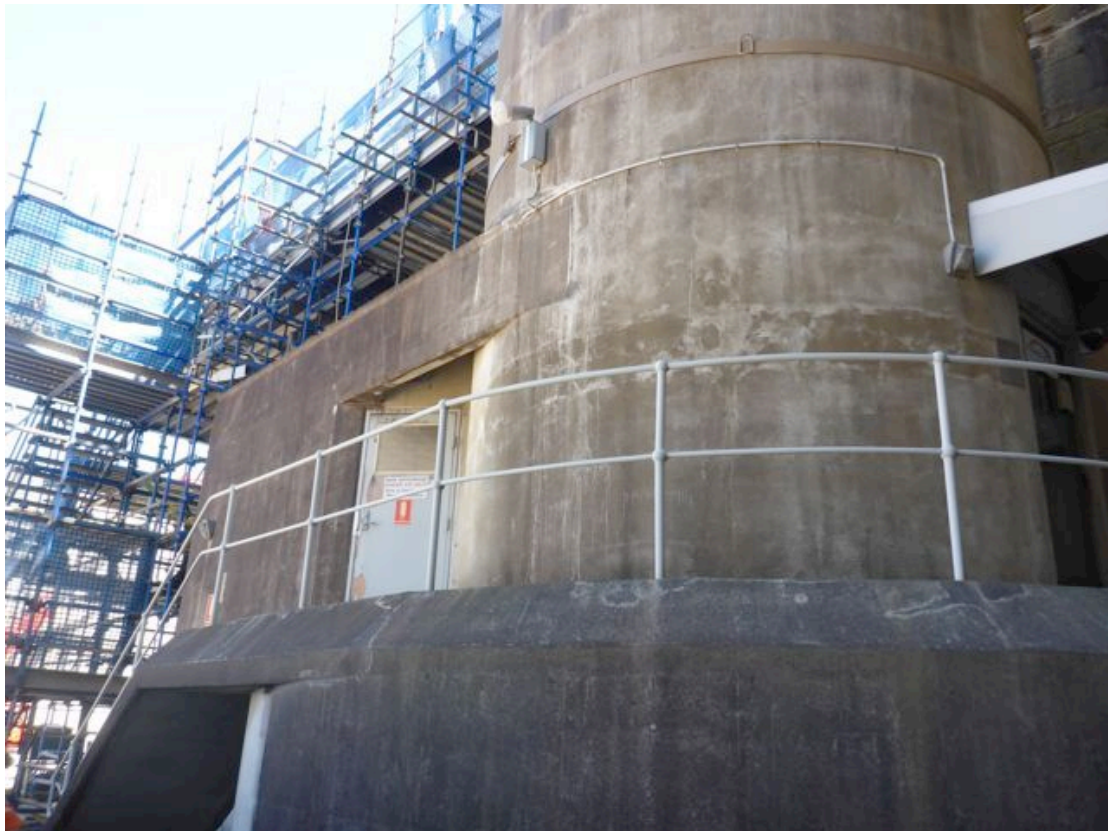
**Figure 4.2. Base of HCT viewed to northwest. Note the large base plinth with walkway and handrail above and main switch room door visible at left and lower main entrance door at right. (Photo Austral Archaeology Pty Ltd, October 2013)**

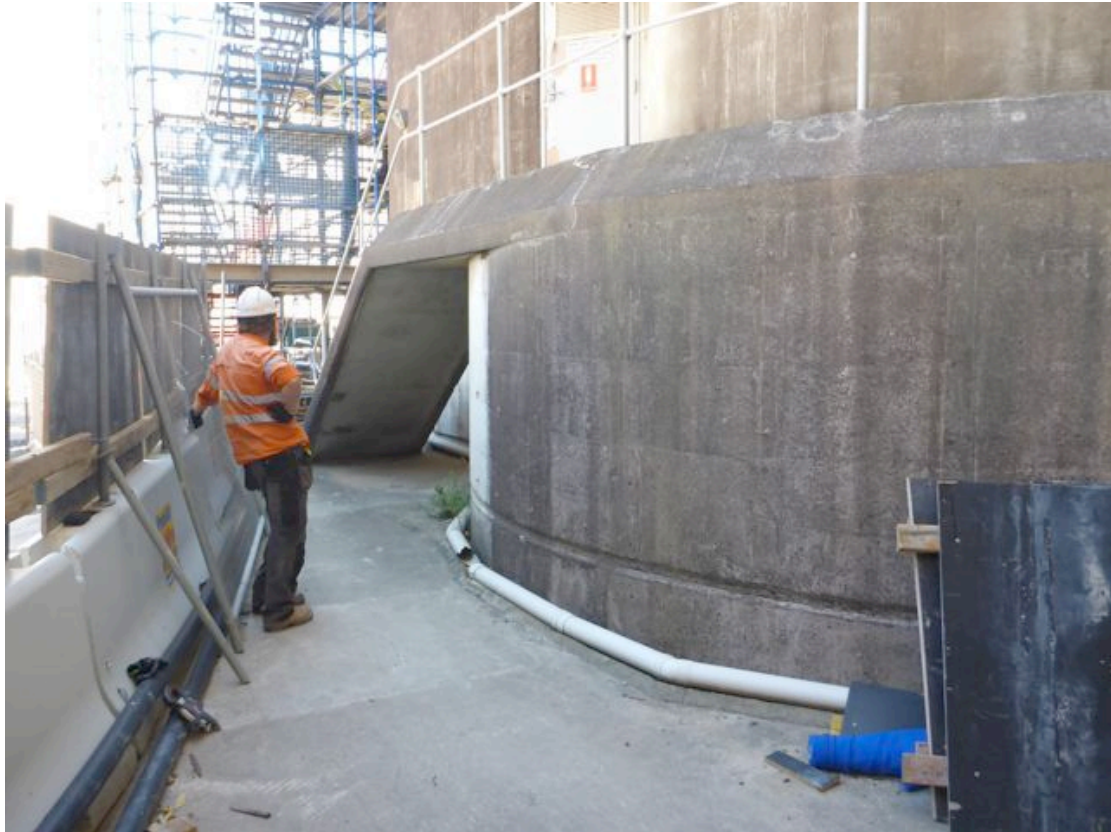
**Figure 4.3. Base of HCT viewed to west. Note the access stairway to the walkway on the large base plinth. (Photo Austral Archaeology Pty Ltd, October 2013)**

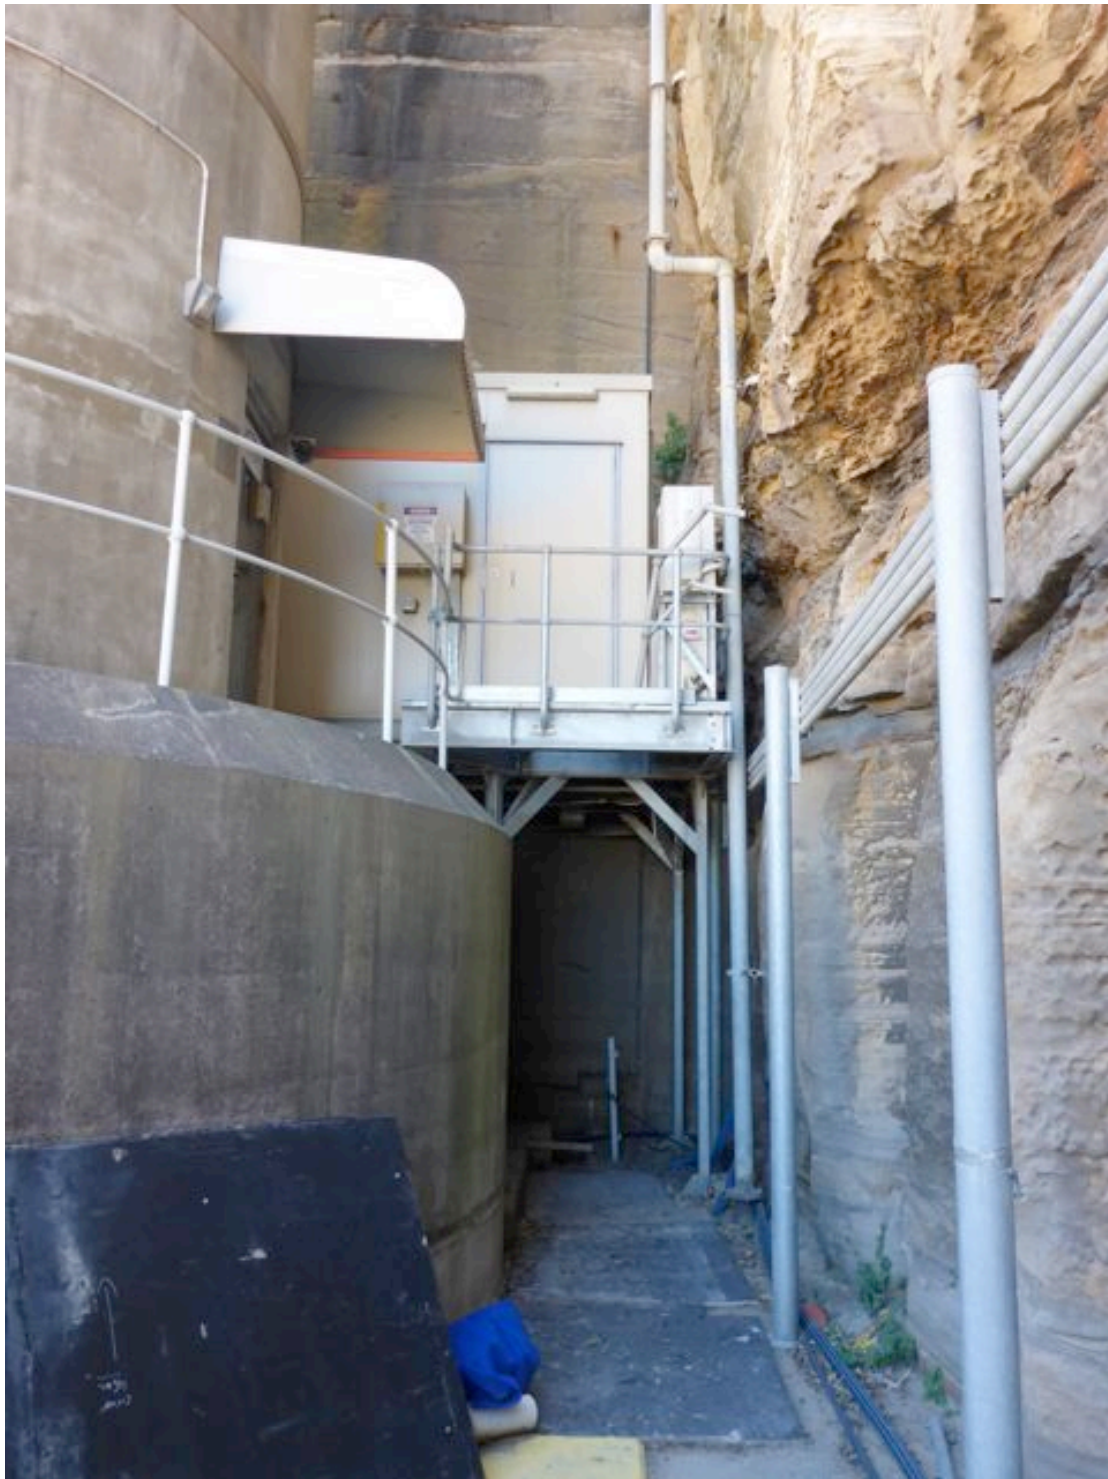
**Figure 4.4. Base of HCT viewed to north. Note the large base plinth with walkway and handrail and entrance door at left, the cliff face at right and rear, and a small external (plant?) room with two split system airconditioning units on its right. (Photo Austral Archaeology Pty Ltd, October 2013)**

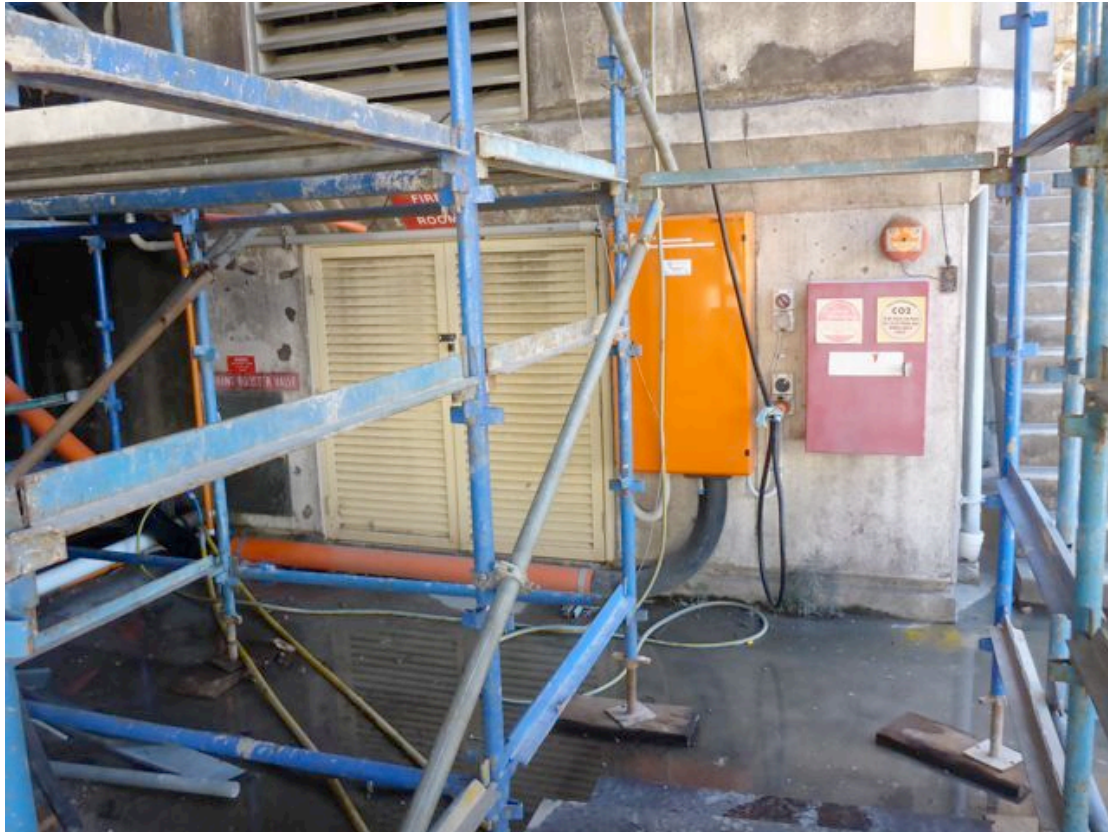
**Figure 4.5. Base of HCT viewed to the east. Note the lower louvred doors provide access to the Fire Room and the upper louvred vent provides ventilation to the western end of the Switch Room. (Photo Austral Archaeology Pty Ltd, October 2013)**

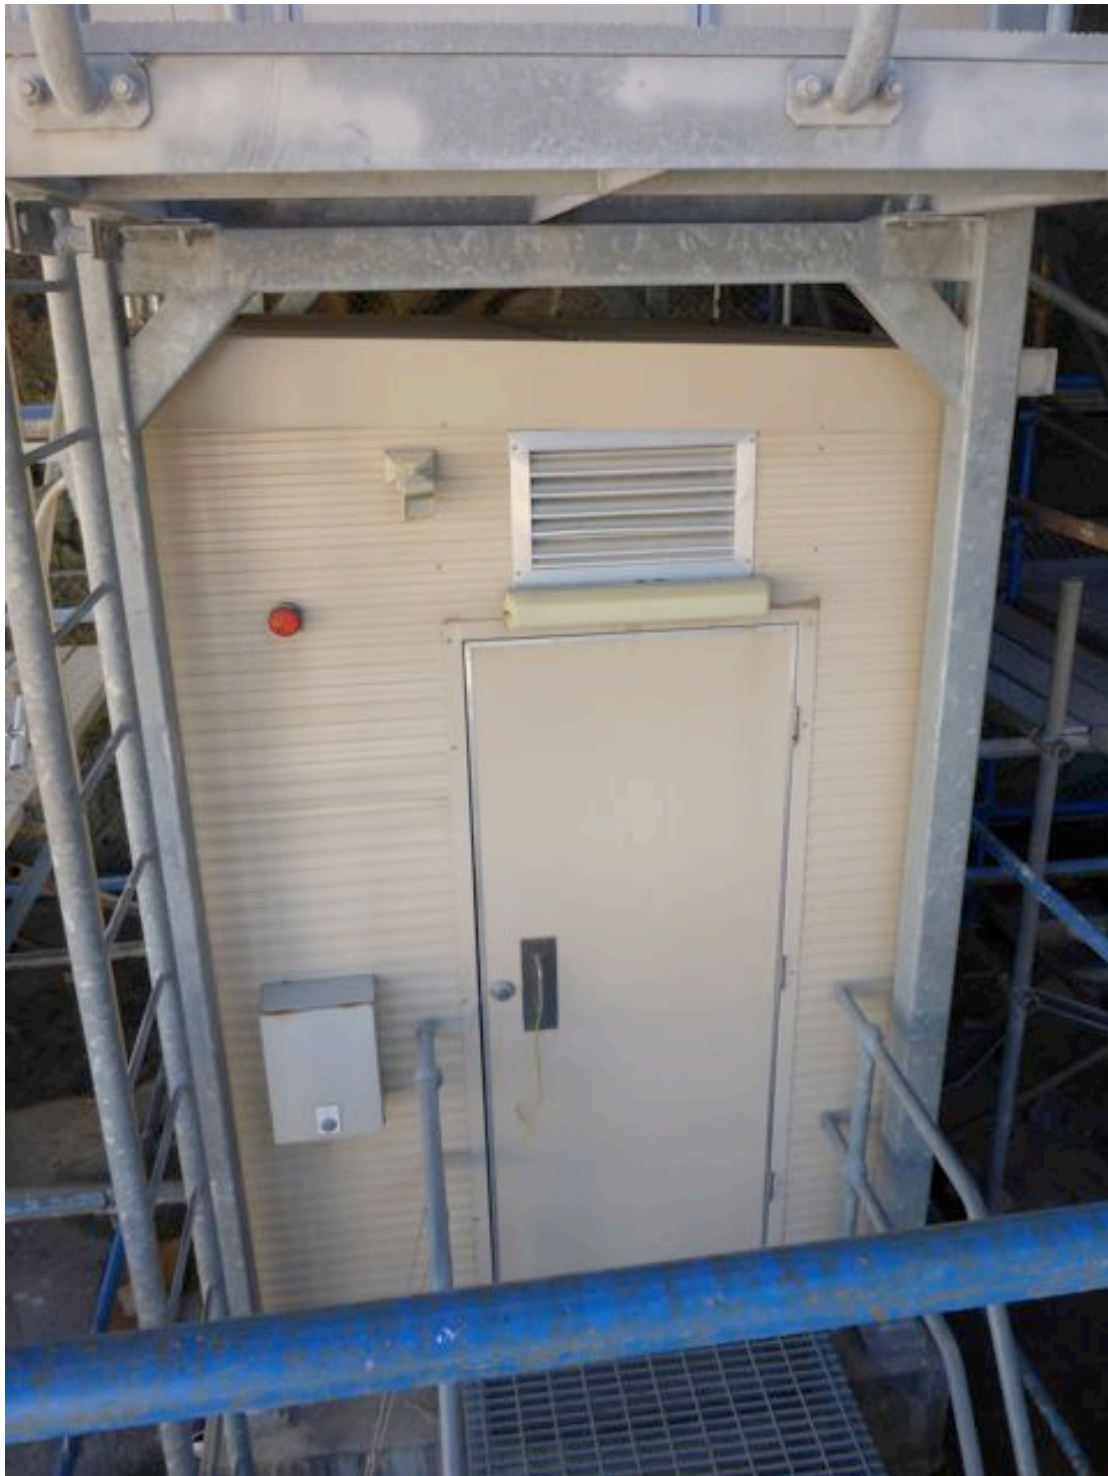
**Figure 4.6. View to the north of the lower level of the freestanding Telstra plant room located on the west side of the tower base. (Photo Austral Archaeology Pty Ltd, October 2013)**

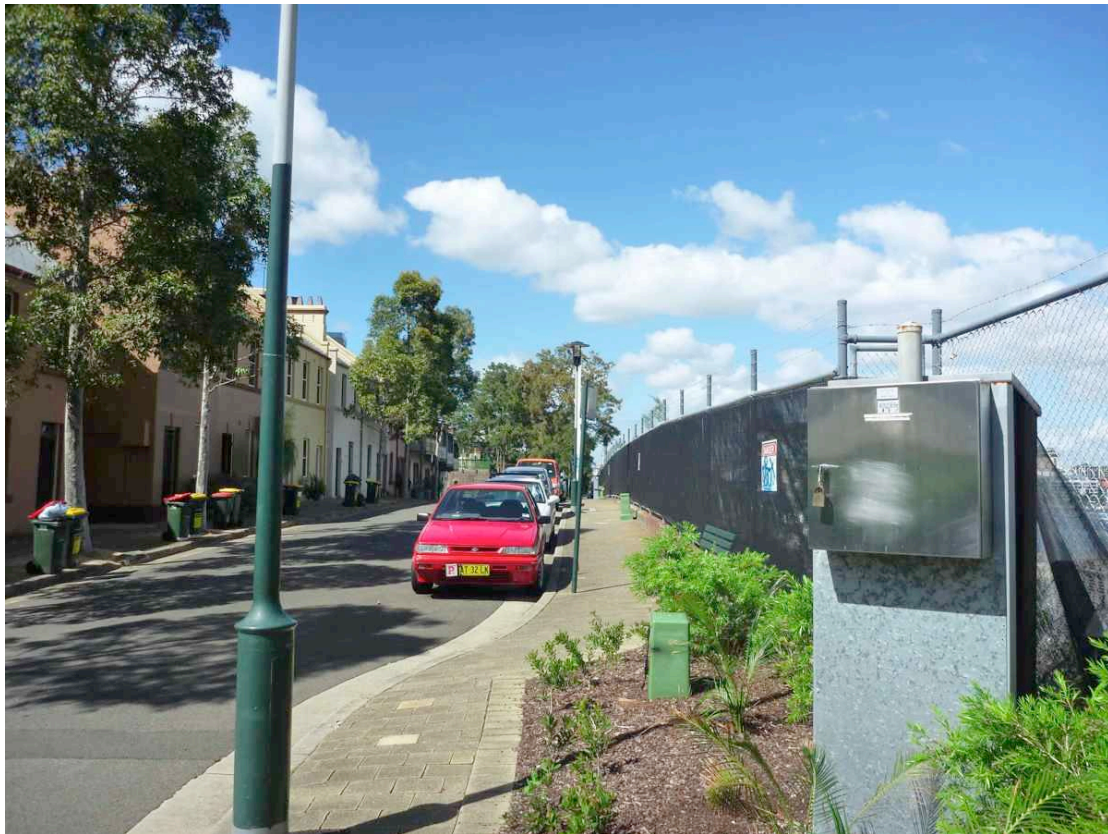
To the south of the tower entrance at the upper level on Merriman Street are the footpath and entries to former driveways of the houses that were removed when the cliff was cut back (see Figure 4.7).

**Figure 4.7. View along west side of Merriman Street to south showing footpath and remnant driveway access points. (Photo Austral Archaeology Pty Ltd, March 2013)**

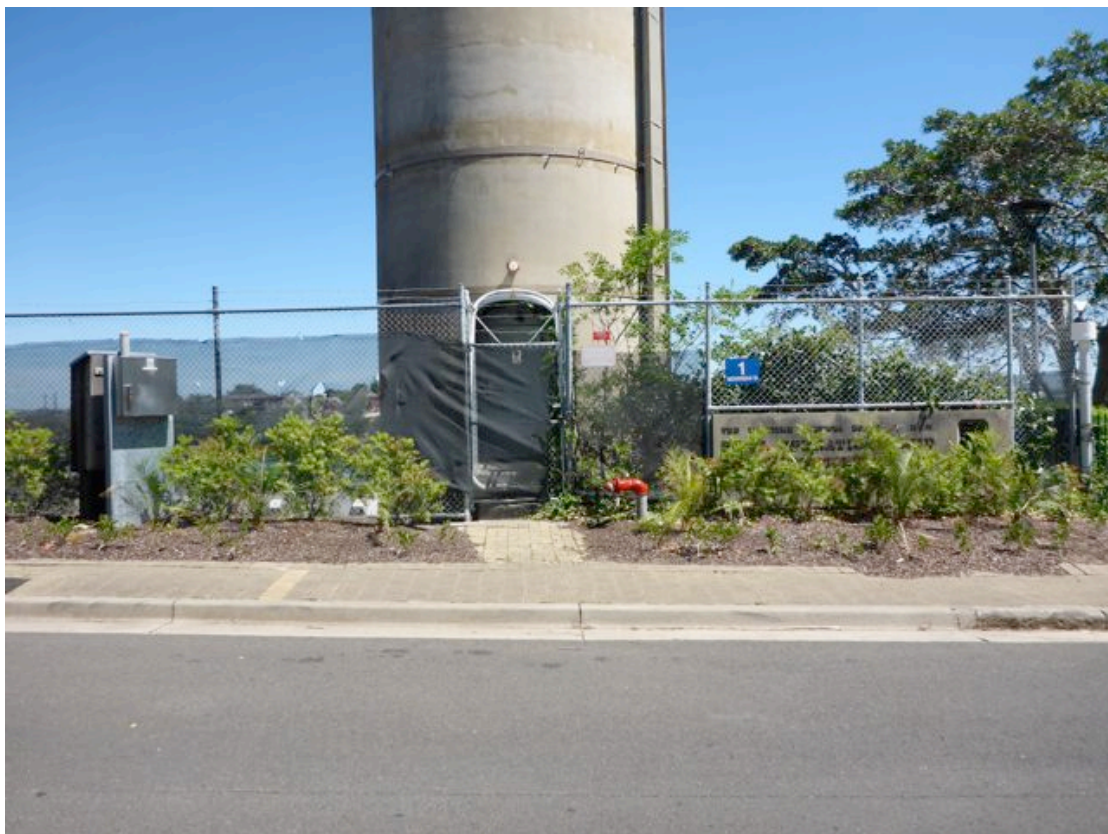
The tower entrance (see Figure 4.8) is located on the west side of Merriman Street. To the north of the tower entrance at the upper level on Merriman Street is a cul-de-sac and the entry to Clyne Reserve (see Figures 4.9 – 4.10). Clyne Reserve is a relatively modern construct and was built over the remains of a number of historic domestic buildings including Victoria Cottage, Dalgety Terrace, Merrimans Terrace and the outbuildings and stables associated with Moorecliff and Victoria Cottage (see Figure 4.11).

**Figure 4.8. Merriman Street entrance to HCT viewed to the west. (Photo Austral Archaeology Pty Ltd, October 2013)**

- if there are to be below-ground impacts around the HCT entrance on the Merriman Street level, the works be subject to monitoring by a suitably qualified archaeologist.

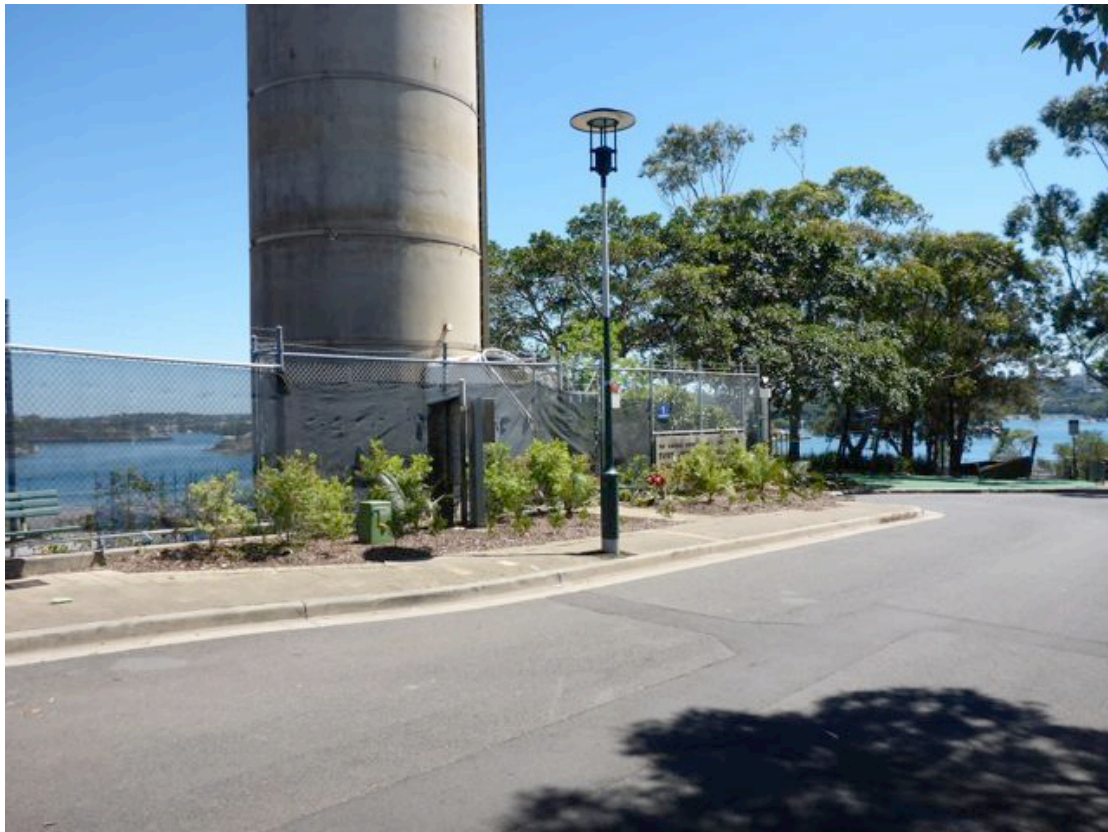
**Figure 4.9. Merriman Street entrance to HCT viewed to the northwest. (Photo Austral Archaeology Pty Ltd, October 2013)**

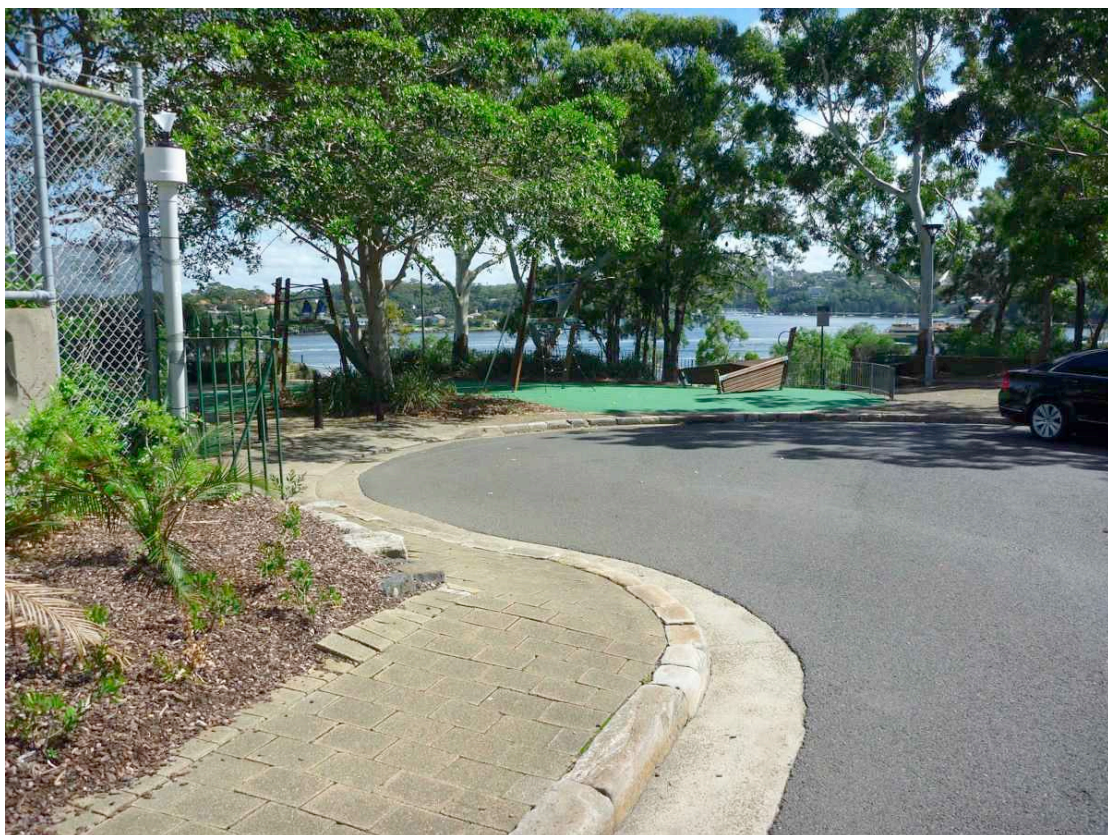
**Figure 4.10. View along west side of Merriman Street to north showing footpath and cul-de-sac. (Photo Austral Archaeology Pty Ltd, March 2013)**

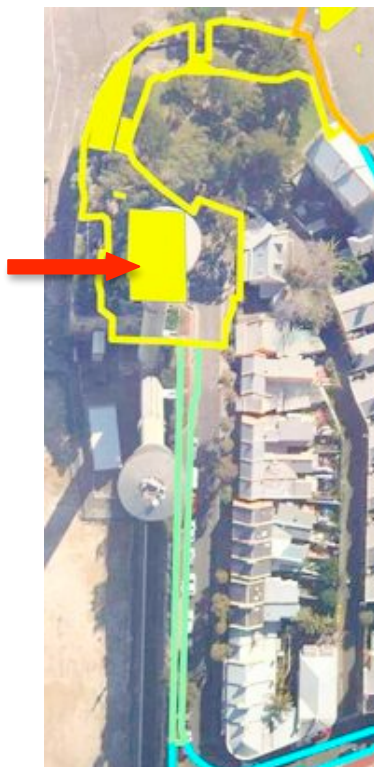
The footpath along the west side of Merriman Street to the south of the tower entrance was assessed in detail as Area C in the report (Austral May 2013b) and predicted to have no archaeological potential (Figure 4.4).

Clyne Reserve was assessed in detail as Area B in that report (Austral Archaeology 2013b). Amongst other things it was predicted to have potential to contain archaeological relics from the mid 19<sup>th</sup> century related to a group of three terraces (Merriman's Terraces). These were located in Merriman Street and it is predicted that any remains would lie to the west of the cul-de-sac, just to the north of the tower. Archaeological monitoring of any below-ground works was recommended for this area (Figure 4.4).

Figure 4.11. Excerpt from Fig 7.1 of the *Integration Concept Barangaroo NSW, Archaeological Assessment, SOHI and Research Design View* (Austral Archaeology 2013b:68) showing area of potential as a yellow rectangle (red arrow) where Merriman Terraces were located to immediate north of the HCT. The area outlined in green along the west side of Merriman Street (the footpath) was assessed to have no archaeological potential.
