**Liverpool State Heritage Inventory.**  
 SHI Number: **1970461**  
 Study Number: **1970461**

**Item Name: South Western Sydney Area Health Service**  
**Location: 1 Campbell Street, Liverpool**

APPENDIX C I CAMPBELL STREET  
SURVEY

**SURVEY OF 1 CAMPBELL STREET**

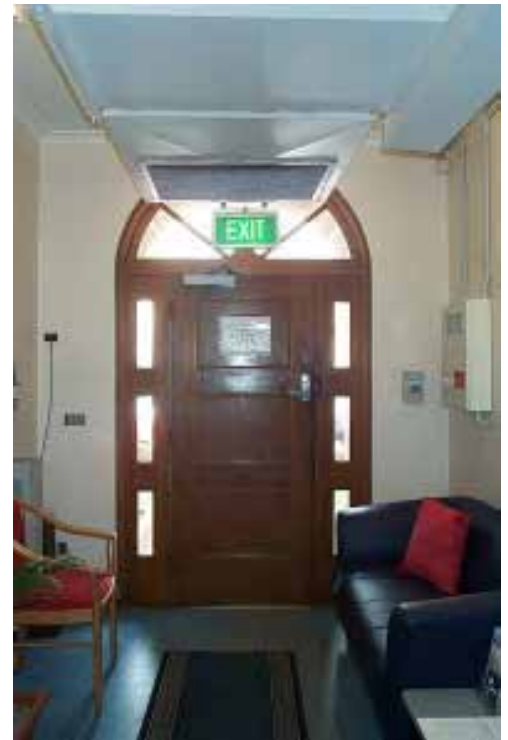
Figure C1: Image of the entry hall and front door. Note the air-conditioning duct. OCP 2006

The entry hall and rooms generally have cement rendered walls with non original covered cornice and plasterboard ceilings (Figure C1). There are air-conditioning floor vents (Figure C3), and a small basement level.

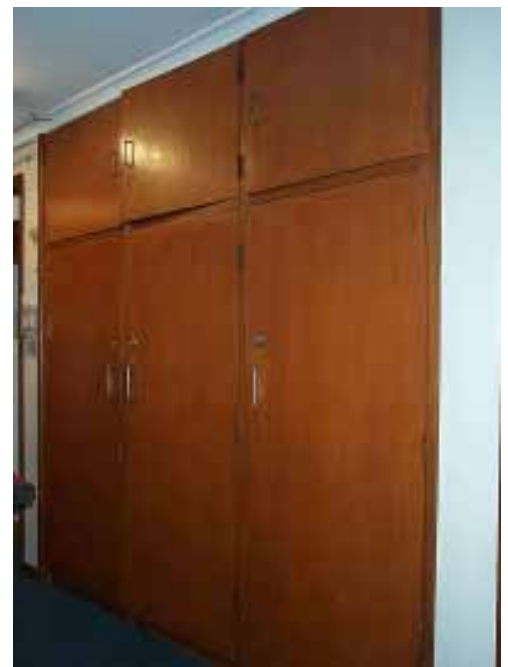
Figure C2: Detail of the Hall cupboards. Note the plaster cornice and the door handles. OCP 2006

The 1950s style doors (interior) are solid core, flush plywood stained, with stained Tasmanian Oak reveals and architraves (Figure C2). The kitchen has 1950s style, 150x150 grey blue Johnson wall tiles (Figure C7).

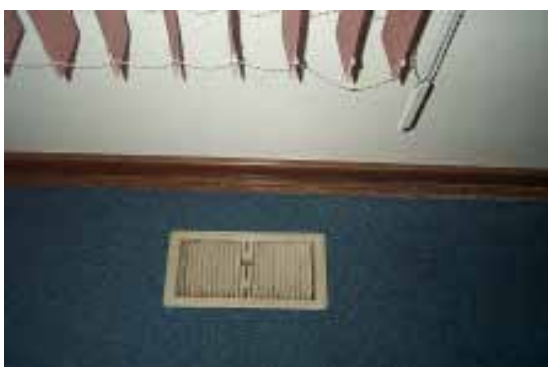
Figure C3: Image of the sub-floor heating vents in the ground floor, south east room. OCP 2006

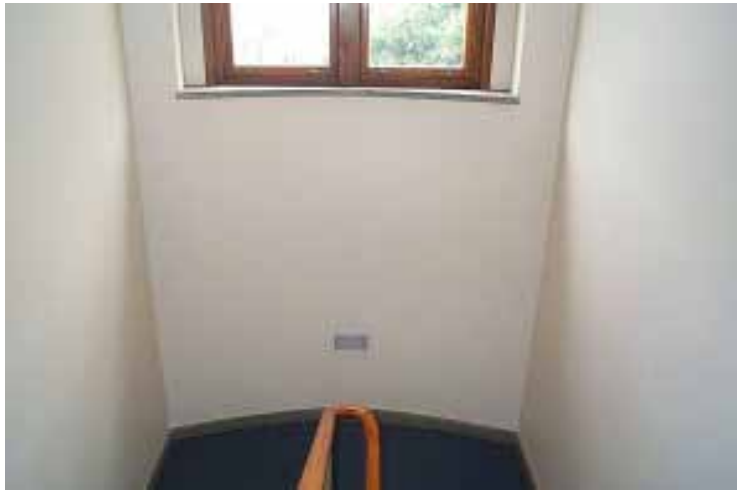
Figure C4: Image of the stair mid-landing. Note the curved wall and curved terrazzo window sill. OCP 2006

The stairwell has a grey terrazzo stringer with cream treads (Figure C5), and a stained timber handrail on wrought iron balustrade (Figure C6). The external wall to the mid-landing is slightly curved, as is the terrazzo window sill (Figure C4). The windows are 1950s style, timber double hung (Figure C10).

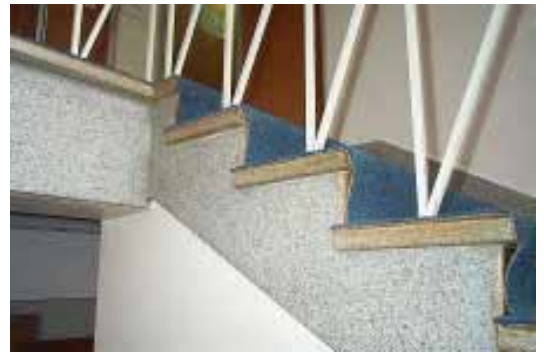
Figure C5: Detail of the stairs. Note the terrazzo stringer and treads, as well as the wrought iron balustrade. OCP 2006

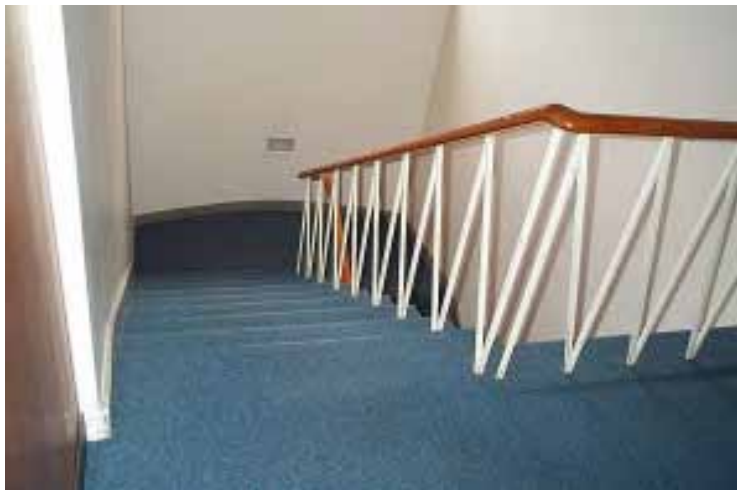
Figure C6: Image of the stairs from the first floor level. Note the timber handrail to the wrought iron balustrade. OCP 2006

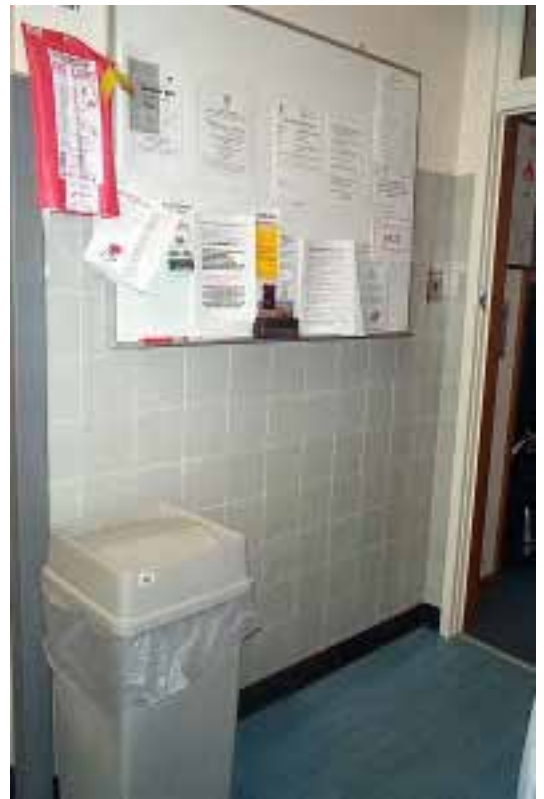
Figure C7: Original kitchen wall tile. OCP 2006

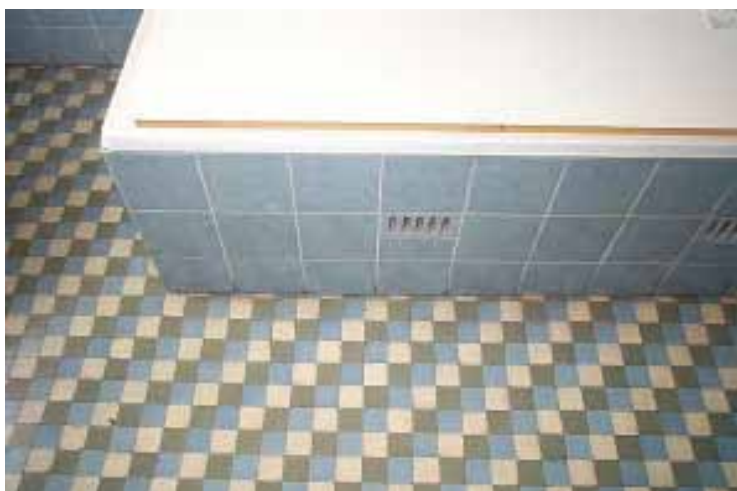
Figure C8: Original bathroom floor tiles. OCP 2006

The bathrooms have 150x150 grey blue Johnson wall tiles with chequerboard floor tiles (Figure C8).

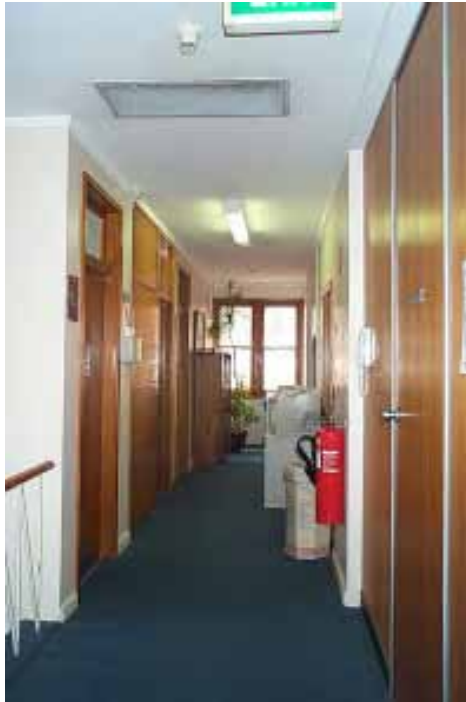
Figure C10: Image of the first floor hall, looking west. Note the timber finishes to the joinery and the double hung windows at the end of the hall. OCP 2006

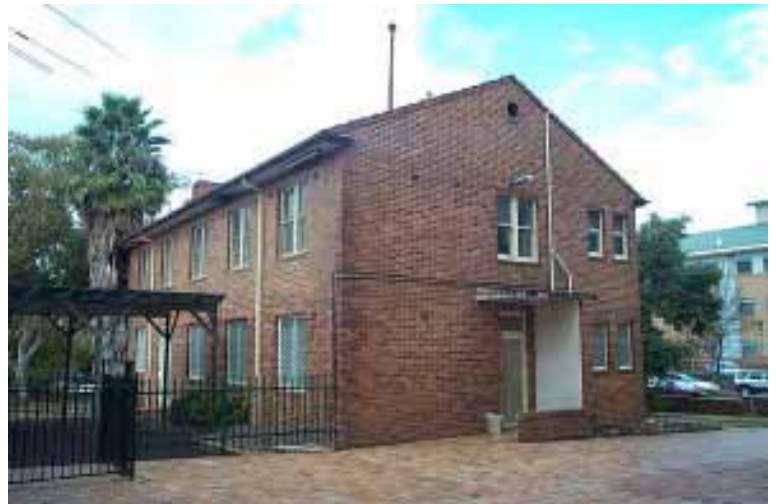
Figure C9: Image from the north west Note the side door entry canopy and the circular gable vent. OCP 2006

The West Elevation has a simple concrete slab awning supported on a single skin brick blade wall (Figure C9). Each gable end has a circular vent (Figures C9 & C12). The East Elevation has a chimney stack off centre (Figure C12).

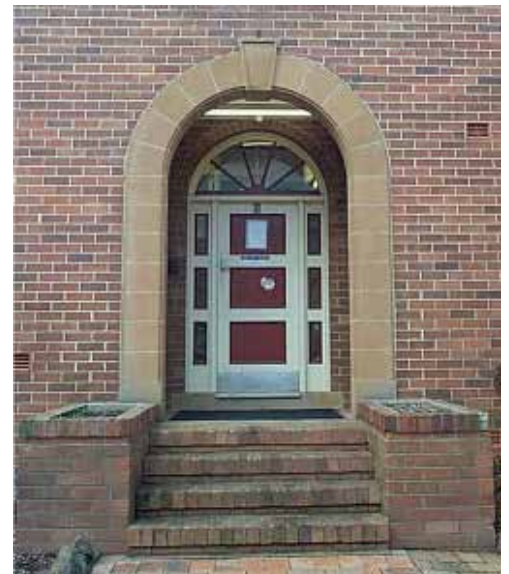
Figure C11: Image of the front door entry portico with sandstone surround. OCP 2006

The entry portico has a sandstone arch surround with keystone (Figure C11). The Georgian Revival front door, with three panelled bolection moulding, has a fanlight and side lights. The stone threshold has a terrazzo inlay step to the door opening, indicating reuse (Figure C13).

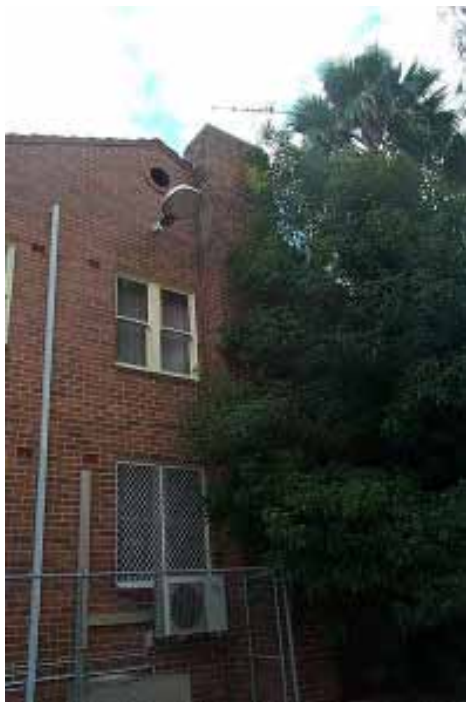
Figure C12: Image of the East Elevation with the chimney stack. OCP 2006

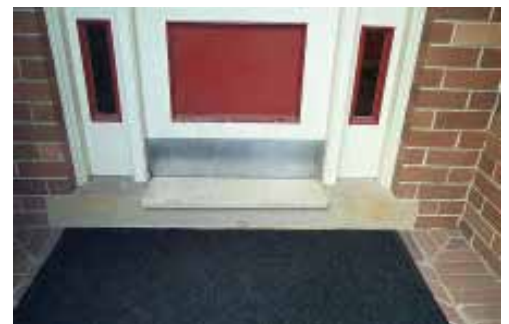
Figure C13: Image of the entry threshold. Note the addition of the terrazzo step into the sandstone block. OCP 2006

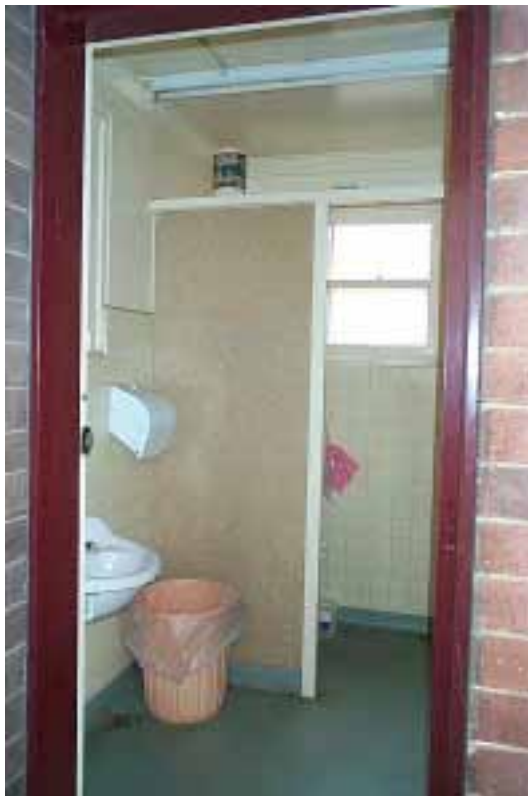
Figure D6: Image of a toilet with original tile and terrazzo finishes and fittings. OCP 2006
