# **SYDNEY FISH MARKET PYRMONT**

## **ASSESSMENT**

### **EUROPEAN ARCHAEOLOGY AND HERITAGE RESOURCES**

**JULY 2010**

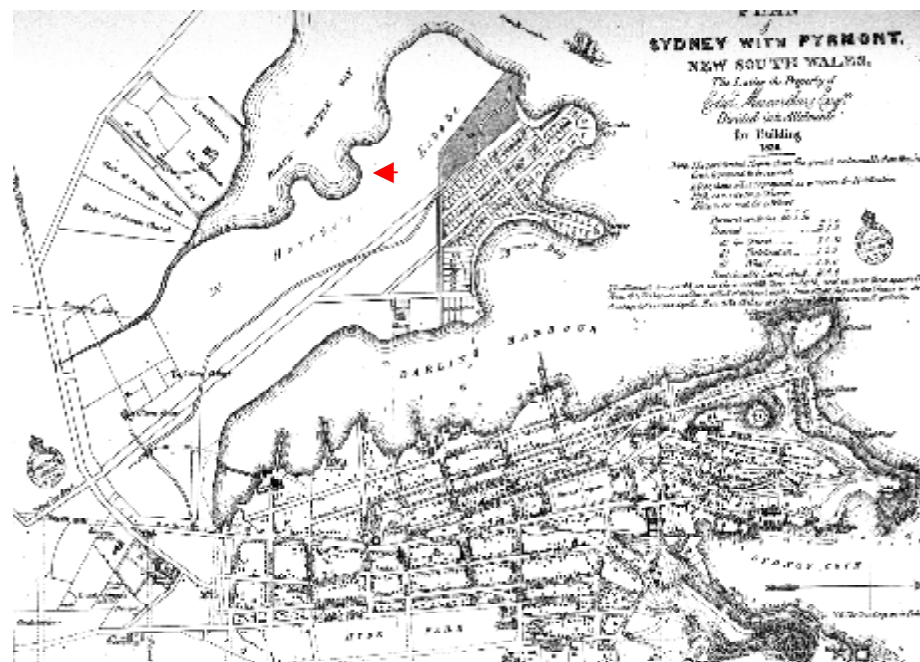
*Plan of the Pyrmont peninsula in 1836 showing the exaggerated shape of the cove now occupied by the fish market (ML Q365/6 Volume 1).*

As the contours of this plan indicate, quite steep sandstone cliffs surrounded the bay. It is likely that at the base of each was a weathered sandstone platform. Archaeological evidence has been recorded of an almost identical in-filled bay on the eastern shore of Darling Harbour. At the base of metres of reclamation fill excavation recorded the water-worn platforms of the original cove as well as what remained of the original sandstone cliff above it<sup>6</sup>.

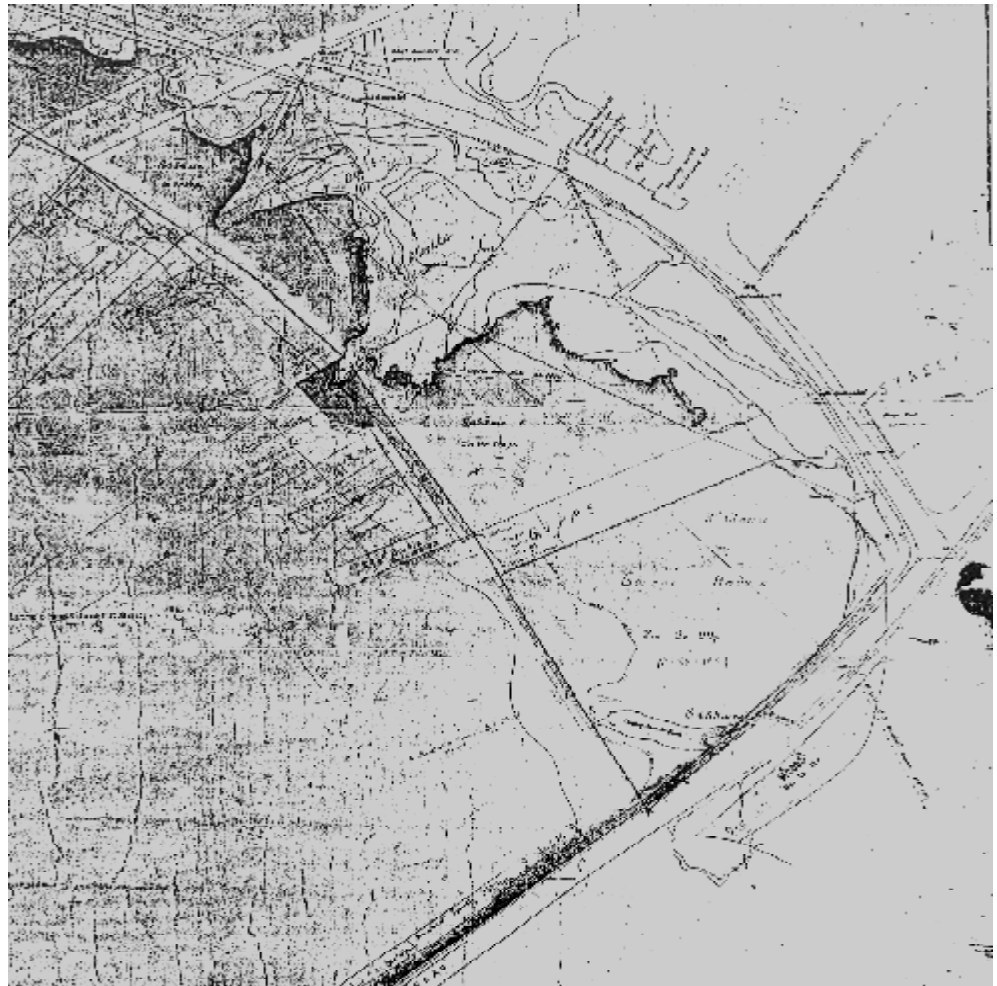
*Detail of Crown Plan 124-574, The Eastern Portion of Blackwattle Bay, showing the bay before it was reclaimed; the high and low water marks are shown and what may have been a small beach at the head of the cove.*

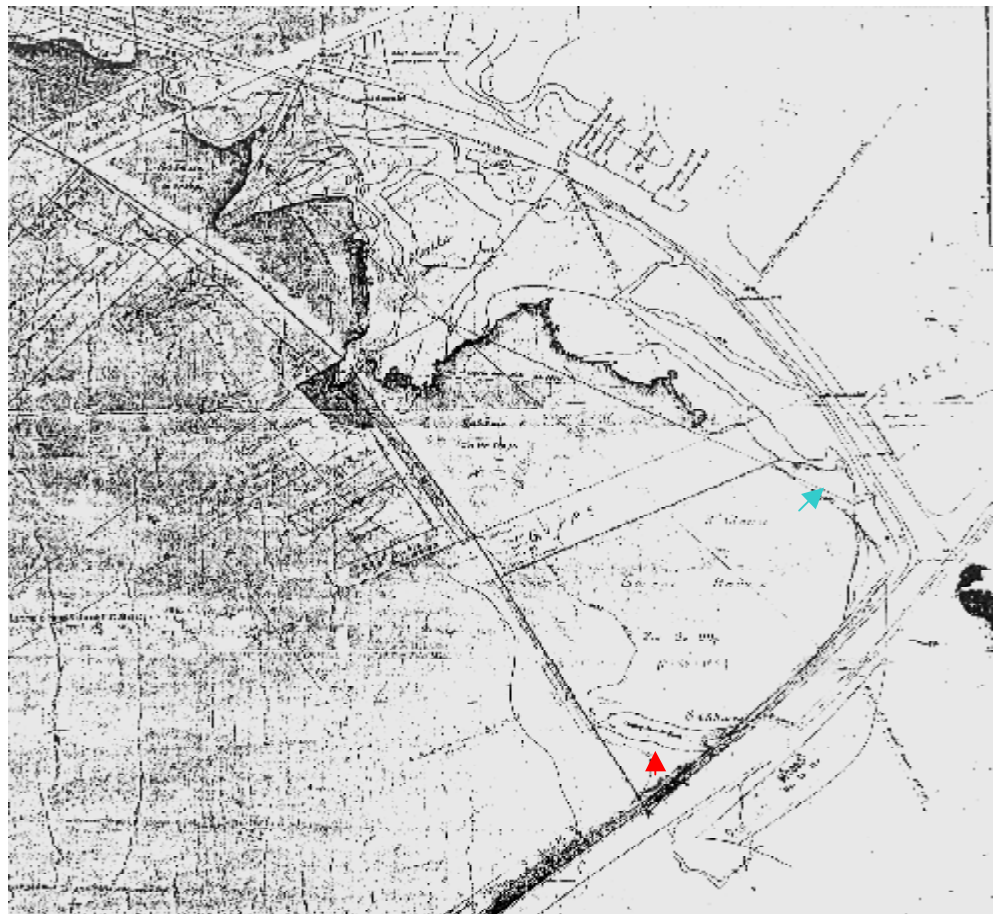
*Detail of Crown Plan 124-574, "The Eastern Portion of Blackwattle Bay", showing the "landing place for boats" (red arrow) and the small beach contained behind a stone wall (blue arrow).*

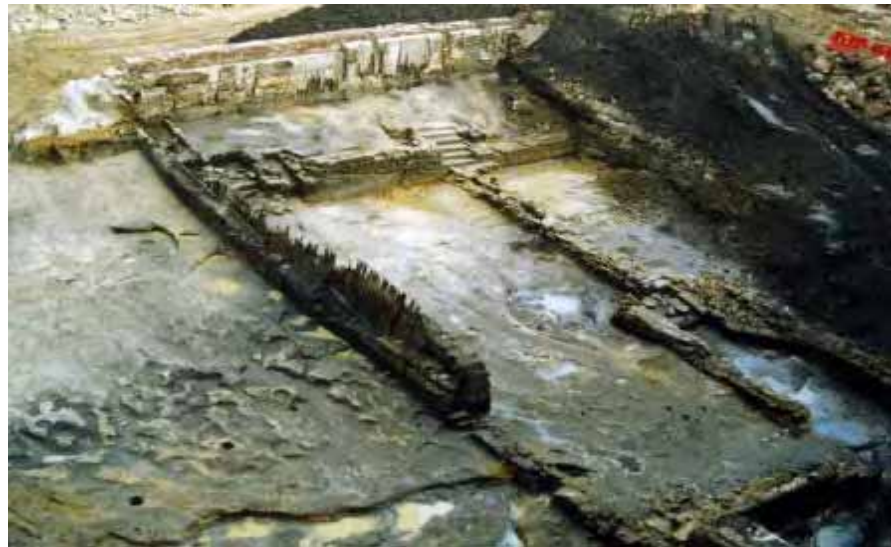
*View during excavation of the KENS site of the 1818 boat dock on a small cove on the eastern side of Darling Harbour recorded six metres below reclamation fill adjoining Sussex Street (W. Thorp)*

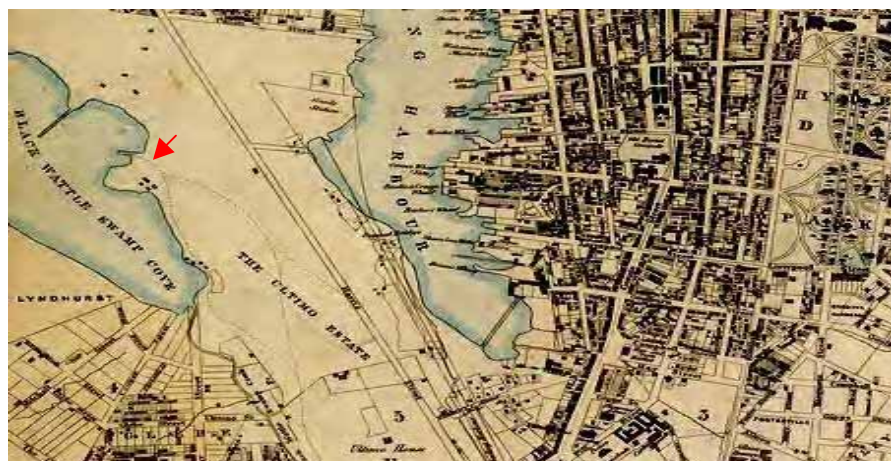
*Detail of Woolcott and Clarke's map of Sydney in 1854 showing the jetty on the southern side of the cove with tracks leading from it to the southern part of the estate (ML M2 811. 17/1854/1)*

Some corroborating evidence for this conclusion is provided by the 1854 survey of the town and its environs. This shows a small jetty or wharf on the southern side of the cove with several tracks leading to it from the southern part of the estate. It suggests that the cove did act as an important access point for the family and tenants. Further, it suggests that the earlier landing place had been replaced or upgraded by the mid-nineteenth century.

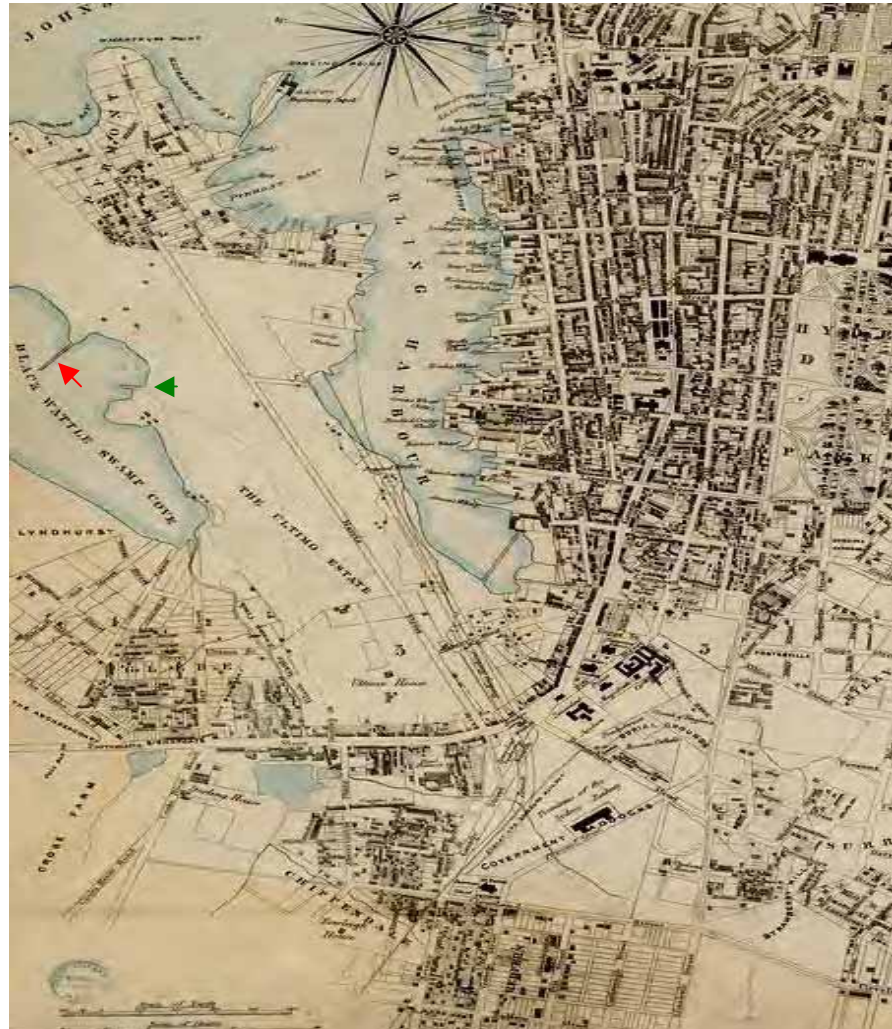
*Detail of Woolcott and Clarke's map of Sydney in 1854 based on Sir Thomas Mitchell's trigonometrical survey of the year before. The red arrow indicates the long jetty from the headland of the study area. The green arrow is the smaller jetty, probably built by the Harris family to service the estate (ML M2 811.17/1854/1).*

The fact that the wharf was in existence in 1854 suggests that it may have been taking stone from some of the earliest quarries on the property established before the family subdivision of the estate, including the small quarry at the northern end of the market site. The wharf was not in existence in 1843 when a town survey of that date shows neither headland to be extended in any way. There are two quarries listed on the peninsula in the 1845 rate assessment<sup>22</sup>. The wharf must have been built in either the later 1840s or the first few years of the 1850s.

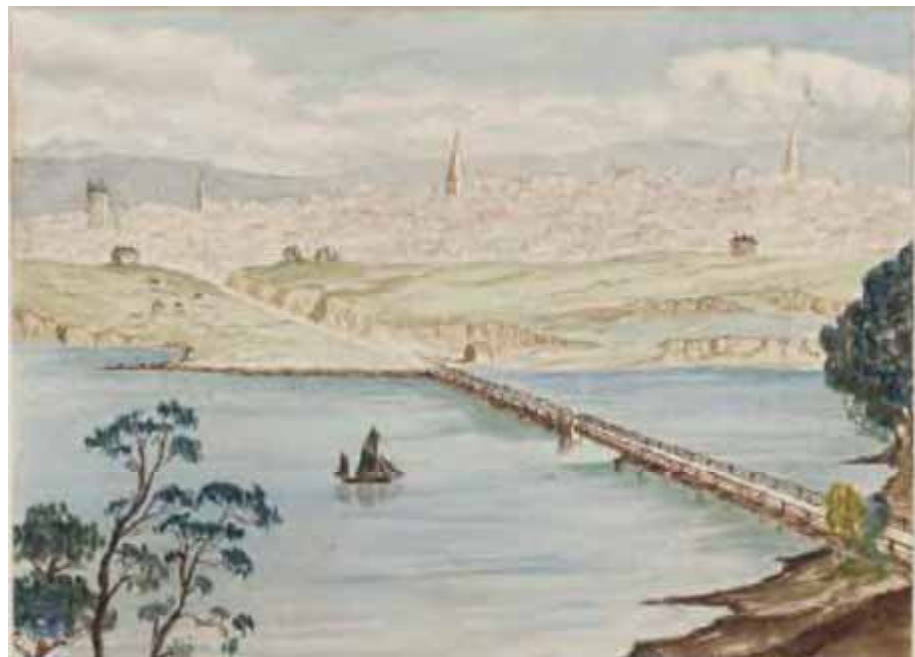
An image of the causeway as it appeared before the reclamation of the head of the bay is shown below. In the foreground is the eastern end of the causeway at the southern end of the market site. The painting demonstrates that the cove still retained some vegetation and much of its original topography. There is no evidence of the small jetty on the southern side of the cove for the estate; this site was out of the artist’s view in this image.

*F. H. Boyer, Sydney From Glebe Point (1870-1873) shows the causeway across the swamp with the market cove site in the foreground (ML SSVI/Bri/Gle/1).*

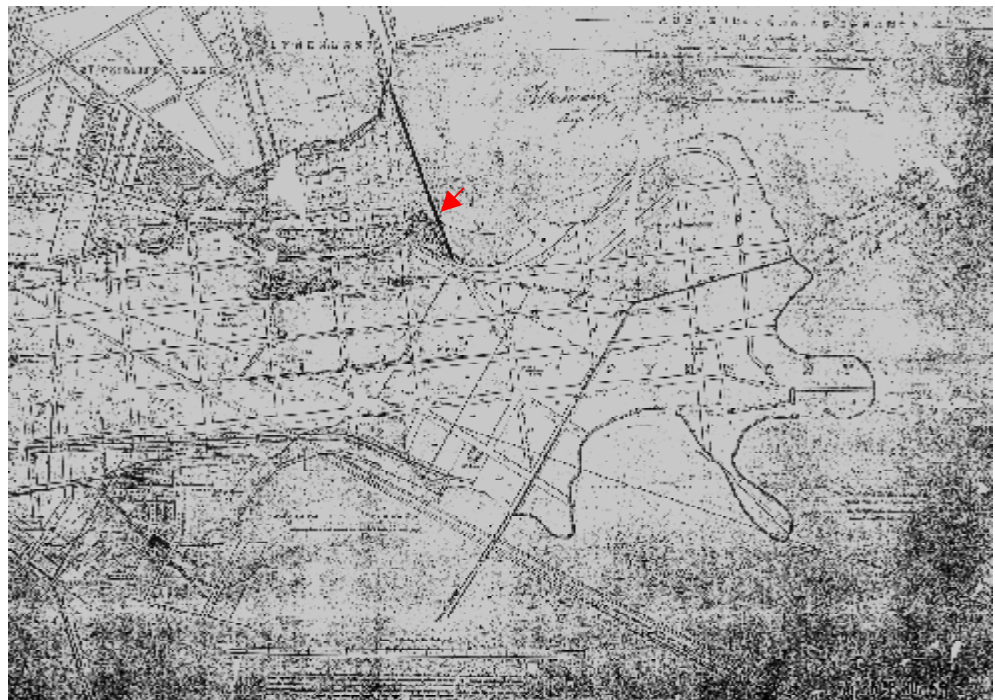
*Plan of the Pyrmont peninsula with the intended area of reclamation nominally subdivided; the black line (red arrow) is the existing causeway entering the small cove (SRO AO Map 59).*

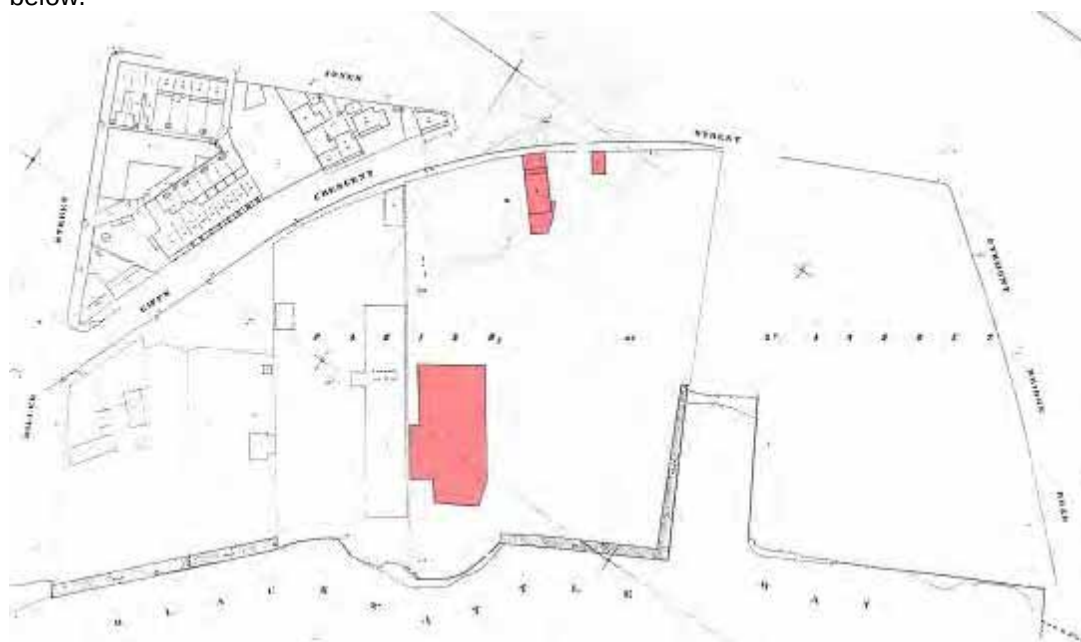
*Detail of 1887 survey with the buildings of Francis Guy coloured red.*

The large building close to the water was constructed from iron; the next largest structure close to the road was a brick building with enclosed yards front and back. The smallest building was made from timber<sup>39</sup>. The property was enclosed by fences to the north and to the east along the road. To the

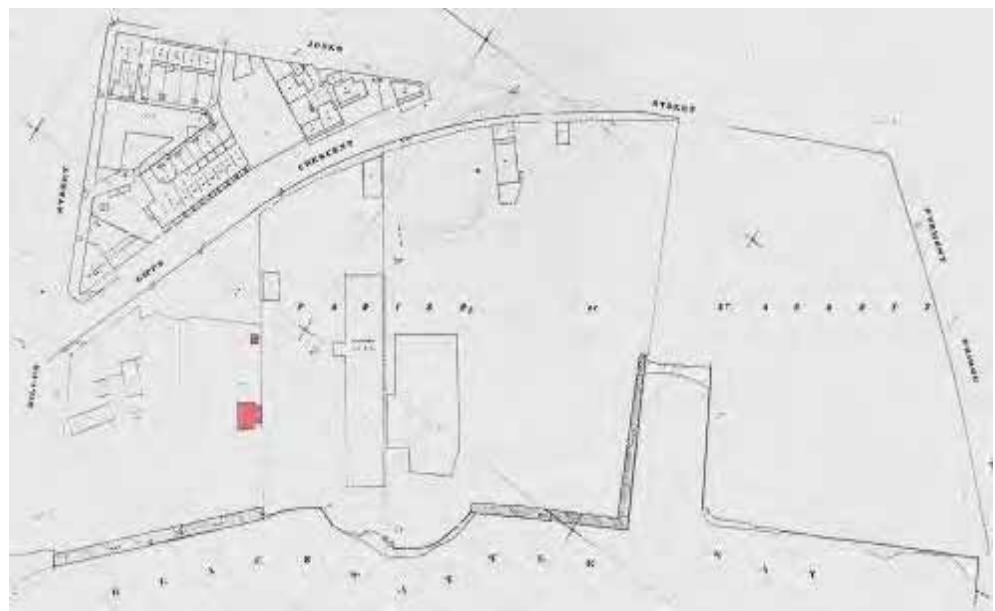
Thomas Davis, a timber merchant was in occupation in 1885 next to the Maze Brothers premises at the northern end of the site<sup>44</sup>. Directory listings also refer to Bowra Wharf in association with this company; this is shown below on the 1887 survey of the site where the buildings associated with the company are highlighted in pink. The encompassed an iron shed, the larger structure, and a small timber building near Gipps Crescent<sup>45</sup>. The site was completely fenced around except at the wharf.

*The yard and buildings of Thomas Davis in 1887  
(Sydney Water, PWD 300-1544).*

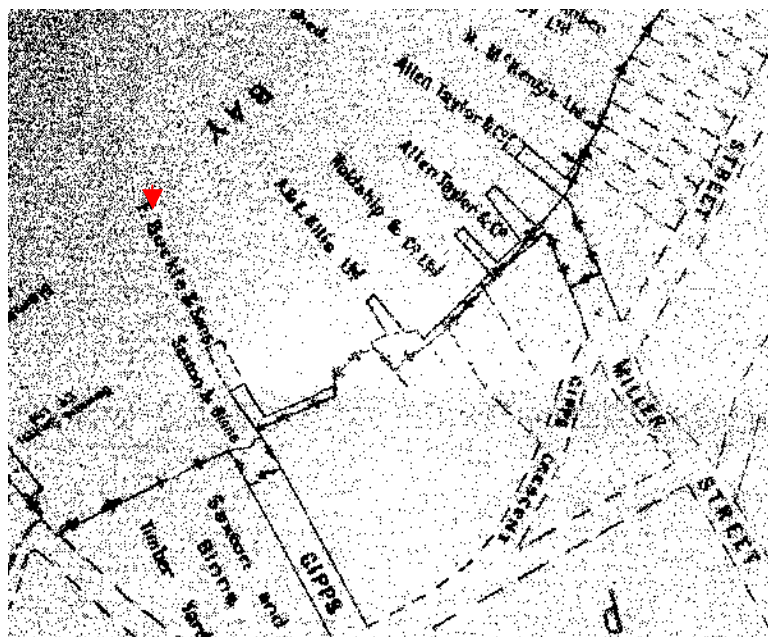
*Position within the site of F. Buckle and Sons in 1908*  
*Sydney Harbour Trust Annual Report 1908*

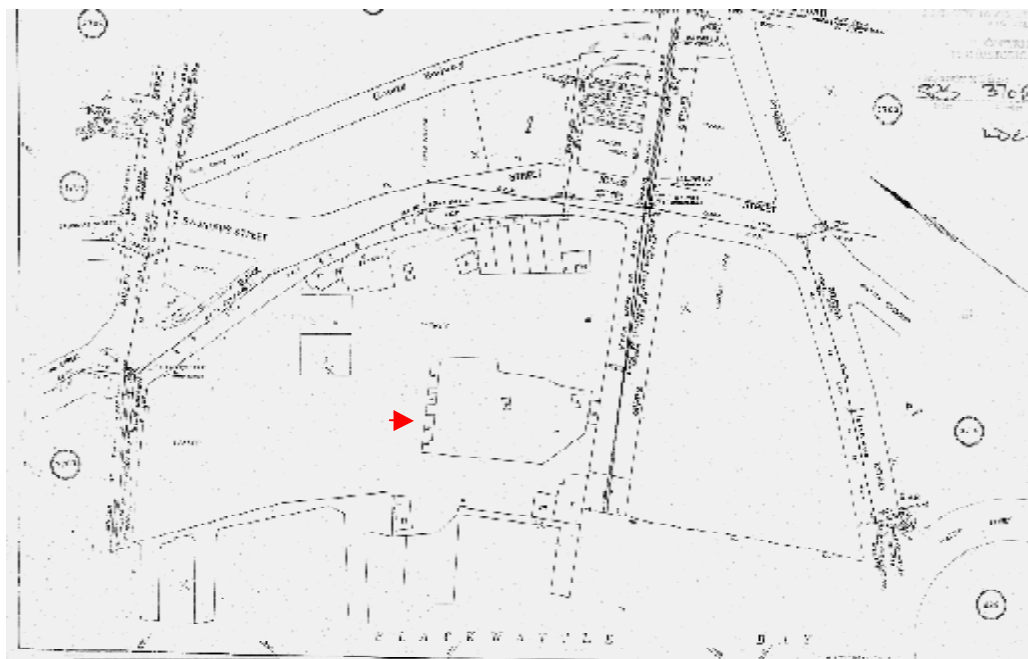
*Survey of the market site in 1968 before the development of the present market hall south of Gipps Street. The principal hall is indicated by an arrow; this was a building constructed for the Shell Company occupation. (Sydney Water, SRS-3798-M/F)*

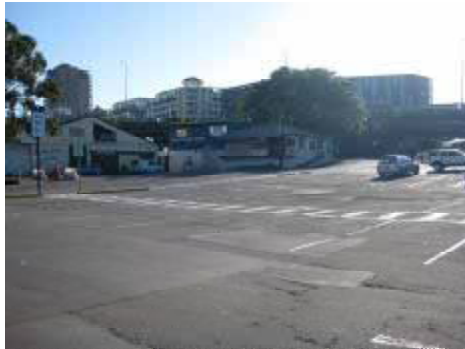
In the north-eastern corner of the site are several service buildings that were constructed as part of the 1964 fish market development (blue arrow below). They comprise a mix of steel frame, concrete and brick structures. There is a retaining wall in this area and a large tree.

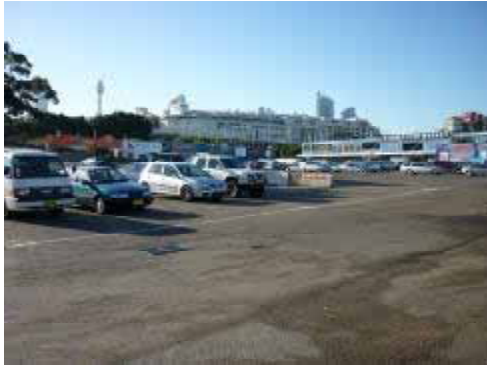
The car park encompasses the majority of the site north of the former line of Gipps Street. This was the site of the original fish market hall in 1964, a former Shell company oil store built in the early years of the twentieth century. This building can be seen in the detail of the 1943 aerial view shown below (red arrow). Discussion of its archaeological potential is contained in Section 4.3.2.

The car park is paved with asphaltic concrete that is in relatively poor condition. It is cracked and in places slumped, pot-holed and mended. It is likely that some of the slumping is due to underground features such as tanks.

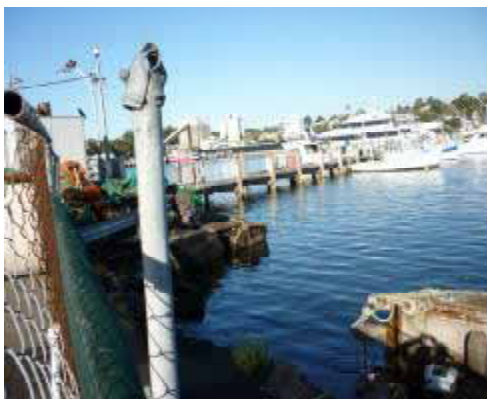
#### 4.1.6 JETTIES

In the original fish market development several of the jetties from the earlier periods of occupation were retained and reused for the new market. These were removed in the 1980s and new jetties were built in their place including one adjacent to the development area.

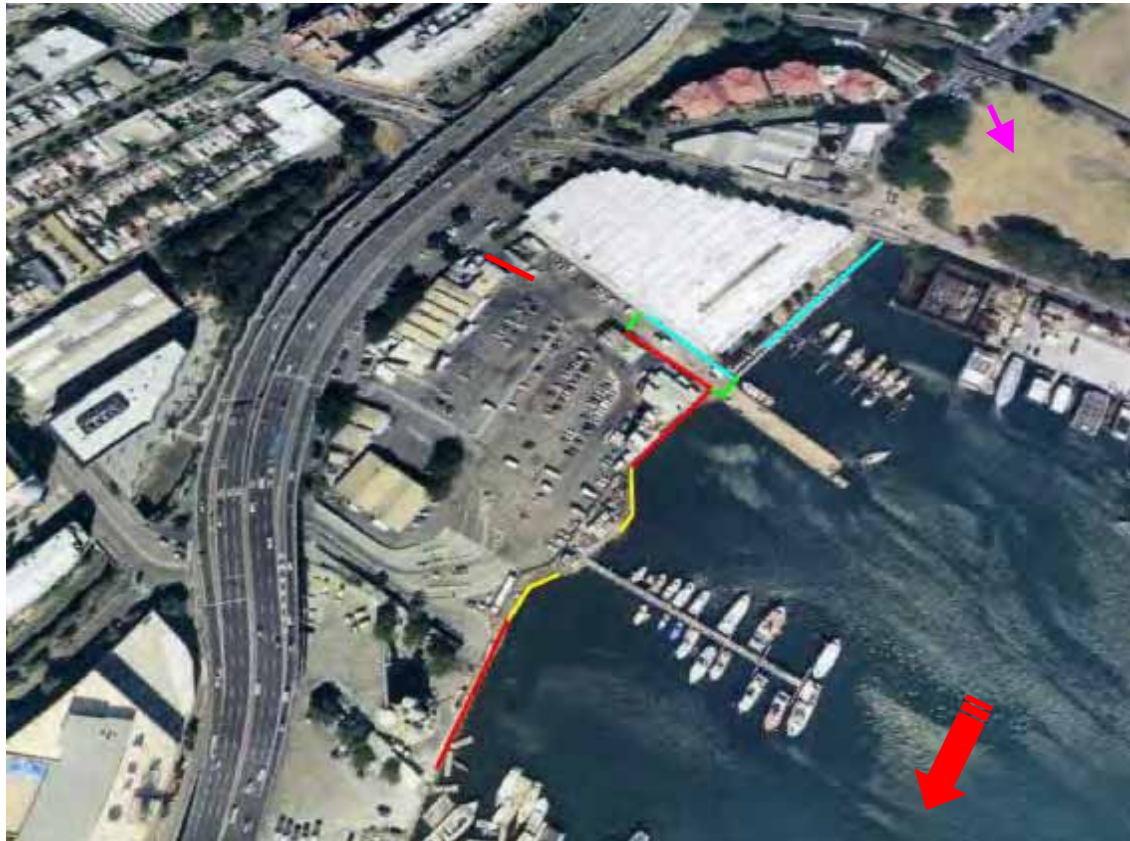
The red lines indicate the area of John Harris's rubble stone walls used in the reclamation of 1882. They appear to have been faced with stone by the latter 1880s.

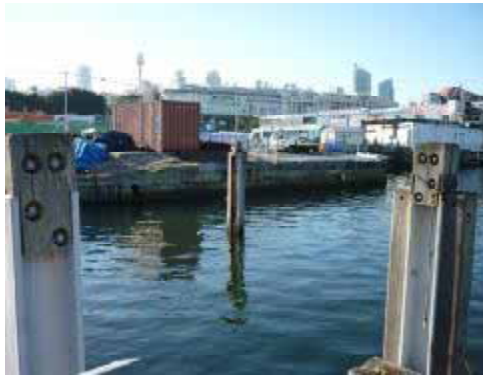
The walls still document these phases of development. The first image to the left shows the stone faced wall that must be enclosing the original rubble wall of John Harris' reclamation on the southern side of his timber-piled section around the northern headland of the cove. The stone facing appears to have been added between 1882 and 1887.

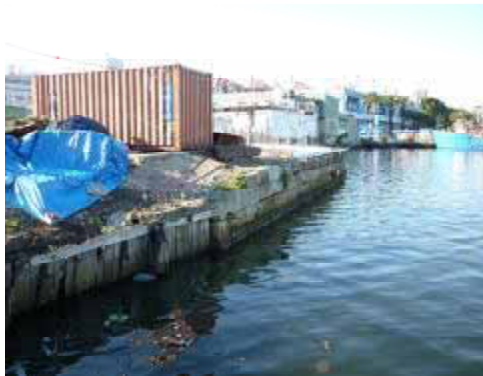
The second image to the left shows the break in the stone wall and a timber-piled section that corresponds with the timber-piling of John Harris' 1882 reclamation around the northern headland "bump"; it is shown in yellow on the preceding page to the south of the existing jetty. The current piling might be a replacement of the original although it does appear to be shown on surveys of 1919<sup>85</sup>.

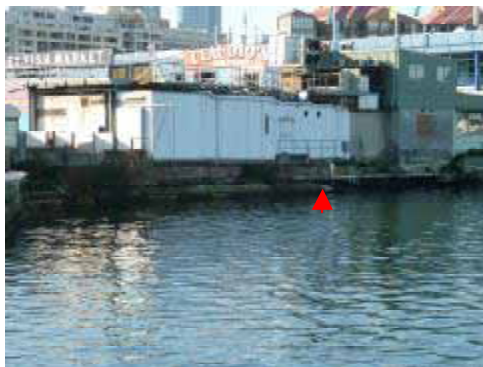
The third image to the left shows the point where Harris' stone wall of the 1880s breaks off, and returns to the east within the reclamation fill, and the rubble of the Gipps Street extension fills in the waterfront from c. 1910.

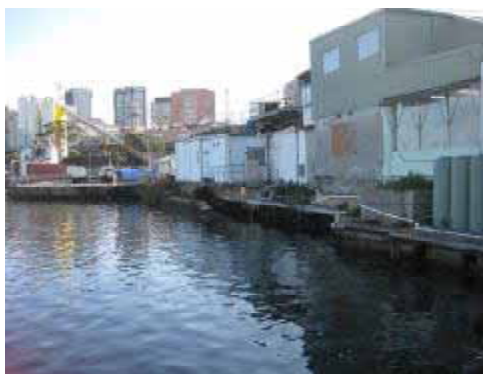
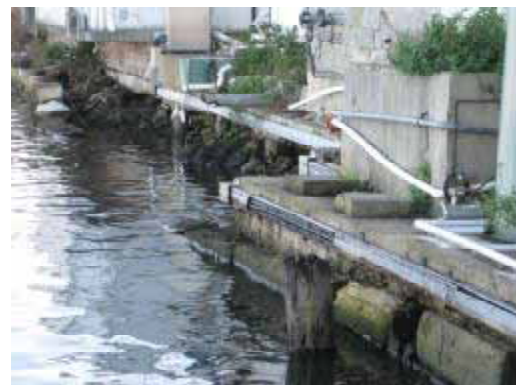
The image below shows that the northern portion of John Harris' reclamation has been more severely impacted by later works. Some components of the stone-walls remain but others have fallen away to reveal the rubble core and cement has been poured in places.

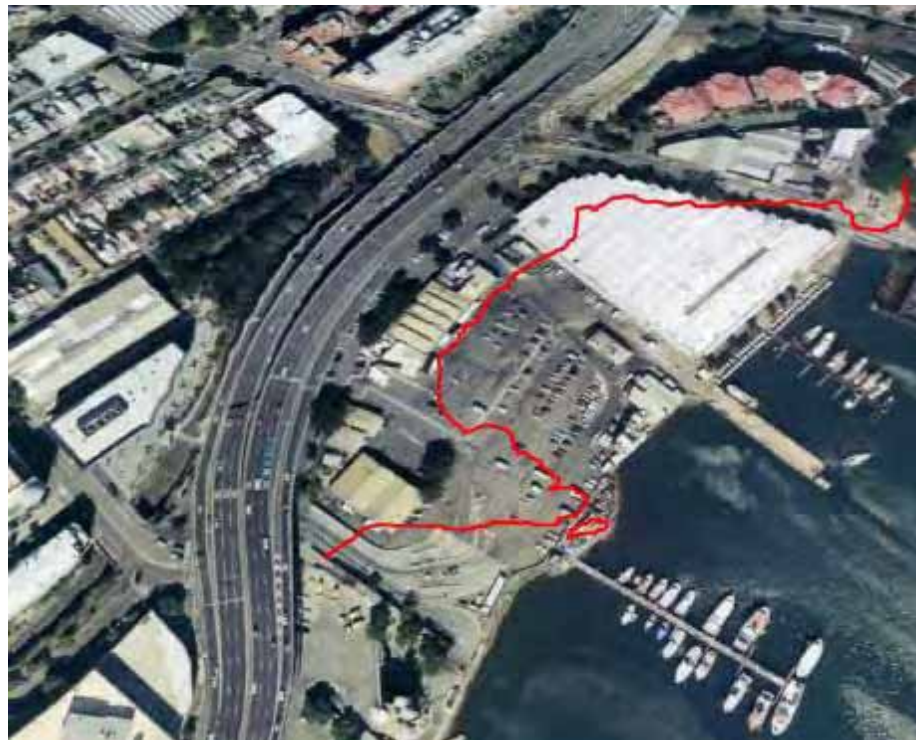
*Approximate line of the bay and headlands*

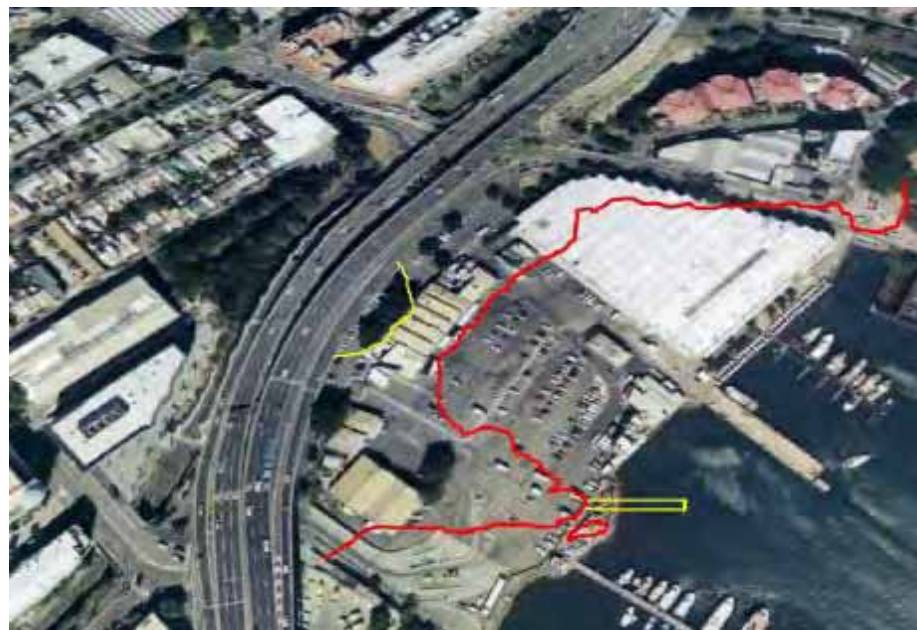
*Approximate area of jetty from 1854 survey and quarry from 1859 subdivision plan*

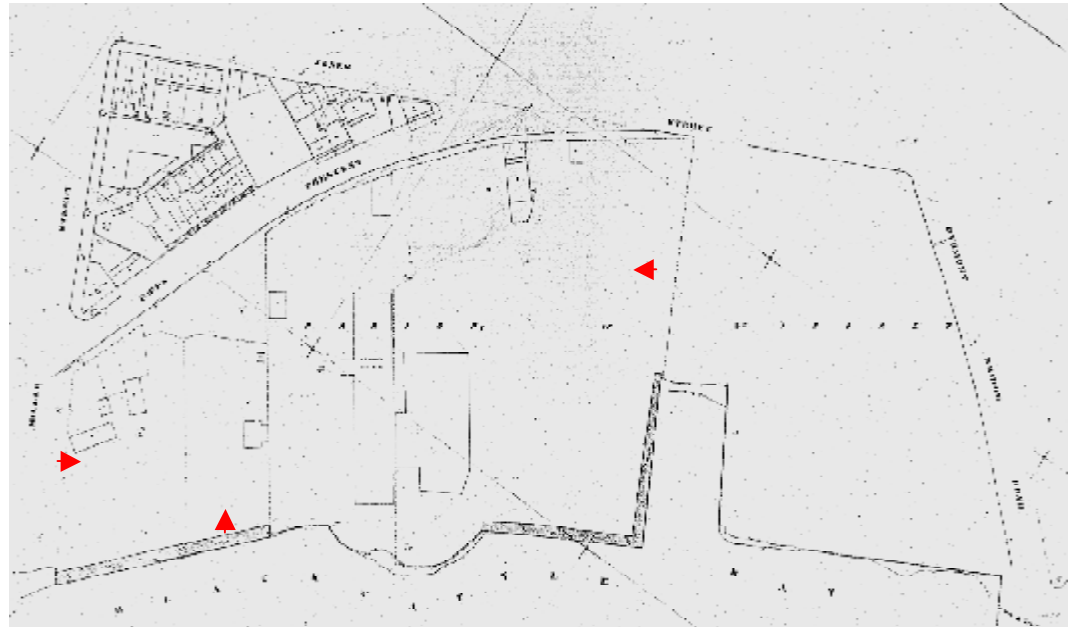
The earliest occupants of the reclaimed bay were companies associated with the timber industry, specifically Francis Guy (1885 – 1898), the Maze Brothers (1885 – 1897), Thomas Davis and Alexander Moir (1885 – 1893) and the Hudsons' company (1892 – 1893). The timber companies succeeded each other in some cases and shared space in others. The principal sites of the premises are shown on the 1887 survey of the site.

The buildings on the site encompassed brick, stone, iron and timber construction. They were all built on and into the reclamation fill. All of these buildings had been removed by 1923 and several apparently before the end of the nineteenth century. It is likely that traces of this first phase of occupation will survive within the site, fragmentary structural evidence and deposits but it is unlikely to have survived substantially intact. The sites have been heavily redeveloped in the twentieth century.

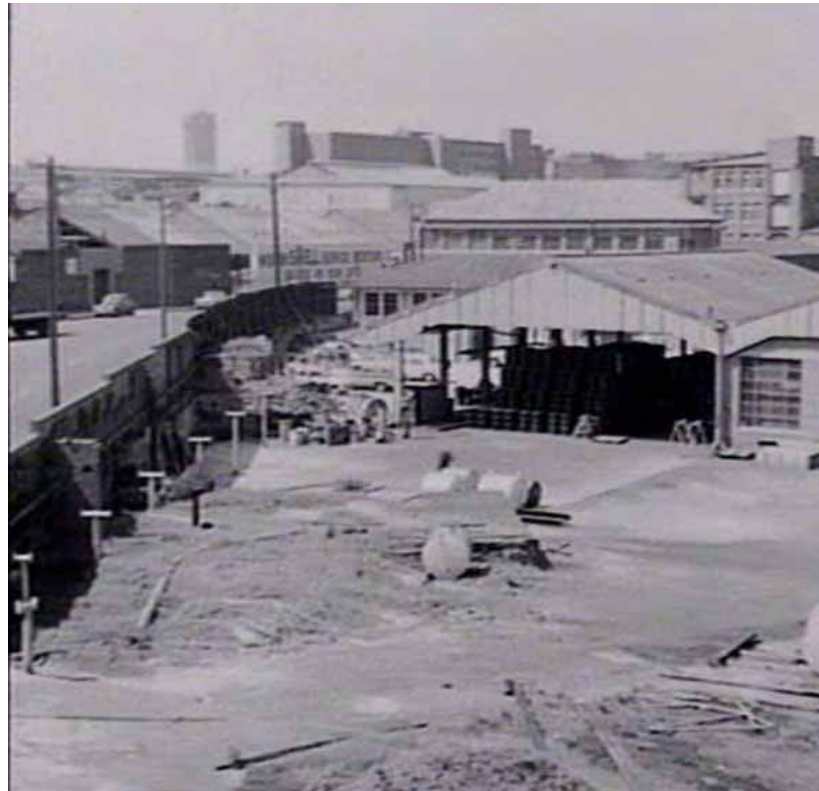
*View of part of the Shell Oil Company site before it was adapted for the new fish market.  
(Sydney City Archives, d2-30747r)*

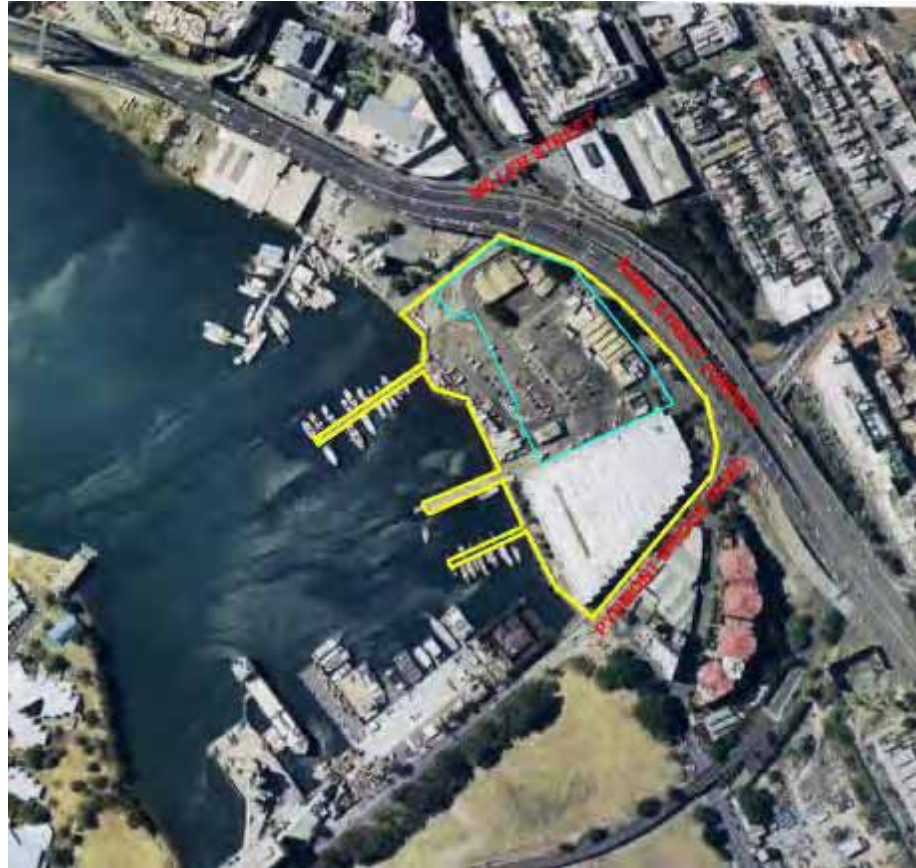
The new development will be located in the northern portion of the fish market site, within the car park and on the sites of several of the small retail and other buildings on the eastern and northern boundary. The blue line in the image below shows the envelope of the development.
