**PRELIMINARY ENVIRONMENTAL SITE  
ASSESSMENT**

**PROPOSED REDEVELOPMENT - WATERFRONT**

**SYDNEY FISH MARKETS, 56-60 PYRMONT BRIDGE  
ROAD, PYRMONT, NSW**

**REF: E24125Krpt**

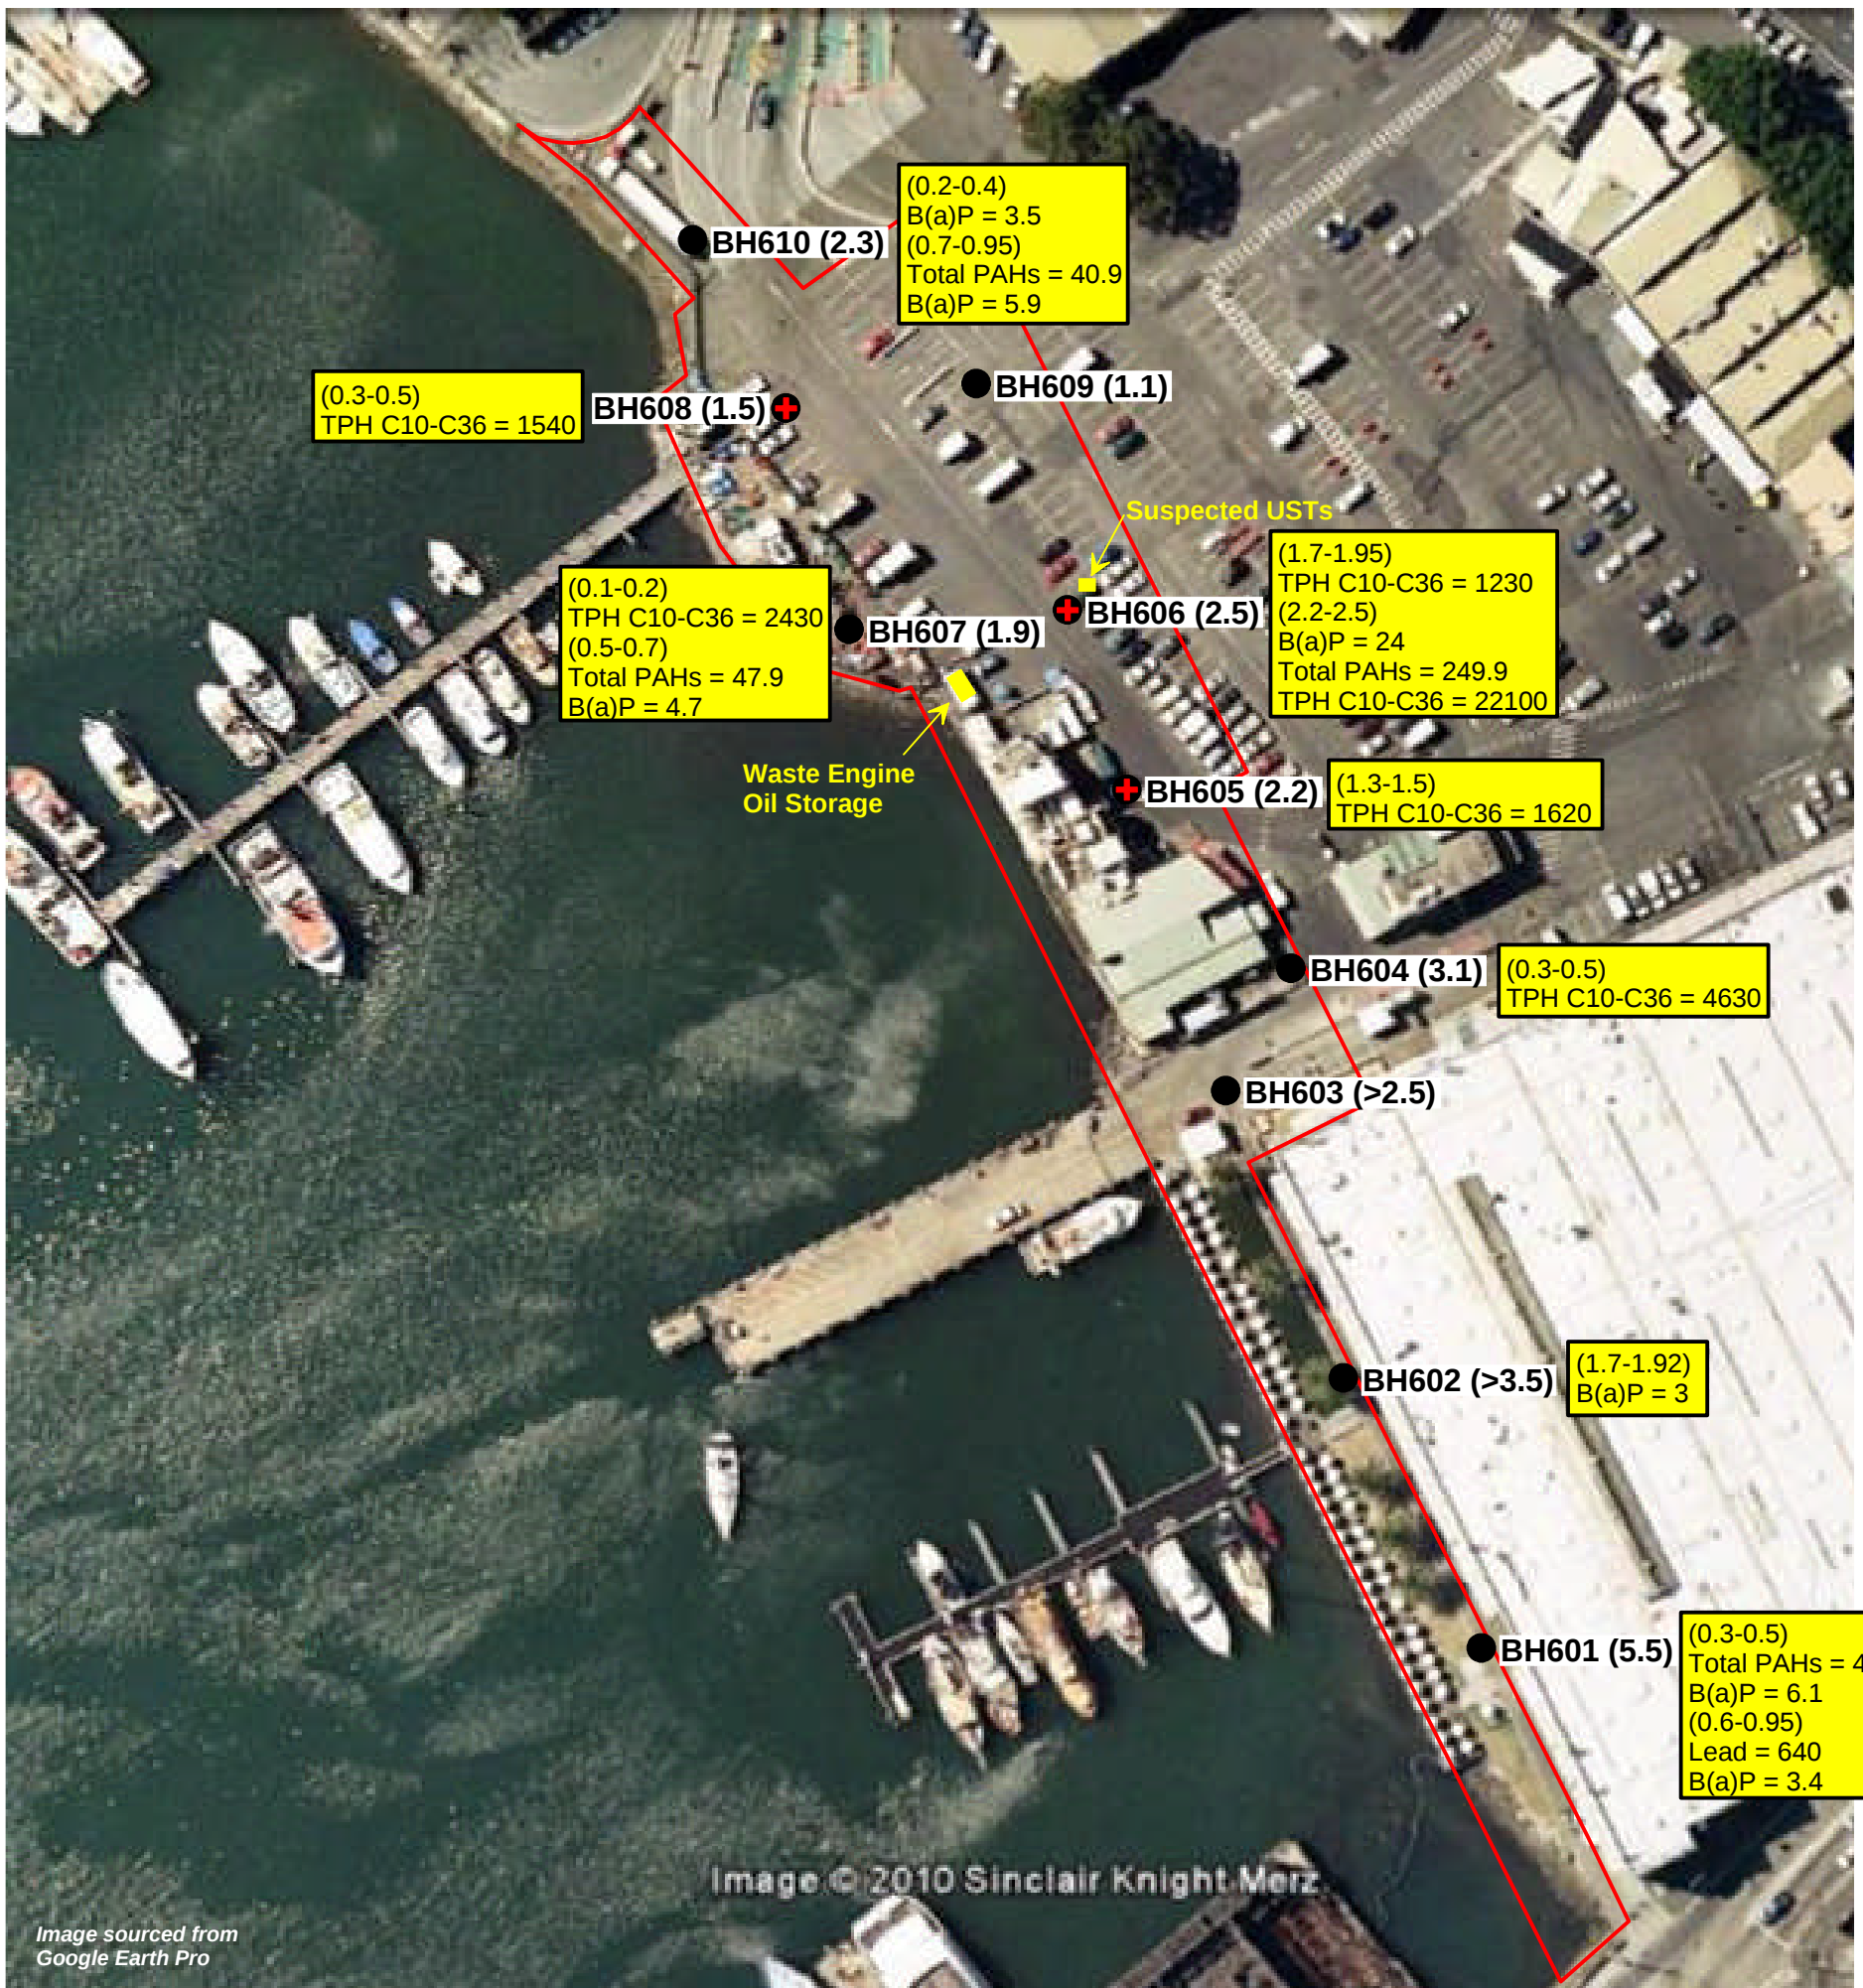
Job No: E24125Krpt  
Figure: 3

- BH601 (5.5) BOREHOLE LOCATION, NUMBER AND DEPTH OF FILL (m)
- + MONITORING WELL LOCATION
- APPROXIMATE SITE BOUNDARY
- (0.3-0.5) B(a)P = 5 TPH = 1000 SAMPLE DEPTH (m) SOIL CONTAMINANT AND CONCENTRATION ABOVE SAC (mg/kg)

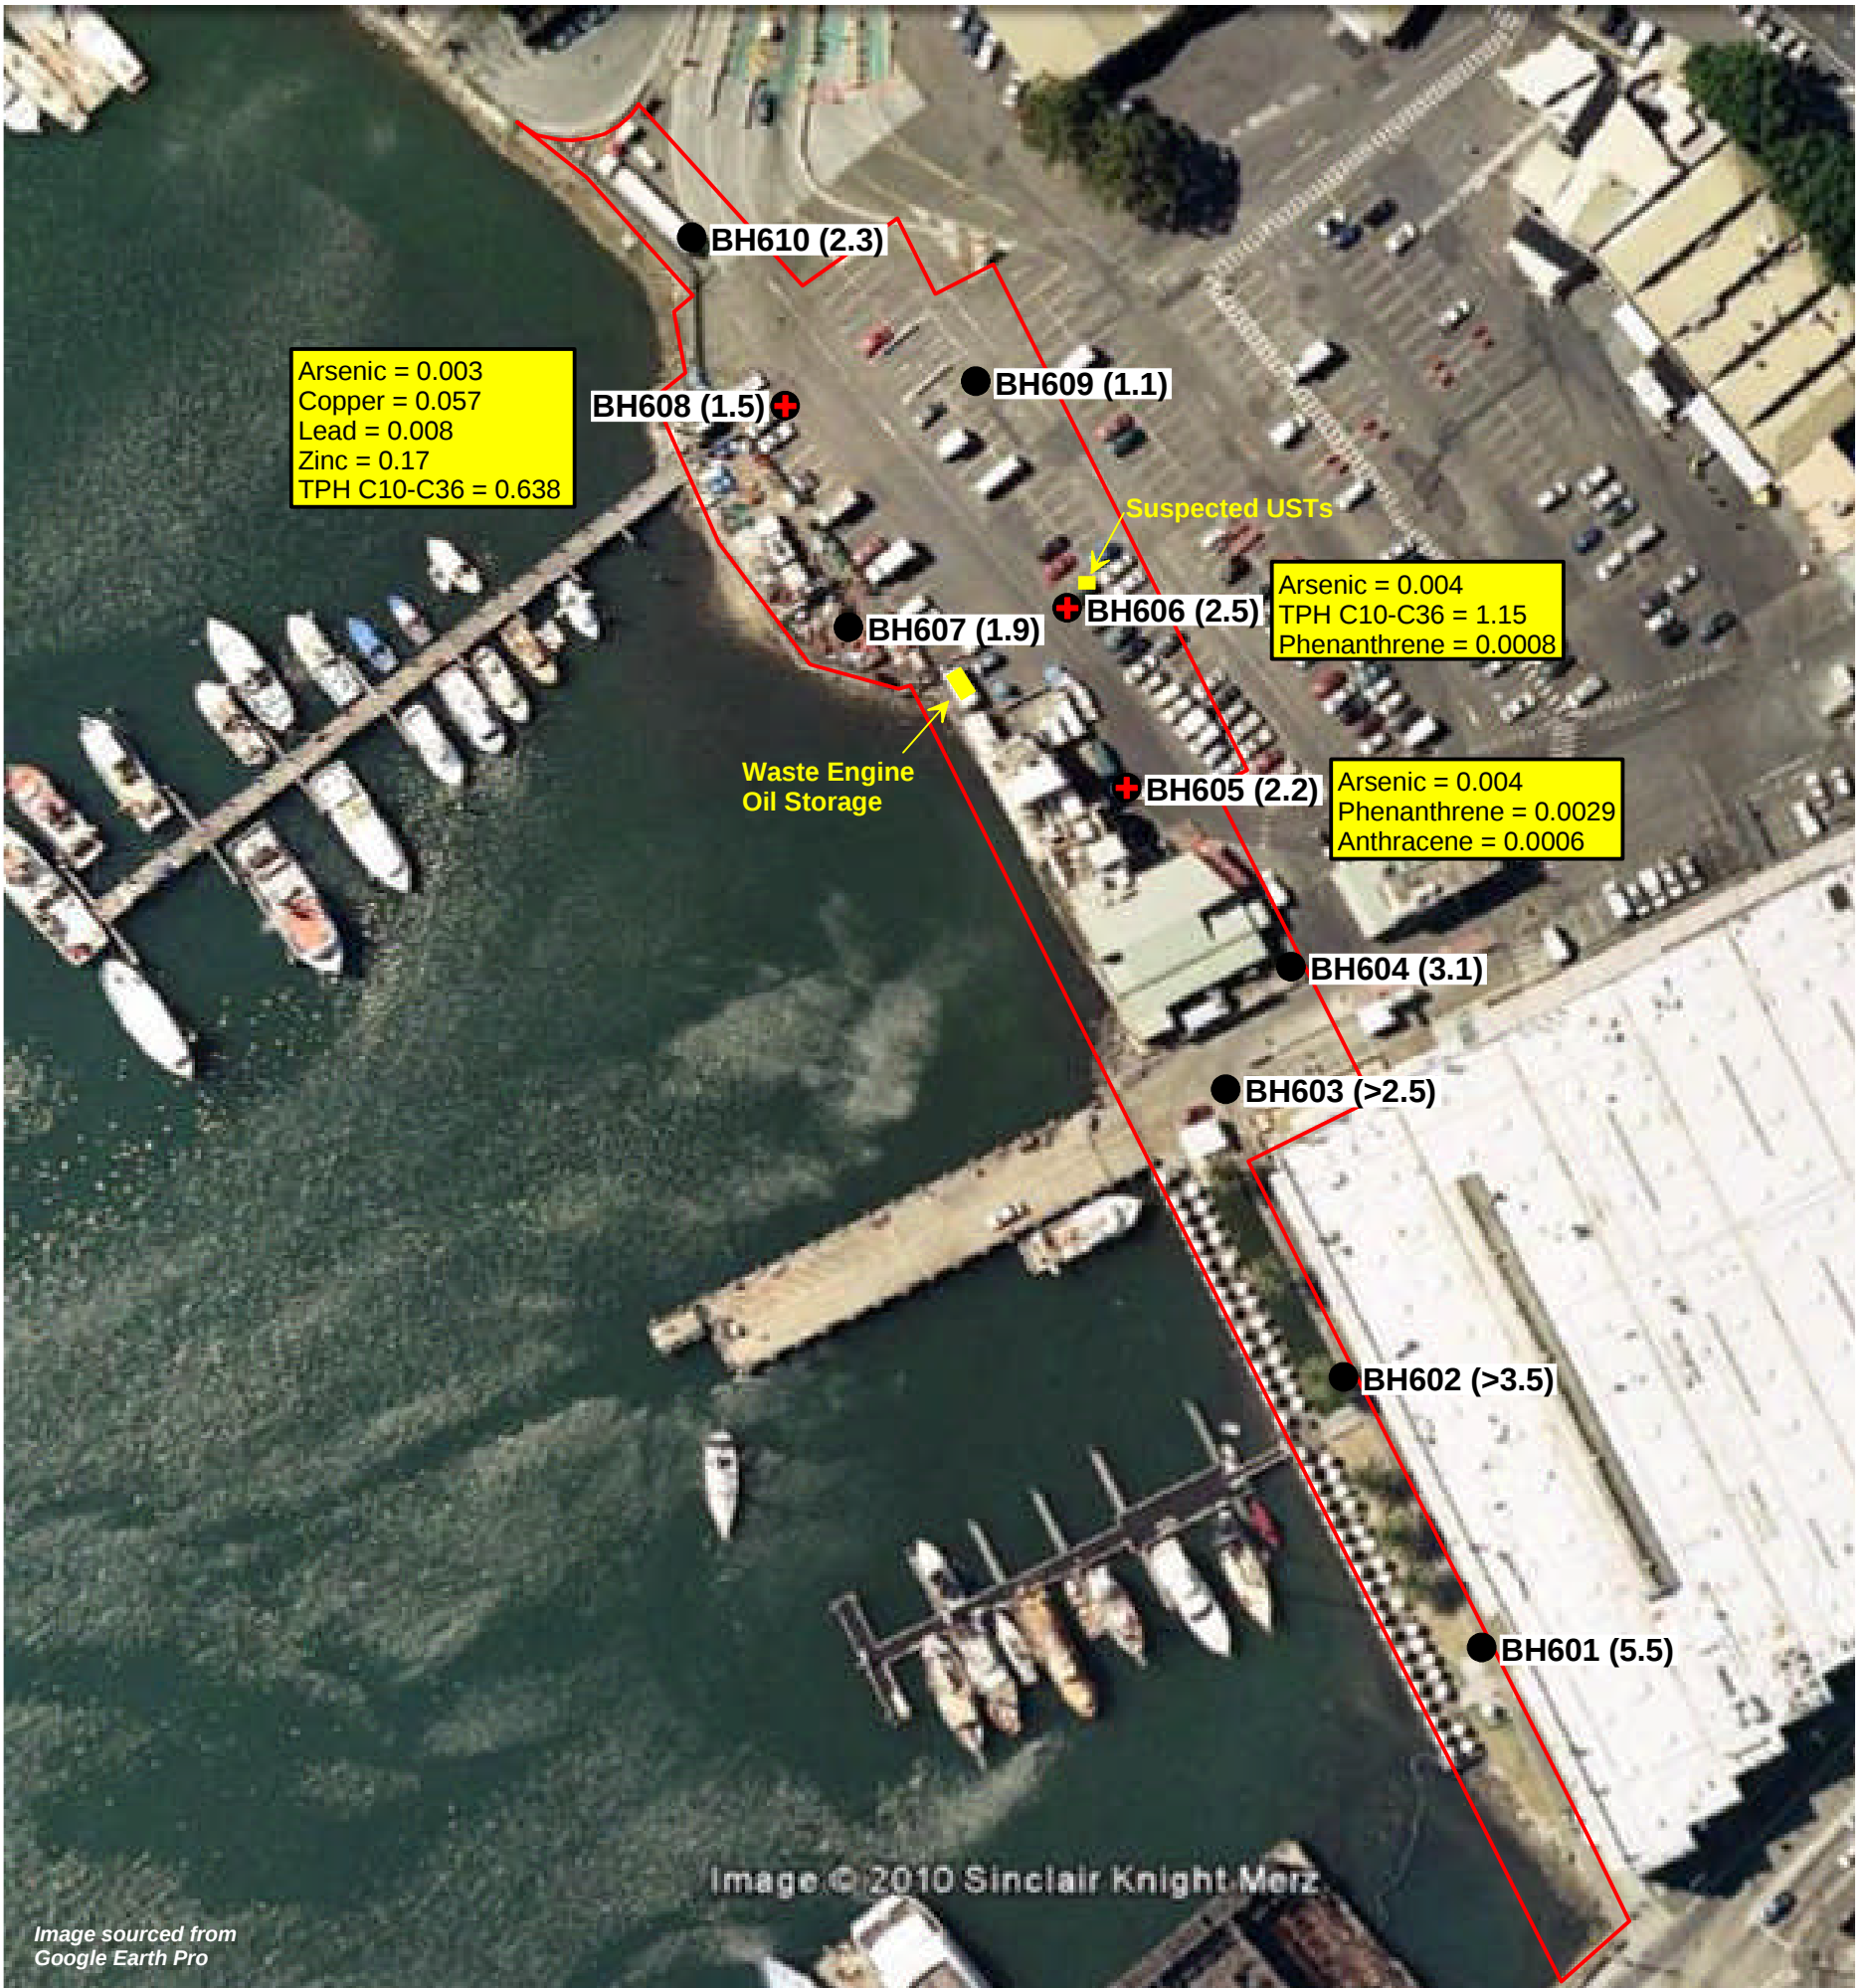
Job No: E24125Krpt  
Figure: 4

● BH601 (5.5) BOREHOLE LOCATION, NUMBER AND DEPTH OF FILL (m)
