Kimbriki Environmental Enterprises
Kimbriki Resource Recovery Project
Environmental Assessment

Volume 3 – Appendices H to P
February 2011

Kimbriki Resource Recovery
Project – Environmental
Assessment
Transport Impact Assessment

Transport Impact Assessment

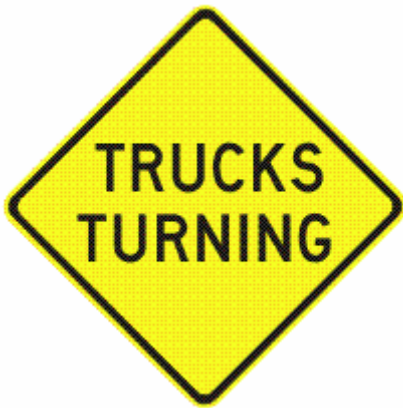
Figure 4.8: Trucks Turning Warning Signage – W5-205

As an additional safety measure, it is recommended that “Trucks Turning” warning signage (Sign No. W5-205 – refer Figure 4.8) be installed on the Mona Vale Road approaches to Kimbriki Road to alert drivers to the construction vehicle activity at the intersection.

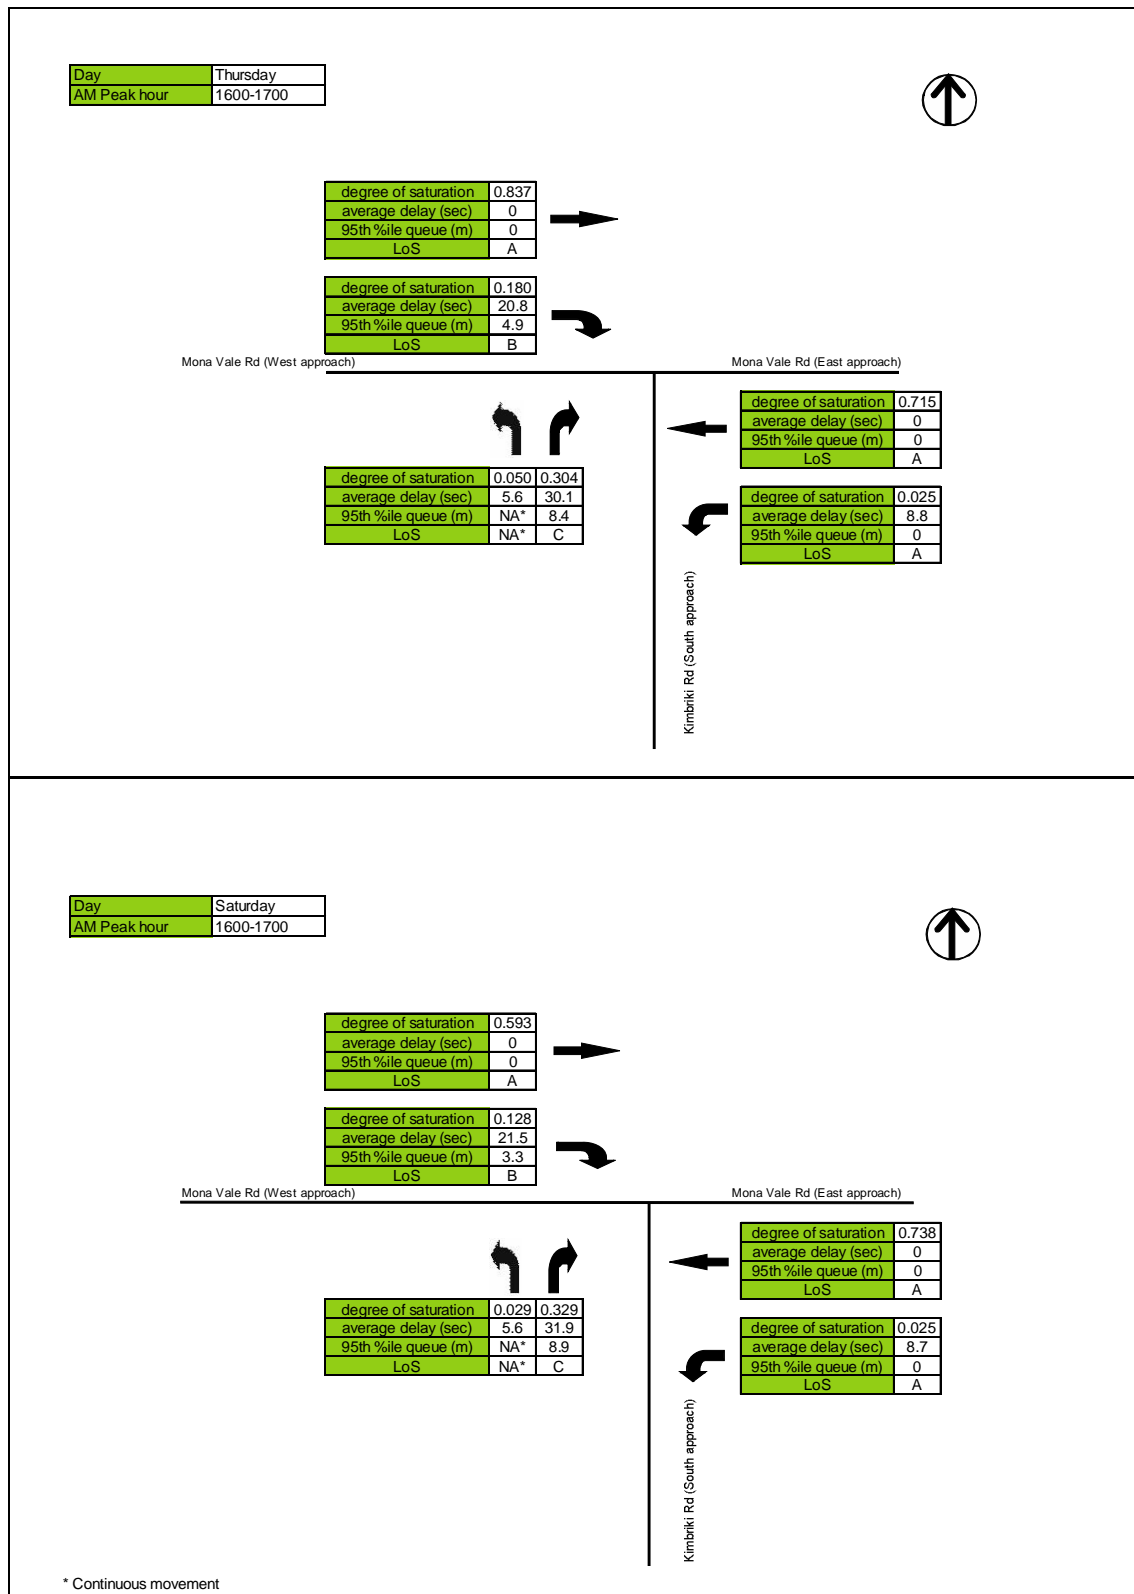
Figure 5.5: SIDRA INTERSECTION Results – 2009 plus Operational Phase Traffic (PM Peak Hour)

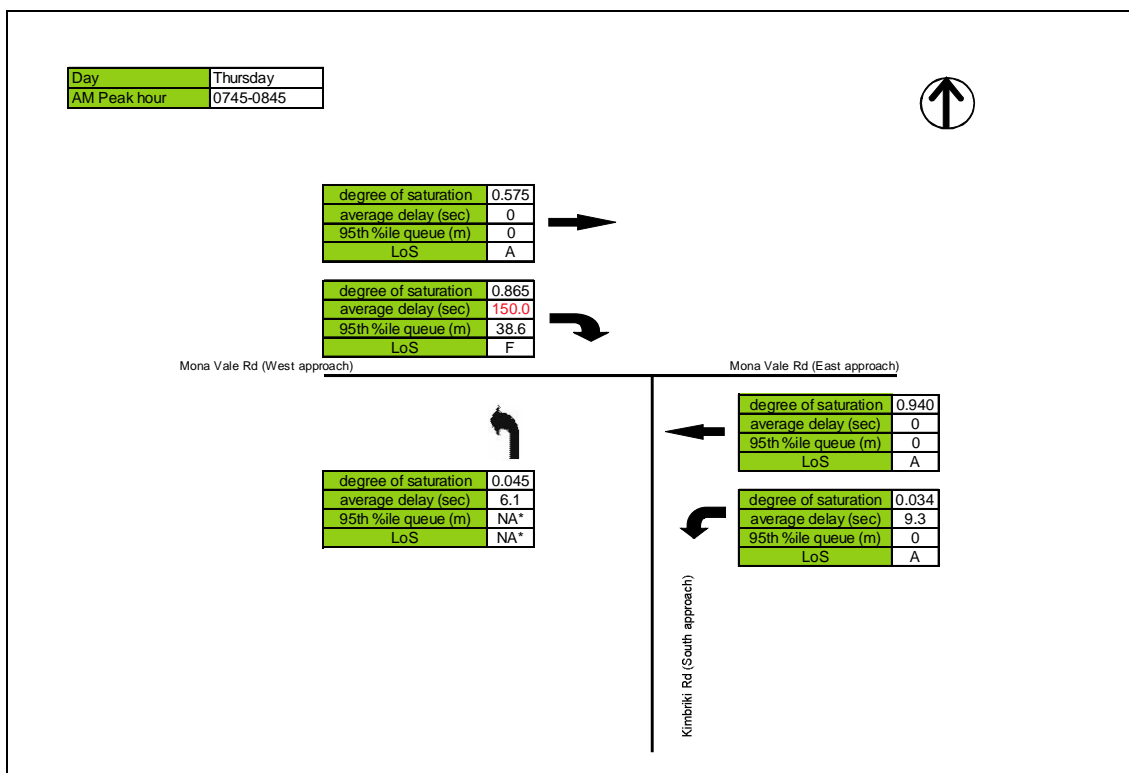
Figure 5.6: SIDRA INTERSECTION Results –2009 plus Operational Phase Traffic (AM Peak Hour Weekday) – Scenario 1

Figure 5.6 indicates that the issues associated with the right-turn movement leaving the site would be resolved. However, the capacity issues for the right turn from Mona Vale Road into Kimbriki Road during the AM peak would not be improved by this action, and would need to be addressed via an alternative solution.

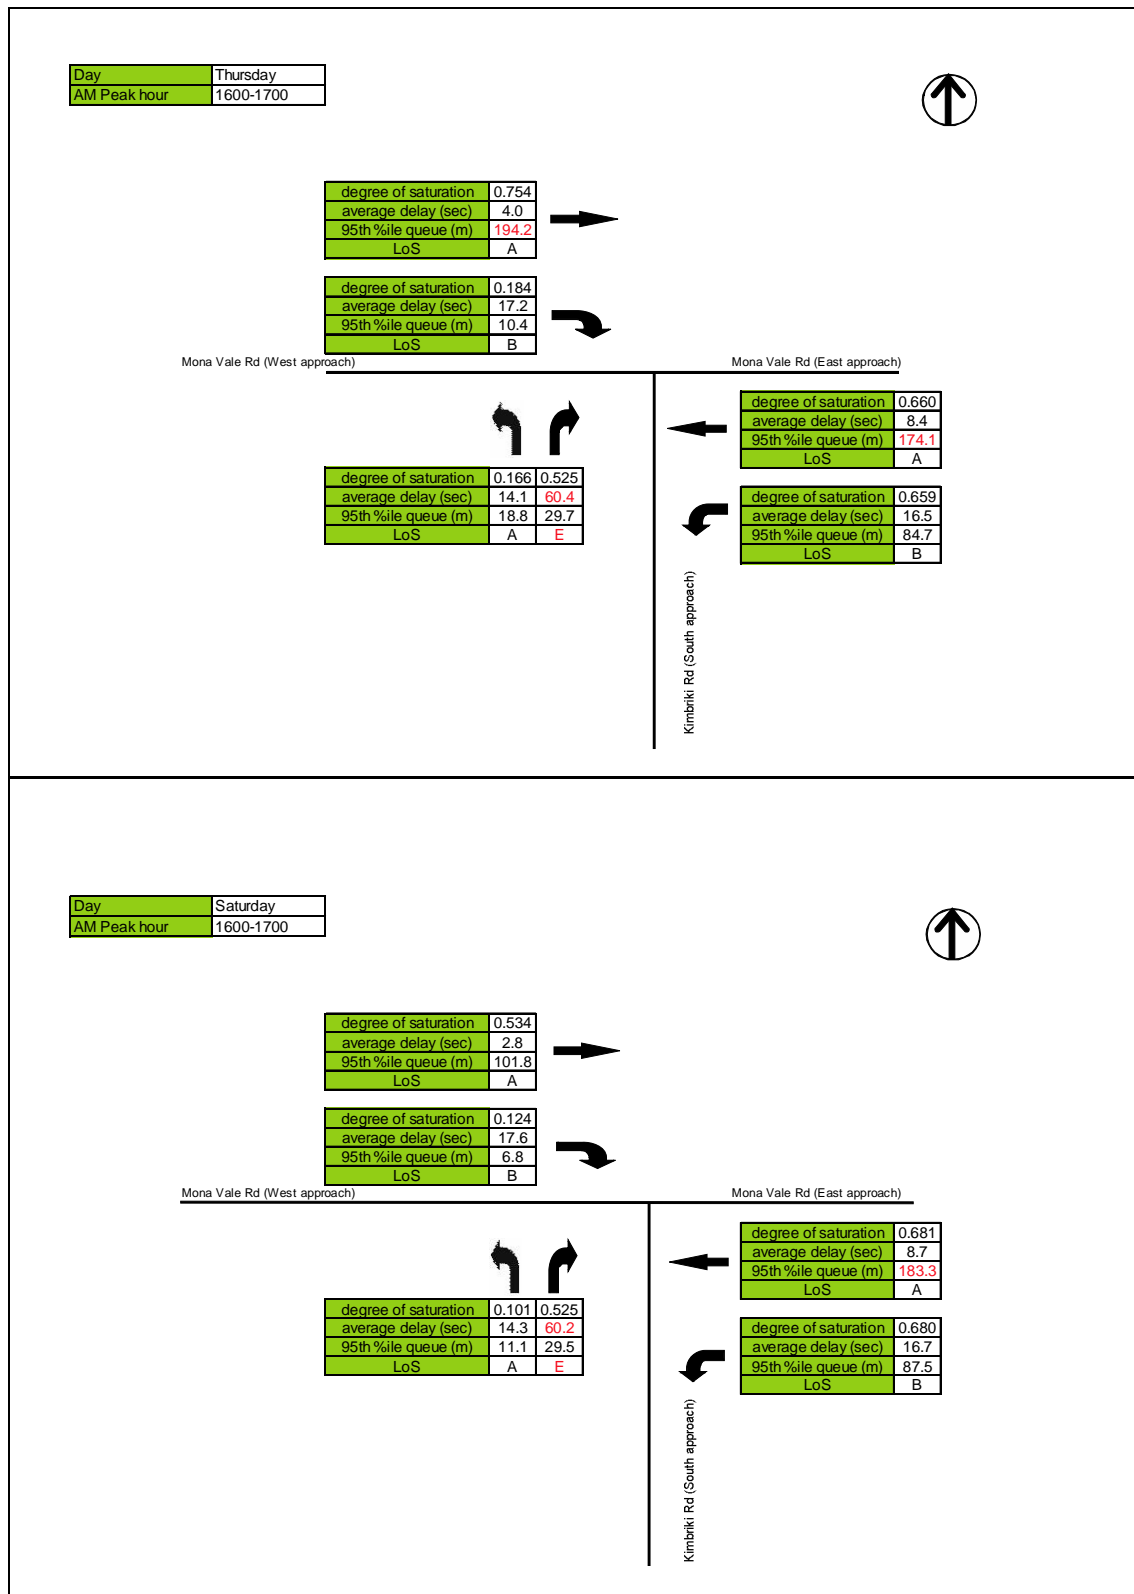
Figure 5.12: SIDRA INTERSECTION Results – 2009 plus Operational Phase Traffic (PM Peak Hour) – Scenario 3

Figure 5.10, Figure 5.11 and Figure 5.12 present a summary of the expected operation of the Mona Vale Road/Kimbriki Road intersection during the operational phase for Scenario 3 based on a cycle time of 100 seconds, whilst Table 5.1 provides a summary of the operation of the intersection as a whole and Figure 5.13 provides a summary of the traffic signal phasing.
