Report on
Preliminary Geotechnical Investigation

Proposed Stables Precinct
Royal Randwick Racecourse, Randwick

Prepared for
The Australian Jockey Club

Project 71976
September 2010

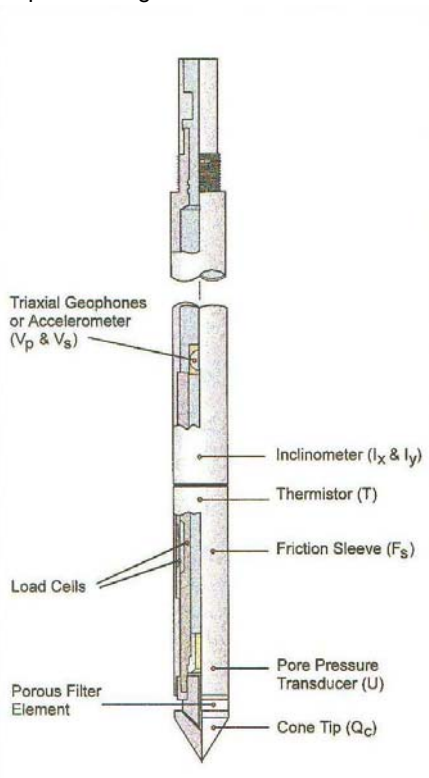
Figure 1: Cone Diagram

- Cone tip resistance q_c
- Sleeve friction f_s
- Inclination (from vertical) i
- Depth below ground z

The inclinometer in the cone enables the verticality of the test to be confirmed and, if required, the vertical depth can be corrected.

In the CPT, a 35 mm diameter cone with a following 130 mm long friction sleeve is attached to rods of the same diameter and pushed continuously into the soil by hydraulic thrust from a truck mounted test rig. Strain gauges in the cone and sleeve measure resistance to penetration. The results are displayed on a digital monitor and stored on computer for later plotting.

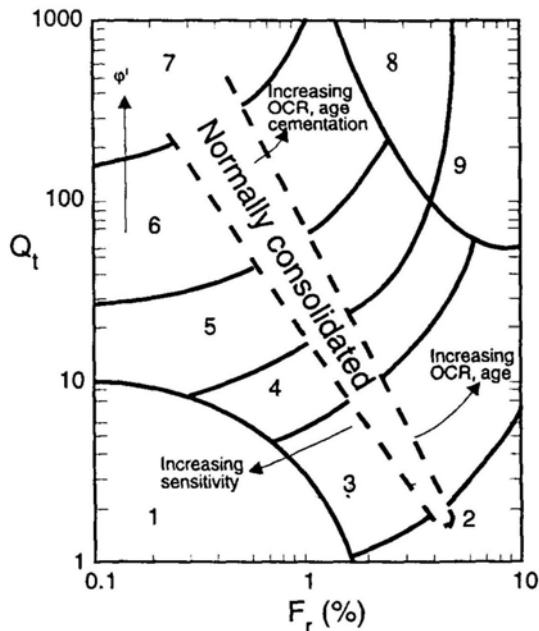
Figure 3: Soil Classification Chart

The CPT parameters can be used to infer the Soil Behaviour Type (SBT), based on normalised values of cone resistance (Q_t) and friction ratio (F_r). These are used in conjunction with soil classification charts, such as the one below (after Robertson 1990)

DP's in-house CPT software provides computer aided interpretation of soil strata, generating soil descriptions and strengths for each layer. The software can also produce plots of estimated soil parameters, including modulus, friction angle, relative density, shear strength and over consolidation ratio.

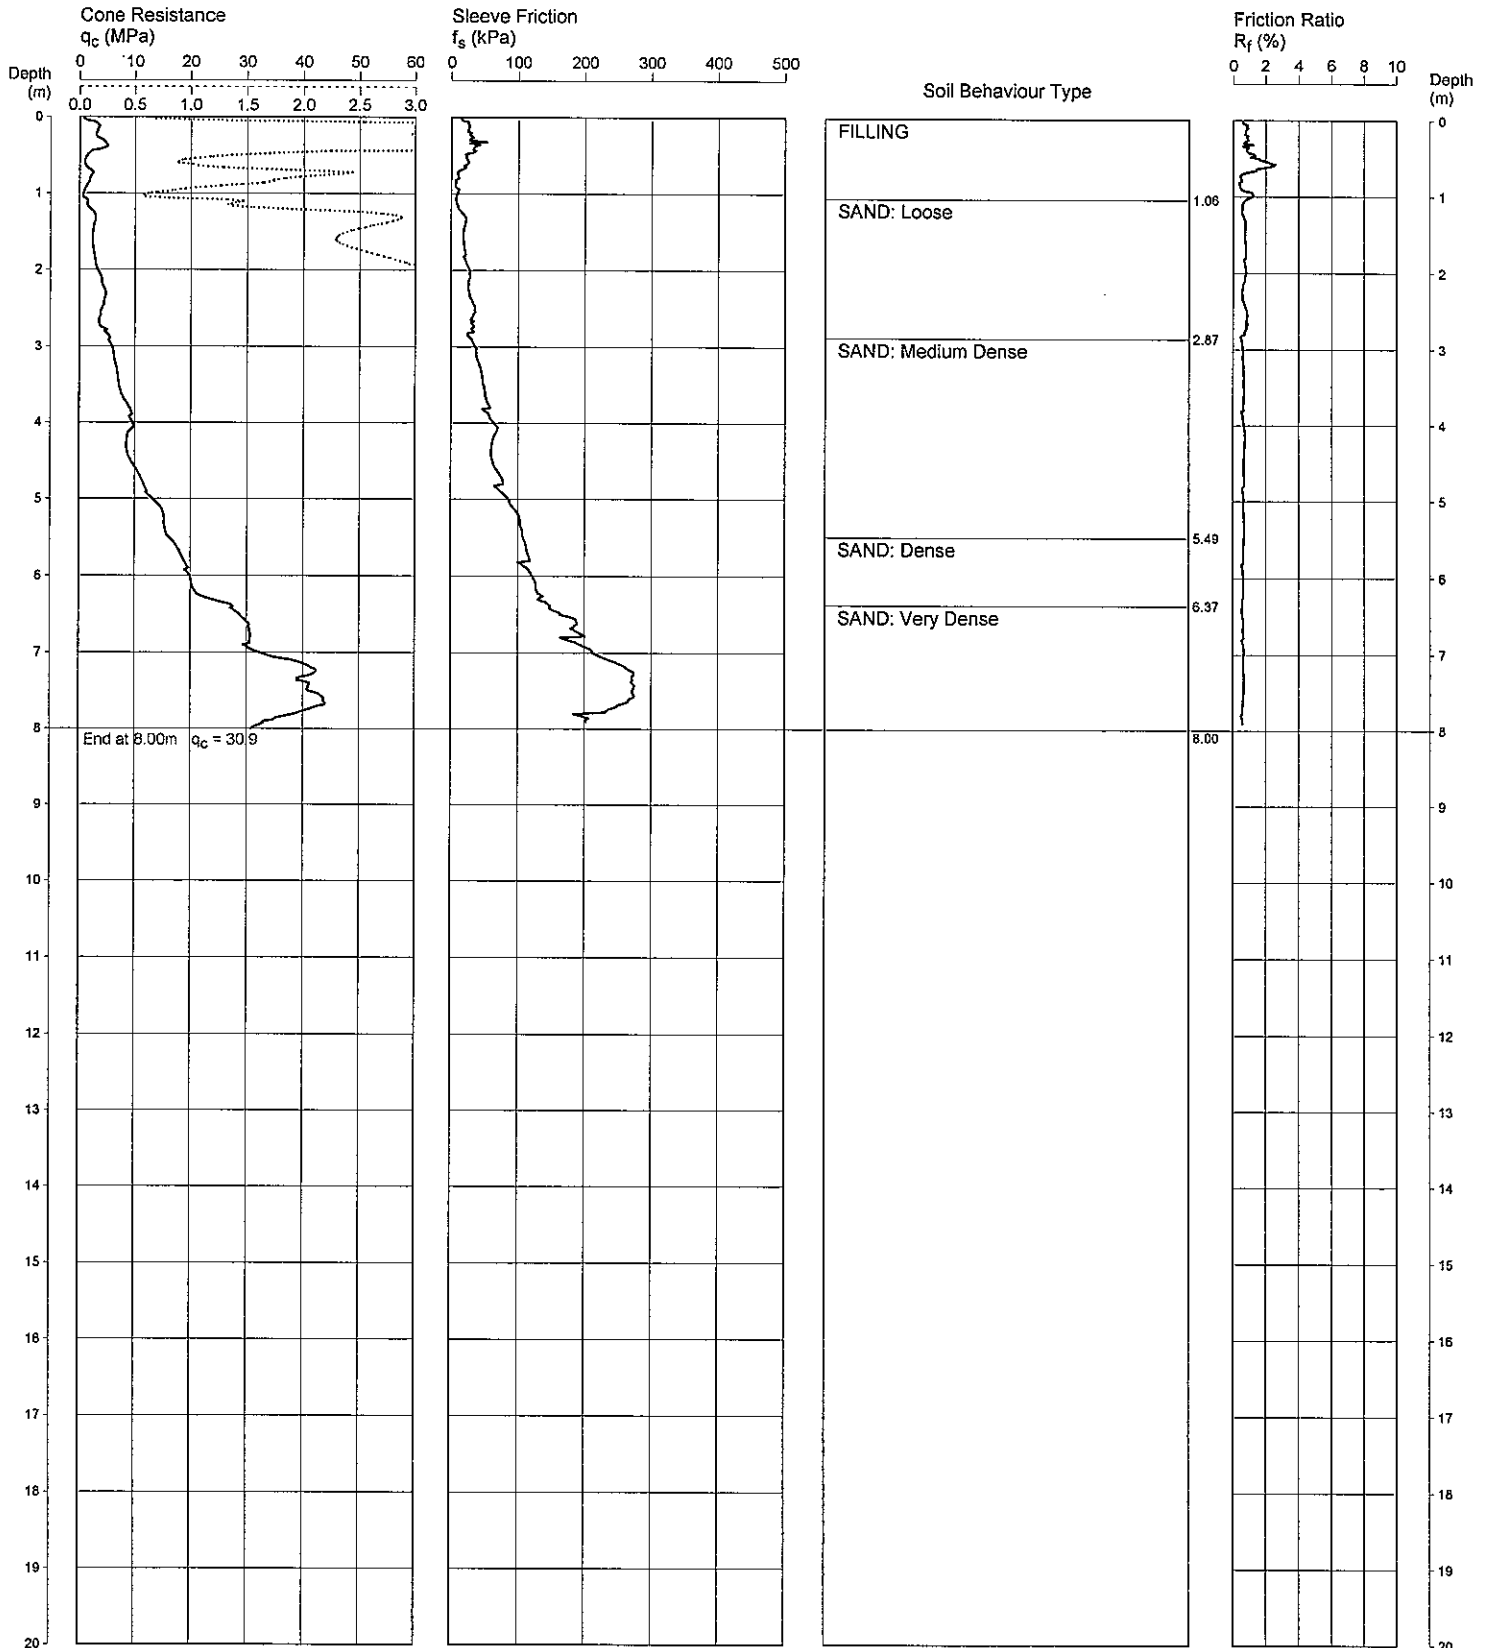
SURFACE RL: 34.4 AHD

REMARKS: HOLE COLLAPSE AT 5.1M DEPTH

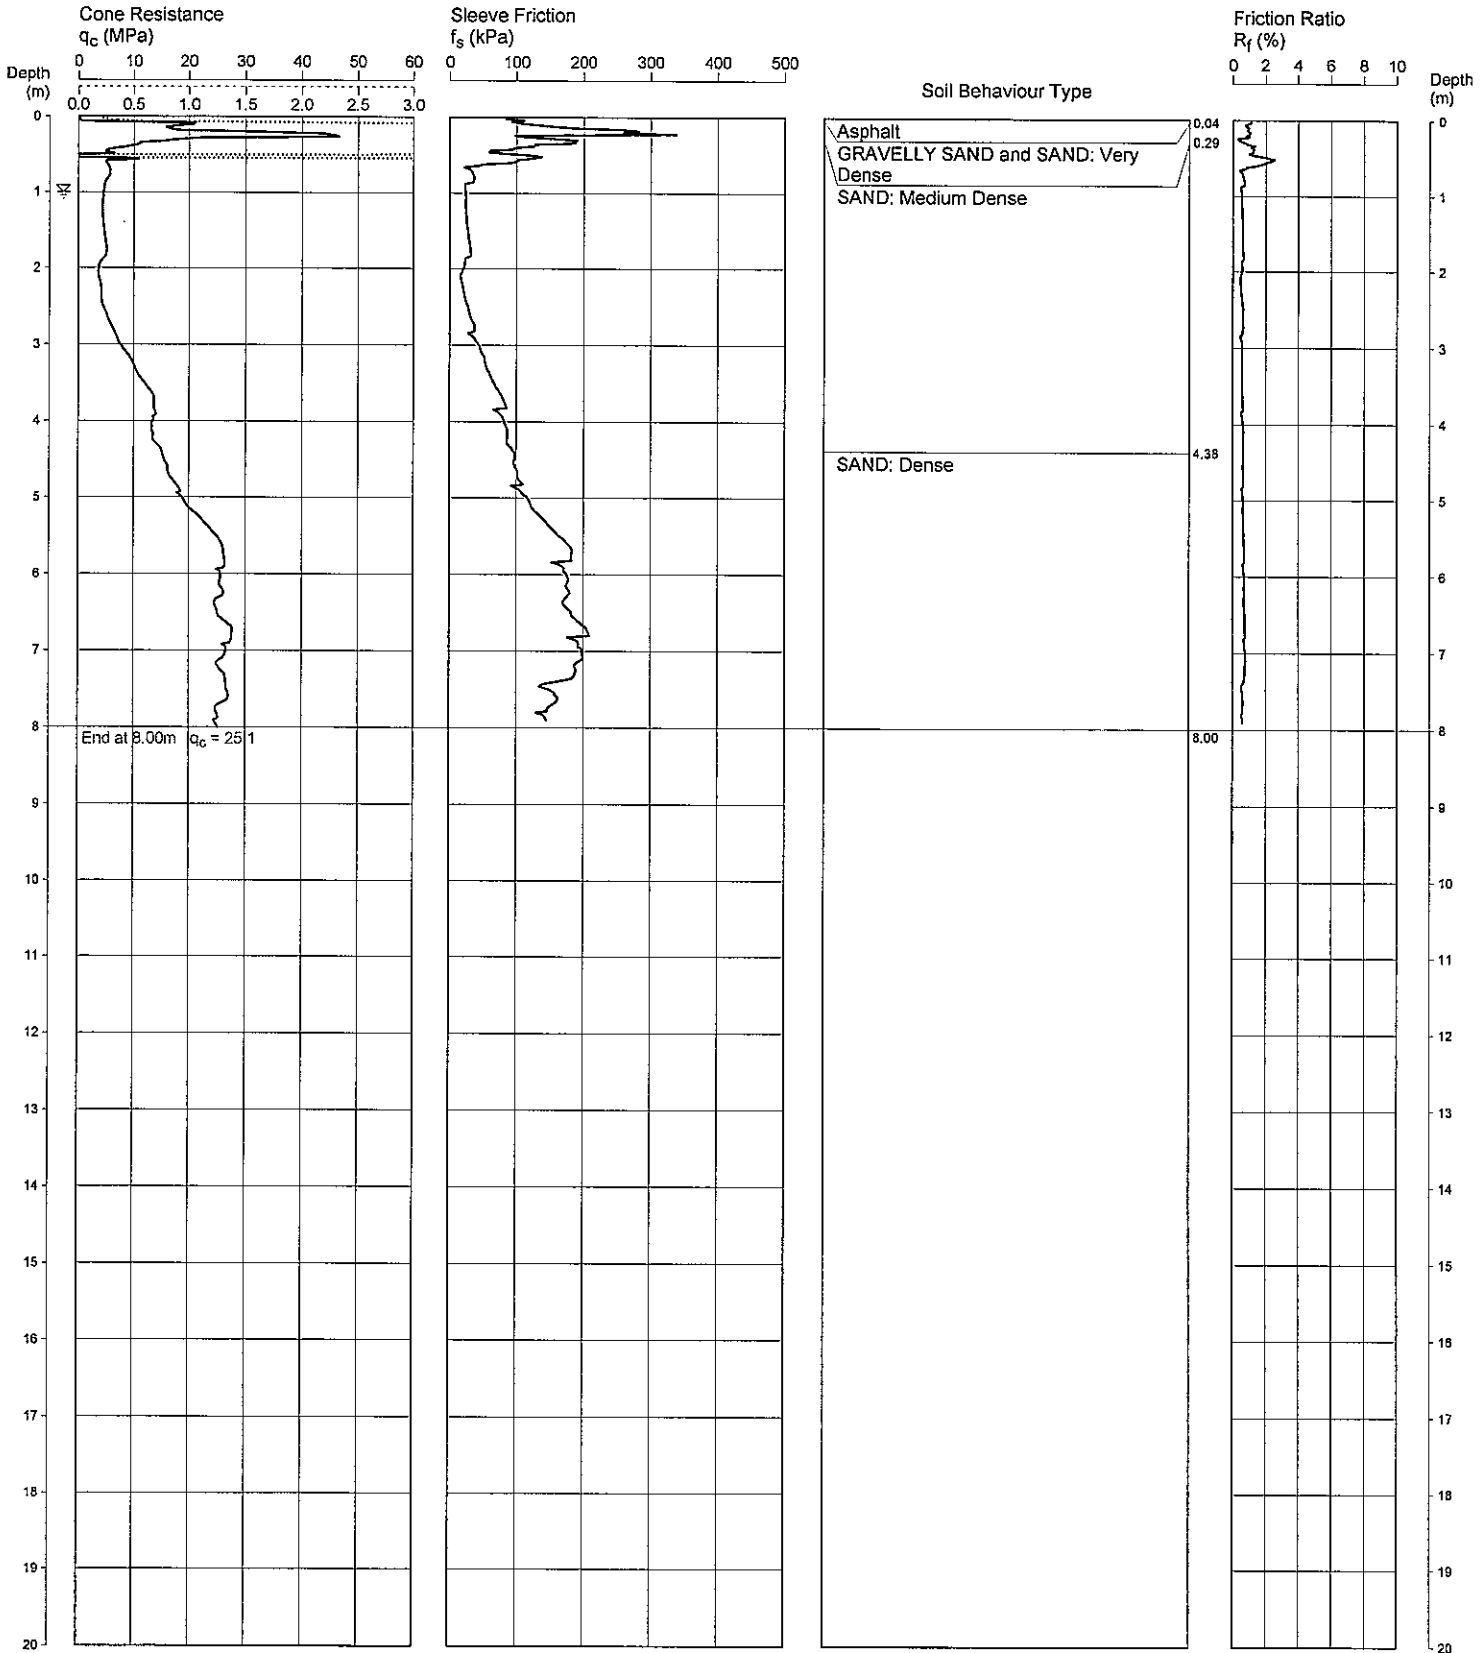
SURFACE RL: 37.8 AHD

REMARKS: UNEXPECTEDLY SHALLOW DEPTH TO WATER AT 1.0M

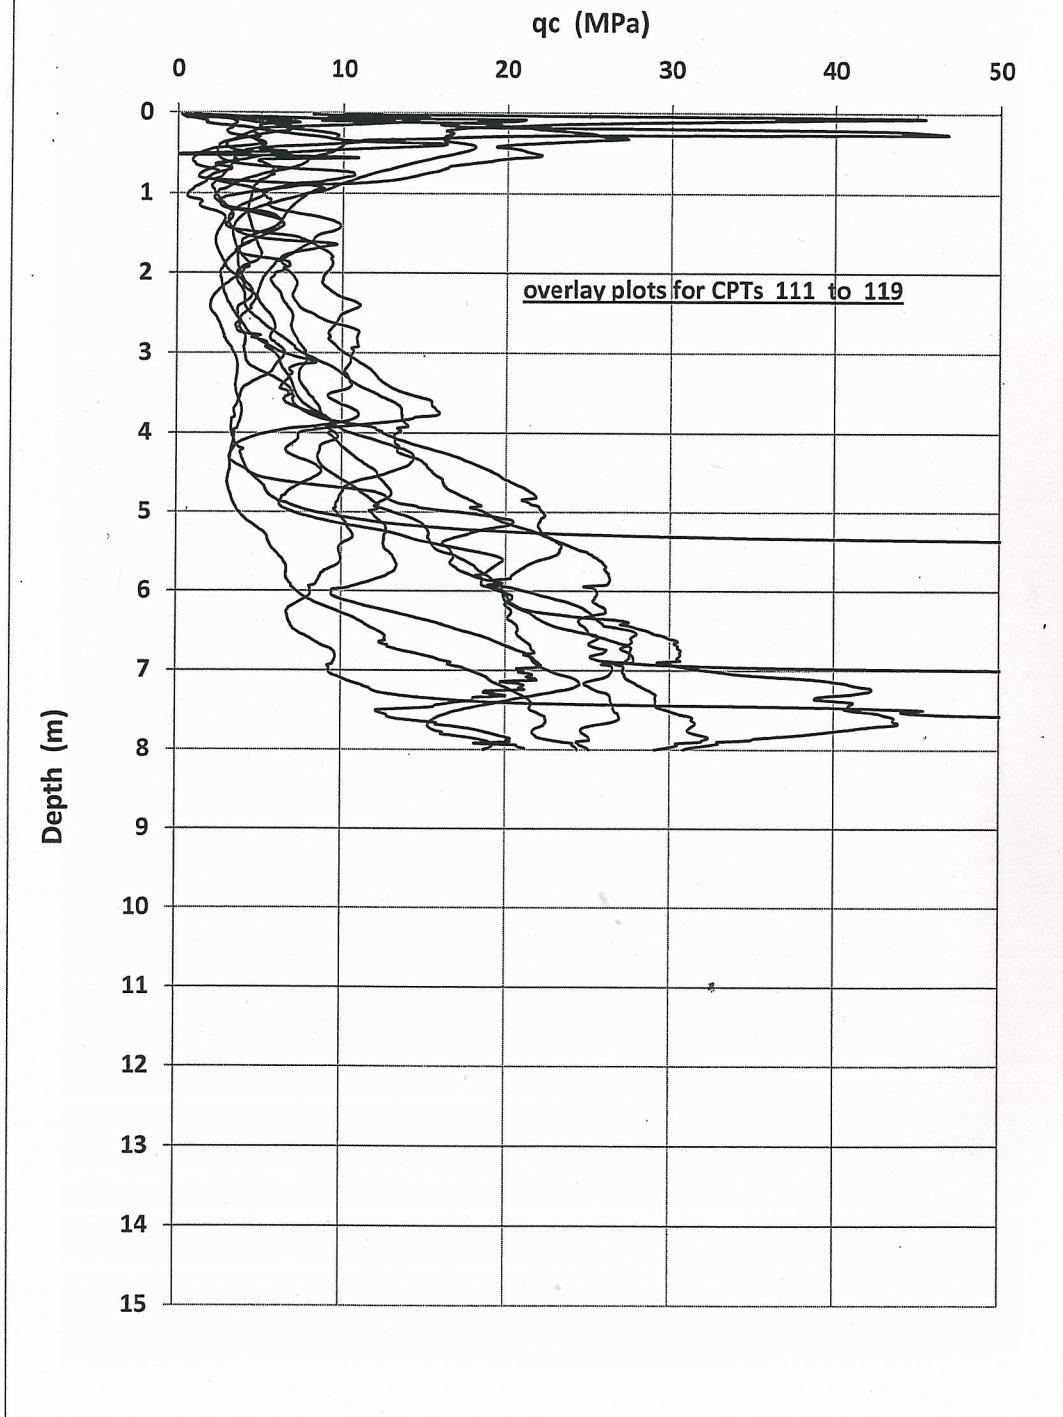
Drawing 2: Summary of CPTs, Proposed Stables

The result sheets for CPT 111 to CPT 119 are included in Appendix B, together with a brochure explaining the operation of the CPT and interpretation of results. Drawing 2 presents superimposed plots of cone resistance (q_c) versus depth.

The densities of the underlying natural sands are very variable across the site. The sands vary between loose and loose-to-very loose for the upper 3 to 4 m, but are medium dense in places. Every

CPT indicates medium dense sand below 5 m depth. All CPTs (except CPT 114) indicate dense sand below 6.5 m depth.

CPT refusal (presumed top of bedrock) was encountered in CPT 114, 115, 116 at depths of 7.8 m, 7.0 m, 5.4 m respectively. These depths correspond to RL 25.7 m, RL 29.8 m, RL 34.0 m respectively, indicating the rising level of the top of bedrock towards Wansey Road.
