## Appendix G Archaeological Assessment

**Proposed Capital Photovoltaic Solar Farm  
Archaeological and Cultural Heritage Assessment**

A report to ngenvironmental  
PO Box 470  
Bega NSW 2550

September 2010

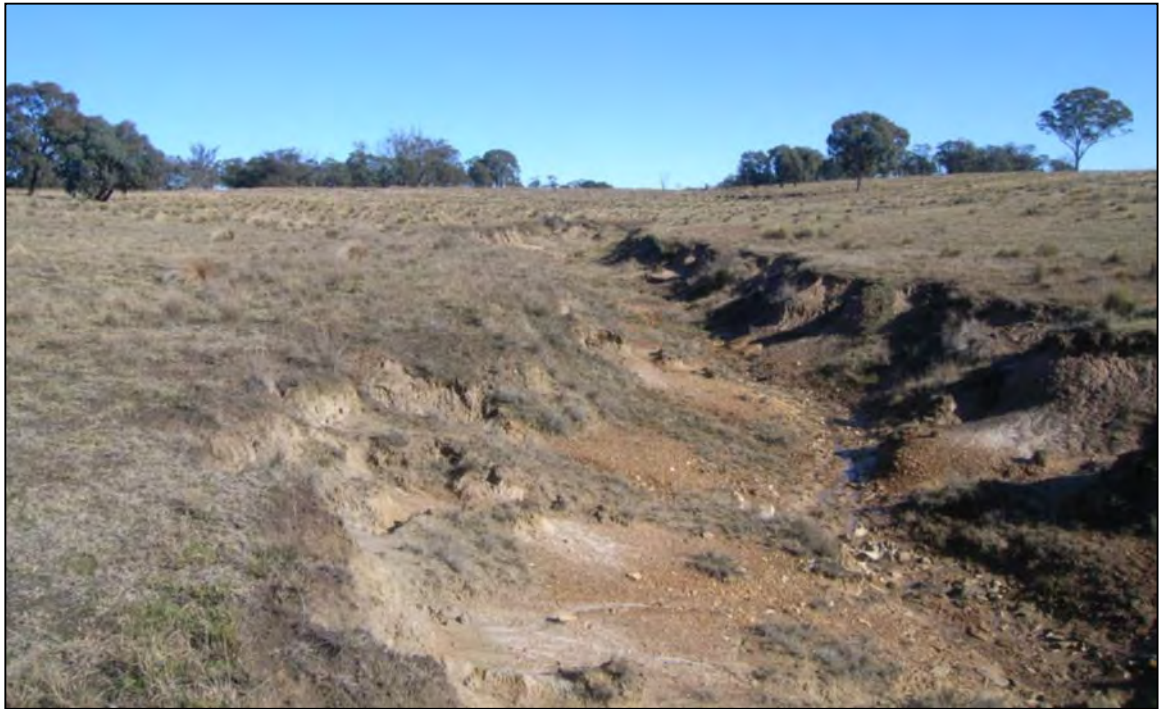
Plate 1. View of typical erosional scouring along drainage lines (tributary to Dry Creek), Survey Unit 8, looking west.

Drainage lines within the proposal area would originally have been comprised predominantly of a chain of ponds stream system with irregularly interspersed bars stabilised by vegetation. However this drainage regime has been significantly altered since European occupation as the result of vegetation clearance which has facilitated ongoing channel incision progressing from downstream. In many areas creeklines are now deeply etched channels with terracing in several sections eroded as the result of over-bank stream flow. The continuing destabilisation of creek banks is currently visible, exacerbated by stock treadage in combination with water generated erosion. As a result of these processes the width of the original drainage channels has also been significantly enhanced (Plates 1 and 2).

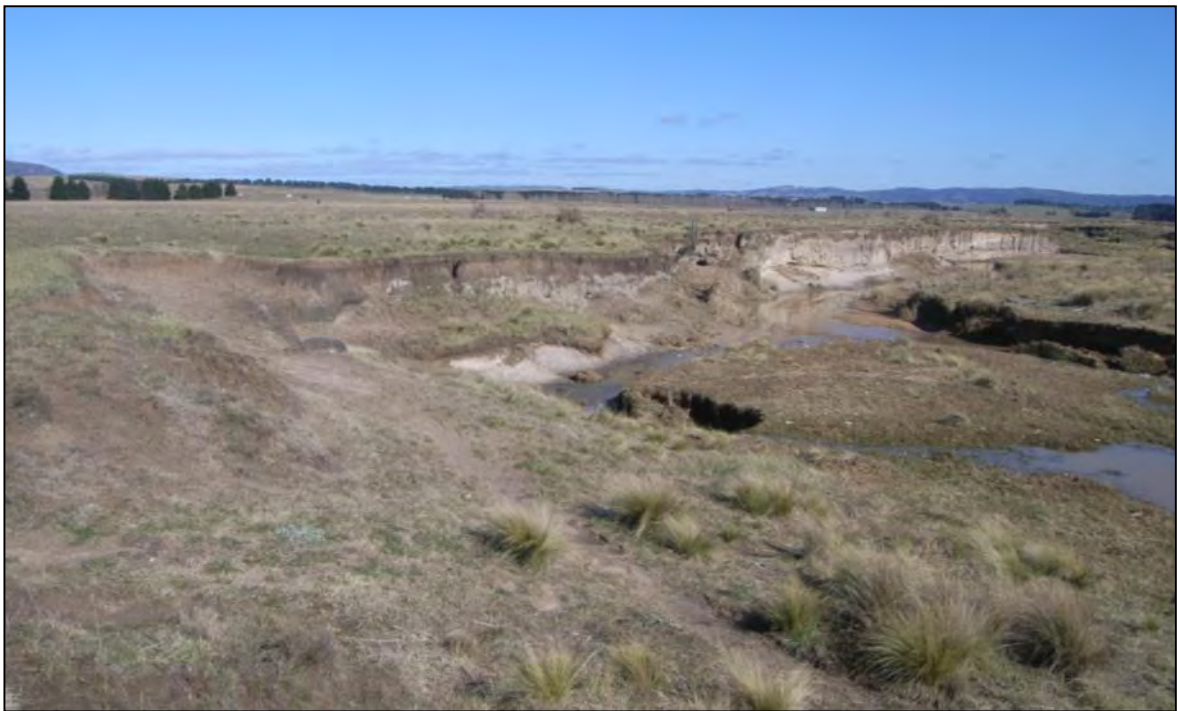
Plate 2. View of actively eroding creek bank (Bridge Creek), Survey Unit 30, looking southeast.

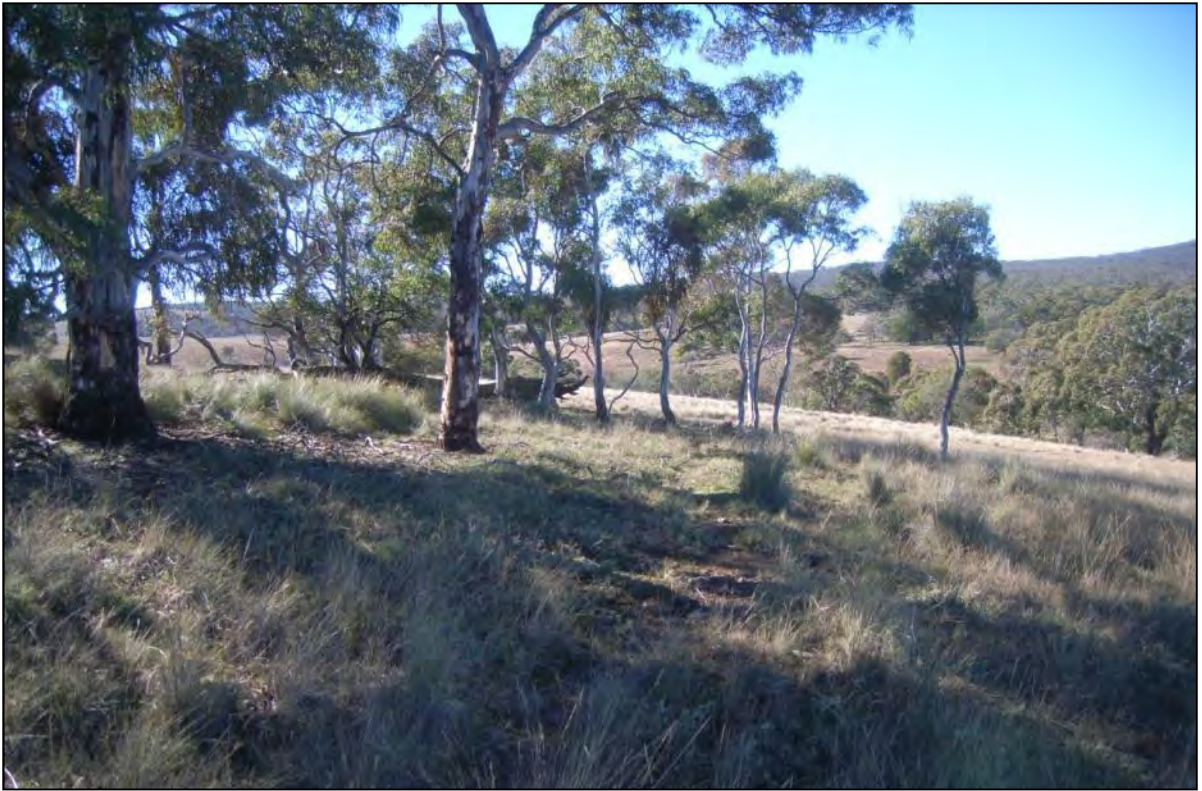
Plate 3. SU11/L1 looking northeast.

| Locale | Type | Size (size class unless otherwise indicated) | Material | Comments |
|---|---|---|---|---|
| SU11/L1 | Broken pebble manuport | 74 x 36 x 41mm | Brown quartzite | No usewear; 40% pebble cortex |

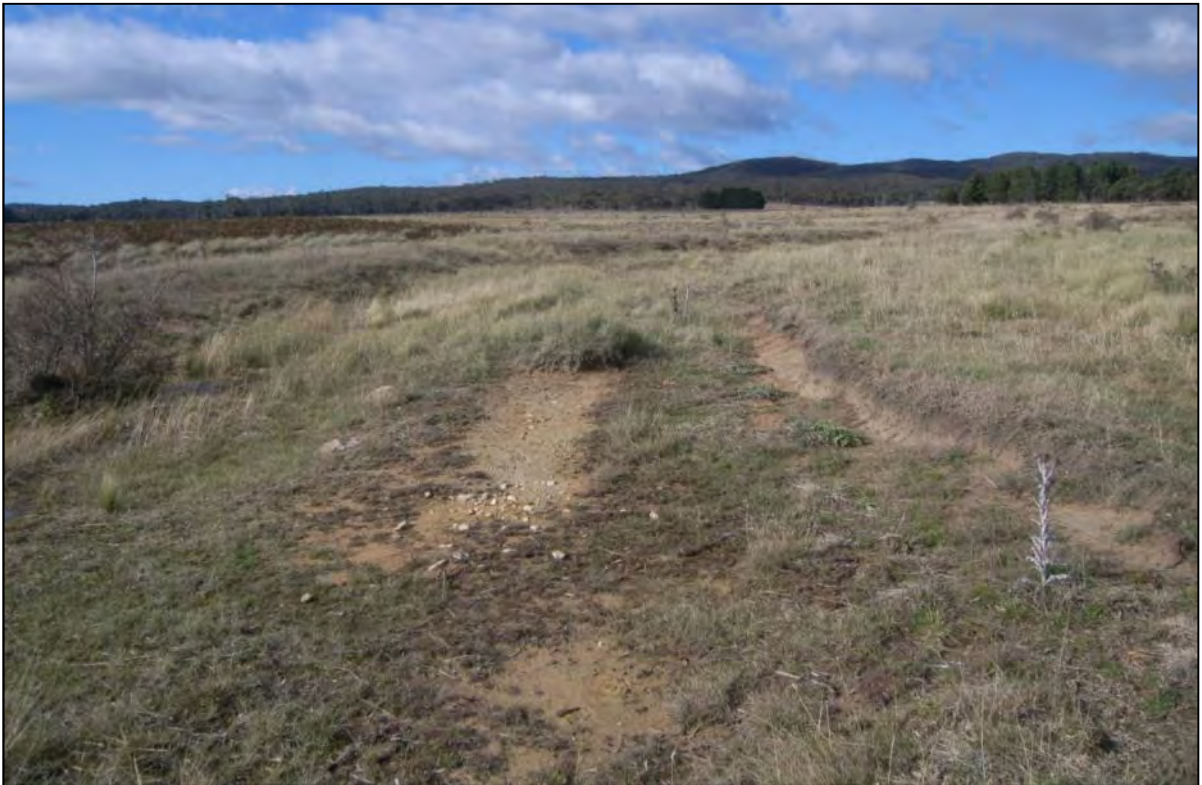
| SU | Locale | Easting | Northing | Area | Exposure | Context | Exposure | Visibility | Artefact Number | Predicted Density | Integrity | Subsurface potential at site | Subsurface potential away from site | Impacts |
|---|---|---|---|---|---|---|---|---|---|---|---|---|---|---|
| SU14<br>(Plate 4) | L1 | 729307 | 6101500 | 5 x 2 | eroded creek<br>bank<br>area: 10 x 10 m | On edge of drainage<br>depression; aspect:<br>NW;<br>very gentle gradient | 70 | 60 | 1 | low | moderately<br>disturbed;<br>eroding | Yes | Yes | Possibly<br>solar panels |

Plate 4. SU14/L1 looking east.

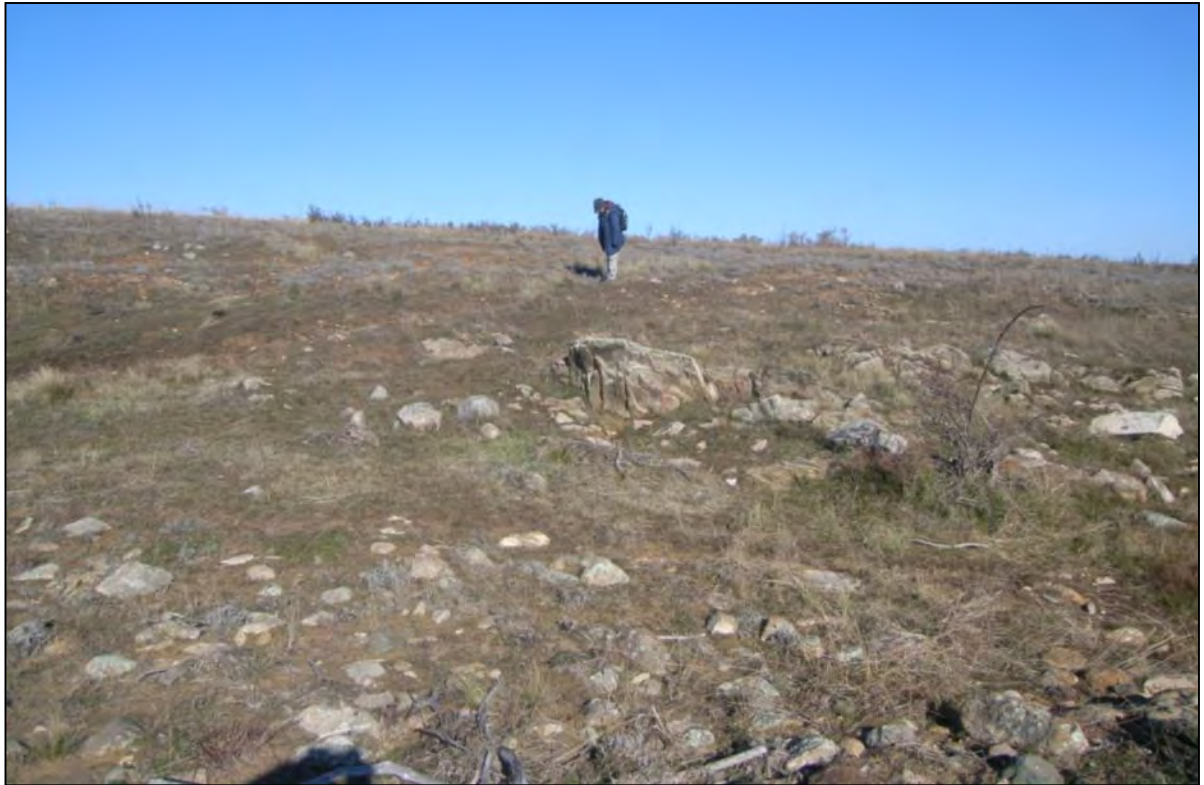
| SU | Locale | Easting | Northing | Area | Exposure | Context | Exposure | Visibility | Artefact Number | Predicted Density | Integrity | Subsurface potential at site | Subsurface potential away from site | Impacts |
|---|---|---|---|---|---|---|---|---|---|---|---|---|---|---|
| SU14<br>(Plate 5) | Pre-<br>recorded<br>site<br>57-2-0062<br>Dry Creek<br>2 | 728513 | 6101984 | 40 x 25 | eroded creek<br>bank<br>area: 25 x 15 m | On edge of drainage<br>depression; aspect:<br>NW;<br>level gradient | 40 | 50 | 0<br>Originally<br>(1988) 9<br>quartz<br>artefacts | low | disturbed;<br>eroding | Yes | Yes | Impacts<br>unlikely |

Plate 5. SU14 - pre-recorded site Dry Creek 2 (Packard 1988) looking southwest.

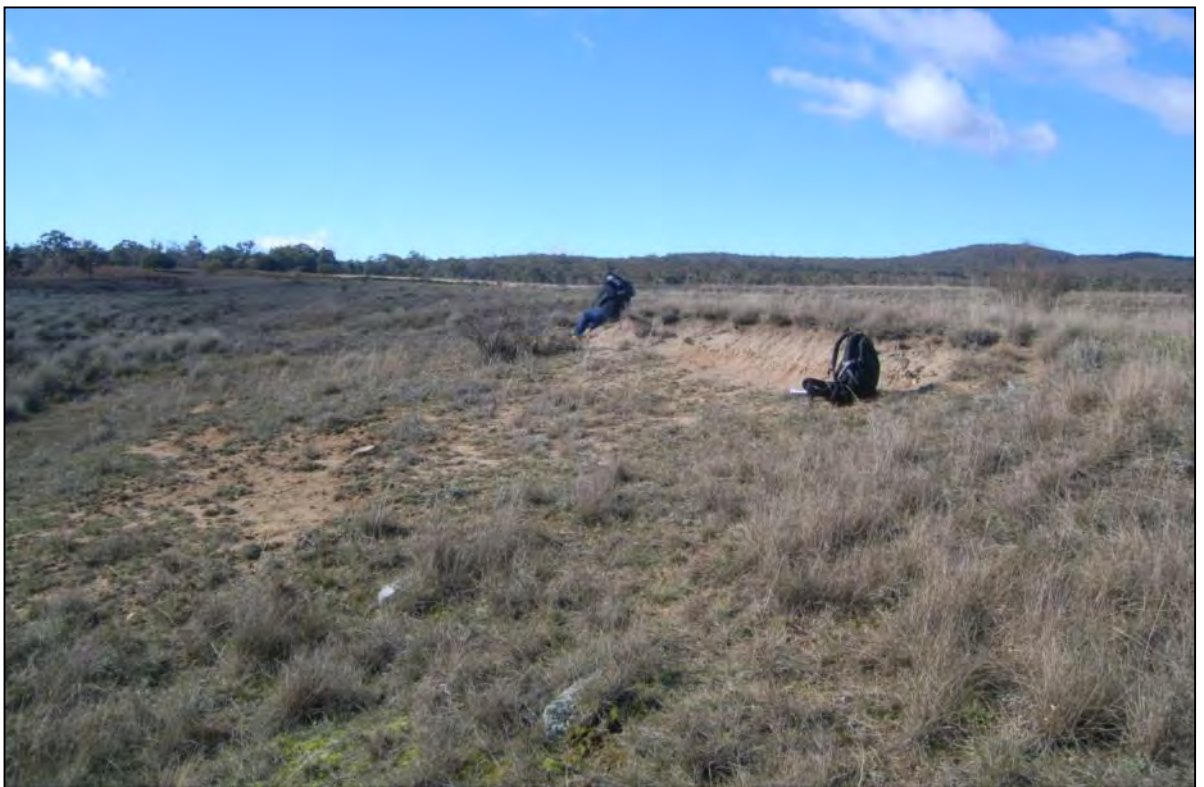
| SU | Locale | Easting | Northing | Area | Exposure | Context | Exposure | Visibility | Artefact Number | Predicted Density | Integrity | Subsurface potential at site | Subsurface potential away from site | Impacts |
|---|---|---|---|---|---|---|---|---|---|---|---|---|---|---|
| SU16<br>(Plate 6) | L1 | 729524 | 6101901 | 15 x 8 | eroded creek<br>bank<br>area: 15 x 3 m | On edge of drainage<br>depression; aspect:<br>SW; very gentle<br>gradient | 60 | 60 | 6 | low | moderately<br>disturbed;<br>eroding | Yes | Yes | No impacts -<br>outside of<br>study area |

Plate 6. SU16/L1 looking northeast.

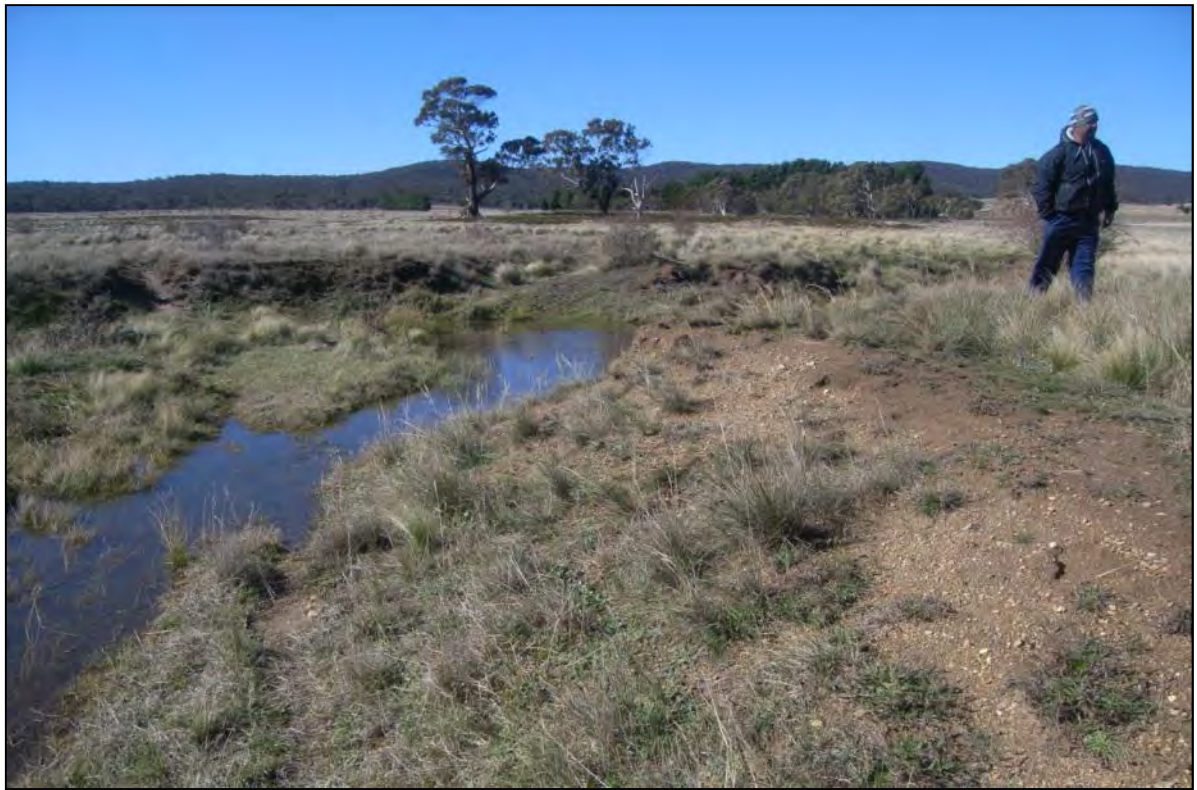
| SU | Locale | Easting | Northing | Area | Exposure | Context | Exposure | Visibility | Artefact Number | Predicted Density | Integrity | Subsurface potential at site | Subsurface potential away from site | Impacts |
|---|---|---|---|---|---|---|---|---|---|---|---|---|---|---|
| SU18<br>(Plate 7) | L1 | 729143 | 6101487 | 15 x 3 | eroded creek<br>bank<br>area: 15 x 1 m | On edge of drainage<br>depression; aspect:<br>open;<br>level gradient | 60 | 75 | 1 | low | moderately<br>disturbed;<br>eroding | Yes | Yes | Possibly<br>solar panels |

Plate 7. SU18/L1 looking east.

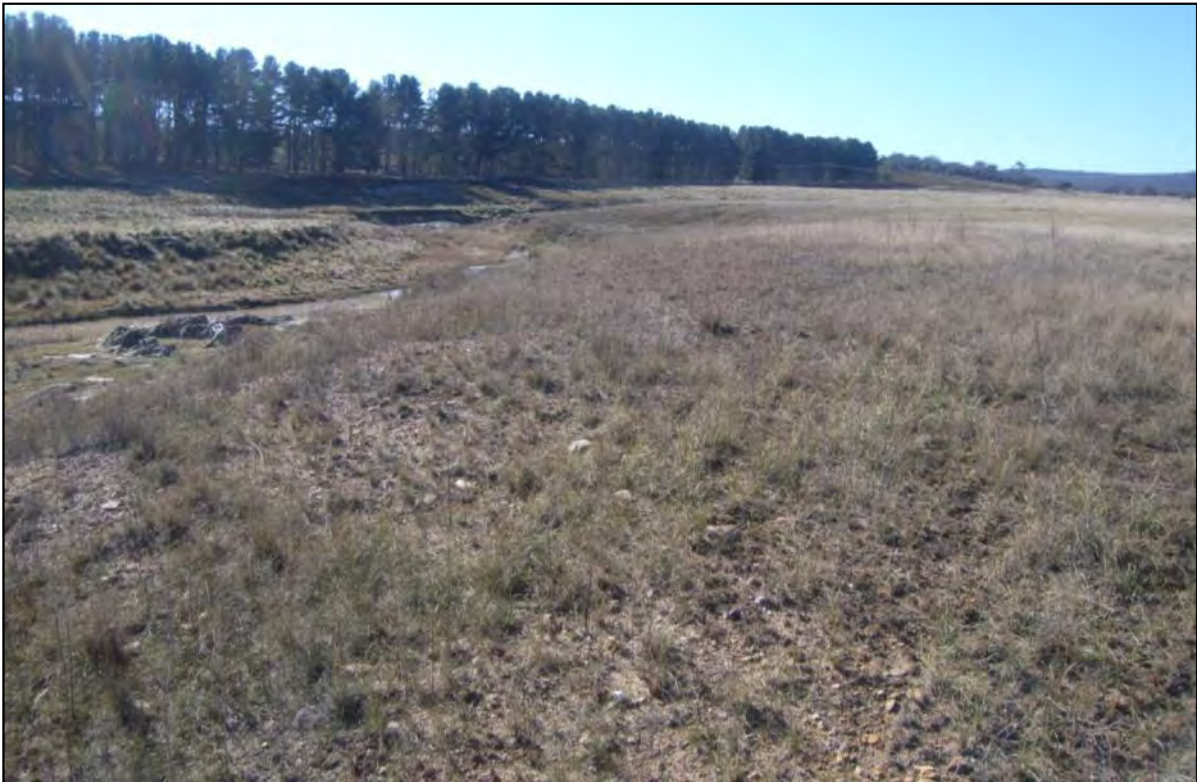
| SU | Locale | Easting | Northing | Area | Exposure | Context | Exposure | Visibility | Artefact Number | Predicted Density | Integrity | Subsurface potential at site | Subsurface potential away from site | Impacts |
|---|---|---|---|---|---|---|---|---|---|---|---|---|---|---|
| SU30<br>(Plate 8) | L1 | 728143 | 6102229 | 80 x 15 | eroded creek<br>bank<br>area: 70 x 10 m | On edge of drainage<br>depression; aspect:<br>W;<br>very gentle gradient | 70 | 60 | 7 | low | disturbed;<br>eroding | Yes | Yes | No impacts -<br>outside of<br>study area |

Plate 8. SU30/L1 looking north.

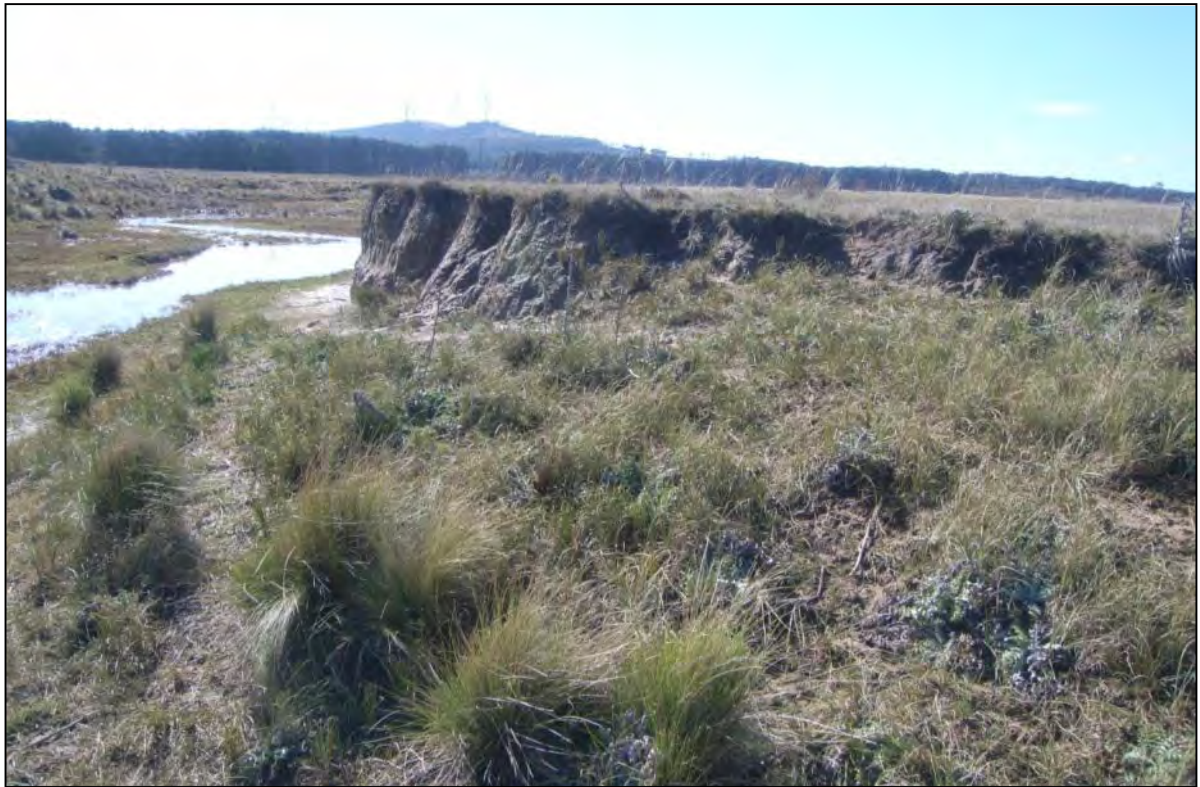
Plate 9. SU30/L2 looking north.

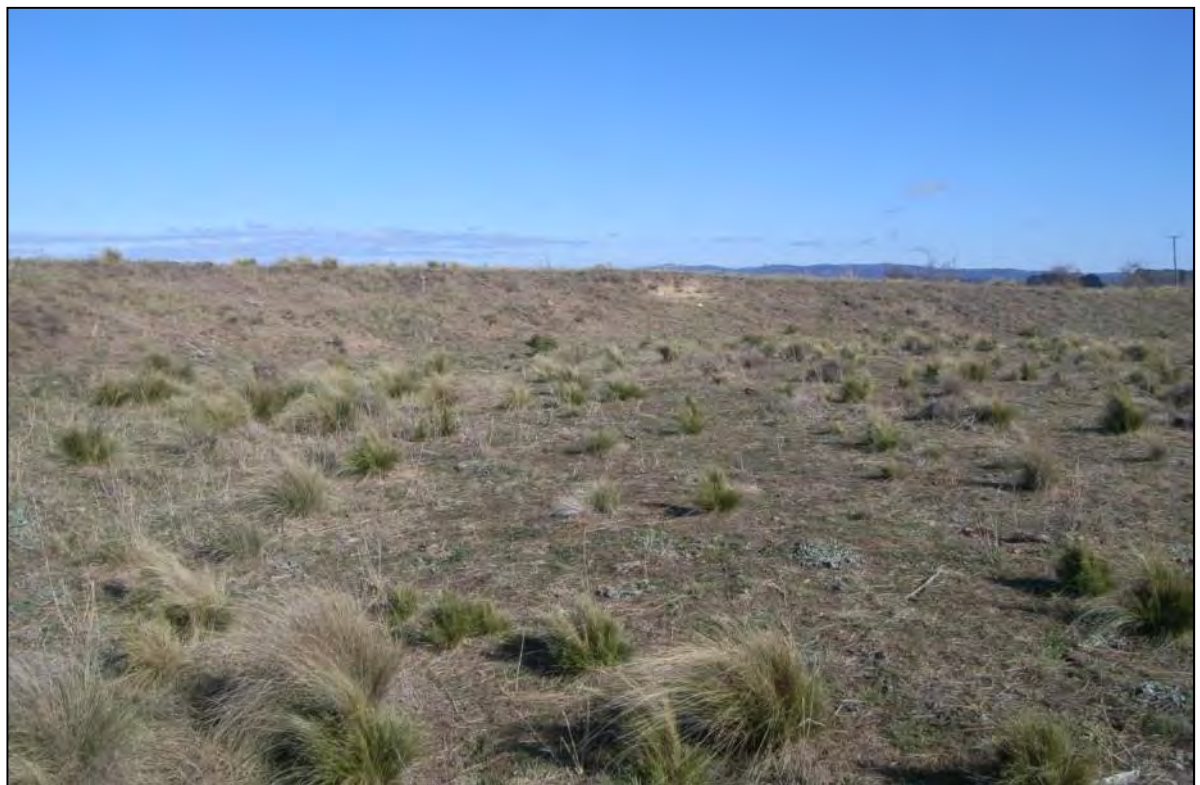
Plate 10. SU30/L3 looking south.

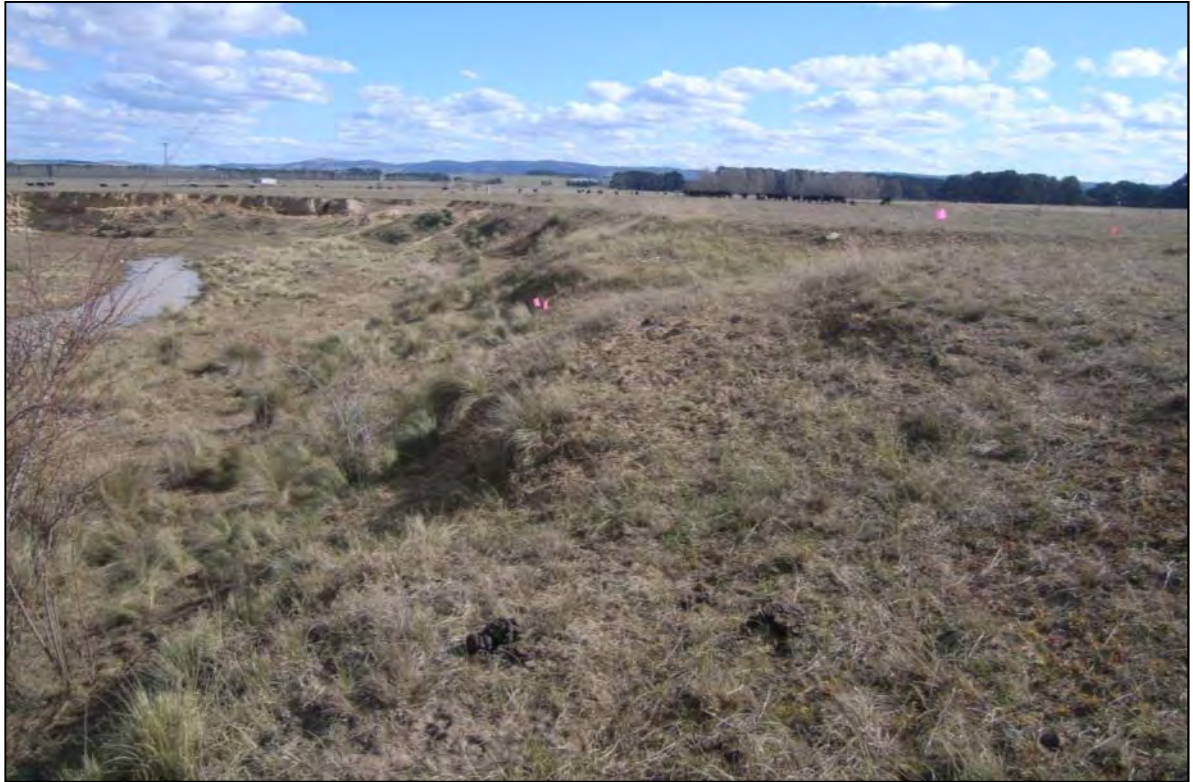
Plate 11. SU30/L4 southwest.

| Locale | Type | Size (size class unless otherwise indicated) | Material | Comments |
|---|---|---|---|---|
| SU30/L4 | Broken pebble | 11 | Metasedimentary | Crushing at one end 45 x 20 mm; abraded usewear - area 20 x 20 mm |

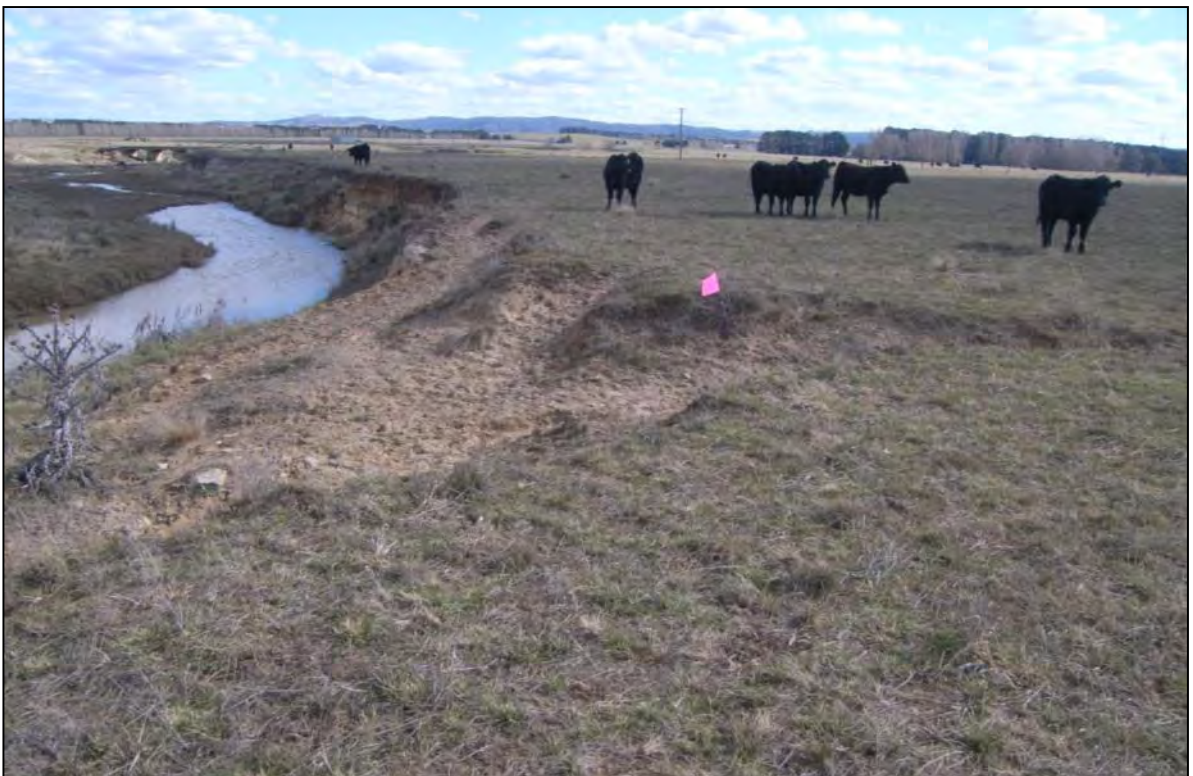
| SU | Locale | Easting | Northing | Area | Exposure | Context | Exposure | Visibility | Artefact Number | Predicted Density | Integrity | Subsurface potential at site | Subsurface potential away from site | Impacts |
|---|---|---|---|---|---|---|---|---|---|---|---|---|---|---|
| SU30<br>(Plate 12) | L5 | 727294 | 6101443 | 25 x 10 | eroded creek<br>bank, stock<br>track | On edge of drainage<br>depression; aspect:<br>open; | 70 | 70 | 1 | low | disturbed;<br>eroding | Yes | Yes | Impacts<br>unlikely |

Plate 12. SU30/L5 looking southwest.

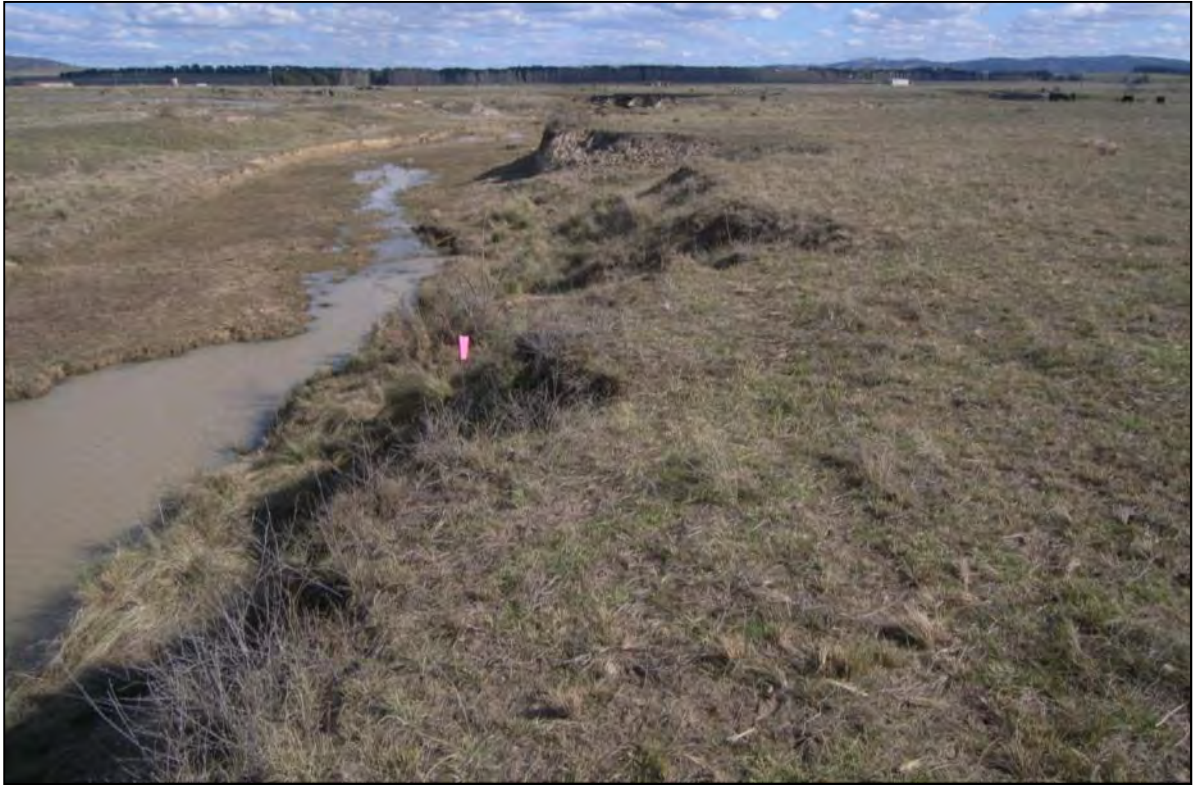
Plate 13. SU30/L6 looking south.

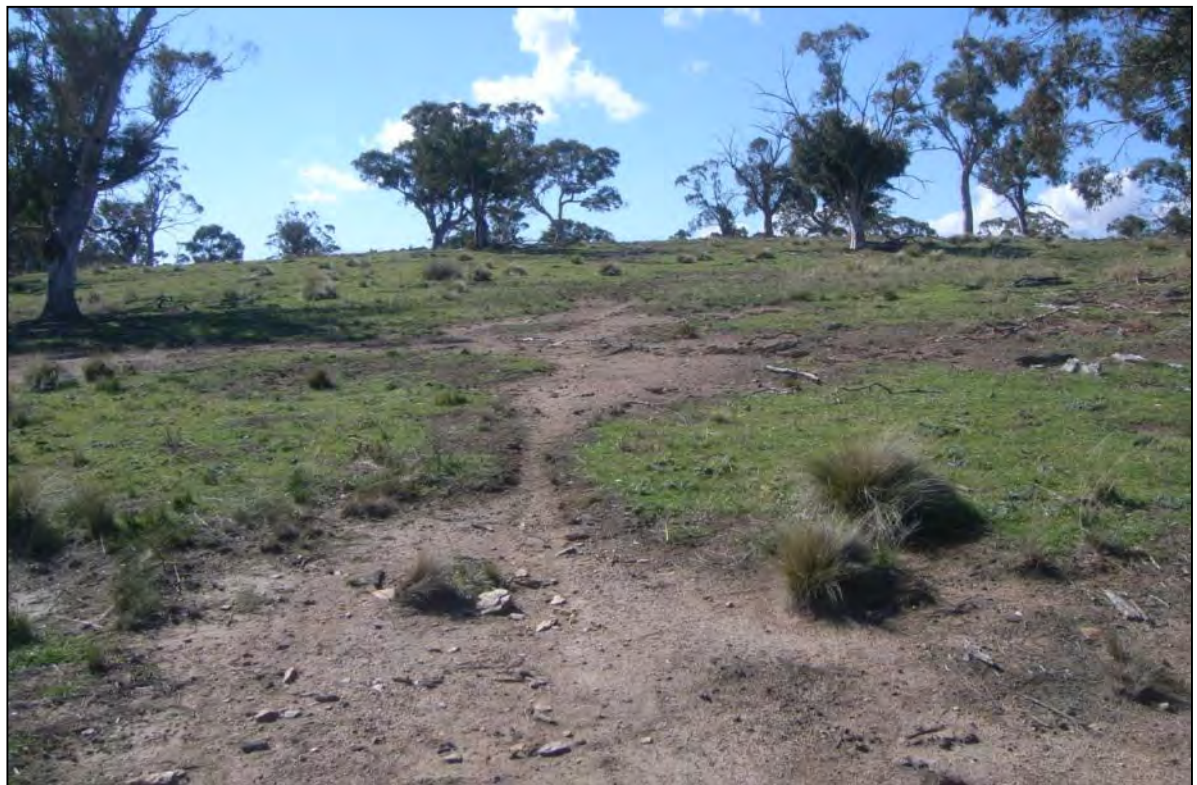
Plate 14. SU35/L1 looking northeast.

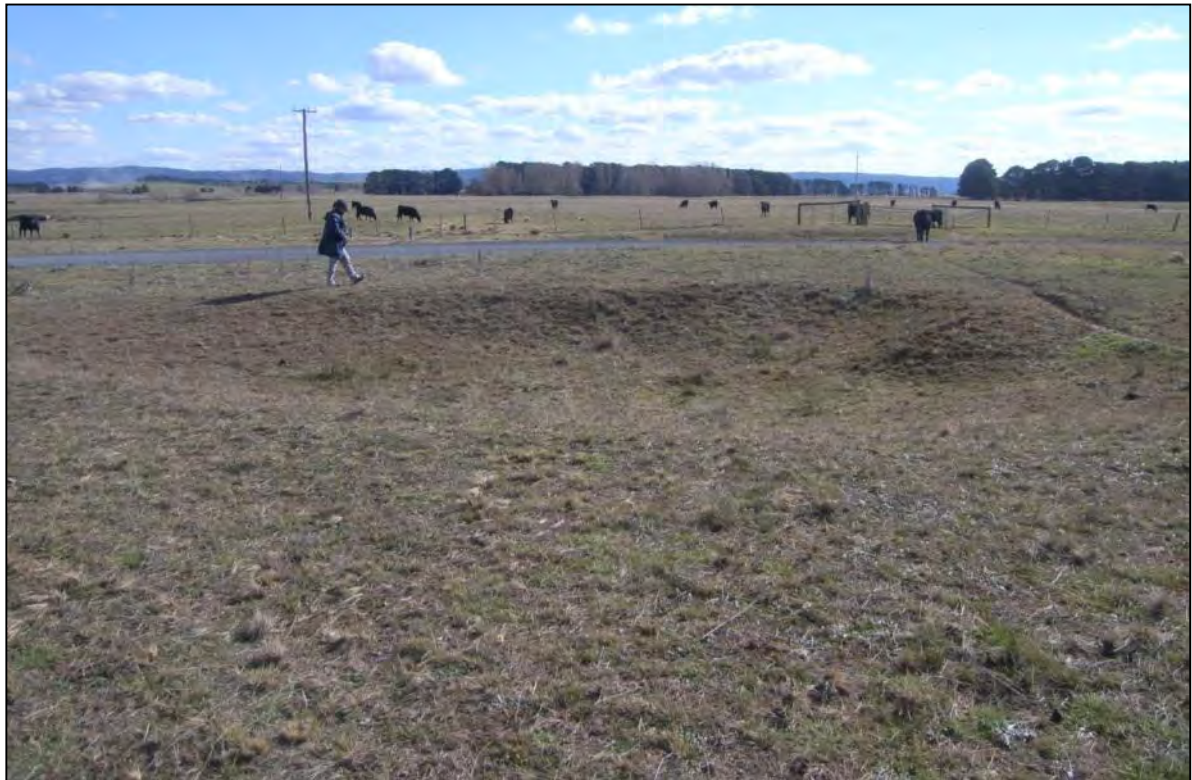
Plate 15. SU38/L1 looking west.

| Locale | Type | Size (size class unless otherwise indicated) | Material | Comments |
|---|---|---|---|---|
| SU38/L1 | Flake fragment | 3 | White quartz | |
| SU38/L1 | Ground edge hatchet fragment | 33 x 27 x 6 mm | Grey volcanic | Discoid chip with ground edge on 1 side; most probably broken piece from ground edged hatchet |

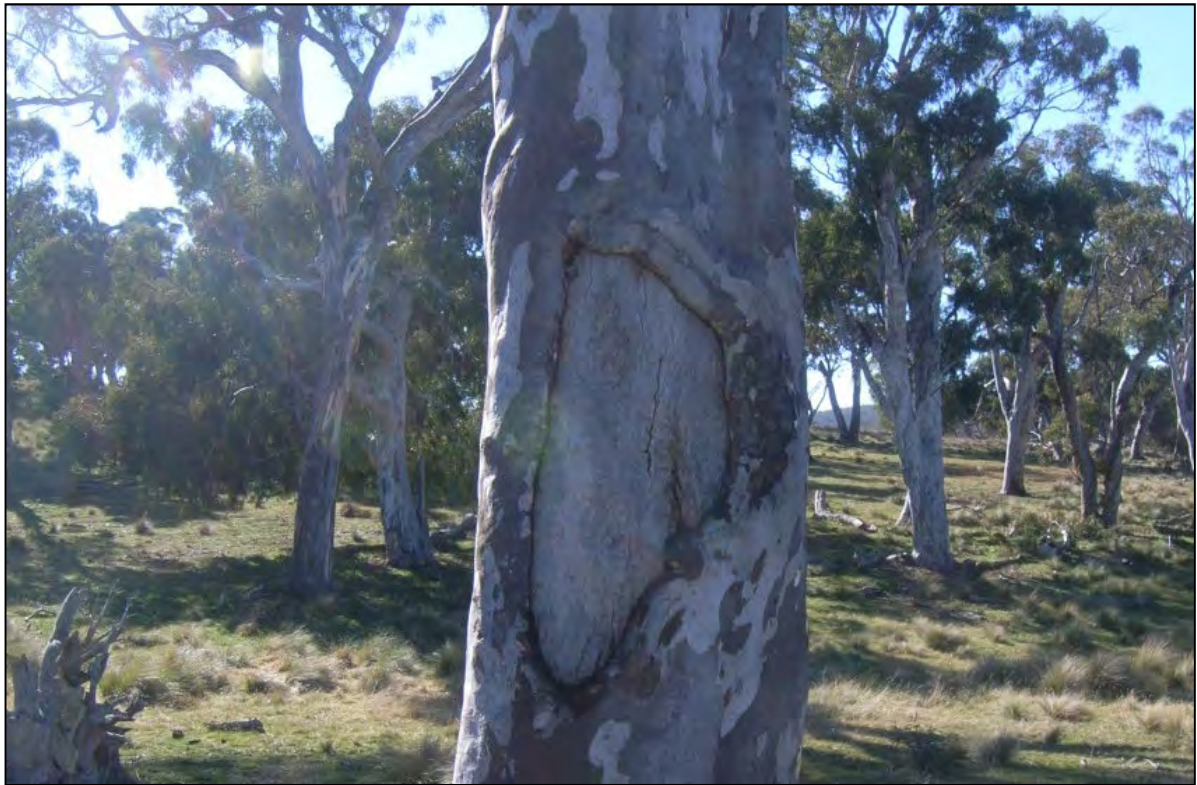
Plate 16. SU31/Tree1

This tree is a Brittle Gum (*Eucalyptus mannifera*) located in Survey Unit 31, amongst a stand of trees of similar age and type (Plate 16). The tree is c. 15 m tall. It has an asymmetrical area of exposed heartwood scarring that measures 900 cm in length and 41 cm in width, the base of which is located 1.38 m above the ground. The tree has a circumference of 2.2 m at the point of scarring. There are no incision marks on the exposed heartwood

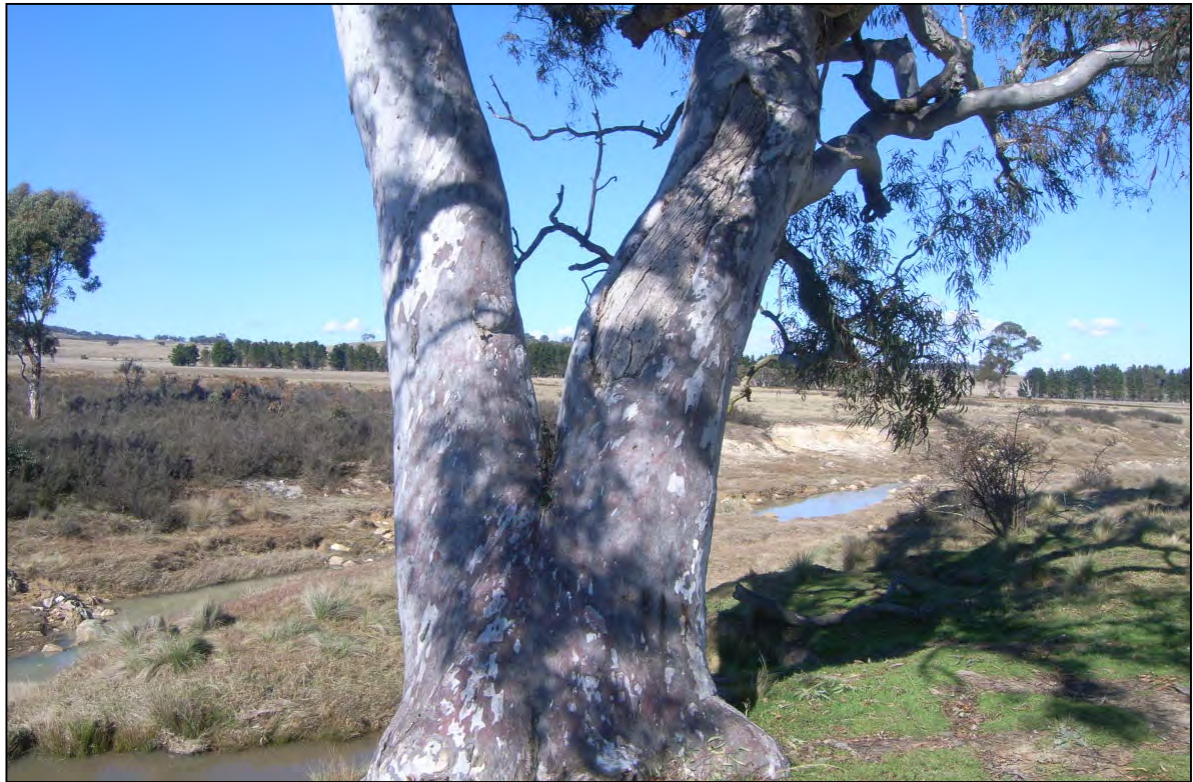
Plate 17. SU33/Tree2

This tree, also a Brittle Gum (*E. mannifera*), is located in Survey Unit 33 immediately adjacent to the creekline (Plate 17). A significant area of the trees' root system nearest to the creek has been exposed and undermined by erosion. The tree is c 13 m tall. It is divided into two main trunks from just above its base, with an area of exposed heartwood on the upper surface of one of the trunks as it angles away from the vertical. The area of exposed heartwood measures 215 cm in length and tapers inwards from its widest point of 60 cm at its base to its narrowest point, 28 cm, at its upper limit. The lowest point of the exposed area is located 1.80 m above the ground. The tree has a circumference of 2.9 m at the point of scarring. There are no incision marks on the exposed heartwood.
