Submissions Report

MANILDRA SOLAR FARM

DECEMBER 2010

Manildra Solar Farm Submissions Report

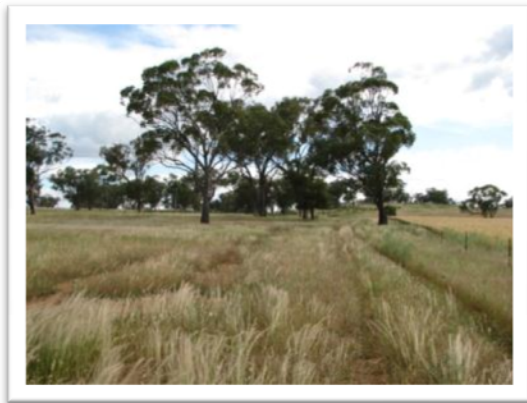
Figure 3-1 Area 3 showing patches of native grasses in foreground.

1. The treeless area within Area 3 comprised a mix of native grasses and exotic groundcover and has been reassessed as Box Gum Woodland Derived Grassland (EEC TSC) in poor condition (refer to Figure 3-1).
2. Area 7 as outlined in Figure 2-1, was dominated by native Spear Grasses (*Austrostipa* spp.) at the time of the survey and has also been reassessed as Box Gum Woodland Derived Grassland (EEC TSC) in poor condition (refer to Figure 3-2).

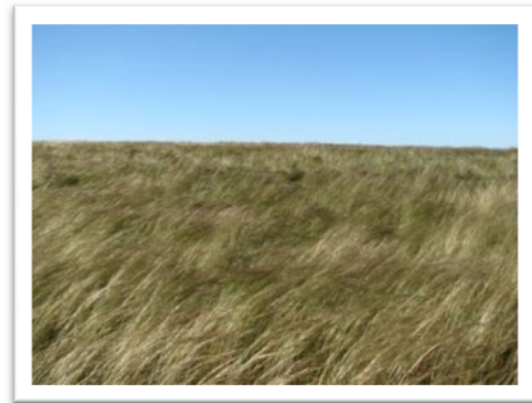
Figure 3-2 Area 7 showing dominant native Spear Grasses.

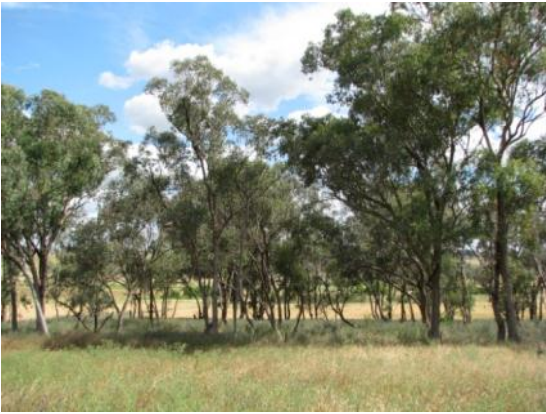
Location	Notes	Photo	Located within Development Envelope?
Area 1	Remnant White Box Woodland surrounded by cropped land. Groundcover predominately exotic with only minor patches of native grasses and no midstorey structure. Limited hollow bearing tree potential due to the age class of the vegetation however some dead stags noted which may provide small fissures for microbats. Embedded granitic surface rocks and small areas of fallen timber (<5% cover) provide limited reptile habitat. No mistletoe observed.

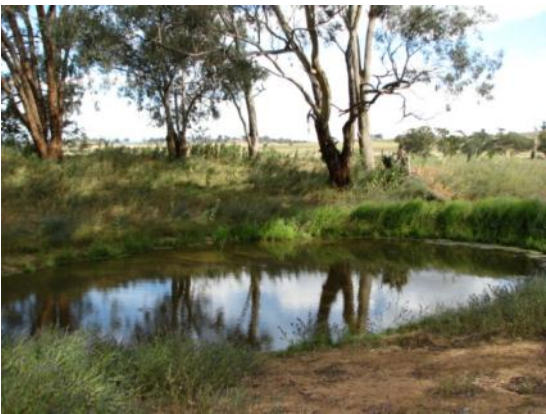
No
Area 2	Small isolated stand of eight Yellow Box trees surrounding small dam (5m x 3m) within cropped area. Groundcover predominately exotic (80% cover) including Paterson's Curse, Sowthistle, Wild Oats and Perennial Ryegrass with one small patch (2m x 2m) of native Spear Grass. Limited fringing vegetation around dam and no emergent aquatic vegetation. Bubbles observed on dam surface possibly from tortoises (tortoise shell found in adjacent paddock). Trees, including one dead stag, likely to comprise small hollows and fissures although no obvious hollows were observed. No mistletoe noted.

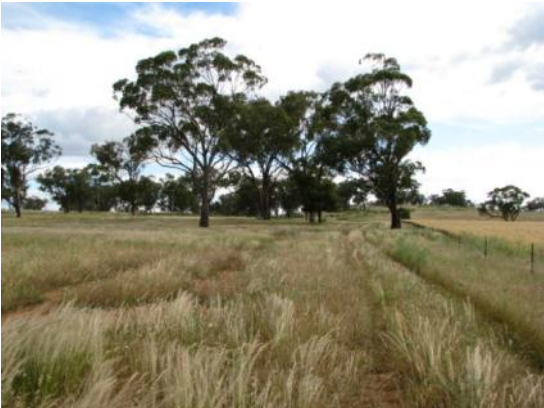
Location	Notes	Photo	Located within Development Envelope?
Area 3	<p>Small area of four White Box trees (20-22m tall) DBH range 30-120cm within narrow paddock area. Midstorey structure minimal with only two Kurrajong trees present. Groundcover comprises a mosaic of native grasses (Spear Grass, Wallaby Grass and Windmill Grass) and exotic species including Perennial Rye, Barley Grass and Spear Thistle. Two species of the common native Bluebell (<i>Wahlenbergia stricta</i> and <i>W. communis</i>) were also noted as common throughout the patches of native grass although general native diversity was low with no other native forbs observed. Three hollow bearing trees were noted in this area, potentially providing habitat for hollow dependent fauna species. However, no scratch marks were present on the tree trunks and no evidence of parrot nesting was observed (for details of the hollows refer to Table 3-3). Small area of fallen timber noted at tree bases and minimal exposed surface rock (<1% cover).</p>

Yes, proposal would require the removal of three hollow bearing trees from this area (refer to Table 3-3).

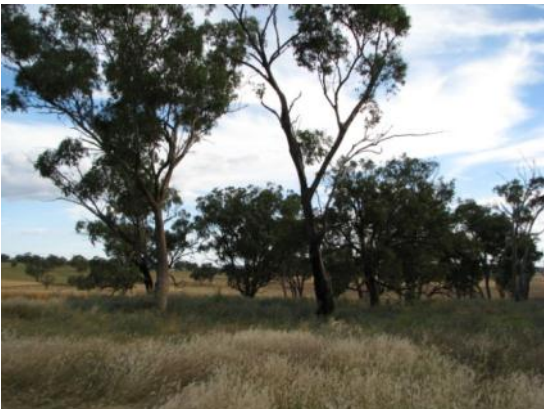
Area 4	<p>Small isolated stand of remnant White Box (15-20m tall) DBH 20-50cm, less than 5% canopy cover with scattered Kurrajong trees in the midstorey. Groundcover predominately exotic, particularly surrounding tree bases. Approximately 10-15 hollow bearing trees, including a number of dead stags with small hollows and fissures located in this area. Limited reptile habitat with only small areas of fallen timber (<2% cover) and no rock outcrops. Large concrete tank with no top located just to the north of the stand.</p> <p>Area currently used for bee boxes</p>

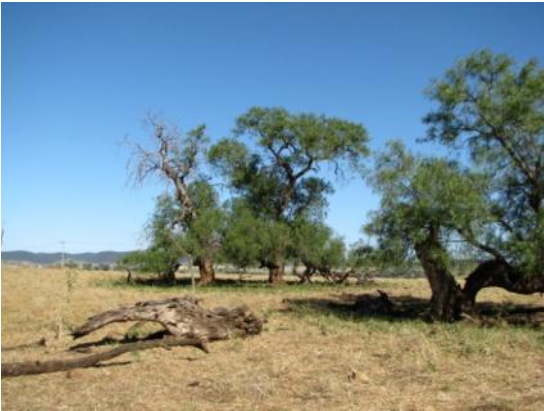
Location	Notes	Photo	Located within Development Envelope?
Area 5	Isolated stand of four Pepper trees (one hollow bearing). Groundcover heavily grazed and dominated by exotic species. Areas of fallen timber and rock outcrops/piles present although these areas are generally disturbed by stock and past cultivation suggesting that the habitat is not suitable for threatened reptile species.

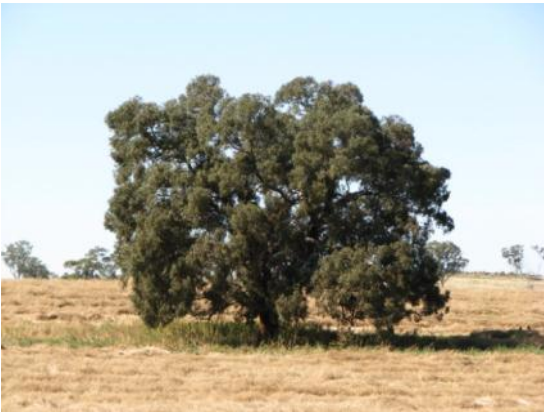
Yes
Area 6	Solitary, isolated Yellow Box tree (15m tall, DBH 70cm) surrounded by cropped land with exotic groundcover species occurring beneath the tree. No hollows observed. Minimal habitat value for fauna.

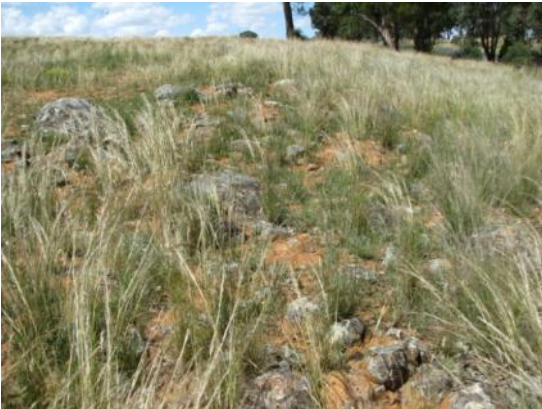
Location	Notes	Photo	Located within Development Envelope?
Area 8	<p>Western paddock comprises a mosaic of native grassland and exotic groundcover. This area comprised the greatest diversity of native forb species and also contains large rock outcrop areas. These rocky areas represent the best quality reptile habitat within the subject site due to the presence of native grasses and low to moderate grazing levels. However, findings of this survey confirmed the finding of the BA in that the rocks present are largely embedded (providing few shelter sites for species with a preference for shallowly embedded or surface rocks such as Pink-tailed Worm-lizard and terrestrial skinks) and food resources are limited (few black ant nests were discovered under rocks – 1 nest for 30 rocks rolled). These rocky outcrop areas were also being utilised by stock at the time of the survey.</p>

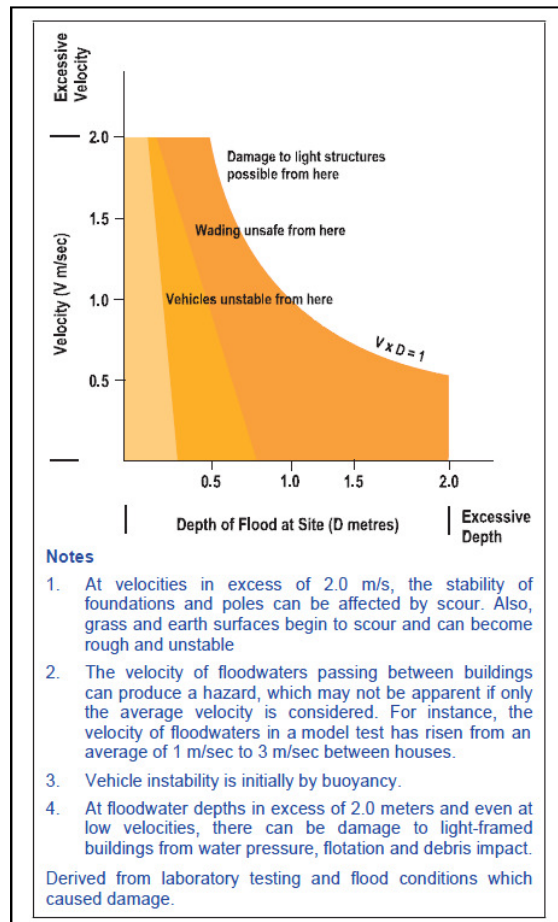
Figure.3 – Velocity & Depth Relationships (DIPNR, 2005)

To determine the most appropriate location for maintenance access crossings of the drainage line reference should be made to Figure L1 of the Floodplain Development Manual (DIPNR, 2005) and shown below in Figure.3 which indicates safe depths and velocities for vehicles. Locating crossings within the safe range will ensure maintenance access to the entire development site is available even during a major storm event.

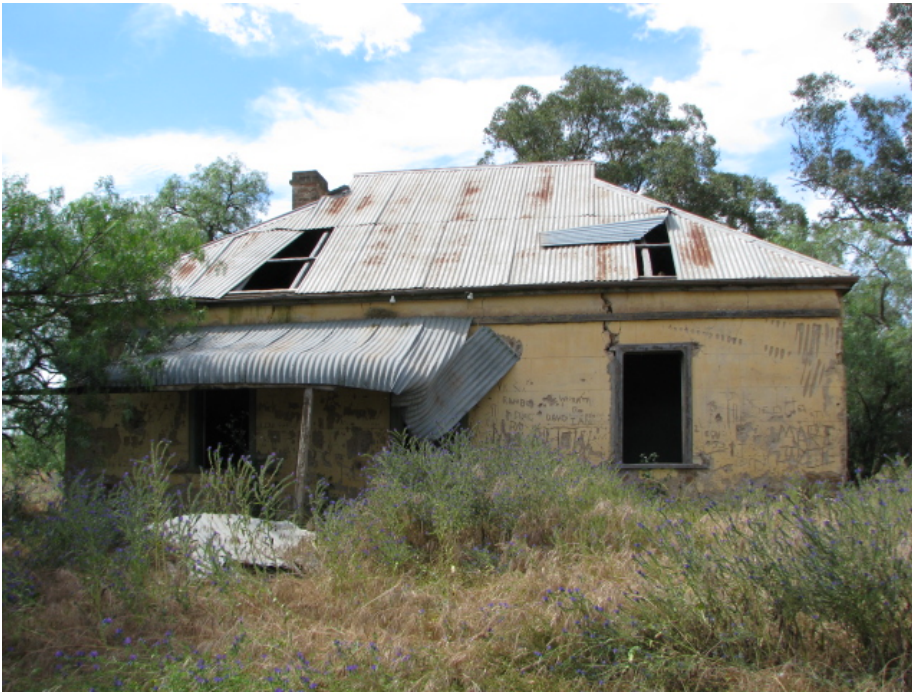
Figure 3.5. Remains of stone cottage (south)

The building of early farmhouses and sheds was usually undertaken by the farmer himself. He may have had help from friends and neighbours, or from a local self-taught builder. Materials used were those that were available and bark, split logs and shingles were pressed into use, and some used stone (Figure 3.5). Many people managed to obtain corrugated iron for use in building (Figure 3.6). Houses were usually square, sometimes with a hall up the centre. The kitchen was often a separate room at the back (Stapleton 1982).

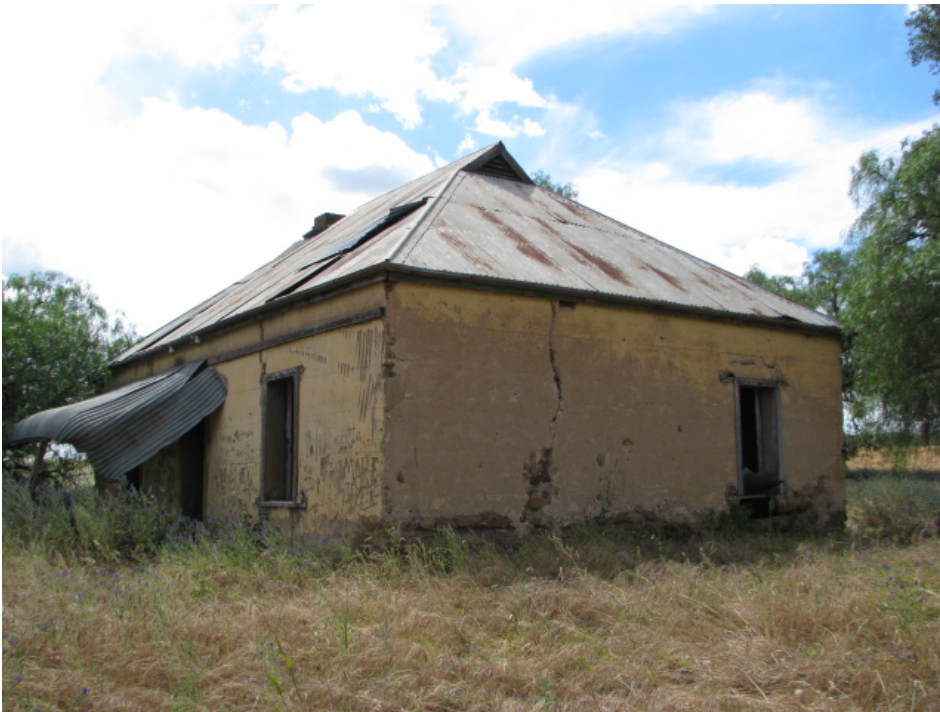
The building consists of a corrugated iron roof and outdoor kitchen, but is currently in very poor condition. No previous assessment of significance appears to have been prepared for this item. The cottage is located near the access road into the property and is of potential heritage significance for at least its historical association with the early settlement of the Manildra area.

Figure 4.1. South East elevation of the stone cottage

SoC	Impact	Objective	Mitigation tasks	Project phase	Auditing
51	Impact to a potential heritage item (abandoned cottage)	Manage direct impacts	<p>Should direct impacts on the cottage ruin or part of its built fabric be required (including road upgrades or heavy vehicle vibration), impacts would be managed in accordance with the assessment of heritage significance recommendations, above, and in consultation with an noise and vibration specialist.</p> <p>This may include:</p> <ul style="list-style-type: none"> Traffic management measures, such as 'go slow' areas or vibration loggers Fencing or demarcating the site Clear identification of the feature on CEMP site maps and staff induction 	Construction	CEMP
52	Disturbance to a potential historic relic	Minimise disturbance	In the event of an item of heritage significance being uncovered at the proposal site after works commence, the NSW Heritage Branch (Department of Planning) should be contacted prior to further work being undertaken at the site.	Construction Decommissioning	CEMP

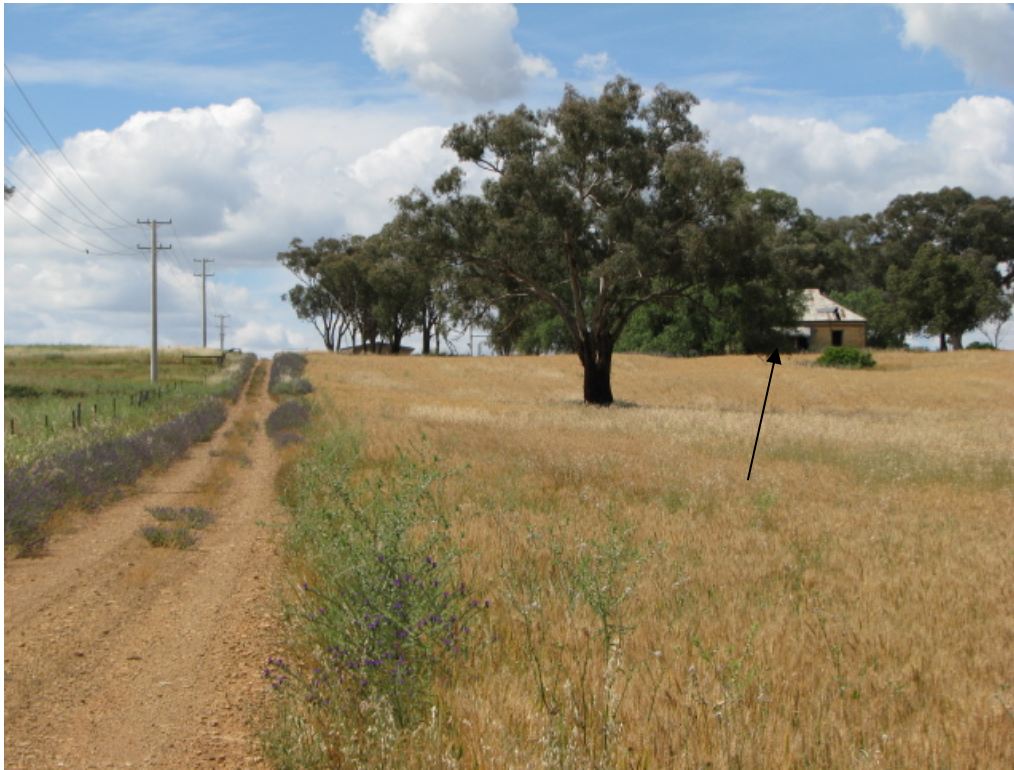
The proposed solar farm site at Manildra is largely cleared and is used for cropping of wheat and canola and pasture for cattle and sheep. The site contains an existing substation located approximately 40 metres north of the cottage (Figure 4.2). The property is located approximately 1.5km north-east of the Manildra township.

Figure 4.2. Location of the cottage (arrow) in relation to the access road (left)

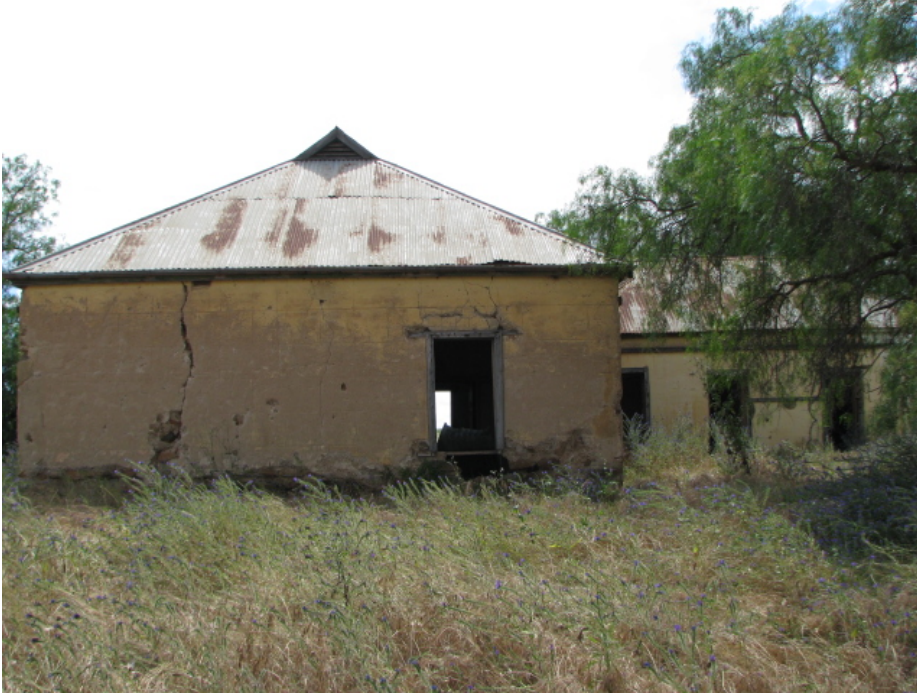
Figure 4.3. East elevation of the stone cottage

The design of the cottage is considered to be fairly typical of the day and consists of stone cladding, timber frame and iron roof (Figure 4.3). The main section of the cottage is rectangular, with a smaller perpendicular extension to the rear (Figure 4.4). This was likely to be a kitchen with additional storage space or laundry.

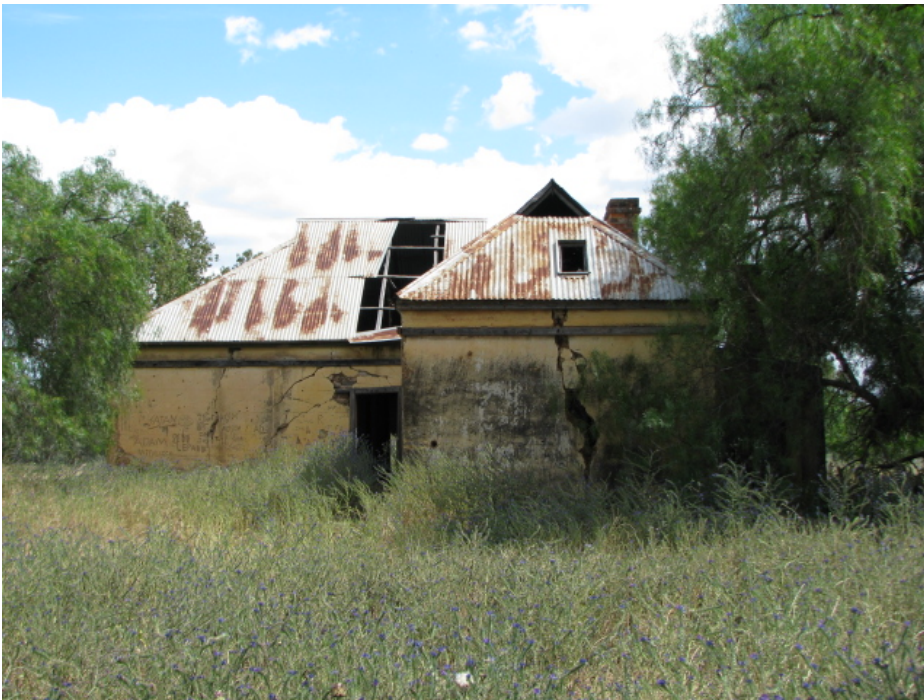
Figure 4.4. Northern elevation of the stone cottage with extension to the rear

The exterior and interior of the cottage is in poor condition. Sections of the cladding are in poor condition showing significant signs of decay, and are cracked (see above photo).

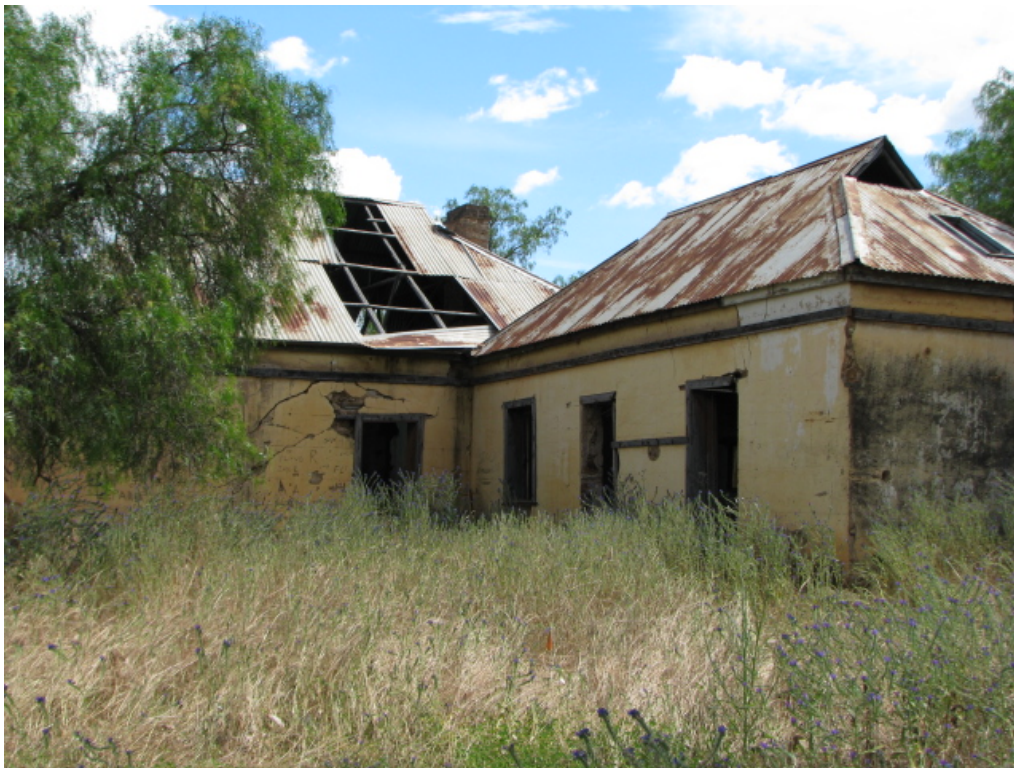
Figure 4.5. North east elevation that shows part of the roof in good condition and other sections loose and falling apart

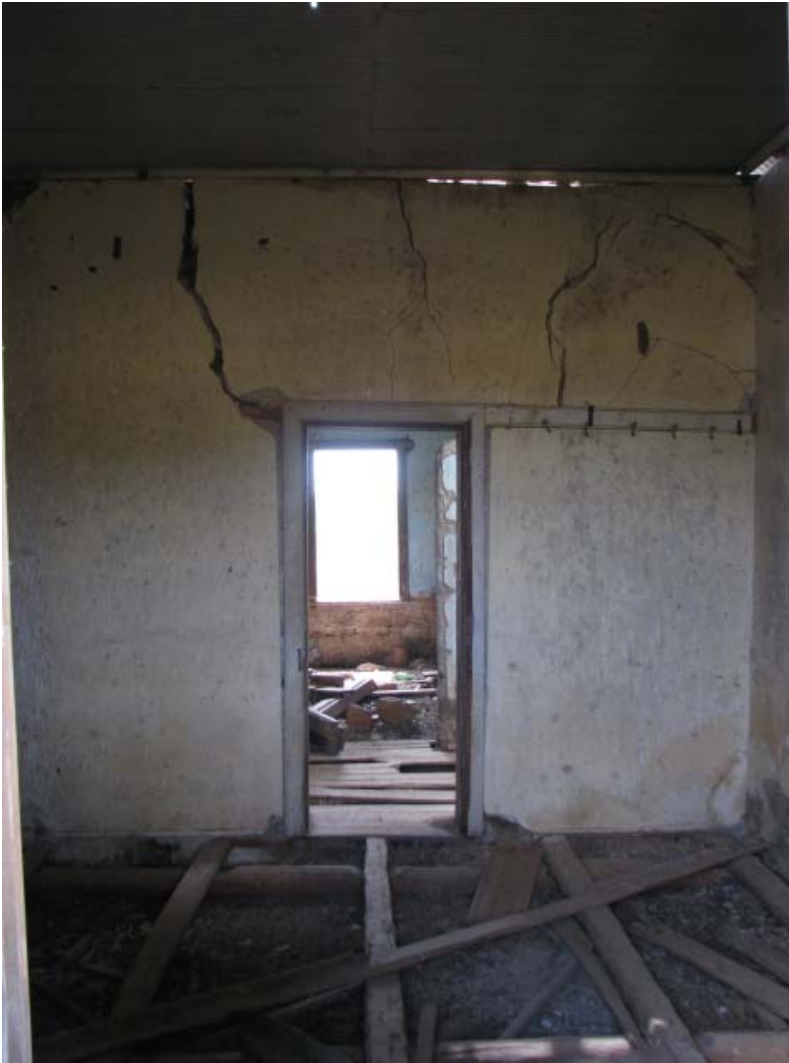
Figure 4.6. Interior flooring of a room in the main cottage

The floors are located close to ground level and sub floor spaces would lack ventilation. Other flooring in the house is poor but is in better condition than the room below (Figure 4.6).
