# Preliminary Site Investigation

Huntlee Future Council Lot

304001022-015

Prepared for  
Huntlee Pty Ltd

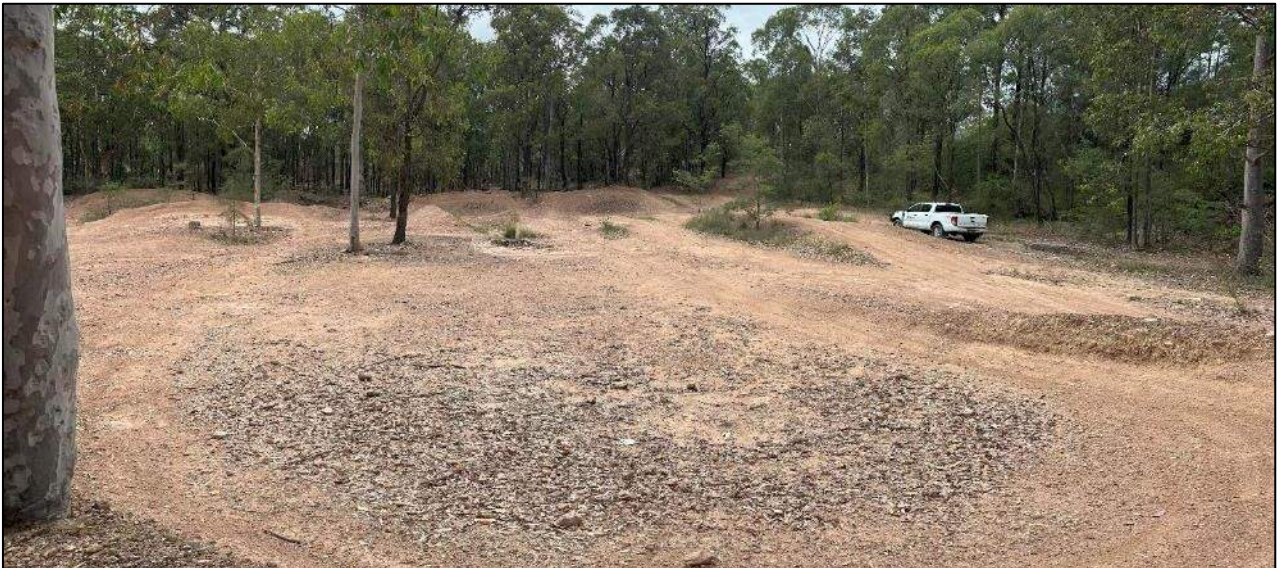
| Item | Observations |
|---|---|
| Site cut and fill | <ul style="list-style-type: none"> <li>Extensive cutting to the heavily disturbed site area, with excavations in excess of 1.0m below former rock head level observed in areas consistent with quarry activities.</li> <li>Filled mounds / berms of overburden materials used for recreational motor bike activities (see Figure 5-4 below).</li> <li>No significant volumes of CWR fill materials were observed within the site extents. However, larger volumes of CWR materials were observed/encountered offsite within the nearby colliery area.</li> <li>Significant cutting and uncontrolled fill materials to the west and south associated with the discontinued colliery and quarry sites.</li> </ul> |

Figure 5-2 General view of heavily disturbed site area - looking south

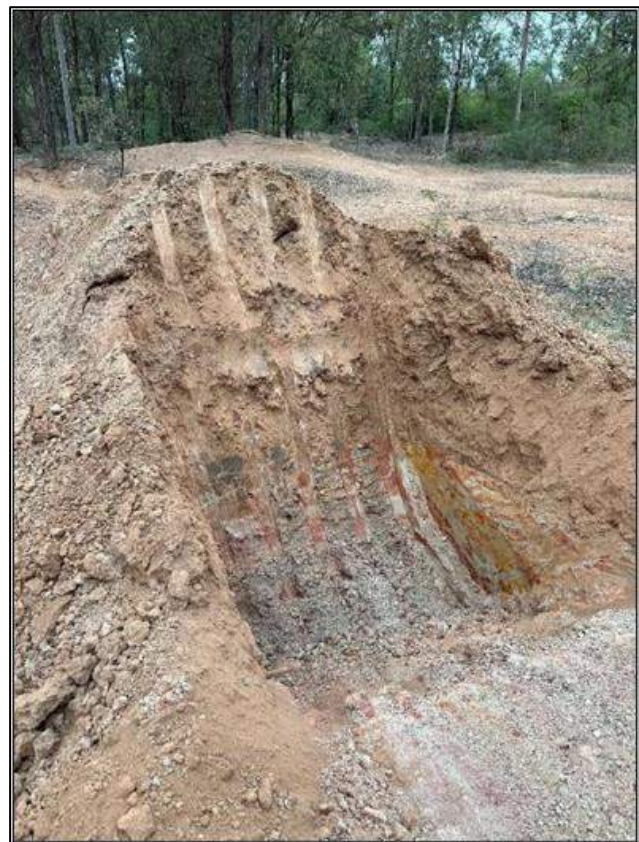
Figure 5-4 Typical existing overburden fill pile overlying in-situ residual soils and weathered materials ('TPCL02') - looking south

Uncontrolled fill materials were encountered in isolated areas across the subject site, however predominant within the heavily disturbed portion of the site. Uncontrolled filling was generally comprised small soil stockpiles and berms / mounds with observed materials comprising:

- > Natural overburden materials, consisting of clayey to clayey gravelly sand likely derived from site-won weathered rock materials, and silty sand materials of similar surficial topsoils and colluvium.
- > Minor surficial observations of coal wash materials towards the western site extent. CWR occurrences within the site extent were predominantly minor surficial fragments, with significant volumes not observed.
