## **Phase 1 Contamination Report – Eastern Creek**

AECOM Australia (Pty Ltd) was engaged by CB Richard Ellis (CBRE) on behalf of Hewlett Packard to complete a Phase 1 Contamination Report for the site located between Roberts Road and Capicure Drive (the Site). The Site is located within a broader area referred to as the M7 Business Hub, within Blacktown City Council Local Government Area (LGA). The location of the Site is shown in **Figure 1**.

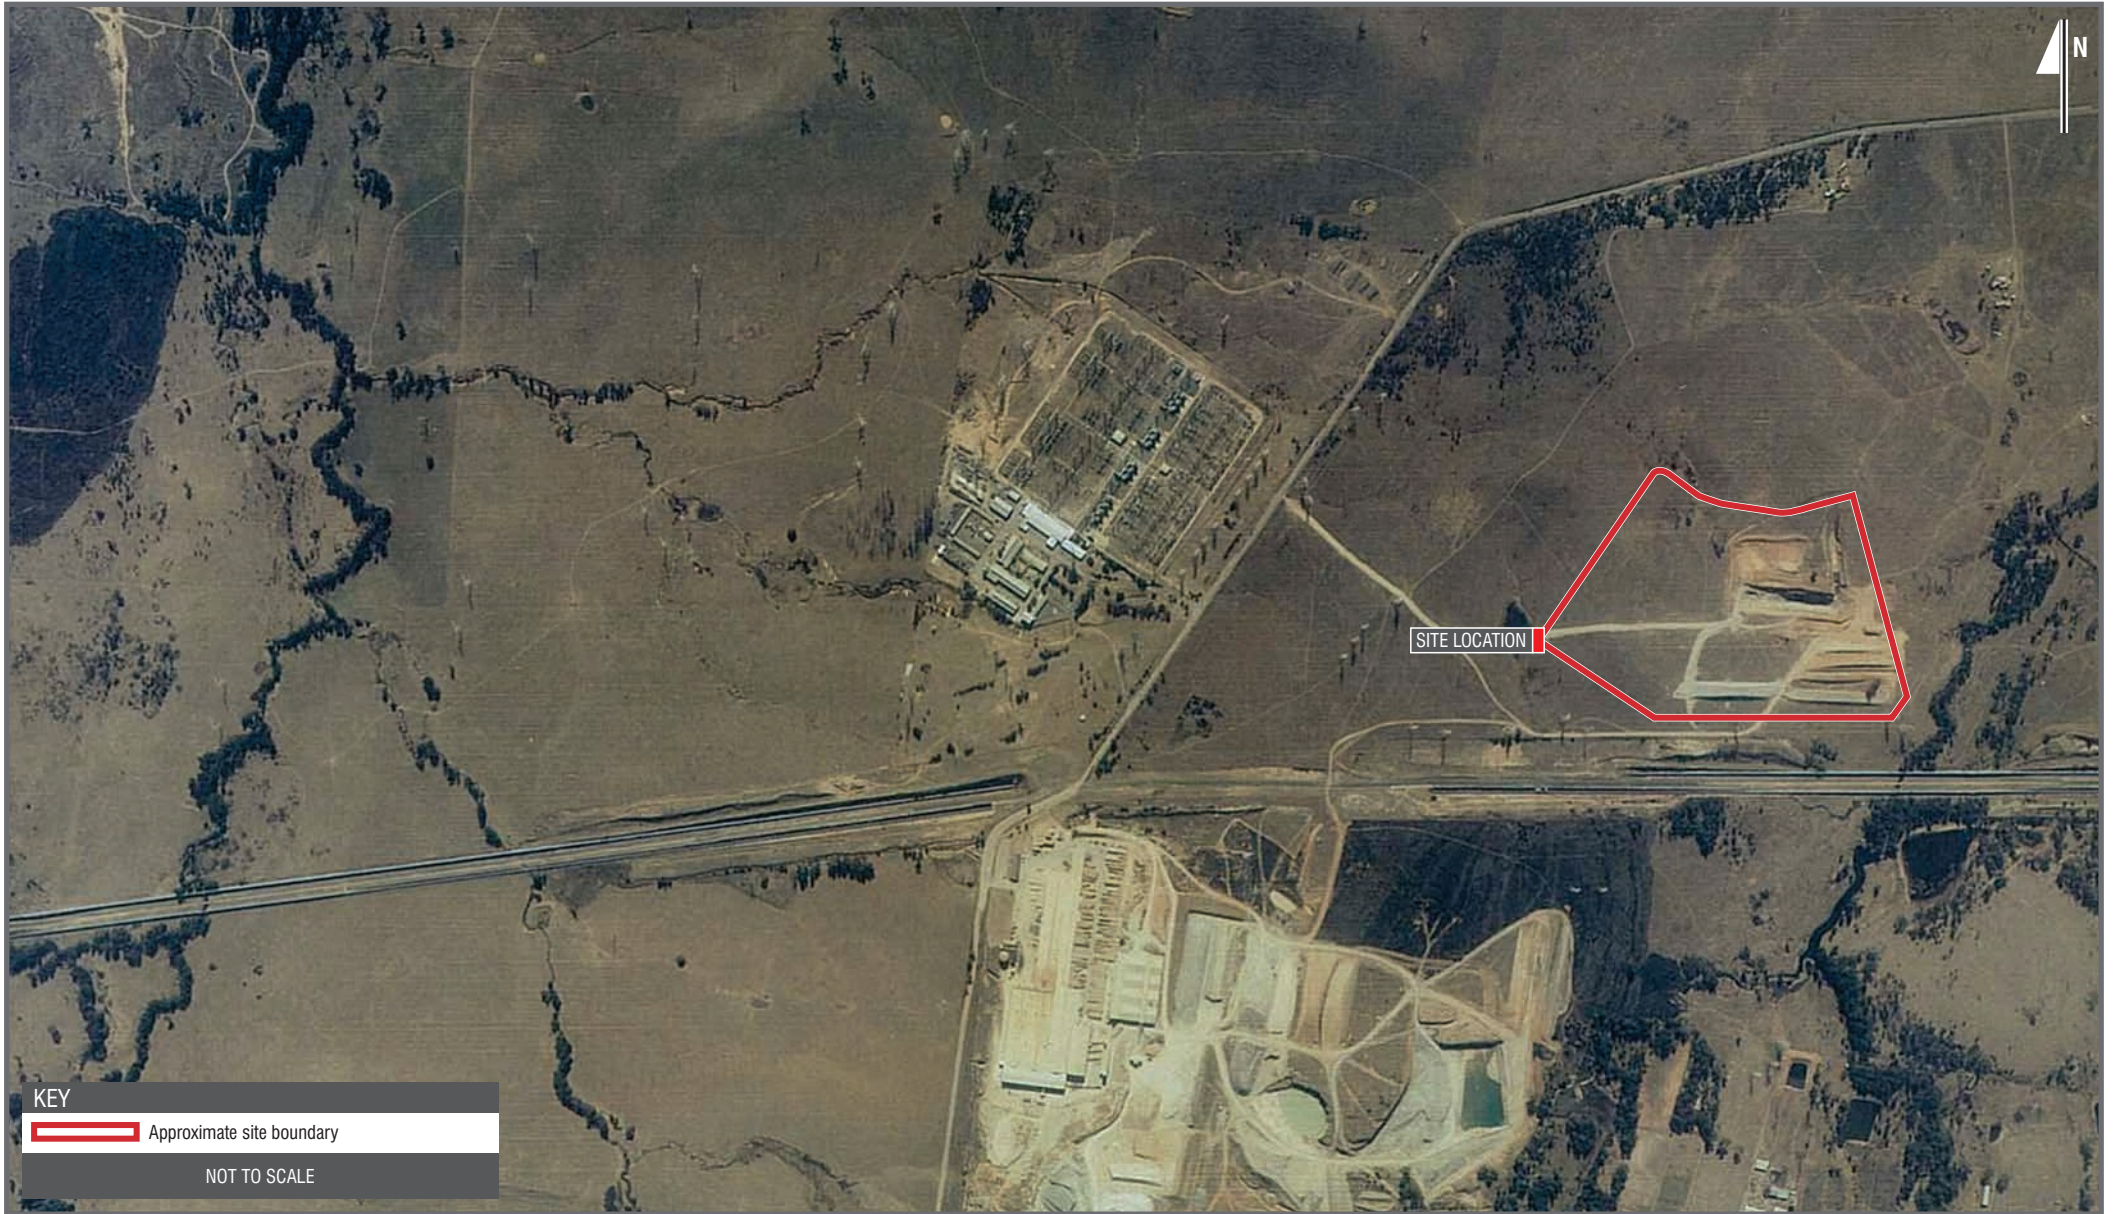
FIGURE 7

| Photograph details | Description |
|---|---|
| April 1978<br>County of Cumberland Run 14<br>Black and White<br>(Figure 7) | <p>Site: The Site appears similar to the 1970 aerial photograph.</p> <p>Surrounds: The surrounds appear similar to the 1970 aerial photograph. To the east of the Site, earthworks/quarrying appears to have commenced in the area of land that had been cleared in the 1970 aerial photograph. To the southwest of the Site, a large portion of land has been cleared and multiple warehouses have been constructed. Earthworks/quarrying appears to have commenced in the vicinity of the warehouses.</p> |

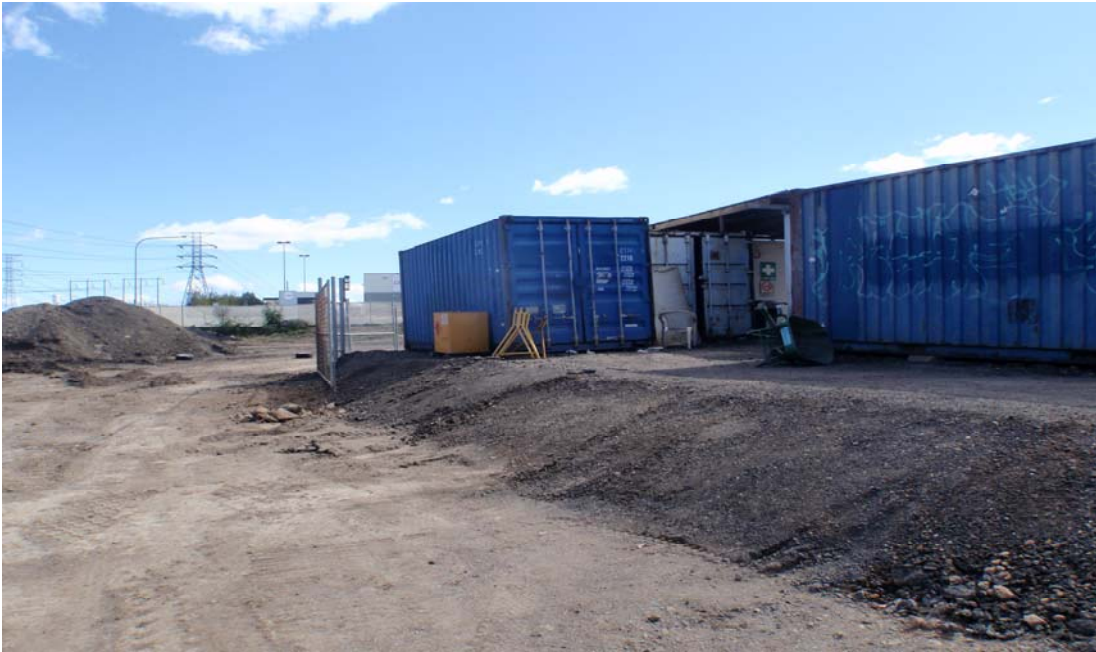
| <b>Plate No.</b><br><b>1</b> | <b>Date:</b><br>25/08/10 | | |

No apparent surface drainage features were observed within the Site office area. Water used to service the Site office and associated facilities appears to be collected in a rain water tank and distributed to the kitchen and toilet facilities via an aboveground pipe system. Water that has accumulated within the base of Pit 2 (generally rainwater) is pumped from the pit and transported to a pond located to the east of the site and adjacent Reedy Creek. Overflow from the ponds is directed into a gross pollutant trap (**Plate 2**) which discharges to Reedy Creek via a rock lined channel (**Plate 3**).

| <b>Description:</b><br>Site Office and Associated Facilities | | | |

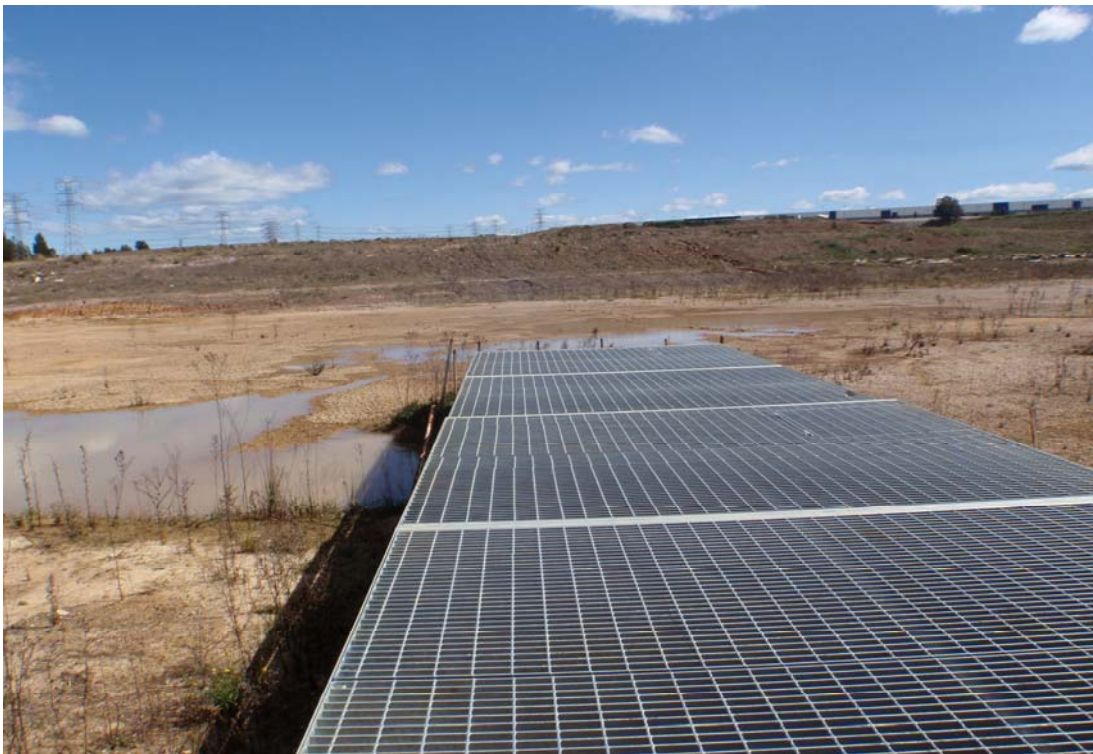
| <b>Plate No.</b><br><b>2</b> | <b>Date:</b><br>25/08/10 | |

| <b>Description:</b><br>Gross Pollutant Trap | | |

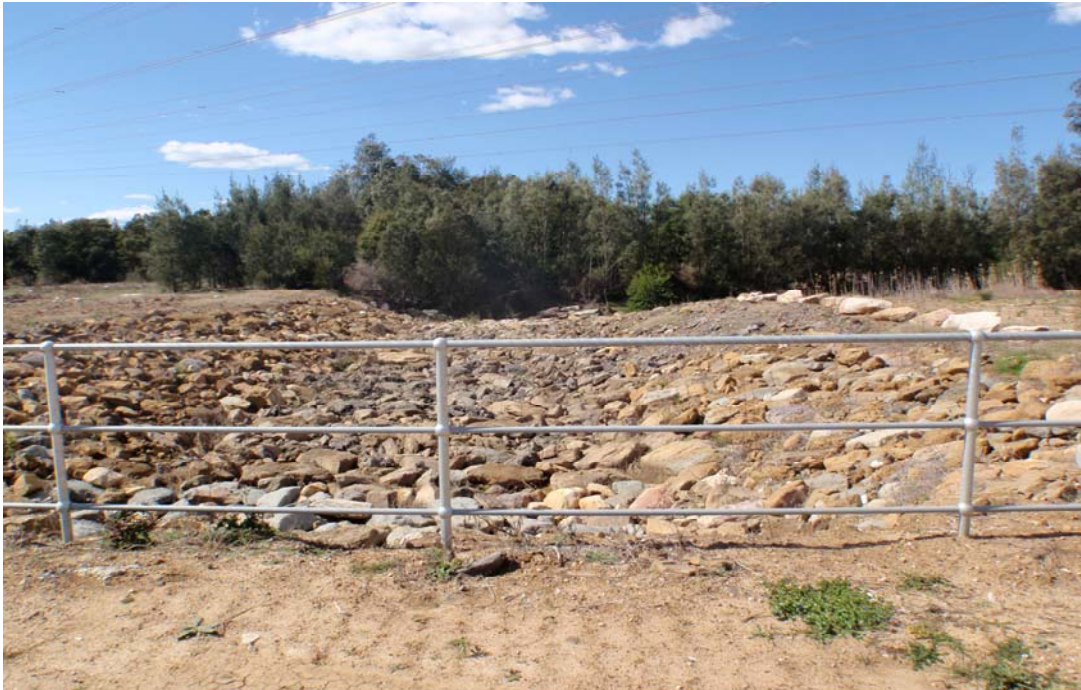
| <b>Plate No.</b><br><b>3</b> | <b>Date:</b><br>25/08/10 | | |

| <b>Description:</b><br>Rock-lined Channel | | | |

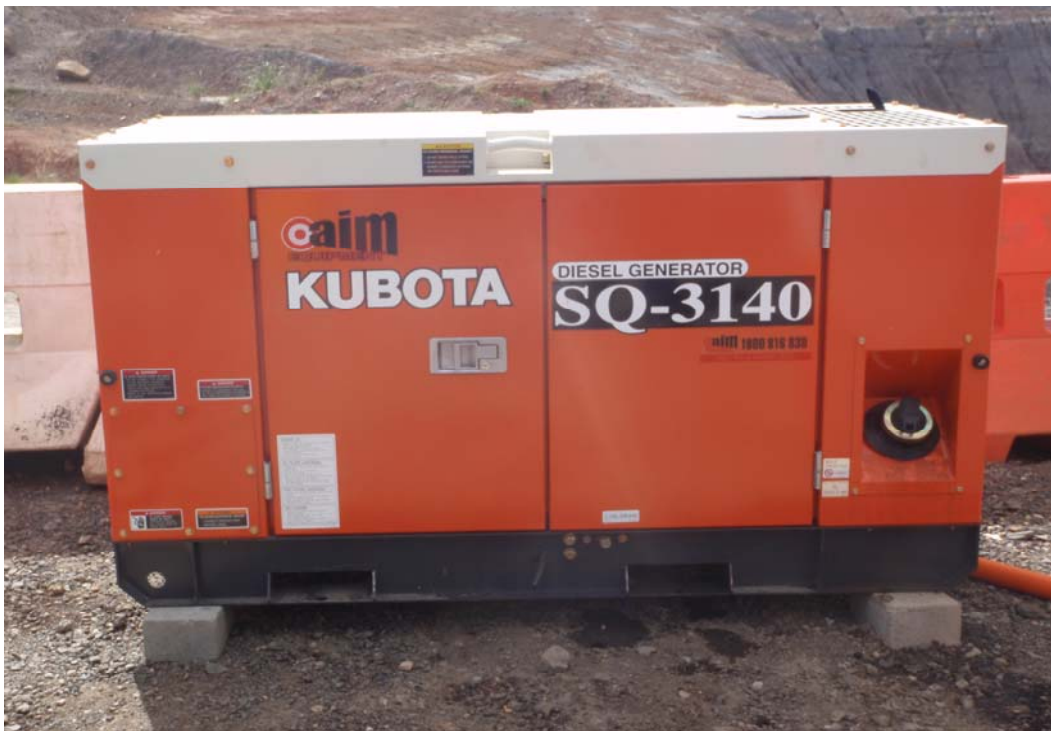
| <b>Plate No.</b><br><b>4</b> | <b>Date:</b><br>25/08/10 | |

| <b>Description:</b><br>Diesel Fueled Generator | | |

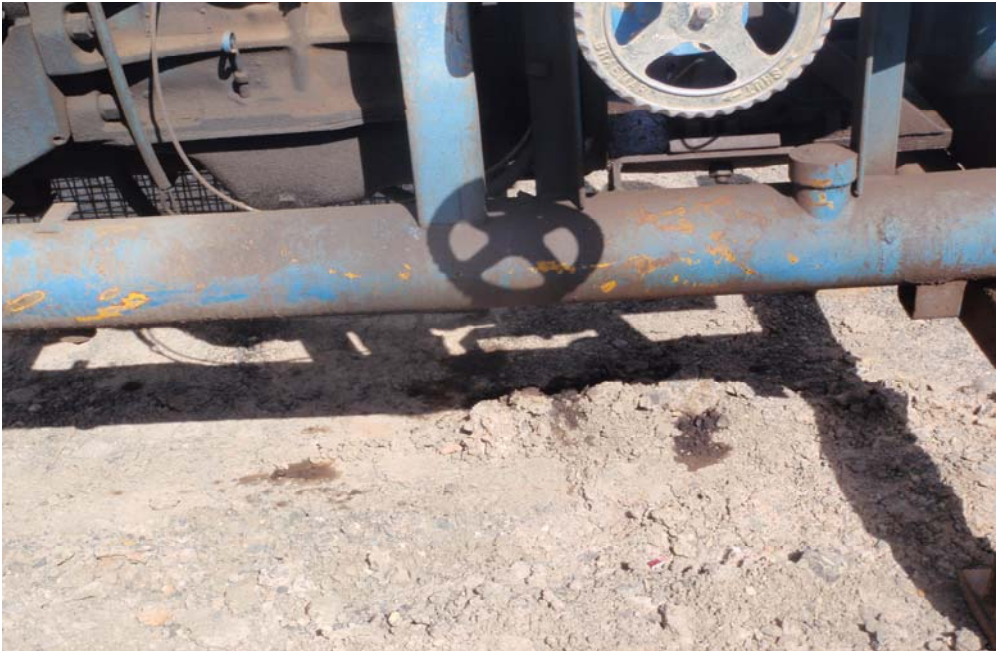
| <b>Plate No.</b><br><b>5</b> | <b>Date:</b><br>25/08/10 | | |

Minor surface staining was noted at two locations within the general Site office area, beneath some disused machinery and a disused engine (**Plate 5**). Minor staining was also noted on the outside of the shipping container (**Plate 6**) used for the storage of unleaded fuel, however no staining of the surface soil was observed at this location. The shipping container was locked during the site inspection. Consequently, it is unclear how the unleaded fuel is stored within the shipping container, or what volume of fuel could be stored at this location,

| <b>Description:</b><br>Surface staining beneath disused engine. | | | |

- Localised areas of surface staining were observed during the Site inspection in the vicinity of the Site office. Depending on the requirements of the Site Auditor, remediation of these areas at the conclusion of the infilling works at Pit 2 may be required.

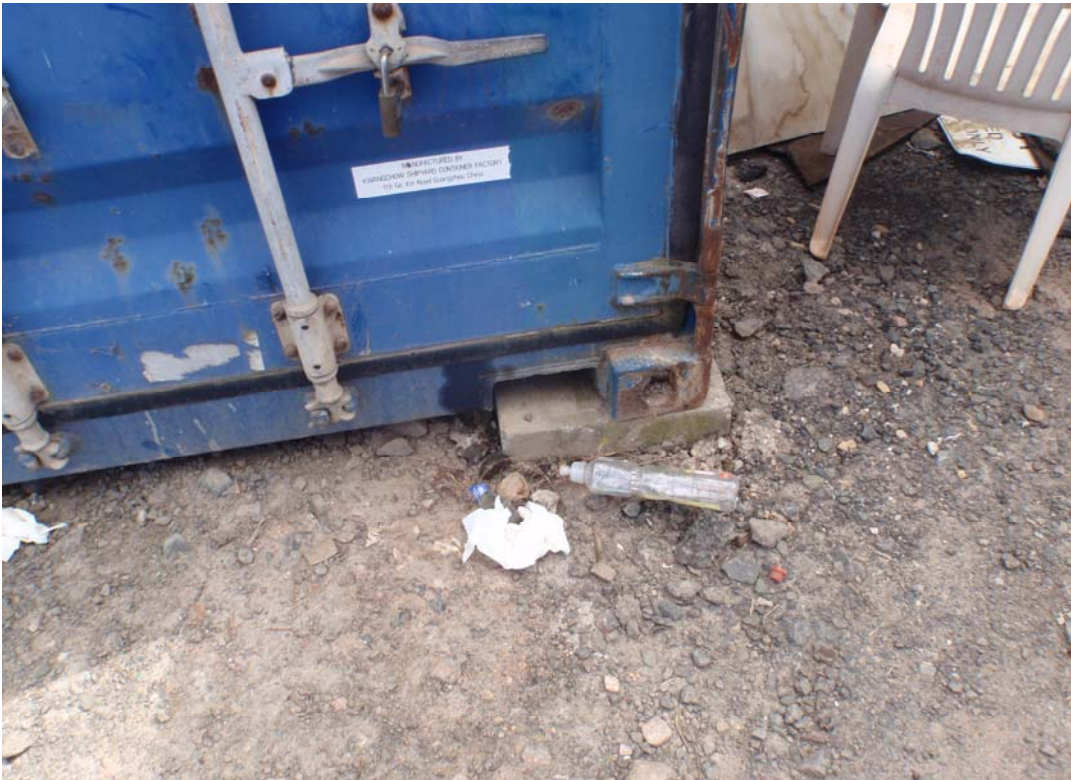
| <b>Plate No.</b><br><b>6</b> | <b>Date:</b><br>25/08/10 | |

| <b>Description:</b><br>Staining on the outside of the shipping container storing unleaded fuel. | | |

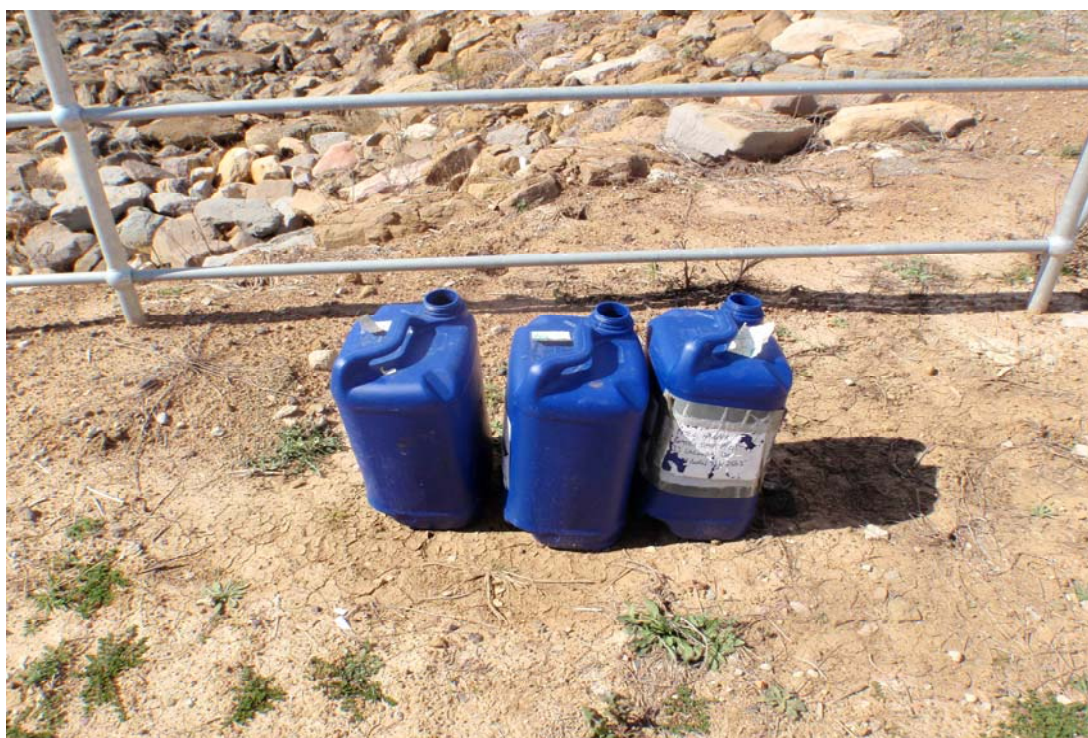
Four 20L chemical storage containers (**Plate 7**) were observed adjacent the rock lined channel immediately east of the Site. Lids were no longer in place and the containers appeared to contain water.

20L chemical storage containers noted adjacent to the rock-lined channel.
