23 January 2019

**MP10\_160 Mod 6 White Rock Wind Farm (WRWF) - Further Information**

## 5.0 Sample transport drawings.

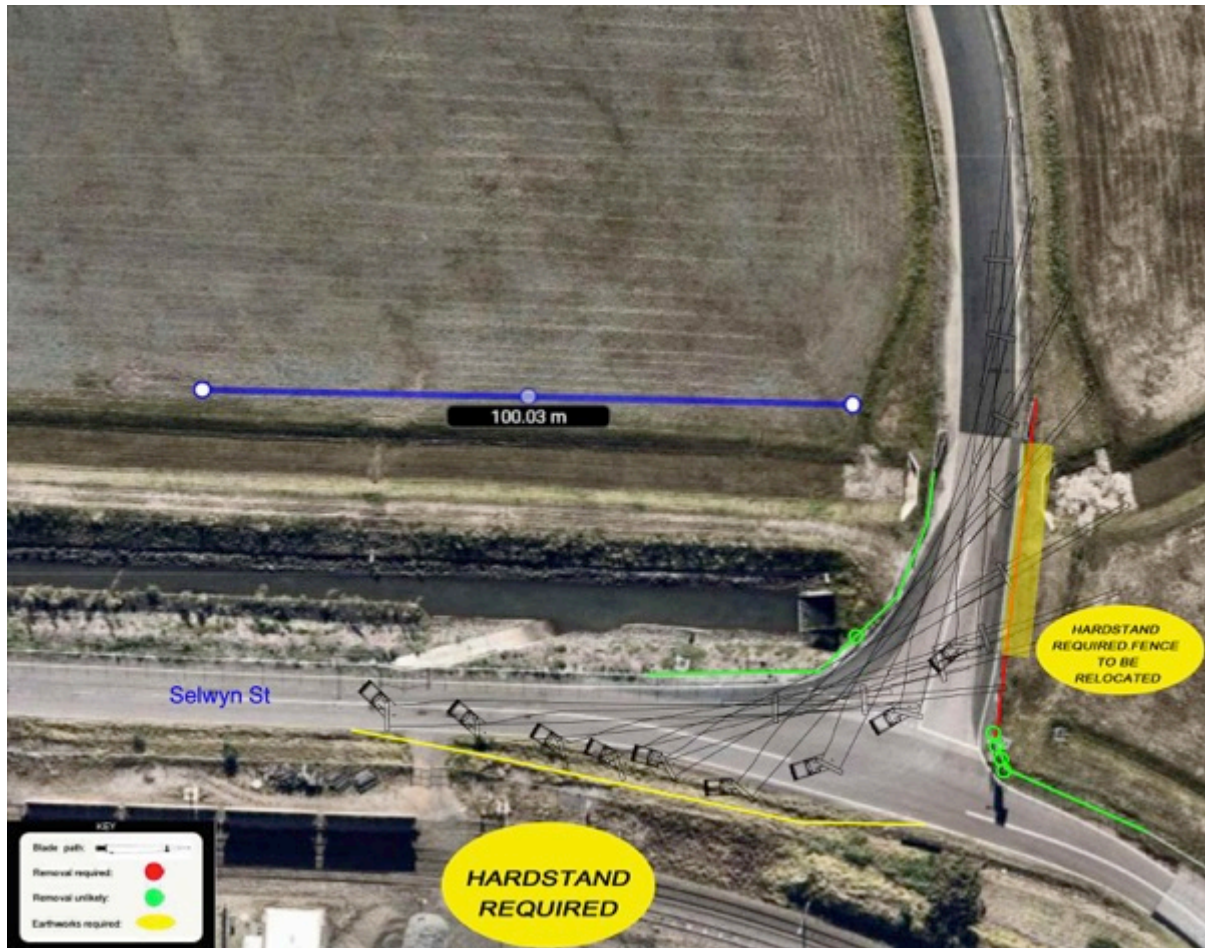
Image 1: (82 Metre blade)

**0.0 Km's:** Mayfield #4 onto Selwyn Street at Mayfield.

**PROCEDURE:** Right hand turn.

**ROAD MODIFICATIONS:** Yes moderate amounts of work are required.

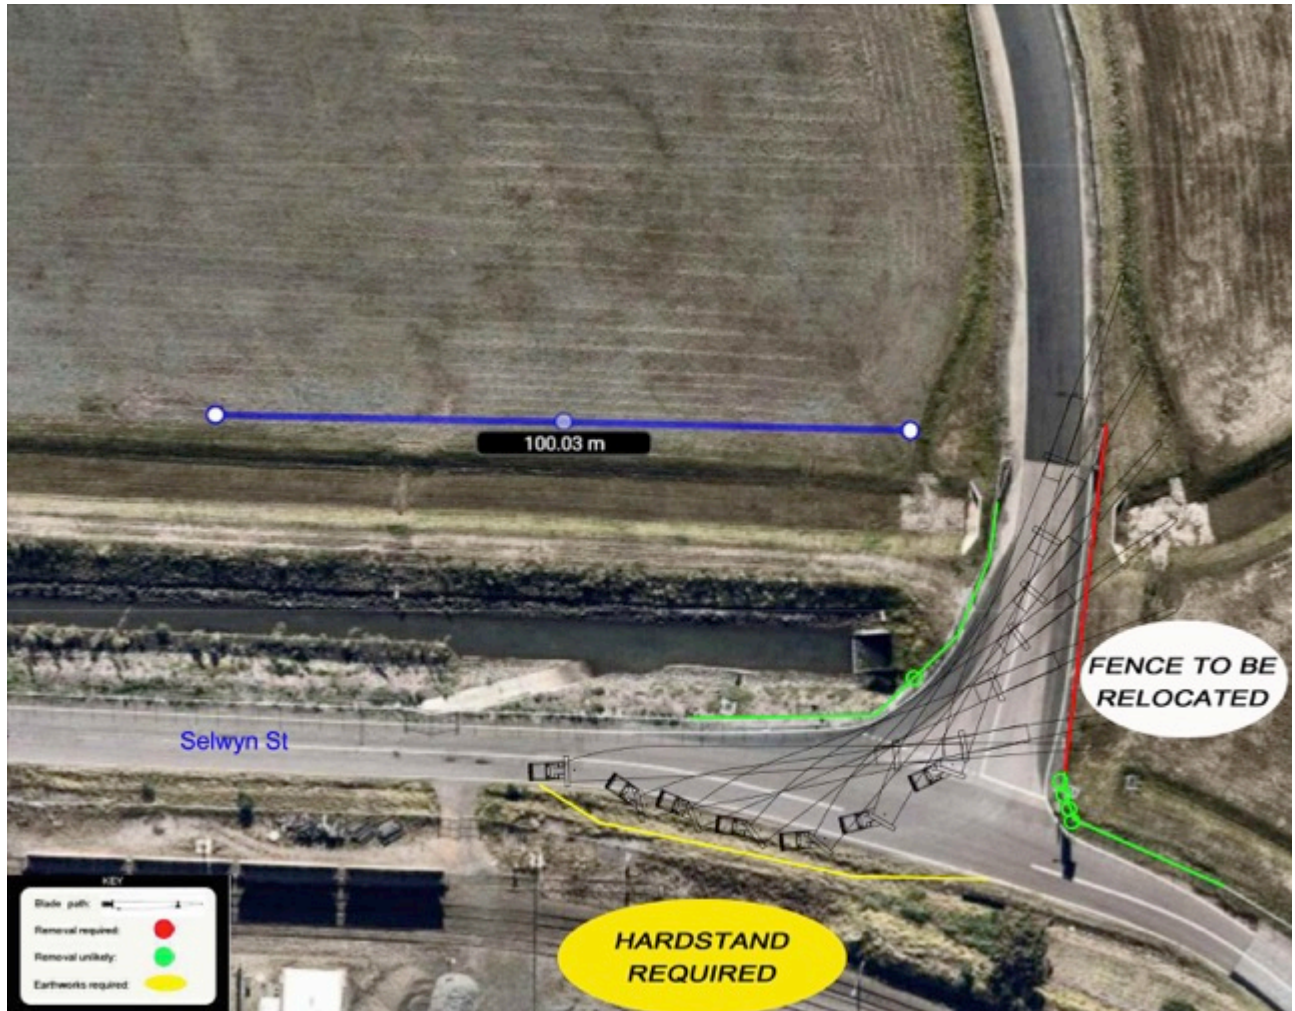
Image 2: (76 Metre blade)

**PROCEDURE:** Right hand turn.

**ROAD MODIFICATIONS:** Yes moderate amounts of work are required.

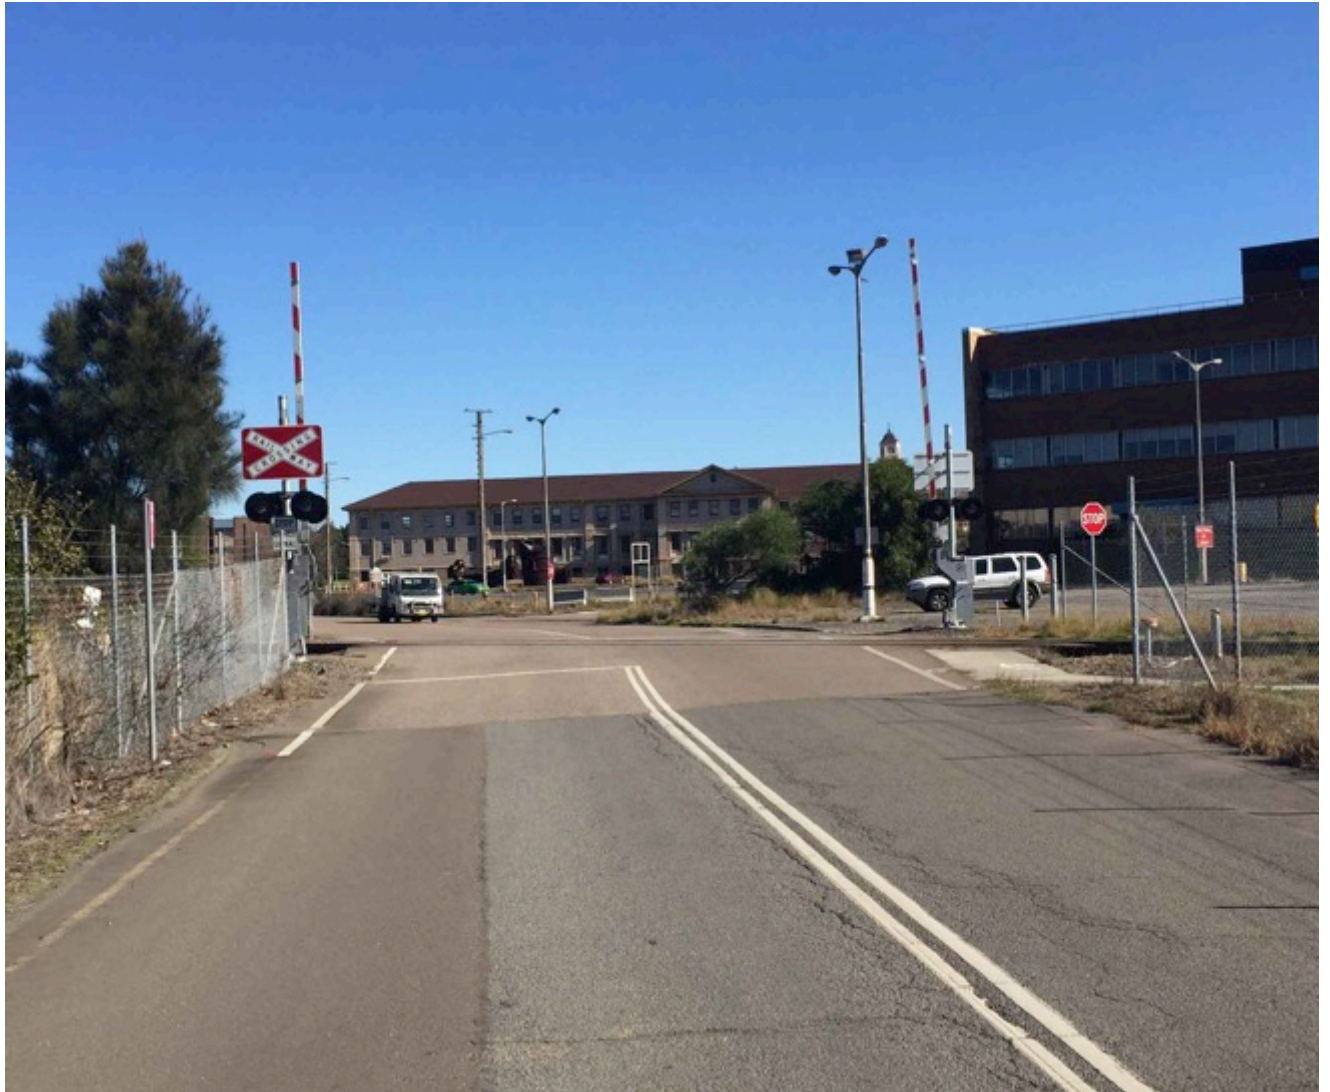
**0.4 Km's: Rail crossing over Selwyn Street at Mayfield.**

**PROCEDURE:** Travel directly ahead over the crossing.

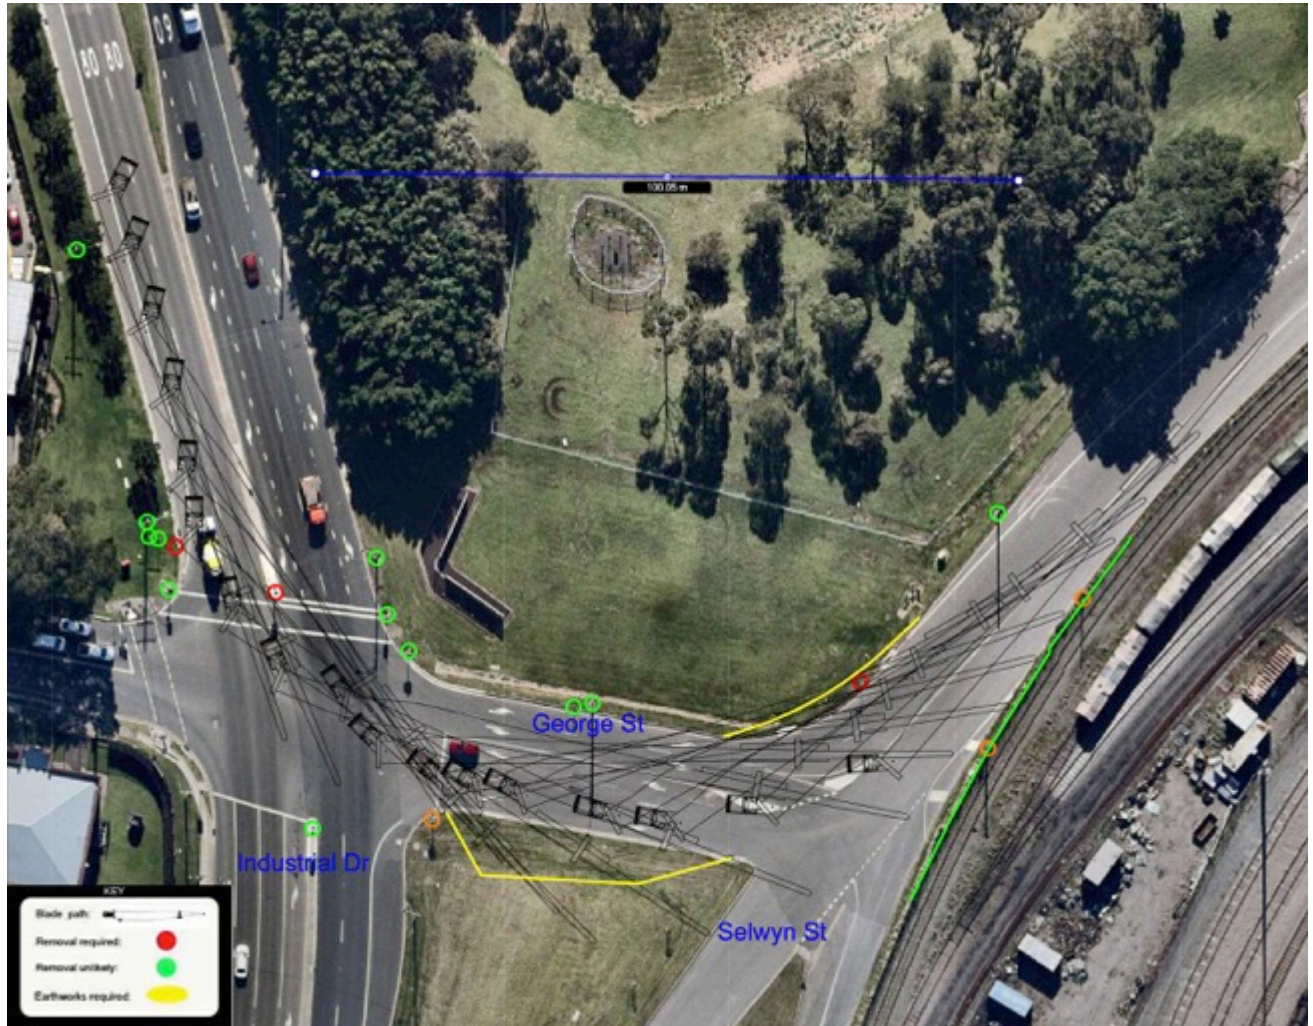
Image 1: (82 Metre blade)

### **1.3 Km's: Selwyn Street onto Industrial Drive, via George Street at Mayfield.**

**PROCEDURE:** Right hand turn from Selwyn Street through George Street and onto Industrial Drive.

**ROAD MODIFICATIONS:** Yes, large amounts of works are required.

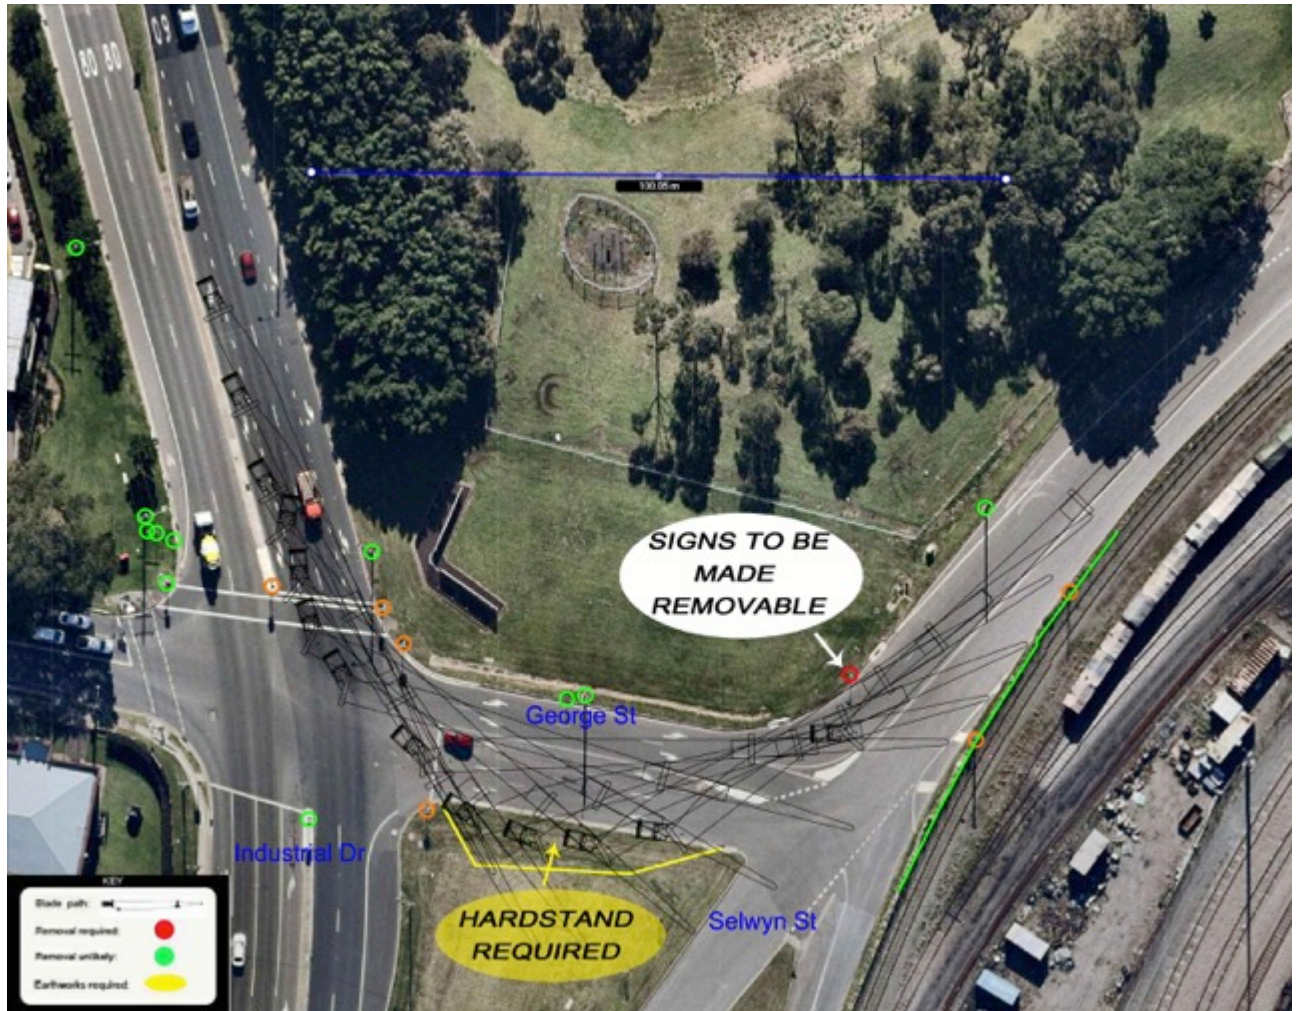
Image 2: (76 Metre blade)

**PROCEDURE:** Right hand turn from Selwyn Street through George Street and onto Industrial Drive.

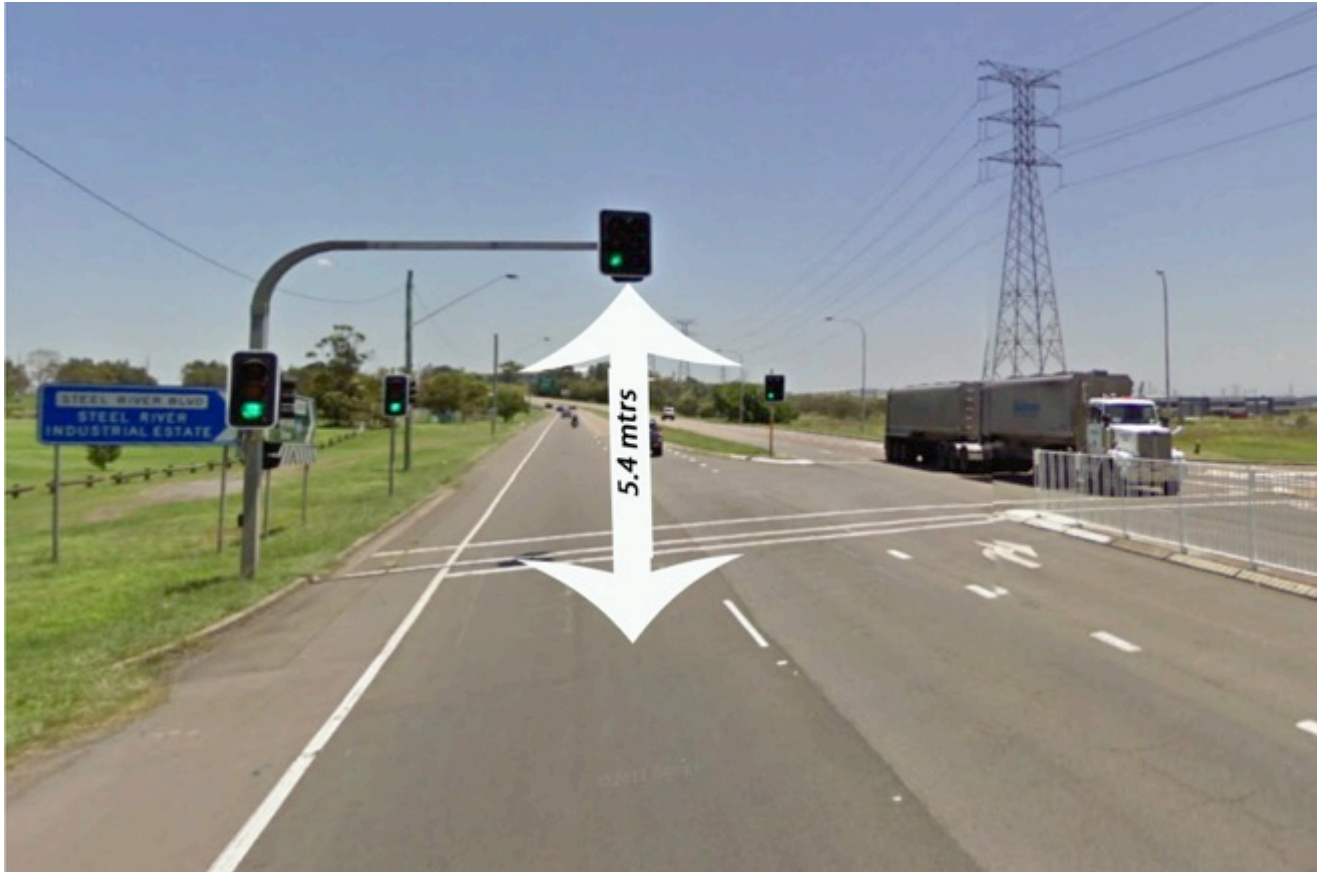
**4.9 Km's:** Standard overhanging Traffic signals Mayfield to Hunter Expressway.

**PROCEDURE:** Overhanging signals while travelling through the intersection.

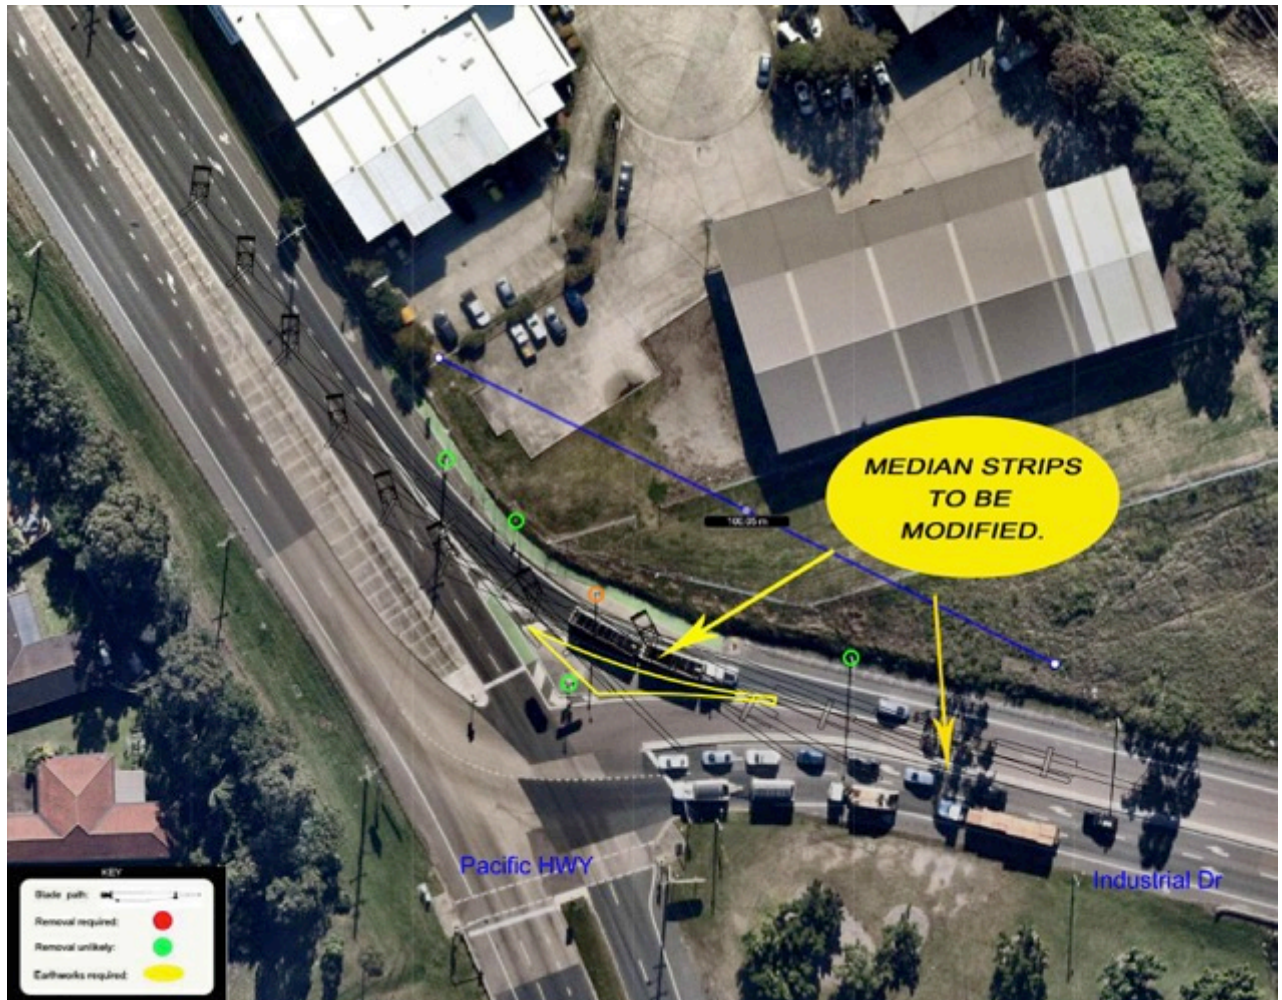
Image 1: (76 & 82 Metre blade)

**PROCEDURE:** Right hand turn from Industrial Drive onto Maitland Road.

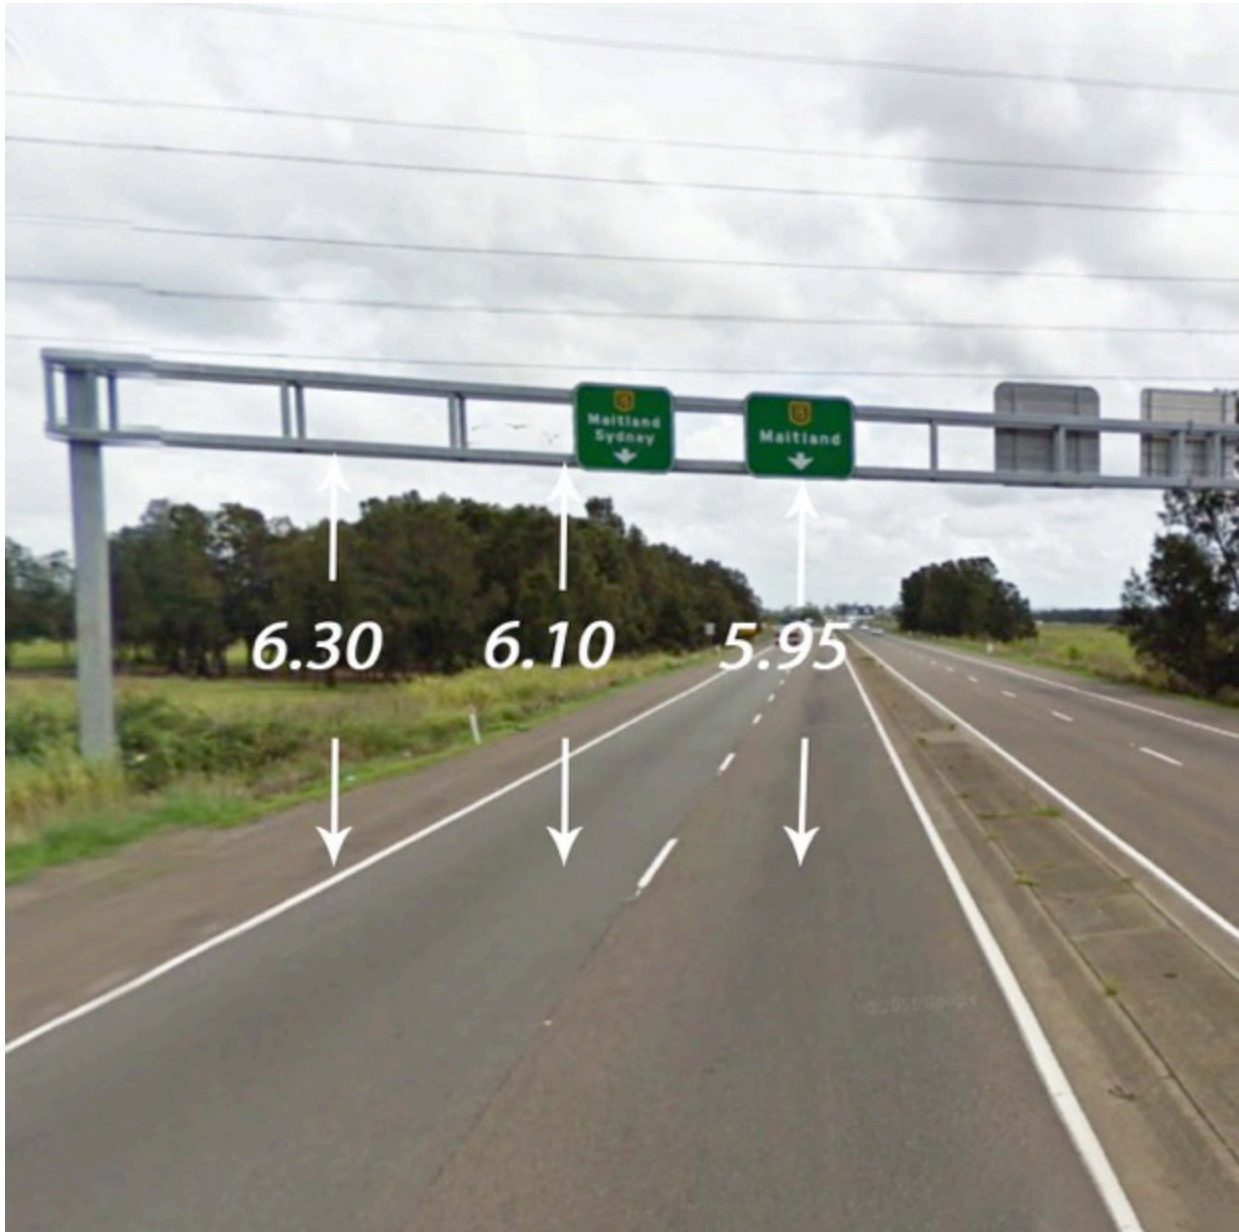
Image 1:

**13.9 Km's:** Lowest structure (Bridge or Sign) between Mayfield and the Hunter Expressway.

**PROCEDURE:** Travel directly ahead in the centre lane.

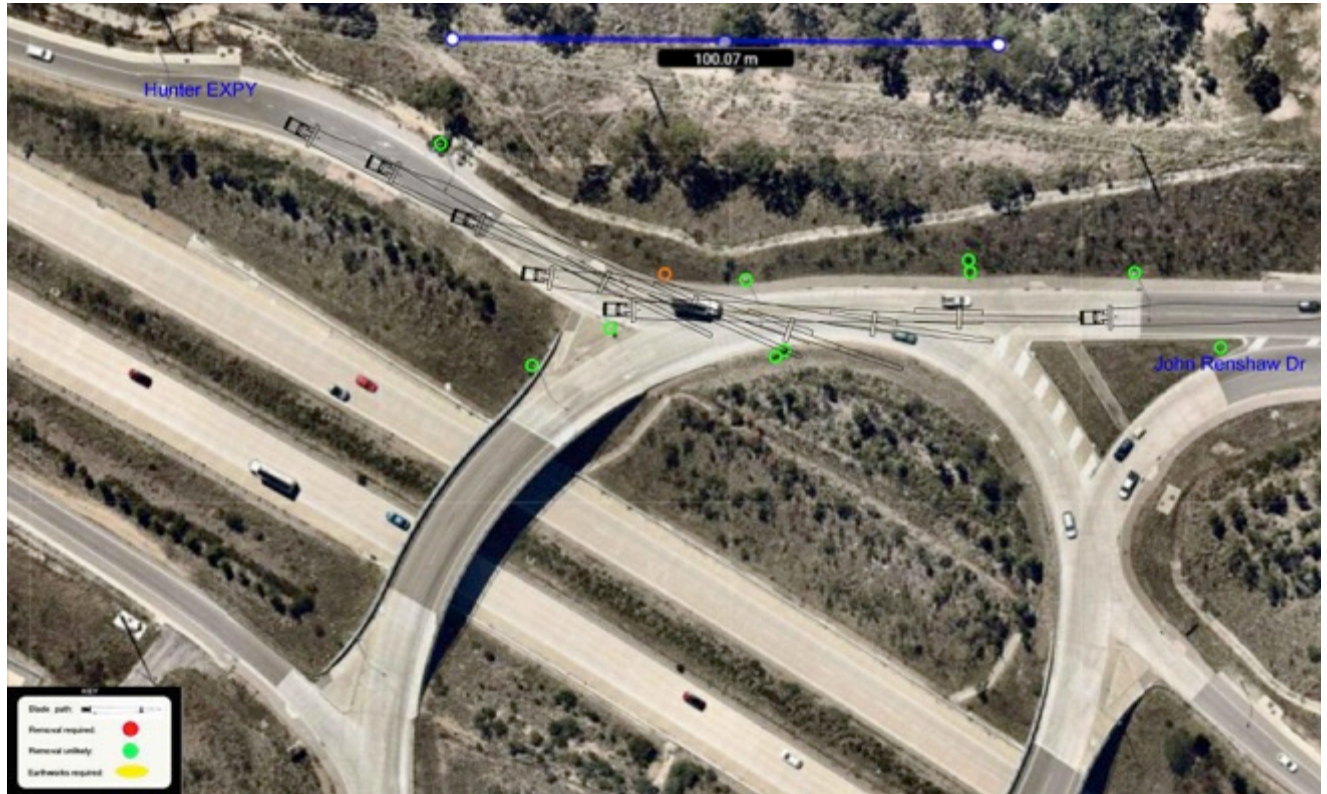
**Image 1: (76 & 82 Metre blade)**

**PROCEDURE:** Right hand turn onto the incorrect side of the Motorway, before crossing back onto the correct side at the crossover bay.

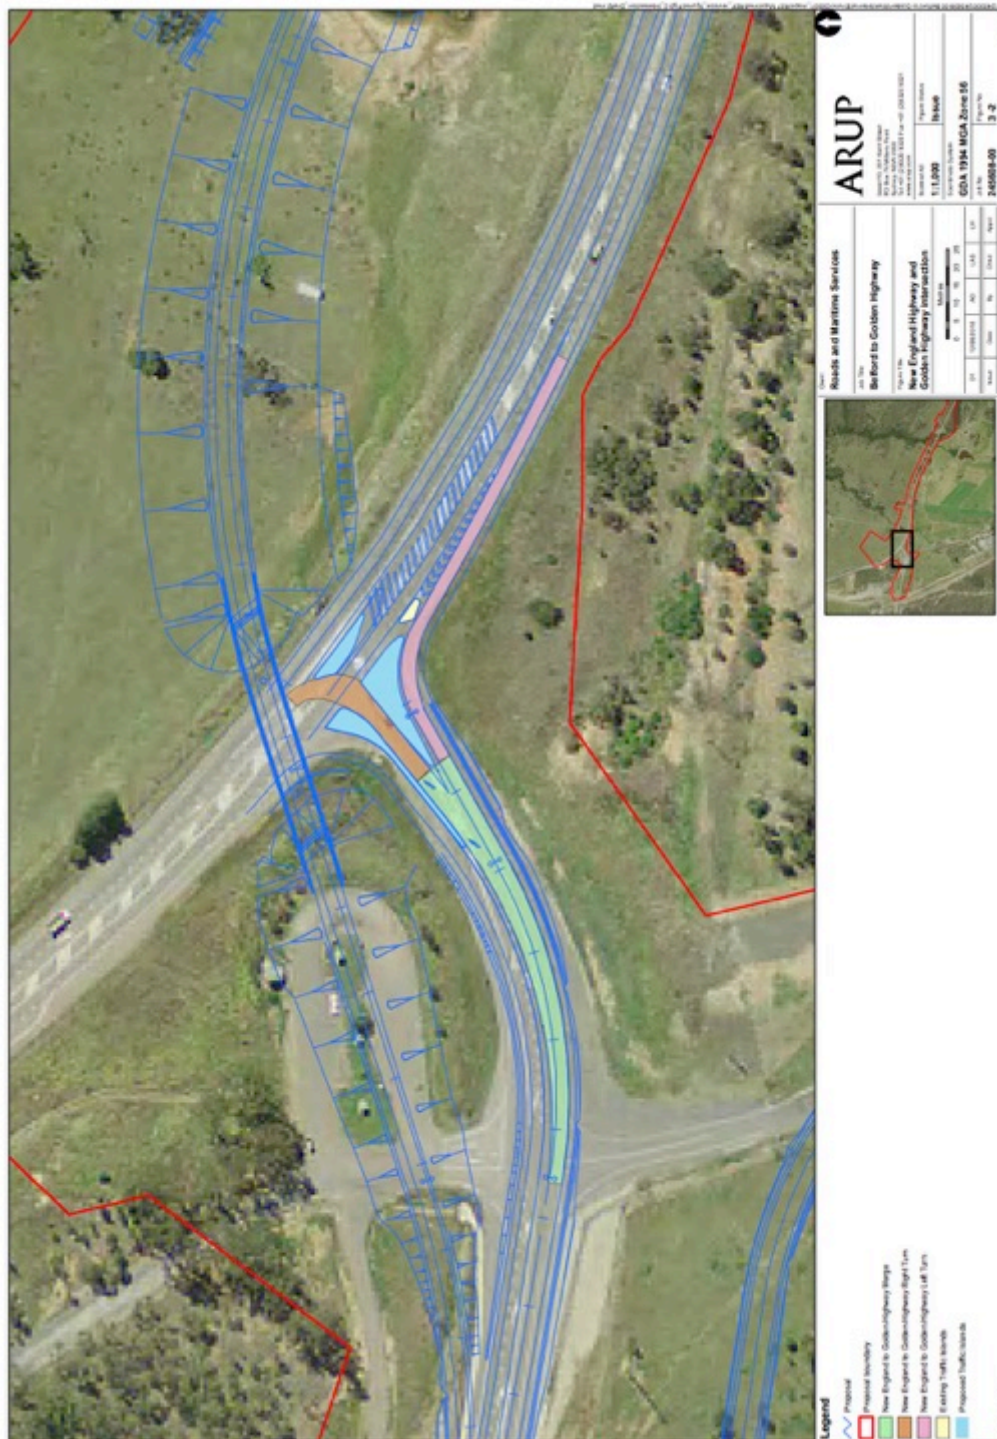
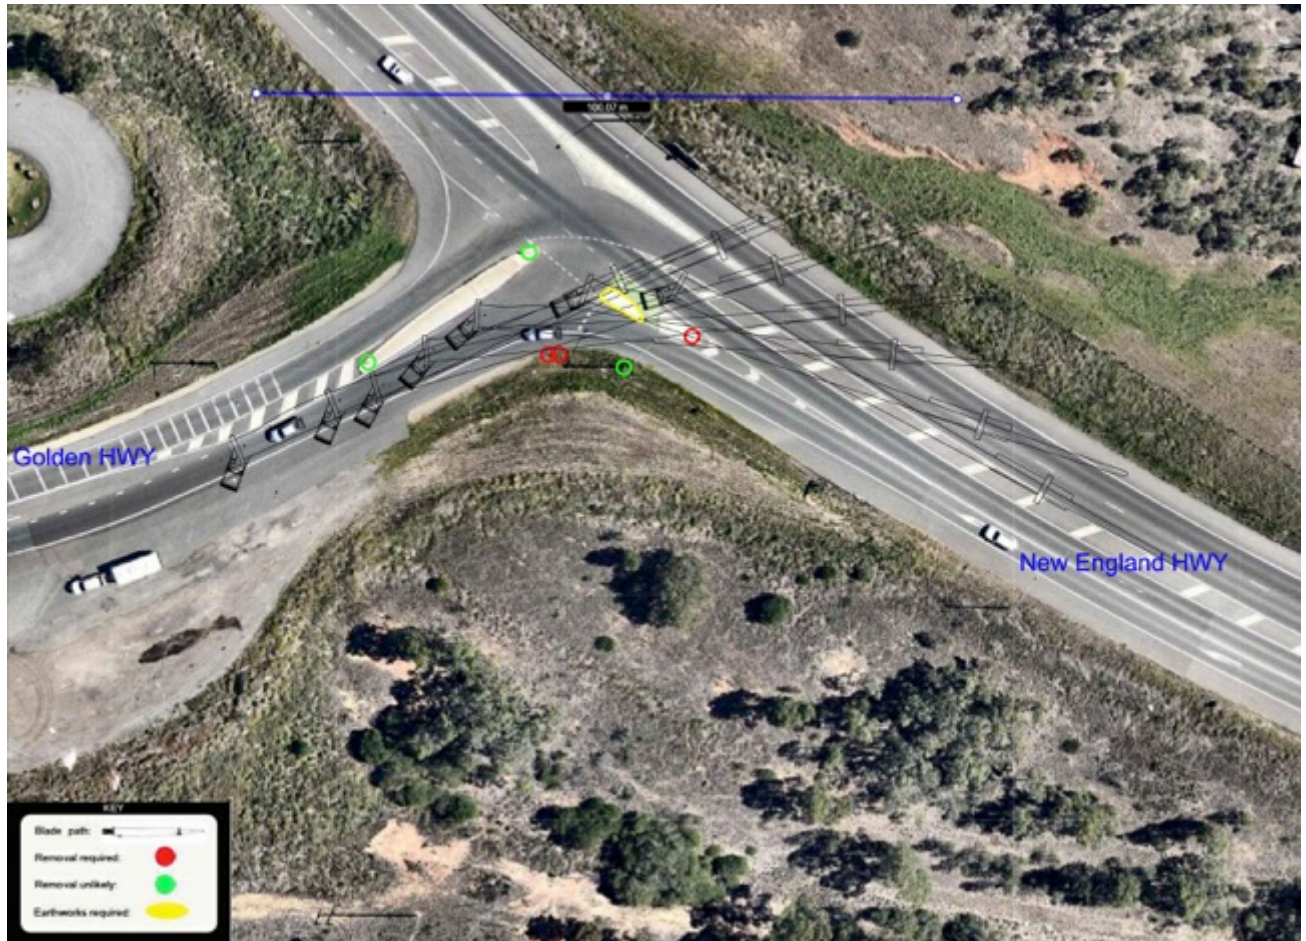
Image 1: (76 & 82 Metre blade)

**PROCEDURE:** Left hand turn from the New England Highway onto the Golden Highway.

**ROAD MODIFICATIONS:** NOTE: This intersection is currently in line to be upgraded. The details on image 1 shows that the changes should not affect the swept path, however it is recommended that this is monitored.

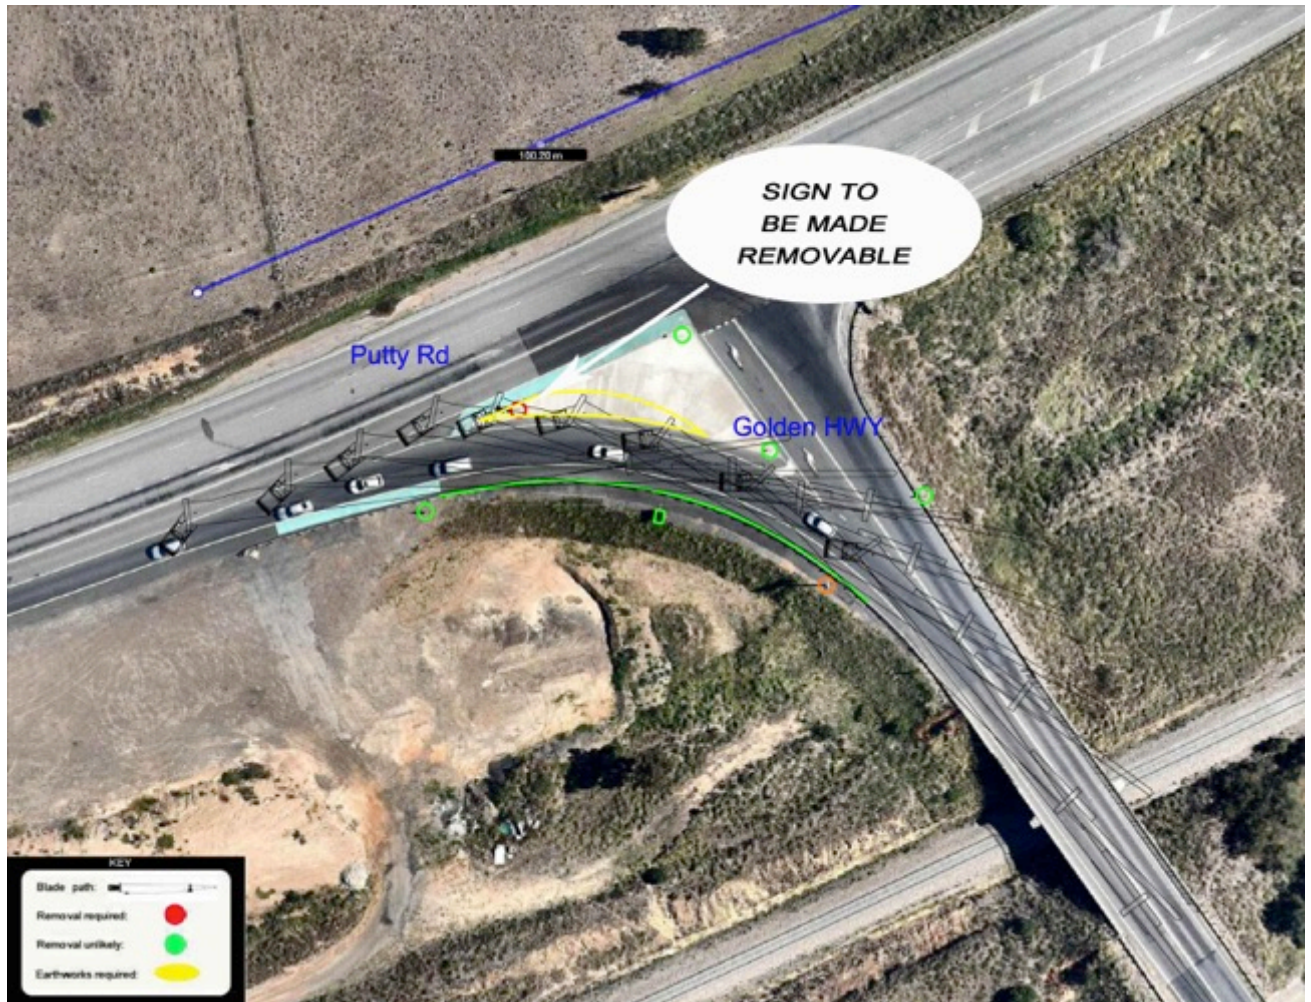
Image 1: (76 & 82 Metre blade)

**PROCEDURE:** Left hand turn from the Golden Highway at the intersection of the Putty Road.

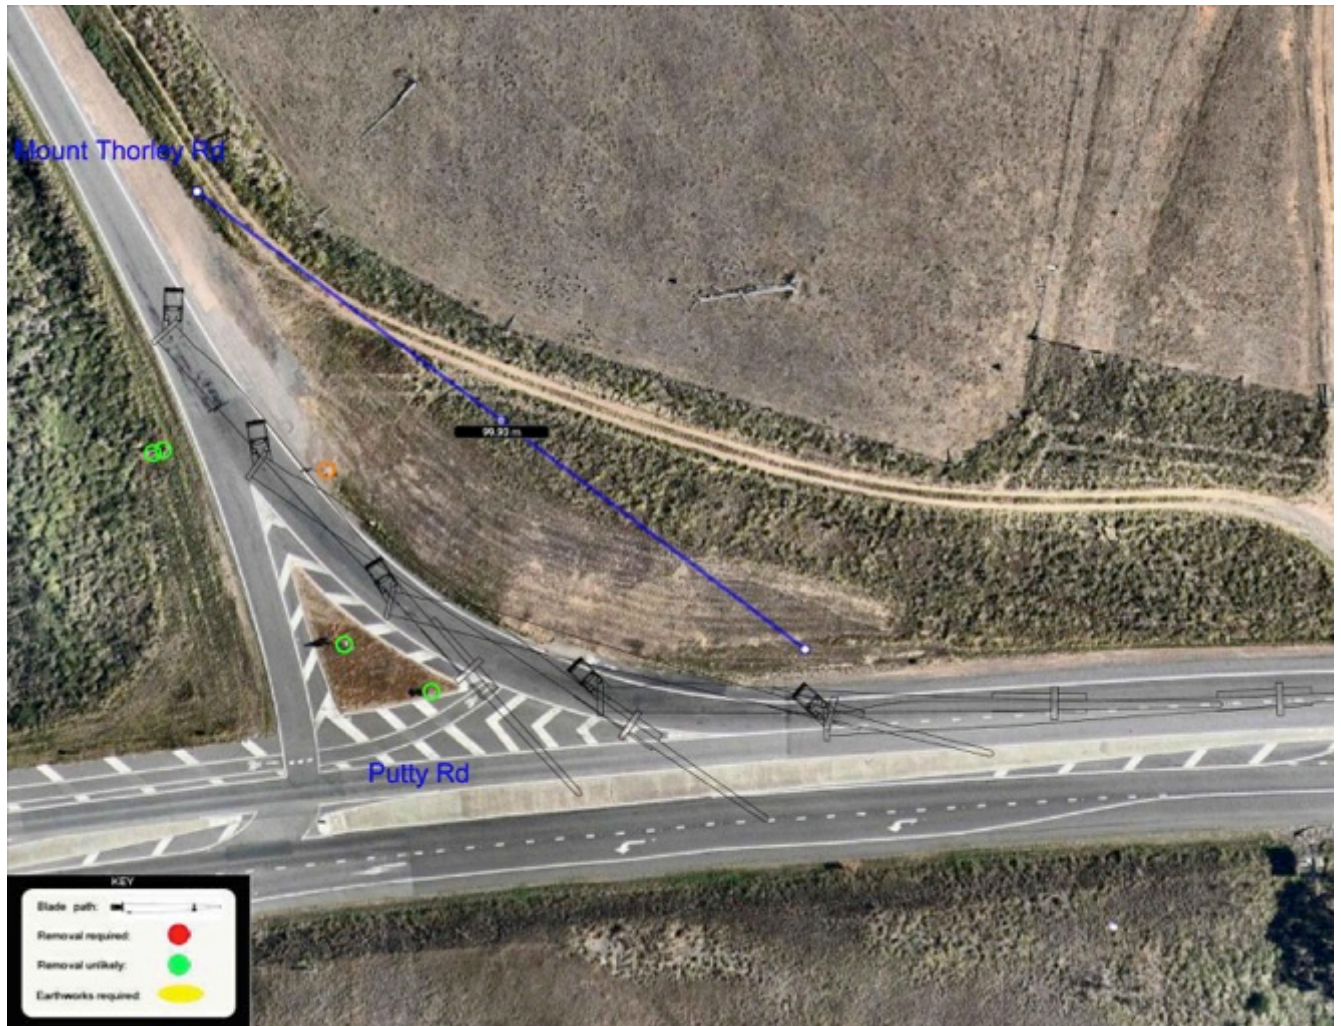
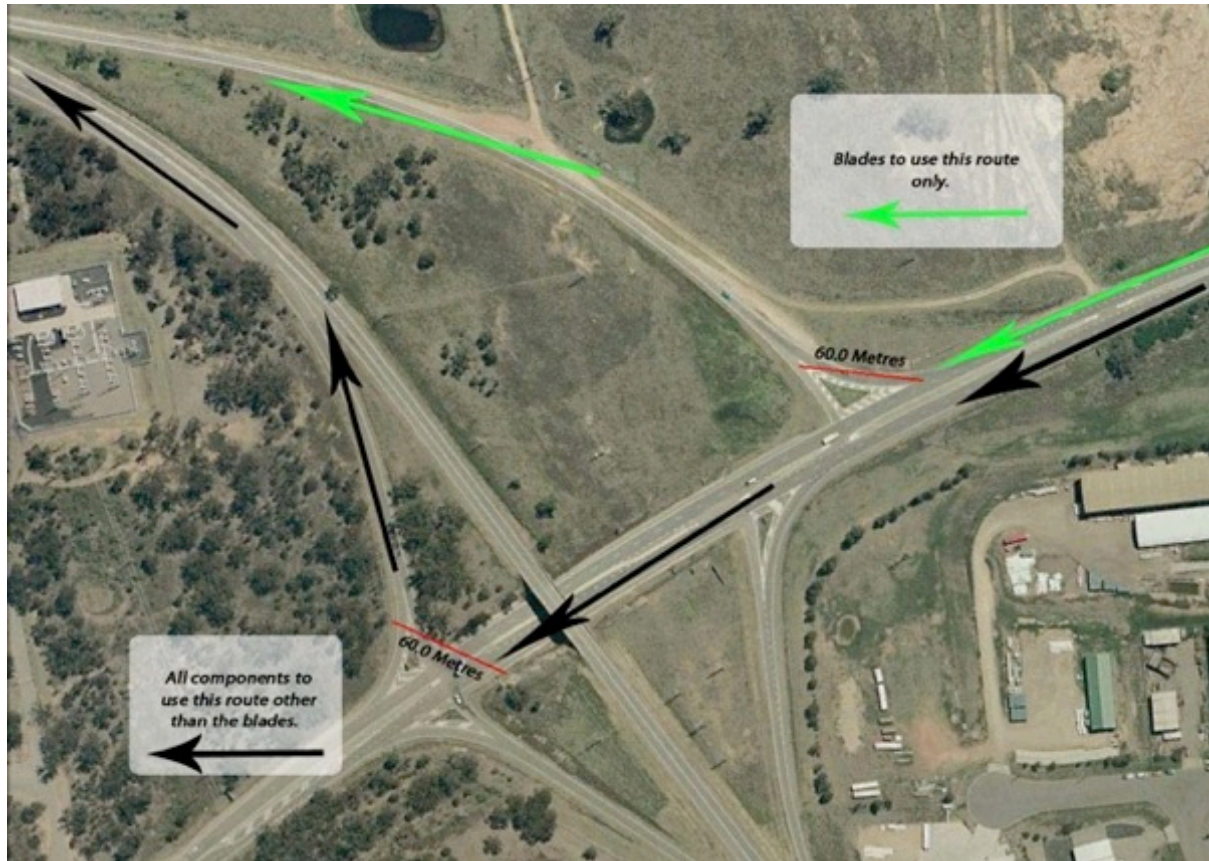
Image 1: (76 and 82 Metre blade)

**PROCEDURE:** Right hand turn from the Putty Road onto the Golden Highway.

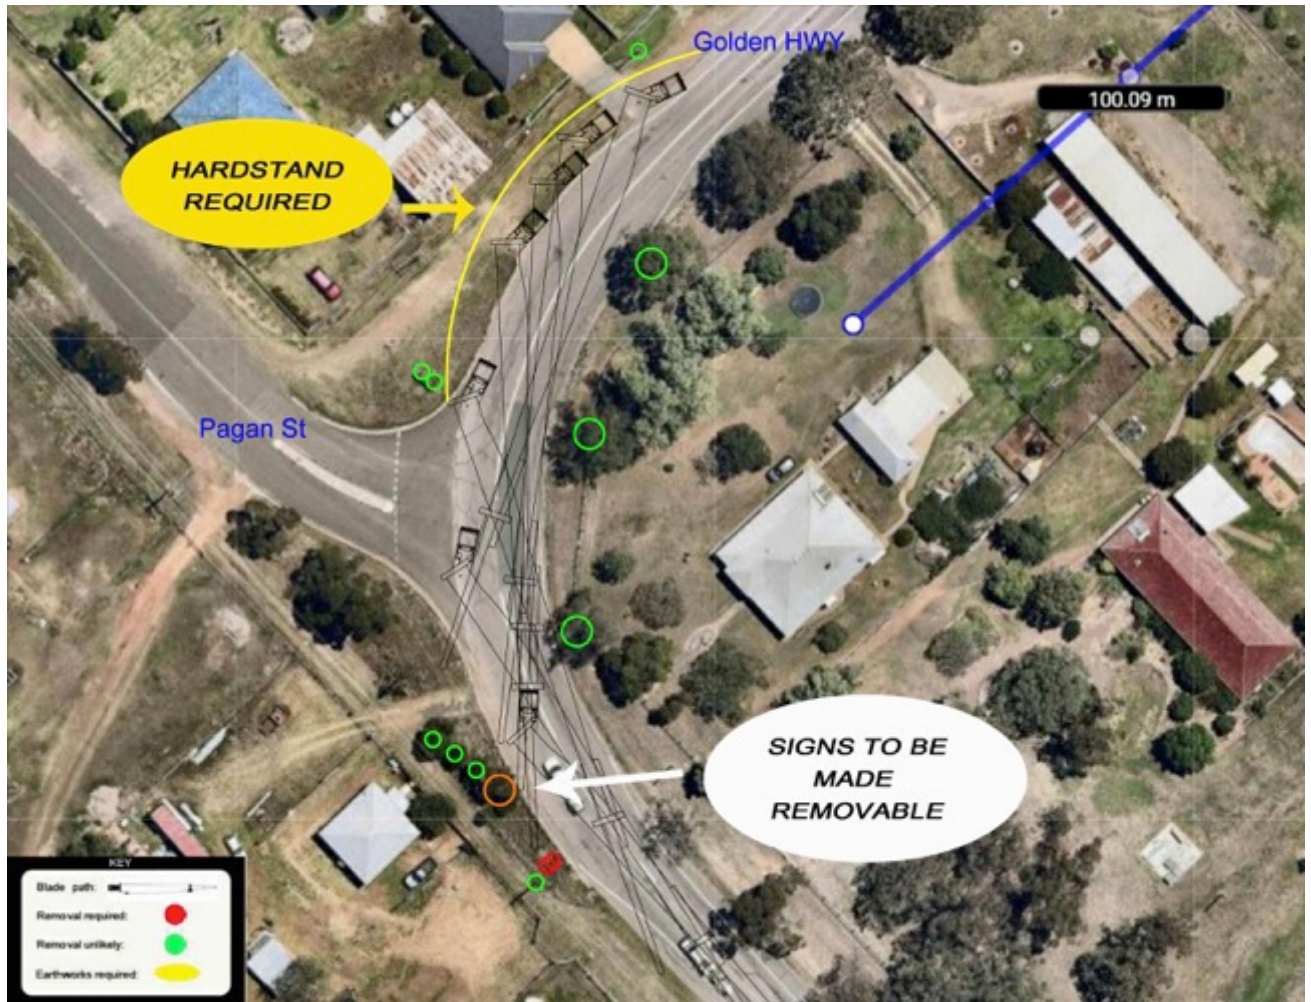
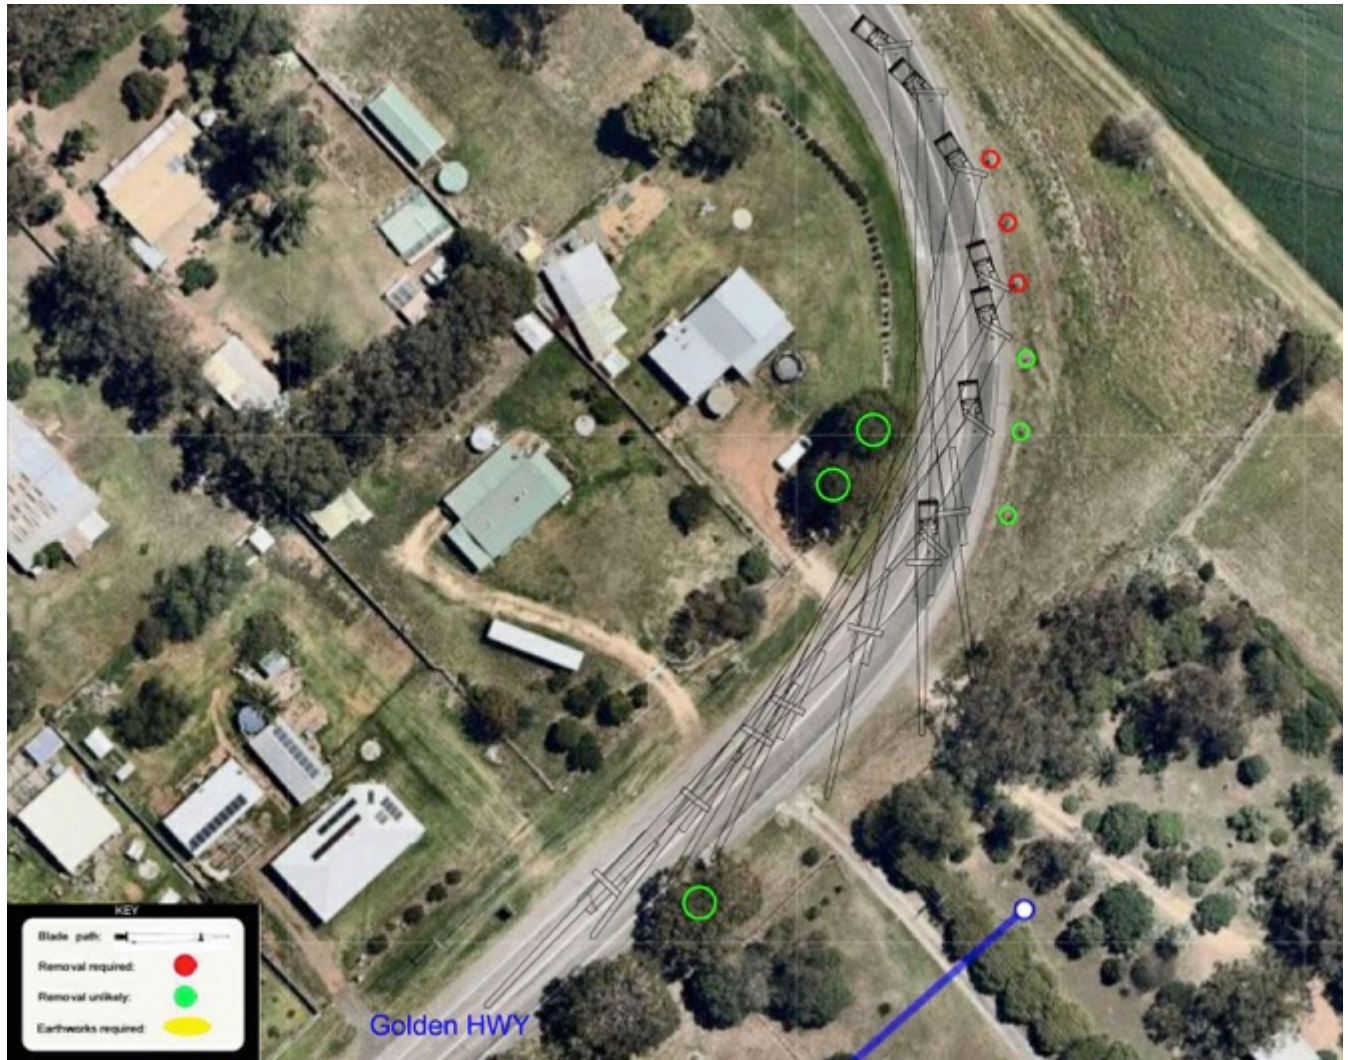
Image 1: (76 & 82 Metre blade)

**PROCEDURE:** Left and right hand turn through the village.

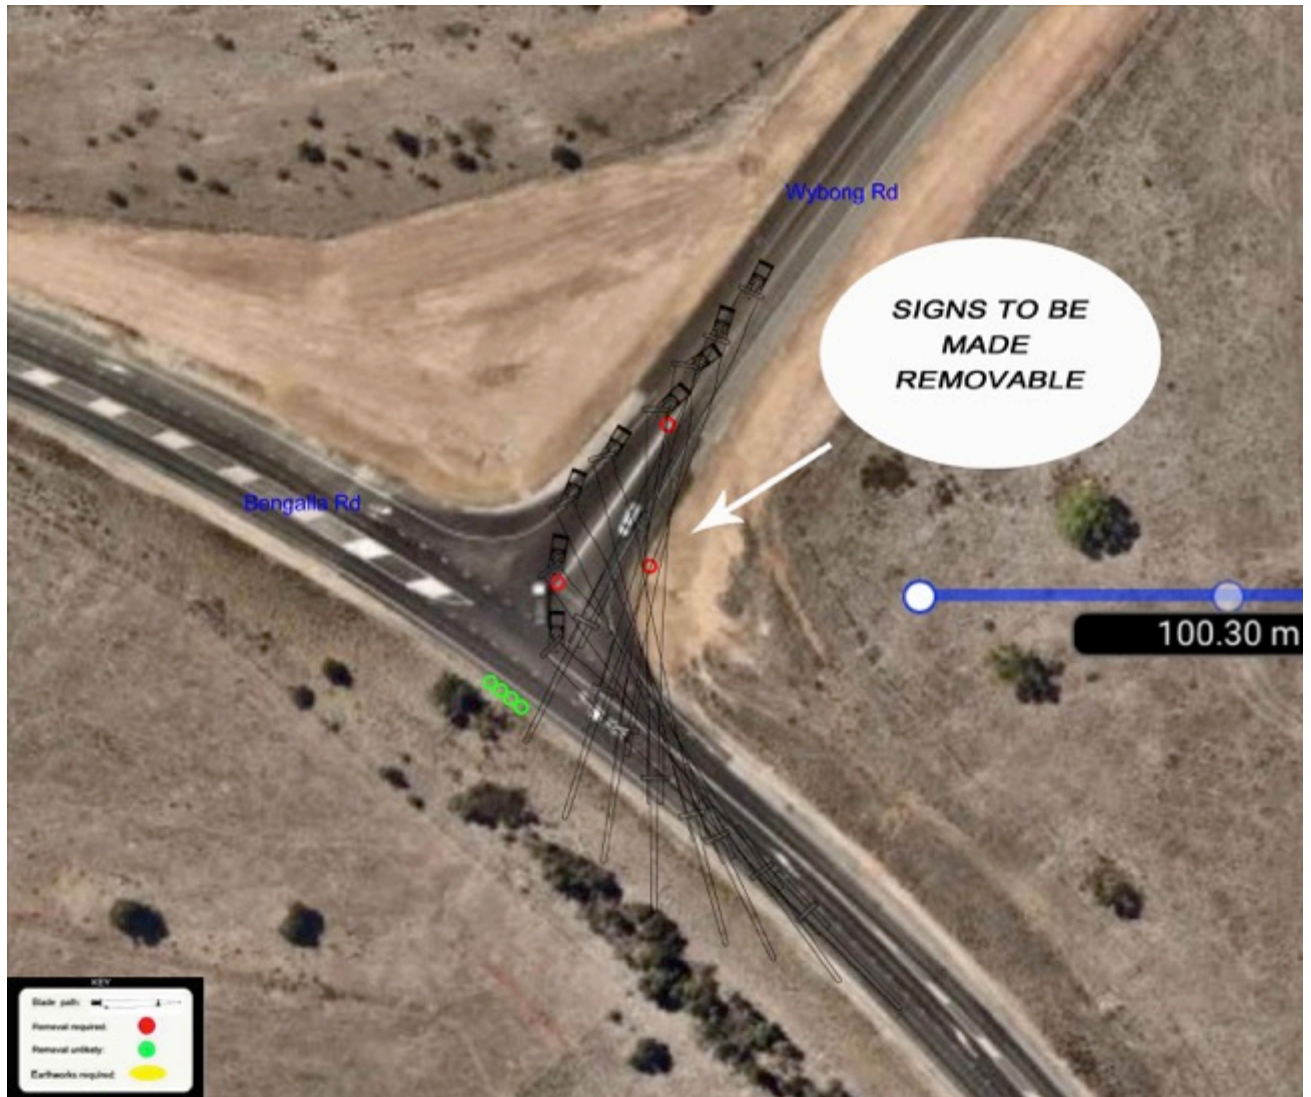
Image 1: (82 Metre blade)

**158.5 Km's:** Bengalla Road onto Wybong Road at Muswellbrook.

**PROCEDURE:** Right hand turn from Bengalla Road onto Wybong Road.

**ROAD MODIFICATIONS:** Small amounts of work are required.
