23 January 2019

**MP10\_160 Mod 6 White Rock Wind Farm (WRWF) - Further Information**

## 5.0 Sample transport drawings.

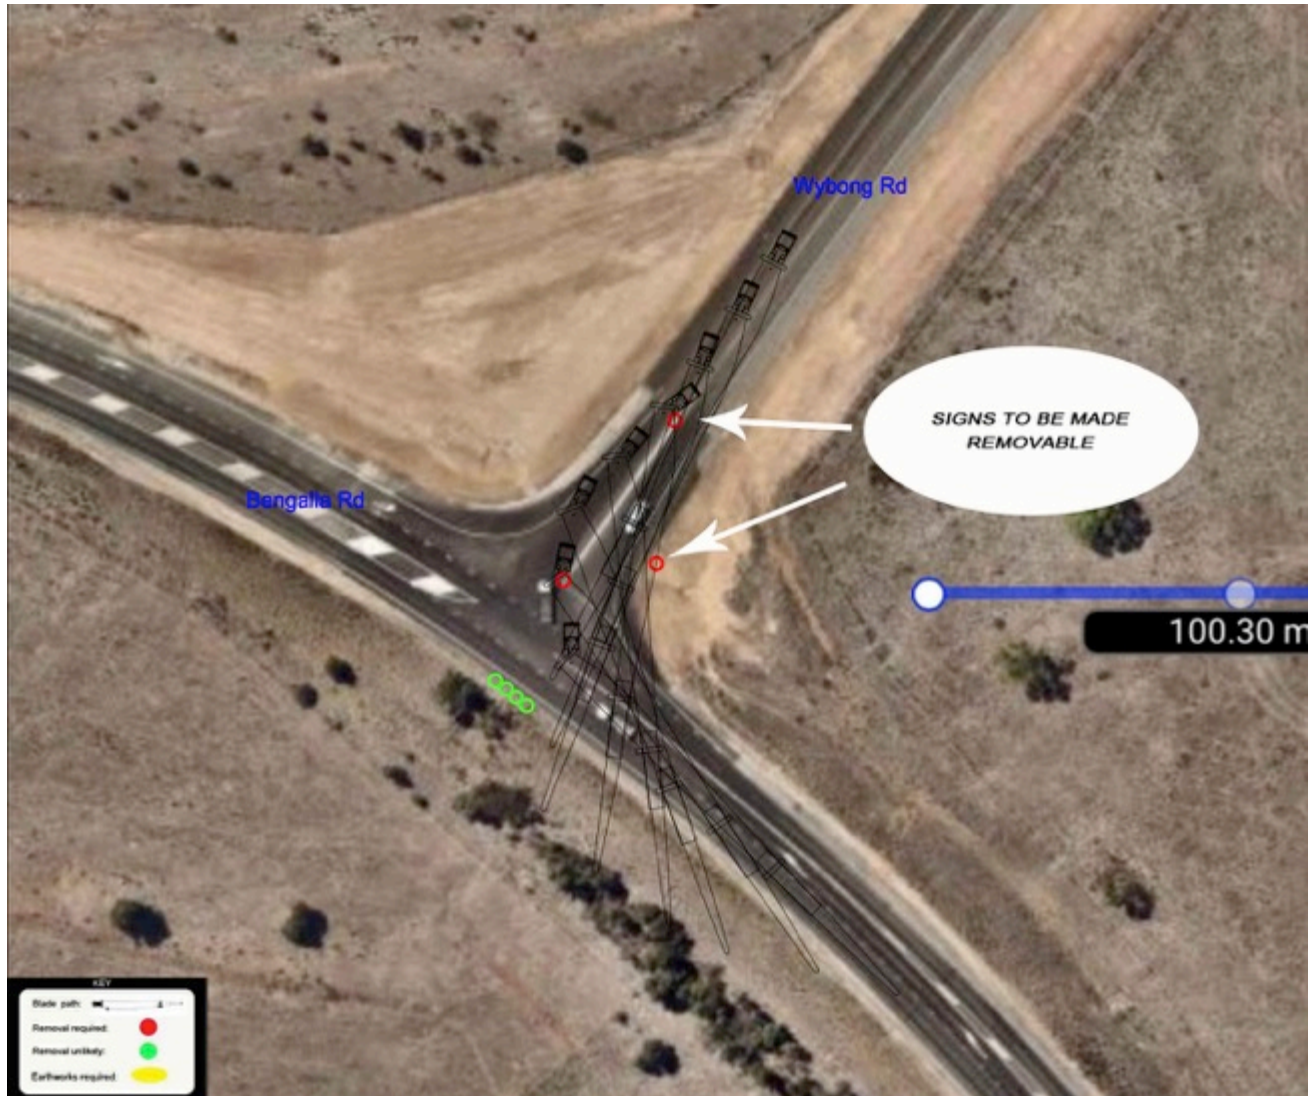
Image 2: (76 Metre blade)

**PROCEDURE:** Right hand turn from Bengalla Road onto Wybong Road.

**ROAD MODIFICATIONS:** Large amounts of work are required.

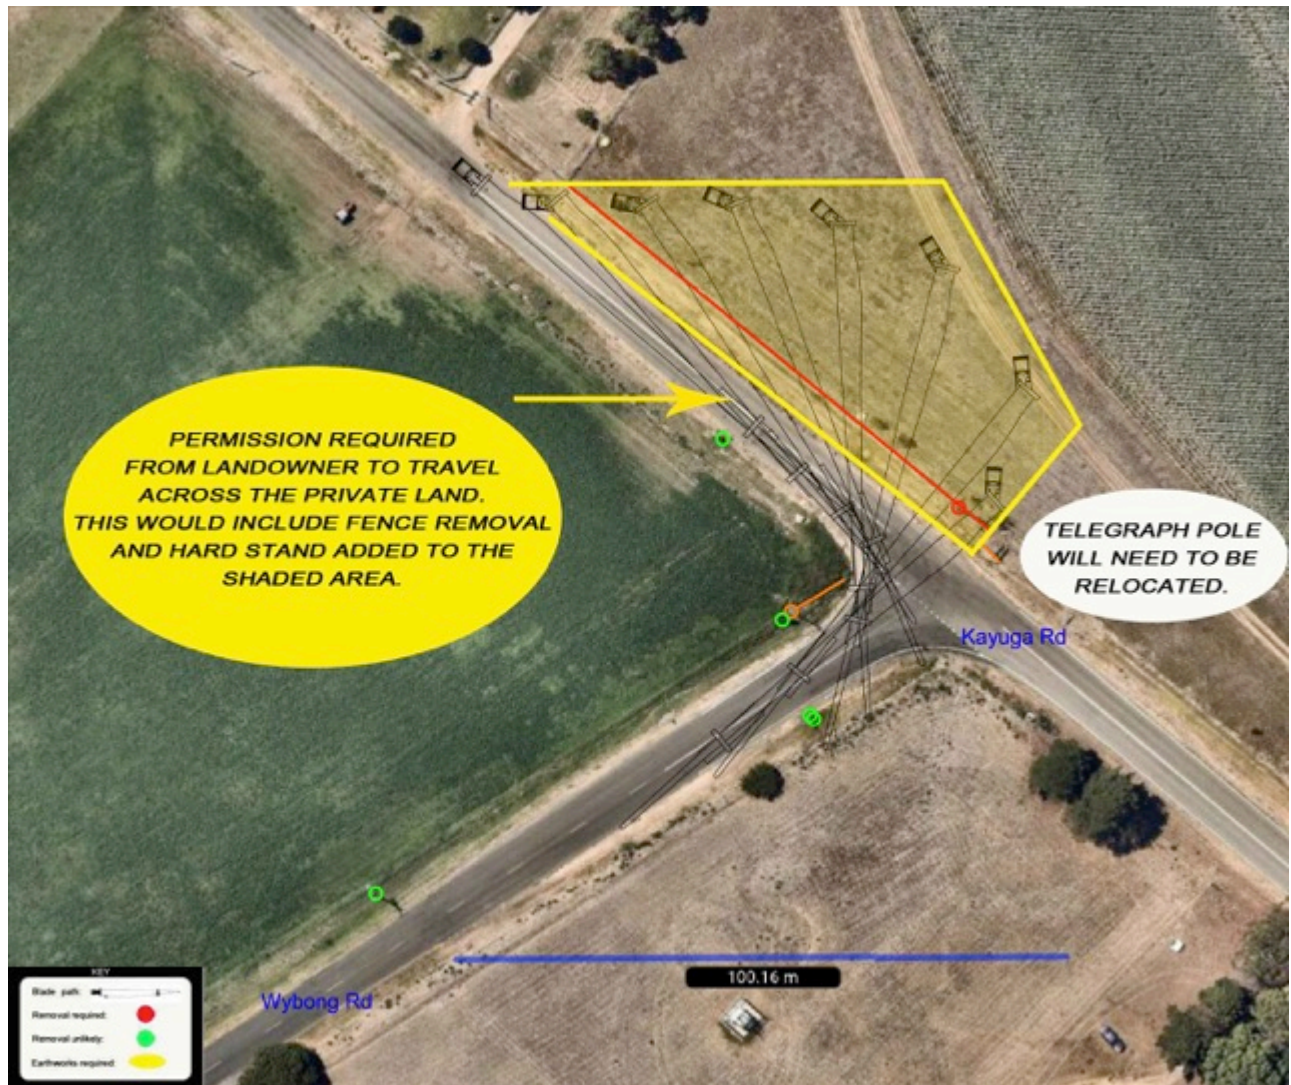
Image 3: Option 2 (82 Metre blade)

**PROCEDURE:** Left hand turn from Wybong Road onto Kayuga Road.

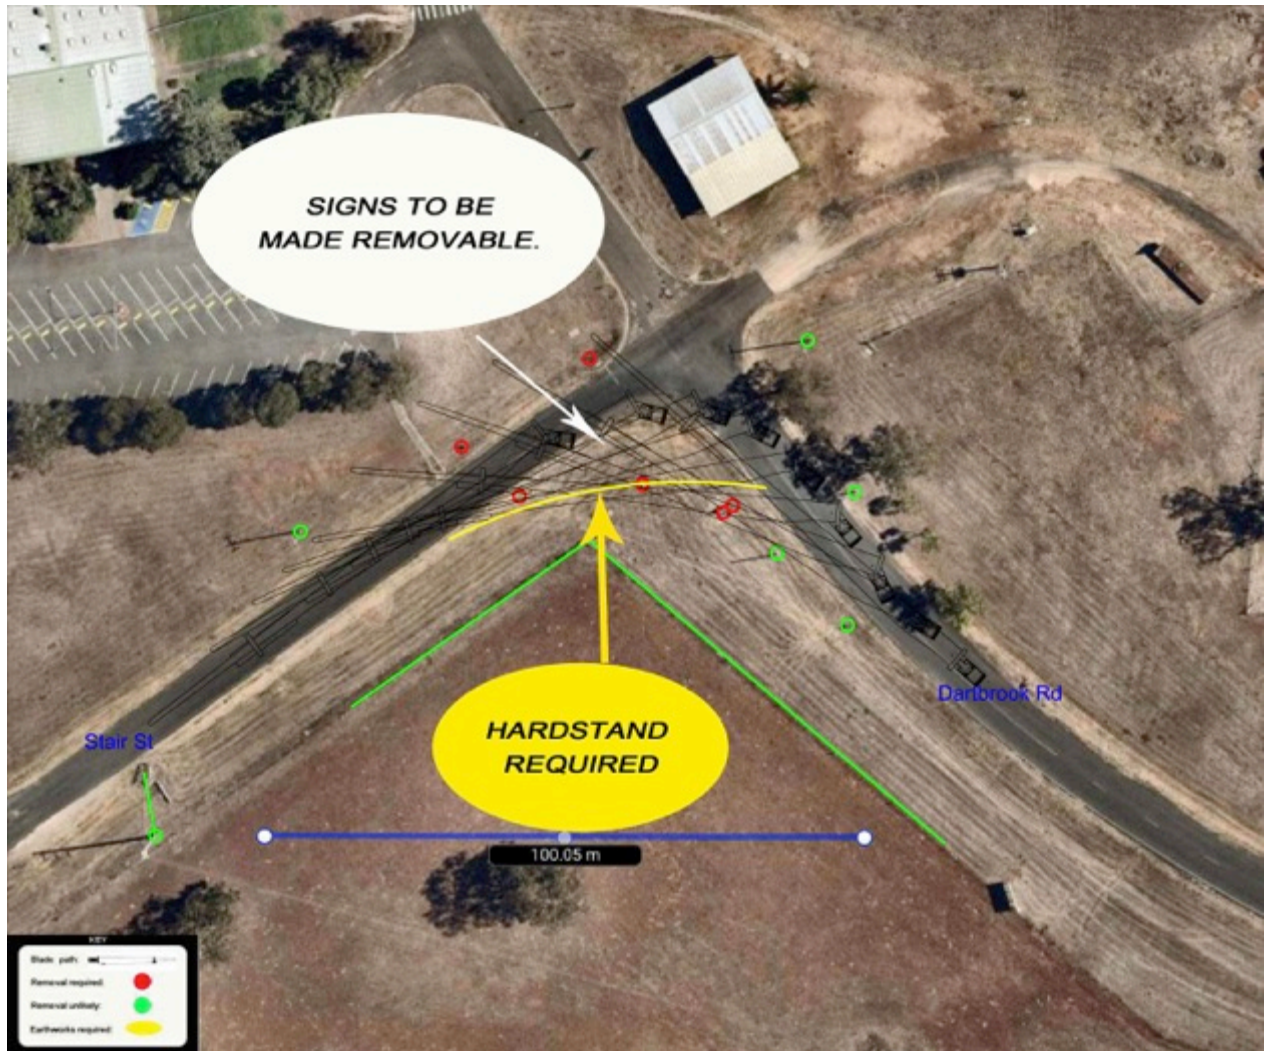
Image 1: (82 Metre blade)

**174.8 Km's:** Dartbrook access Road at Muswellbrook.

**PROCEDURE:** Right hand turn on the Dartbrook mine access Road.

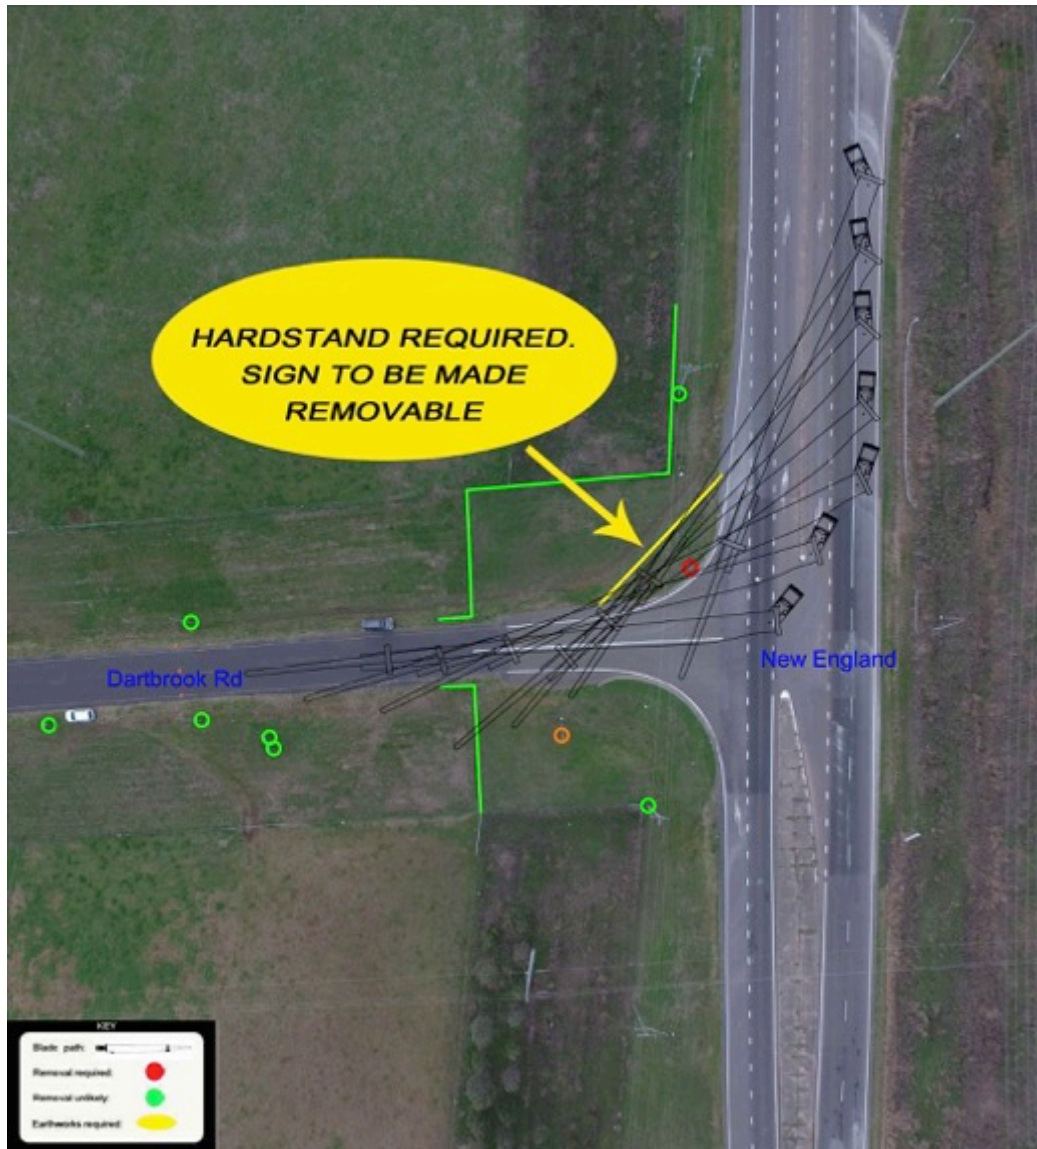
Image 1: (82 Metre blade)

**174.8 Km's:** Dartbrook access Road onto the New England Highway at Muswellbrook.

**PROCEDURE:** Left hand turn from the Dartbrook mine access Road onto the New England Highway.

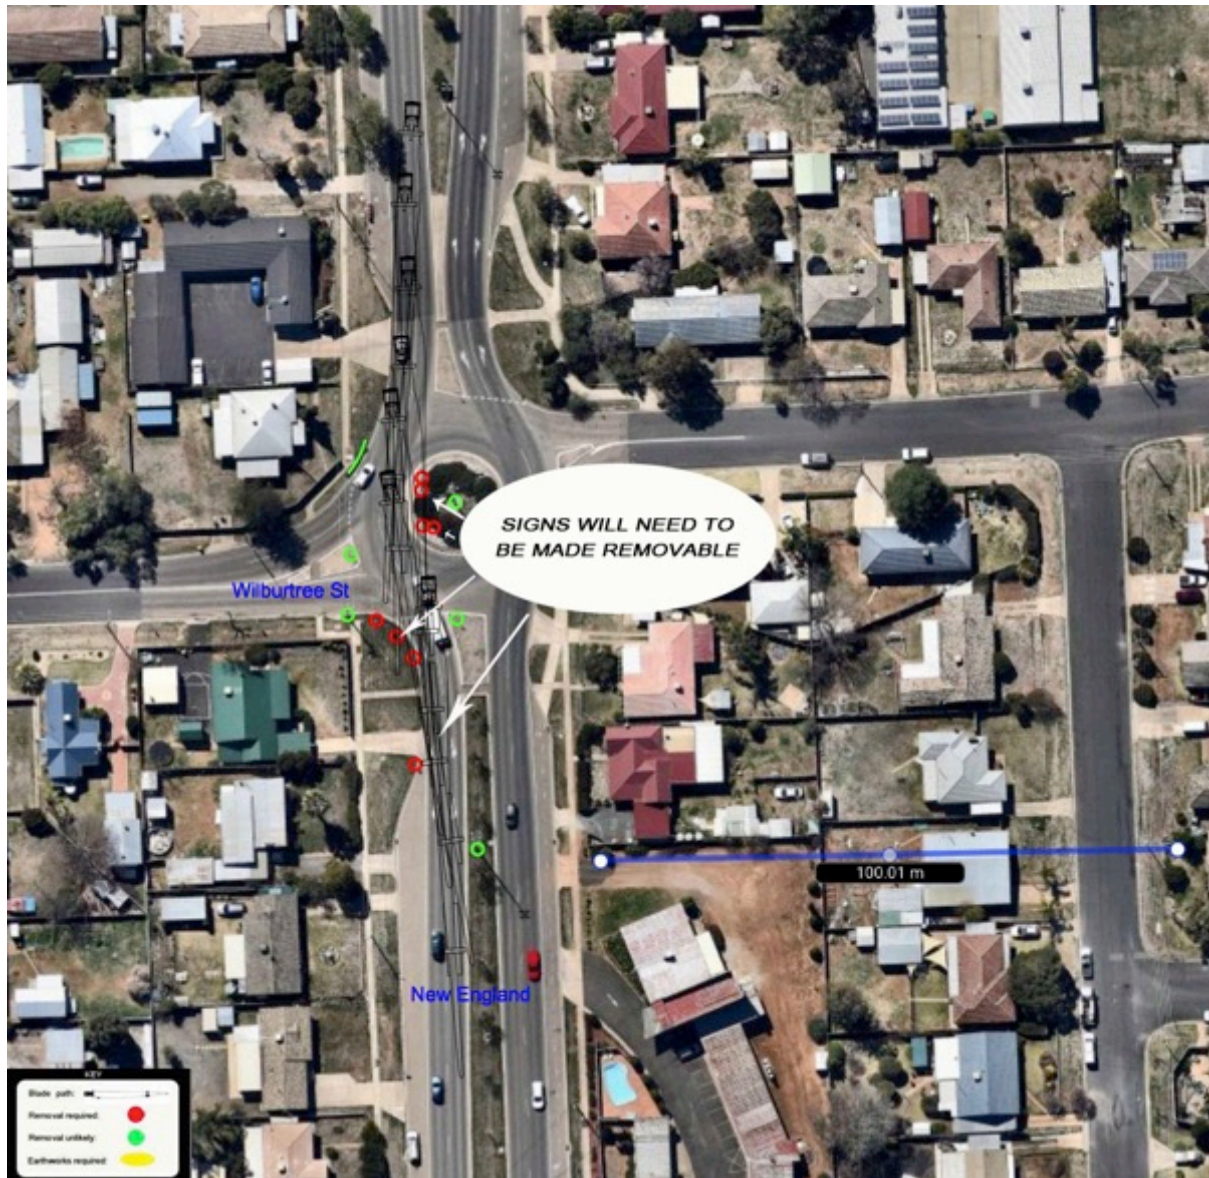
Image 1: (82 Metre blade)

**319.0 Km's:** Standard Roundabout on the New England Highway at Tamworth.

**PROCEDURE:** Loads to travel straight ahead through roundabouts, on the following intersections. (Jack Smyth Drive, Greg Norman Drive, Calala Lane and Kurrawan Street).

**ROAD MODIFICATIONS:** Small amounts of work are required.

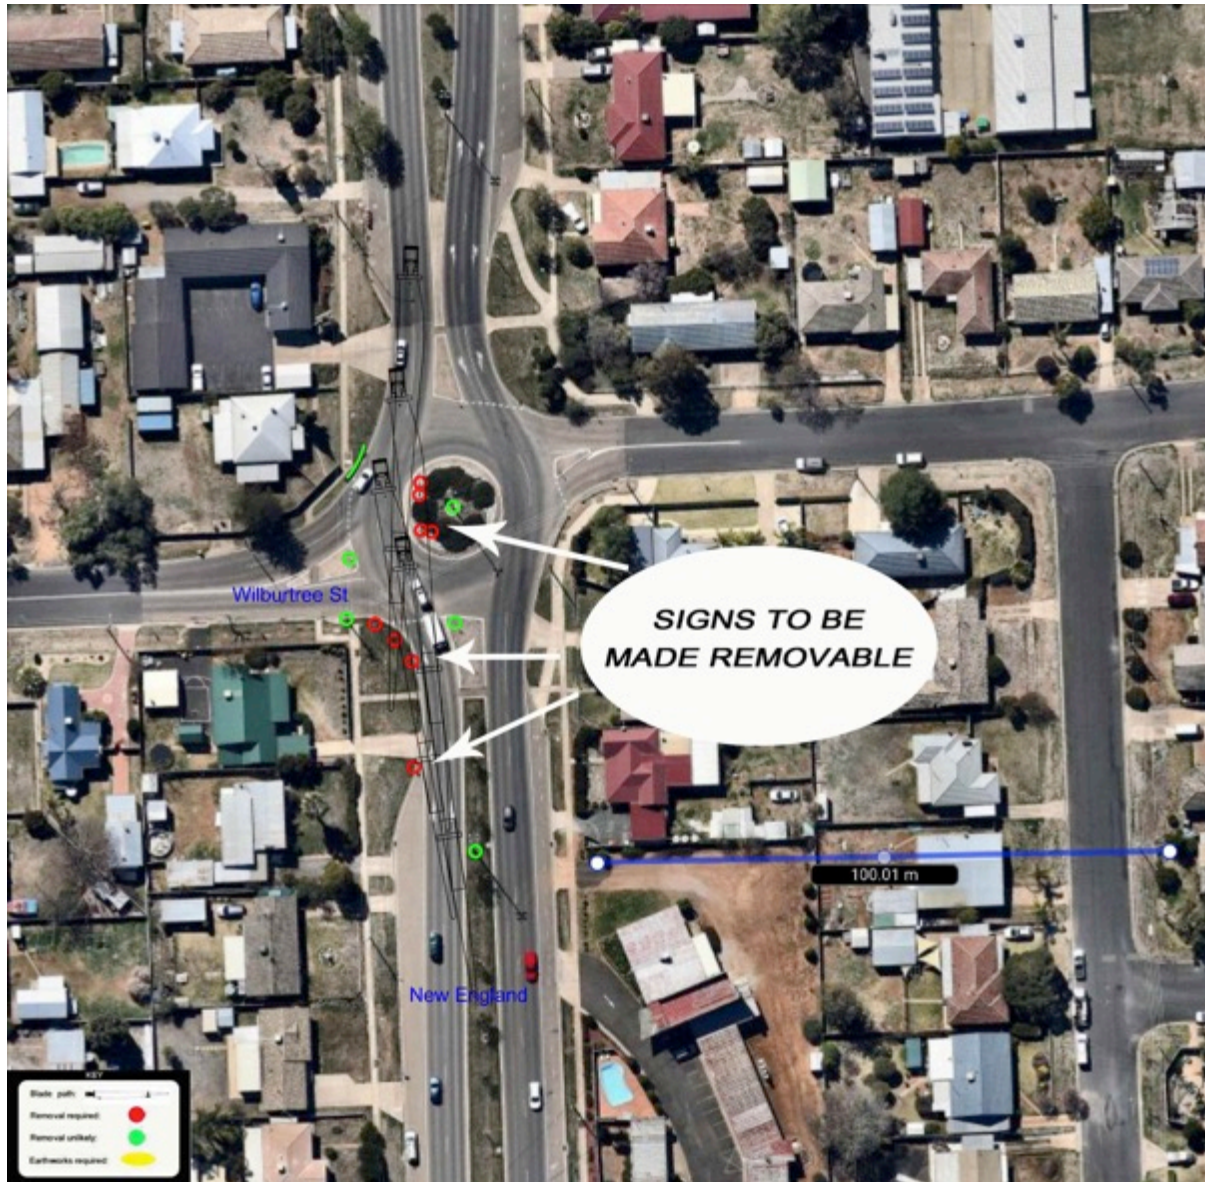
Image 1: (76 Metre blade)

**PROCEDURE:** Loads to travel straight ahead through roundabouts, on the following intersections. (Jack Smyth Drive, Greg Norman Drive, Calala Lane and Kurrawan Street).

**ROAD MODIFICATIONS:** Large amounts of work are required.

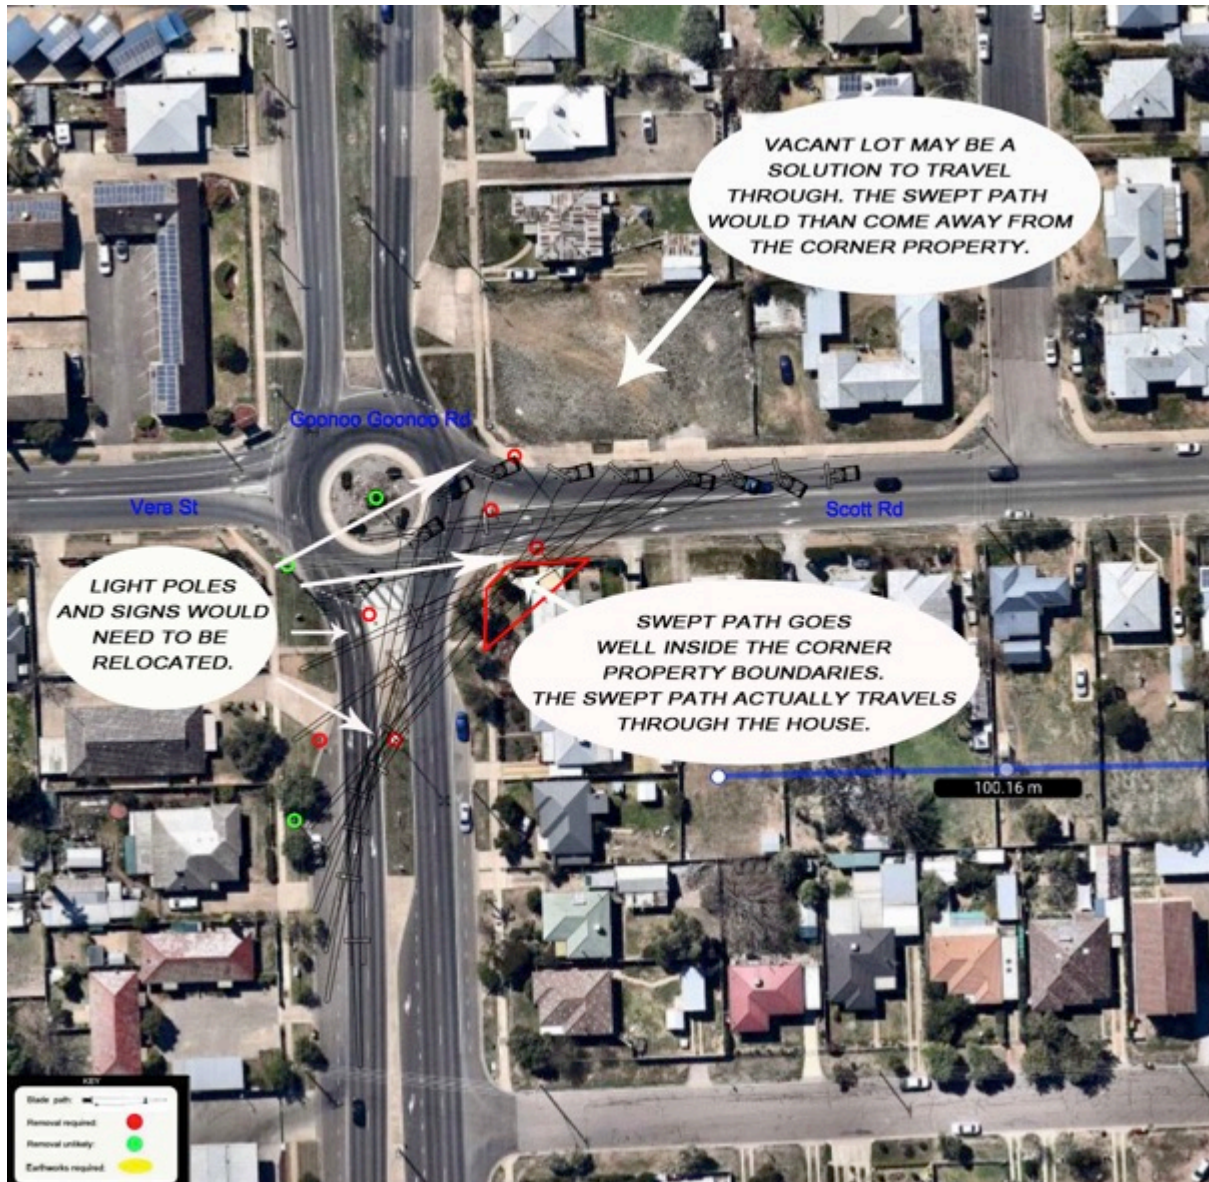
Image 1: (82 Metre blade option 1)

**PROCEDURE:** Loads to cut across the wrong side of the roundabout from correct side to correct side.

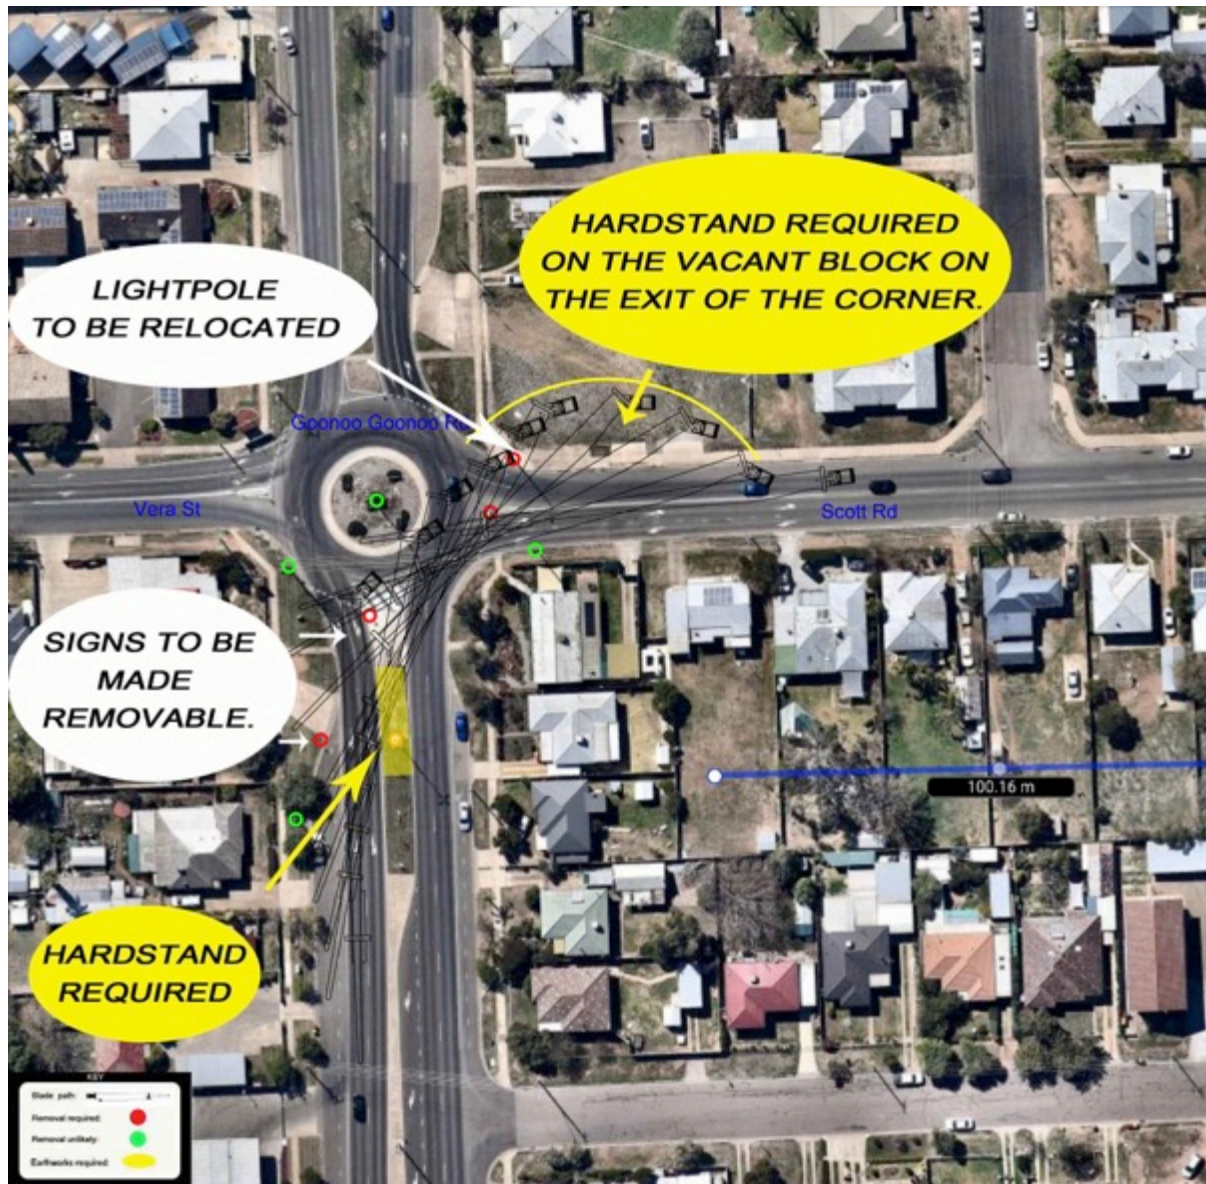
Image 2: (82 Metre blade option 2)

**PROCEDURE:** Loads to cut across the wrong side of the roundabout from correct side to correct side with the prime mover travelling into the vacant block on the exit of the corner.

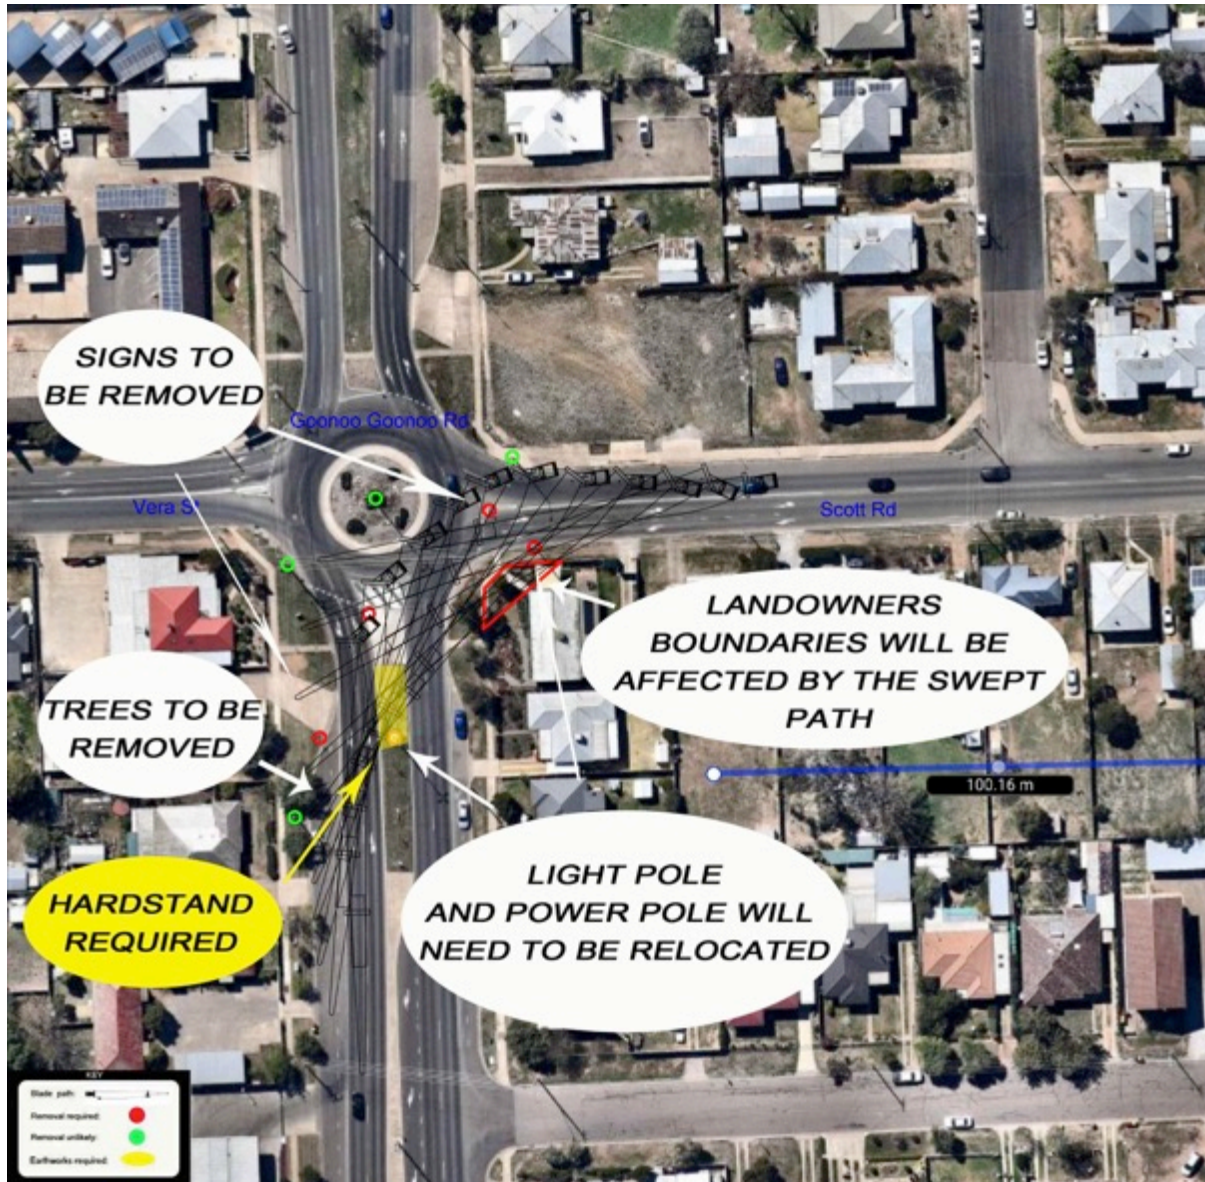
Image 3: (76 Metre blade option 1)

**PROCEDURE:** Loads to cut across the wrong side of the roundabout from correct side to correct side.

**ROAD MODIFICATIONS:** Extreme amounts of work are required.

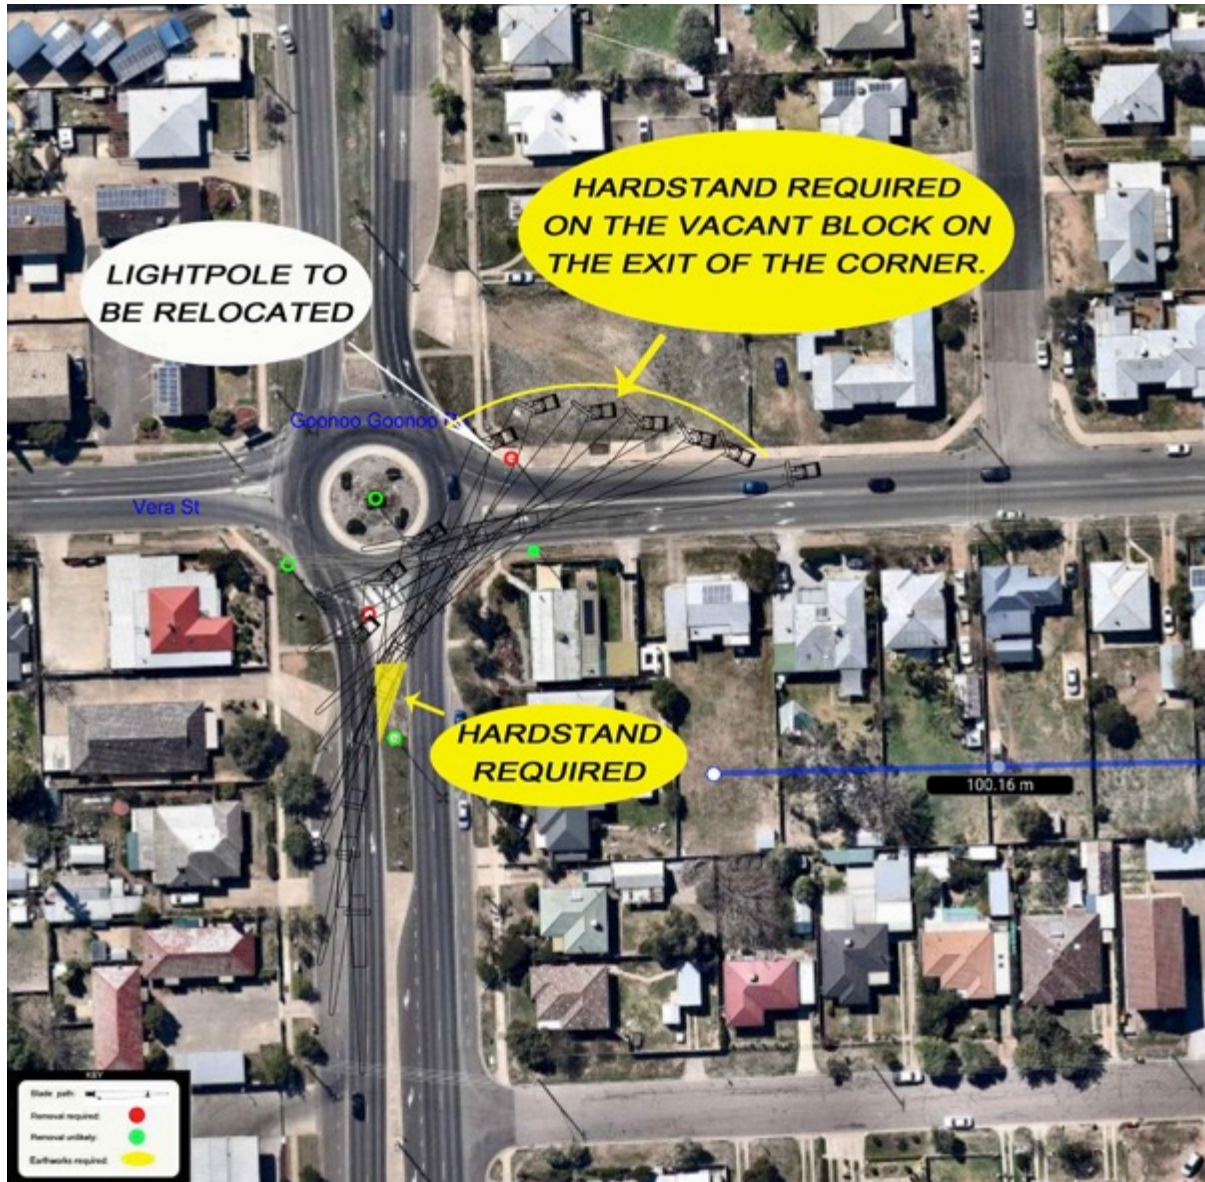
Image 4: (76 Metre blade option 2)

**PROCEDURE:** Loads to cut across the wrong side of the roundabout from correct side to correct side with the prime mover travelling into the vacant block on the exit of the corner.

**ROAD MODIFICATIONS:** Large amounts of work are required.

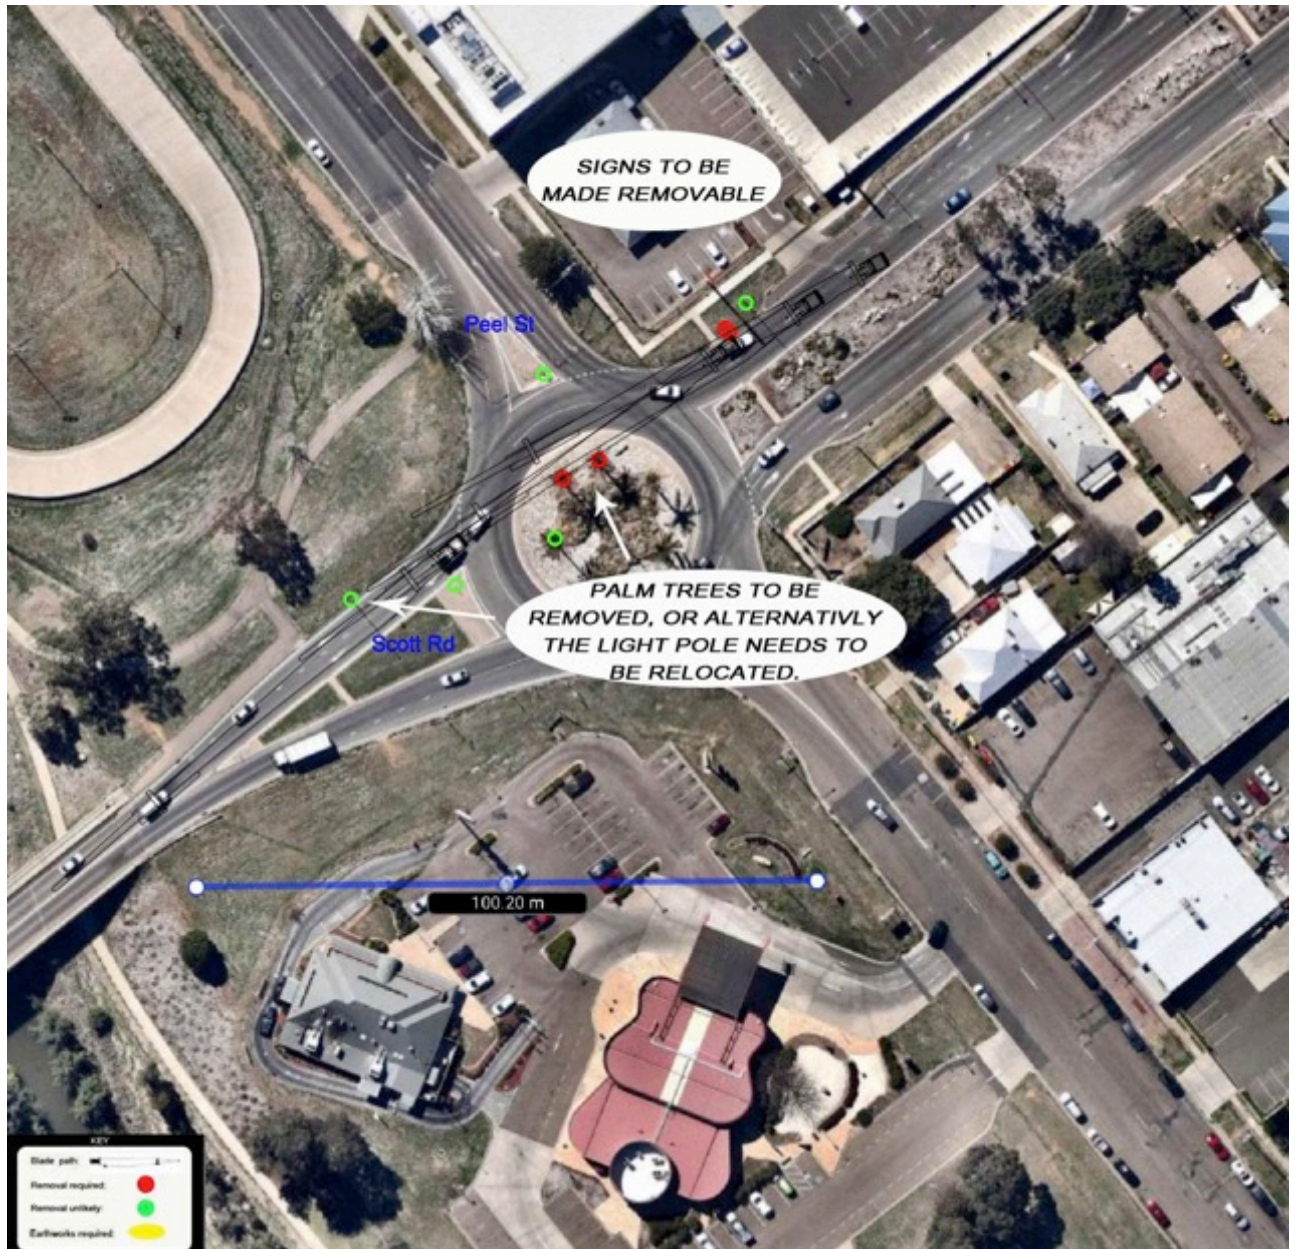
**322.7 Km's: Scott Road onto Murray Street at Tamworth.**  
Image 1: (82 Metre blade)

**PROCEDURE:** Loads to travel through the roundabout on the correct side.

**ROAD MODIFICATIONS:** Large amounts of work are required.

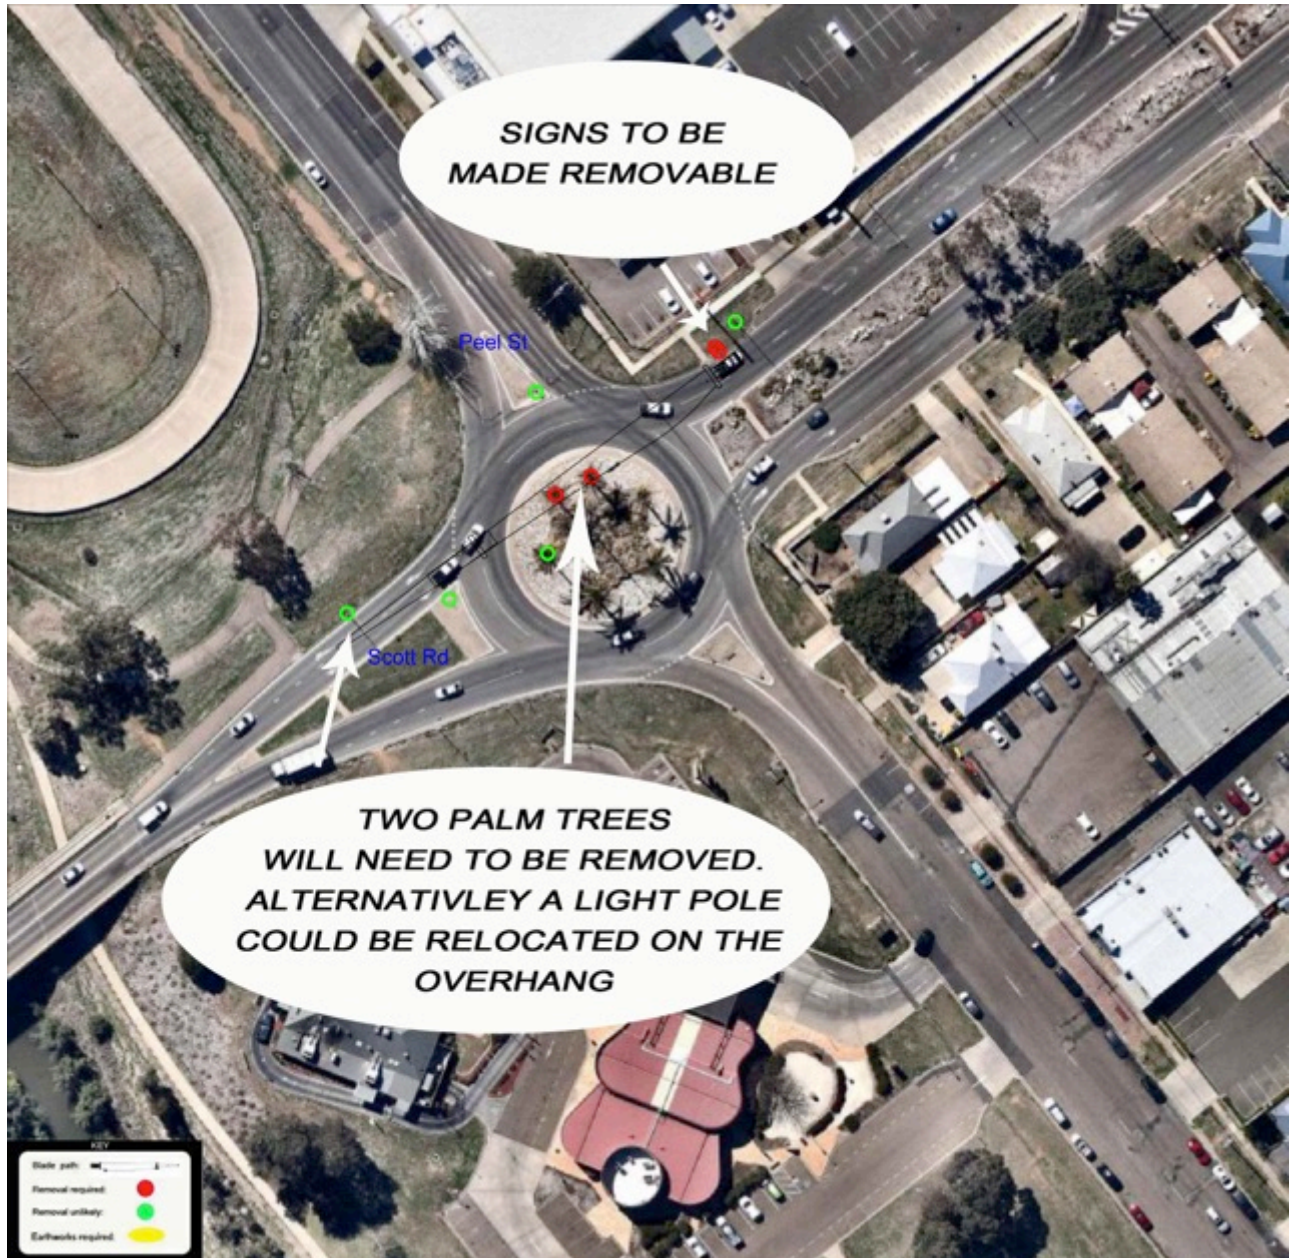
Image 2: (76 Metre blade)

**PROCEDURE:** Loads to travel through the roundabout on the correct side.

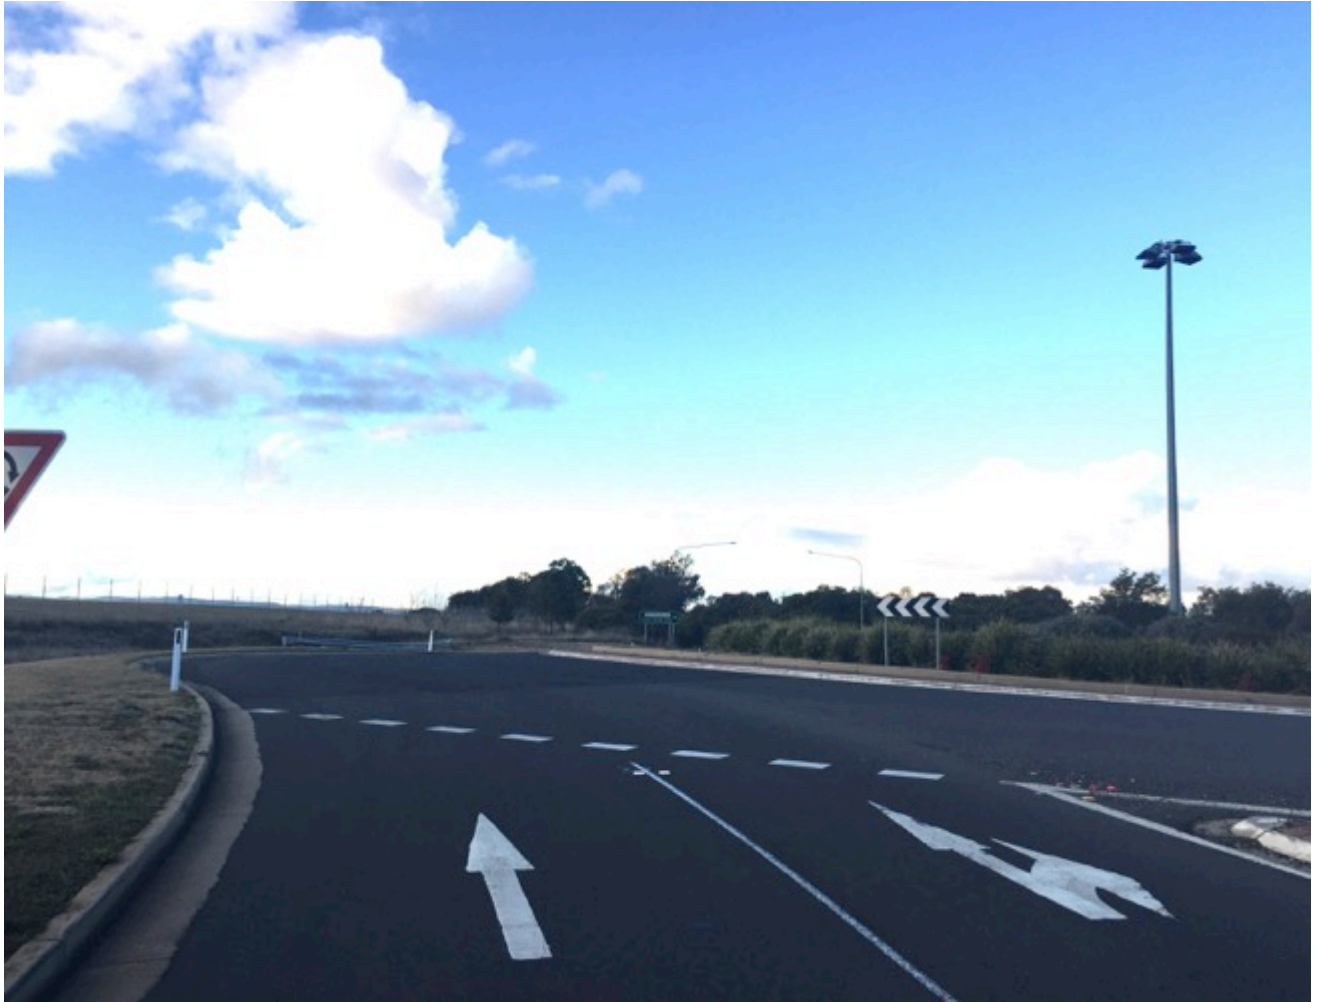
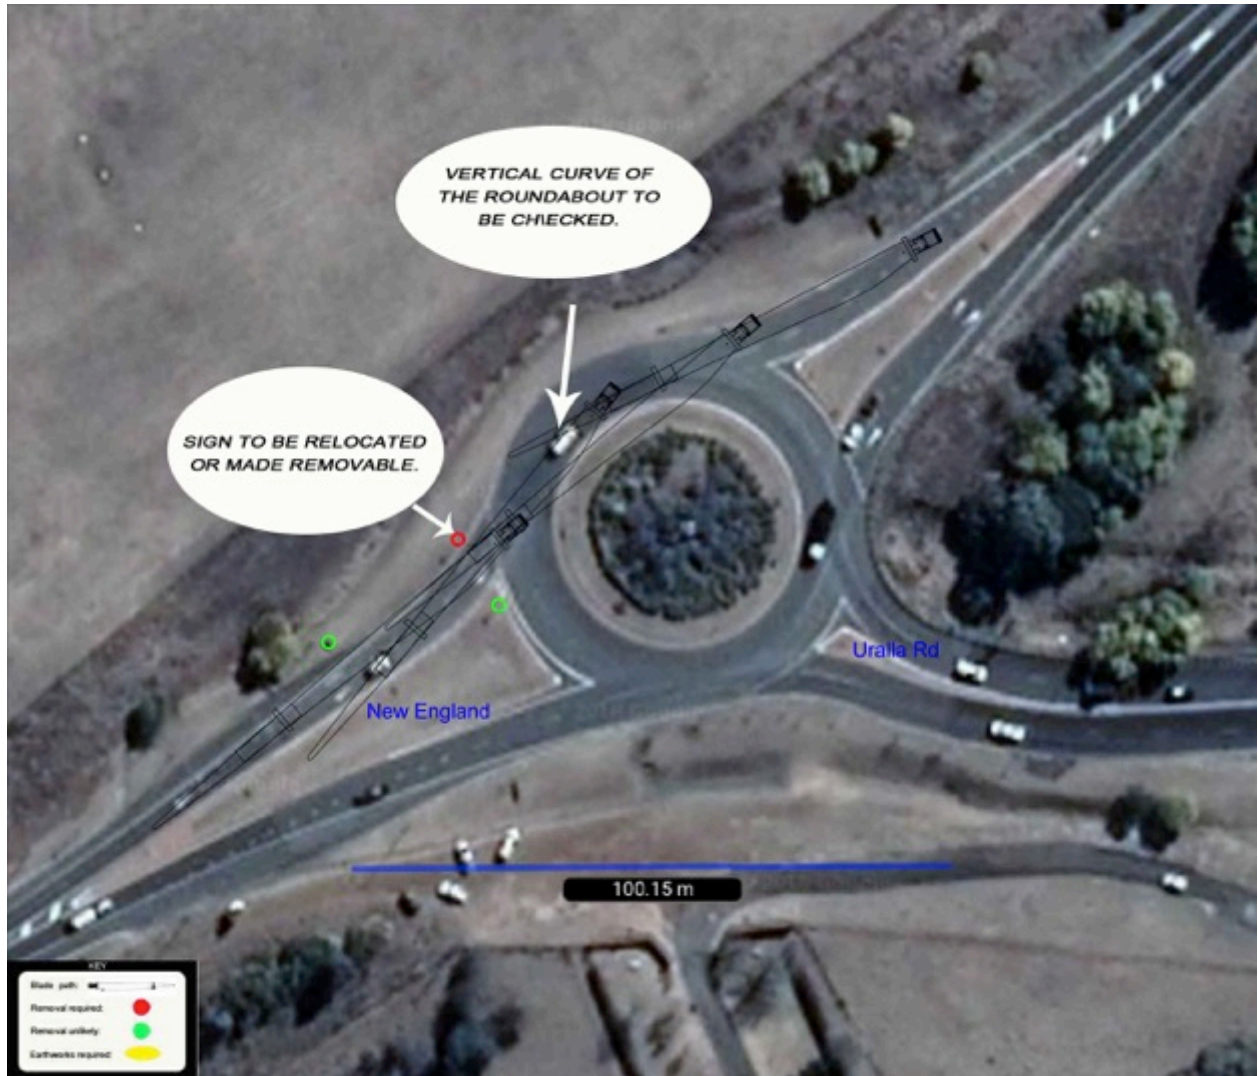
Image 1: (82 and 76 Metre blade)

**PROCEDURE:** Loads to travel straight ahead through roundabouts, on the following intersections. (Uralla Road & New England Highway).

**COMMENTS:** The worst of the roundabouts has a sharp crest; it would be recommended that trailers with hydraulic lift are used to clear this crest. Additionally the tail swing will travel close to the roundabout warning signs, these will also need to be made removable.

| KM index | Location | Section of road | Critical Measurement | Procedure | Notes |
|---|---|---|---|---|---|
| 428.0 | Armidale | Roundabouts<br>GPS link:<br><a href="https://goo.gl/maps/TyVgxMW5xs">https://goo.gl/maps/TyVgxMW5xs</a> | 66.0 metres clearance | Drive directly ahead | The worst of the roundabouts has a sharp crest; it would be recommended that trailers with hydraulic lift be used to clear this crest. Additionally the tail swing will travel close to the roundabout warning signs, these will also need to be made removable. Same for both blade types. |
