23 January 2019

**MP10\_160 Mod 6 White Rock Wind Farm (WRWF) - Further Information**

## 5.0 Sample transport drawings.

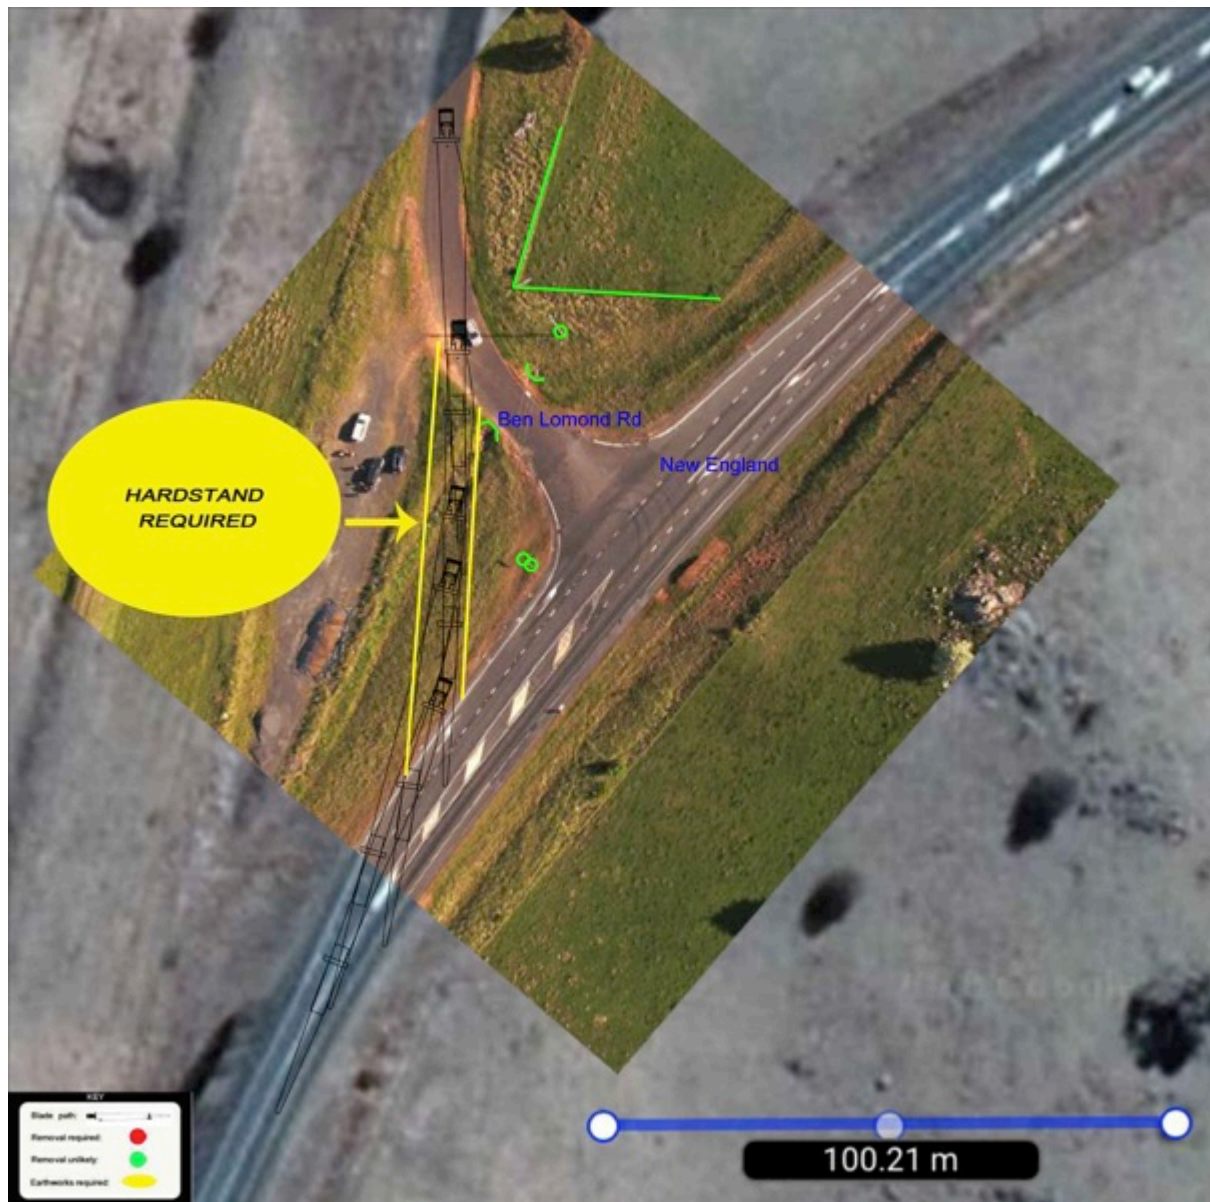
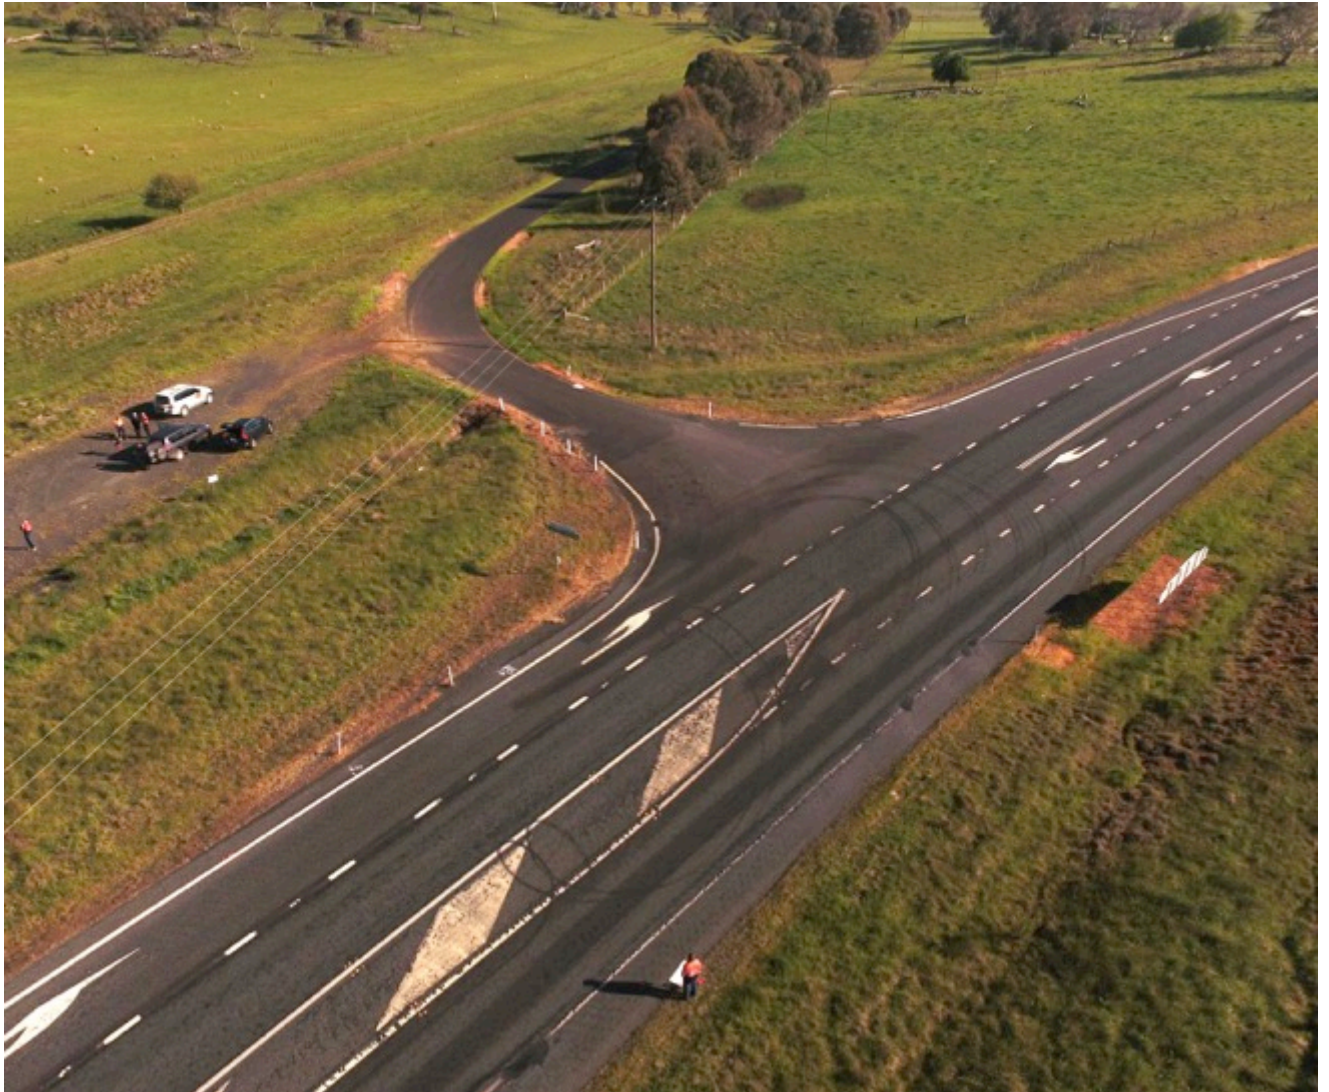
**481.2 Km's:** New England Highway onto Ben Lomond Road.  
Image 1: (82 and 76 Metre blade)

**PROCEDURE:** Loads to veer to the left through an upgraded hardstand area.

**COMMENTS:** This corner has a moderate crest; it would be recommended that trailers with hydraulic lift be used to clear this crest. Additionally the inside of the corner will need to be realigned, and filled with hardstand. This would allow the large blades to travel through the corner.

| KM index | Location | Section of road | Critical Measurement | Procedure | Notes |
|---|---|---|---|---|---|
| 481.2 | Ben Lomond | New England highway onto Ben Lomond Road<br>GPS link:<br><a href="https://goo.gl/maps/12E37v5z3JS2">https://goo.gl/maps/12E37v5z3JS2</a> | 64.0 metres clearance | Veer to the left | This corner has a moderate crest; it would be recommended that trailers with hydraulic lift be used to clear this crest. Additionally the inside of the corner will need to be realigned, and filled with hardstand. This would allow the large blades to travel through the corner. Same for both blade types. |

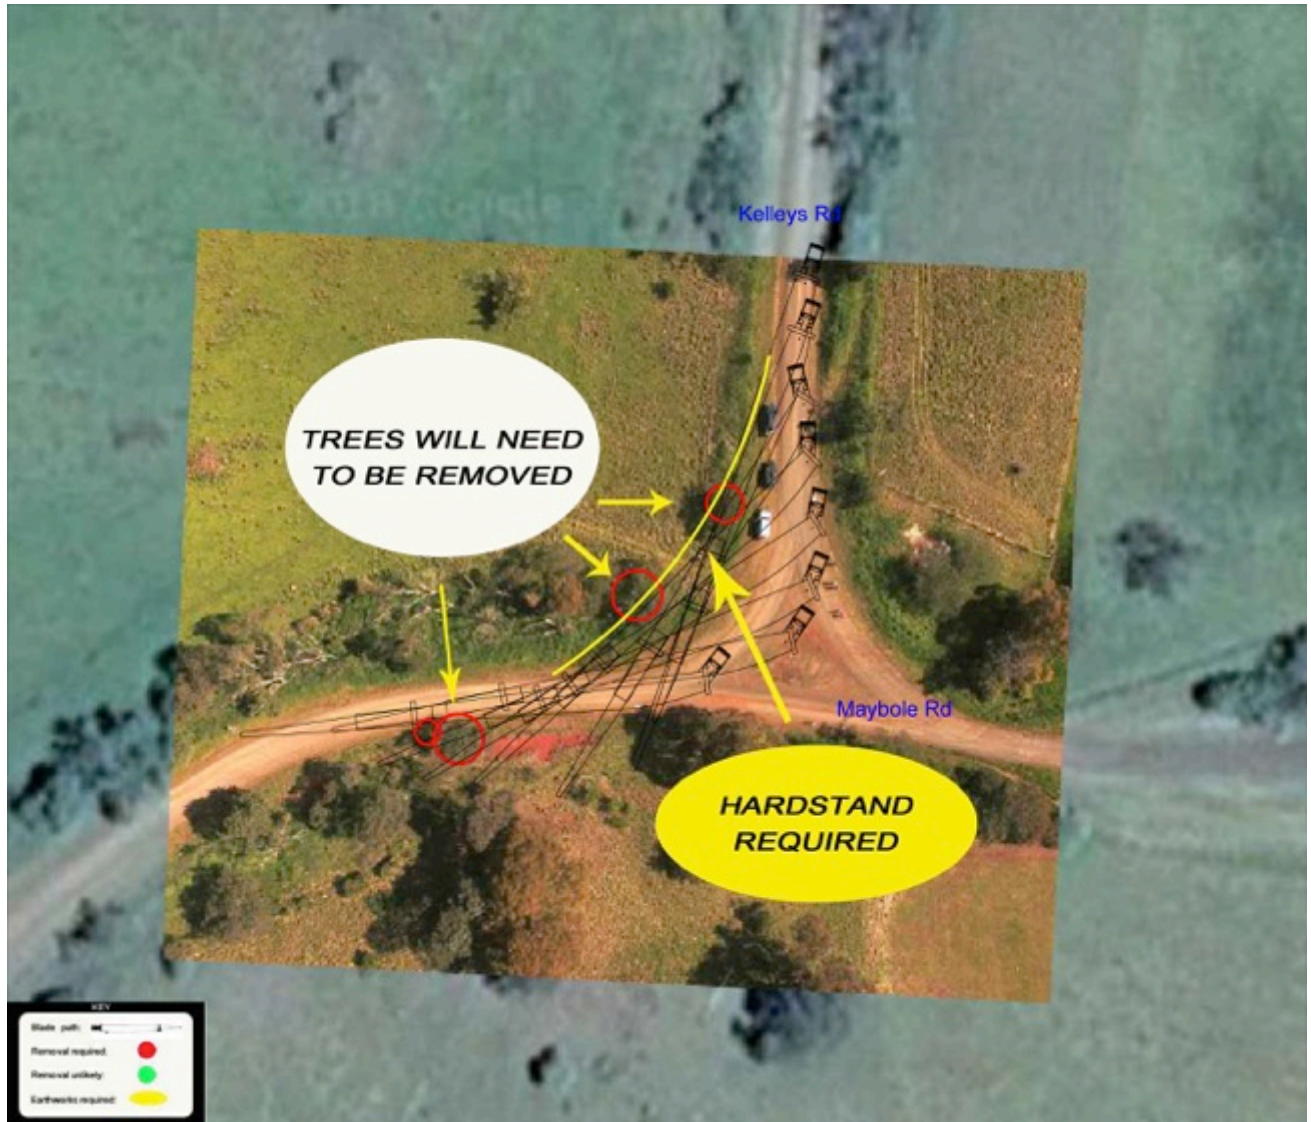
Image 2: (76 Metre blade)

**PROCEDURE:** Maybole Road onto Kellys Road.
