Remediation Action Plan

Riverwood North Residential Renewal
Project
Riverwood, NSW

January 2011
JBS 41131 - 16137
© JBS Environmental Pty Ltd

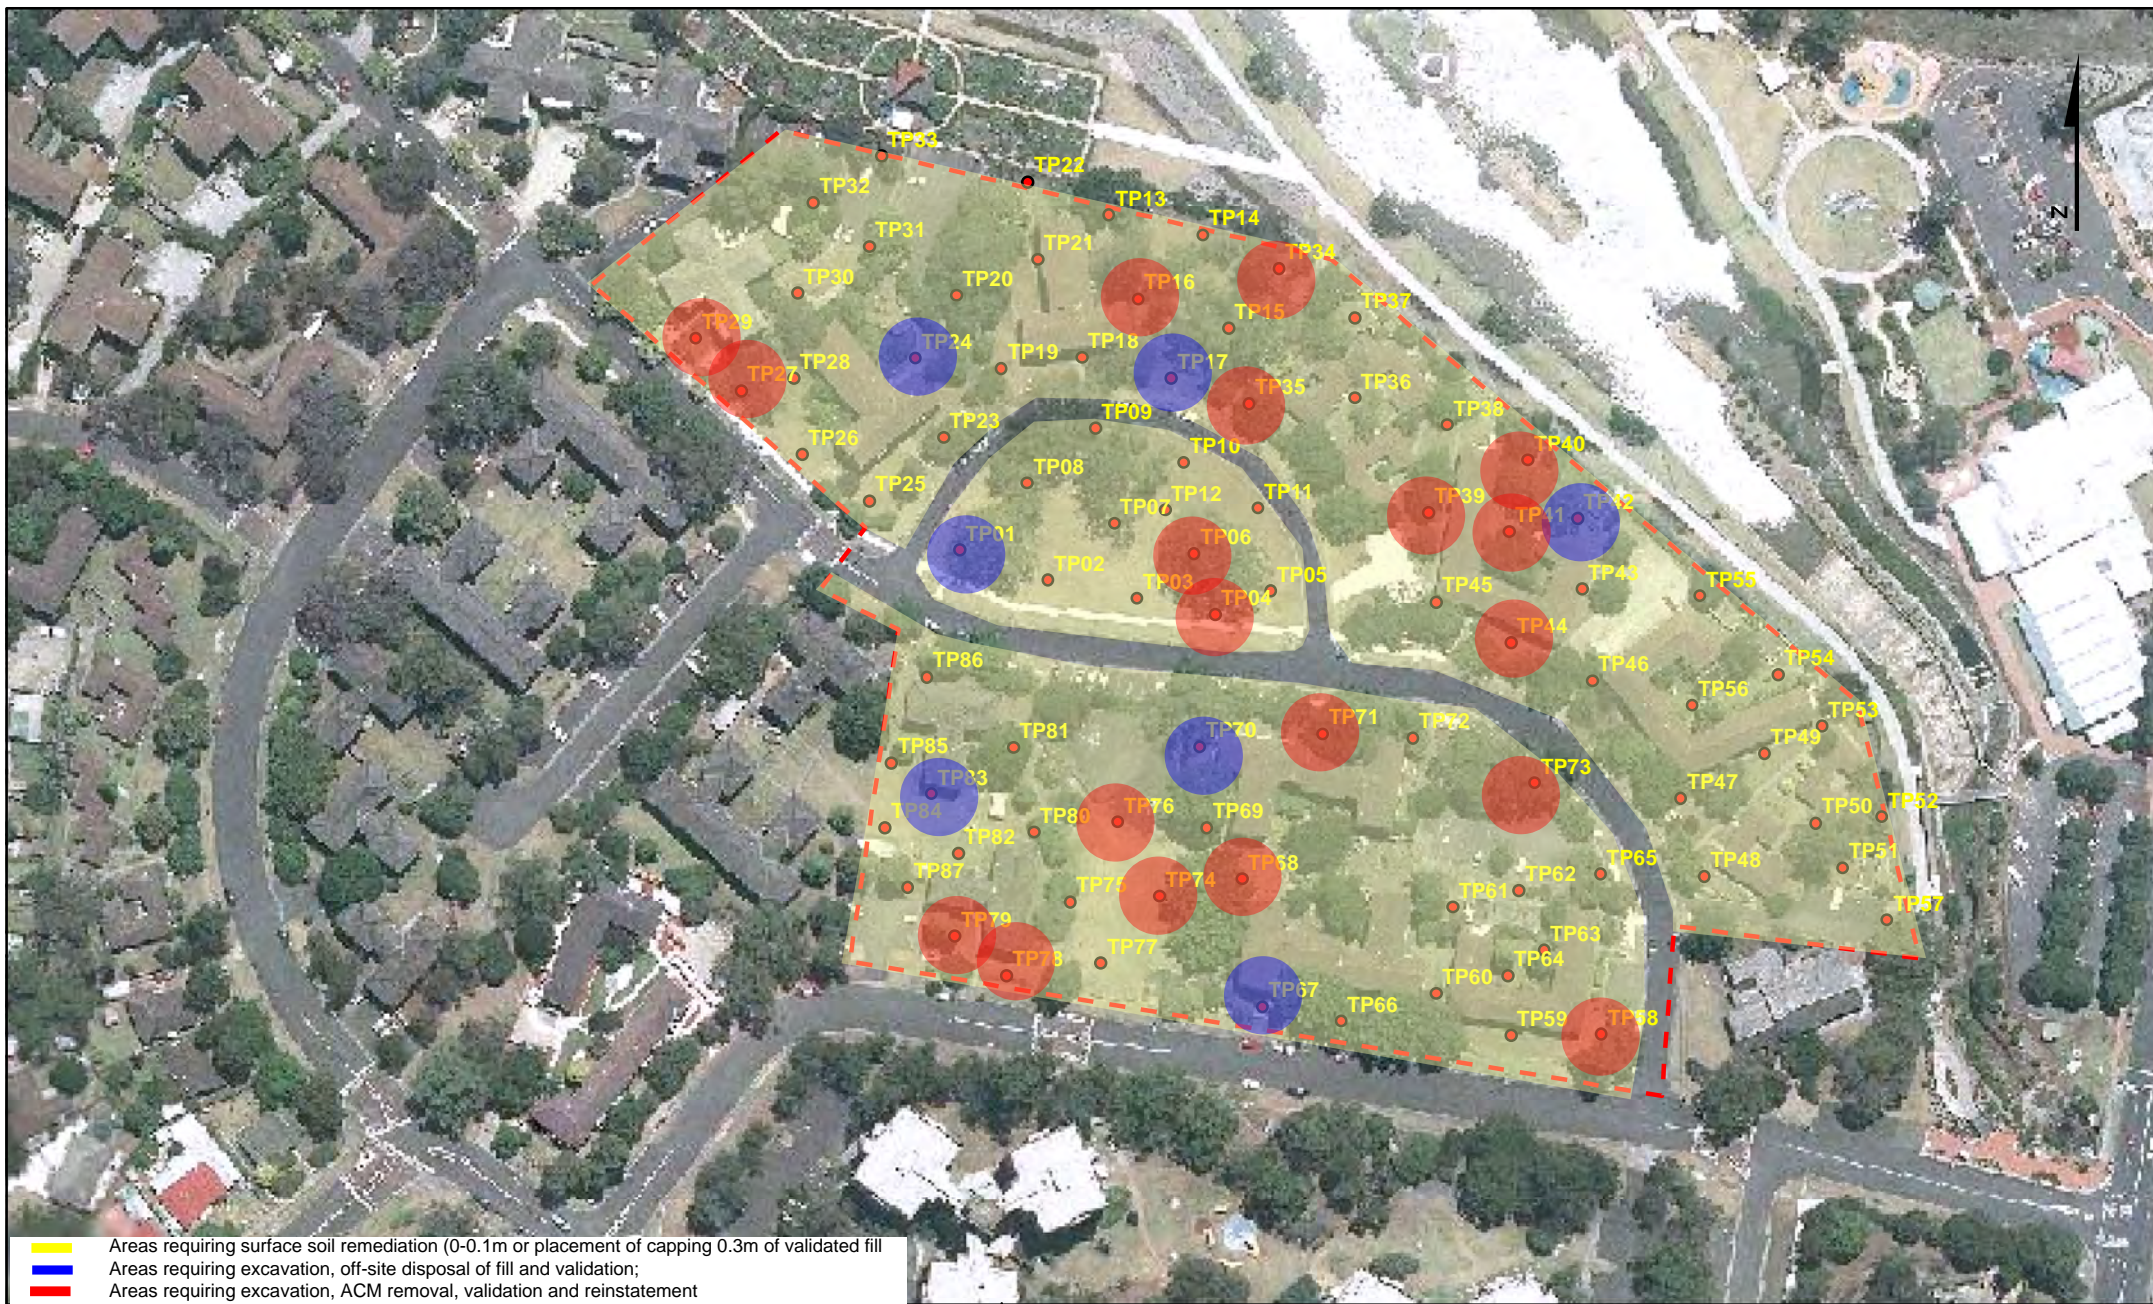
■ Areas requiring surface soil remediation (0-0.1m or placement of capping 0.3m of validated fill)
■ Areas requiring excavation, off-site disposal of fill and validation;
■ Areas requiring excavation, ACM removal, validation and reinstatement

Based on the findings of the Stage 2 ESA (JBS 2010b) and subject to the limitations of that investigation, the anticipated extent of the proposed remediation is shown in **Figure 4**. Based on the currently available information, the following areas¹⁰ require remediation/validation, however it is noted that additional areas of impact may be identified in other parts of the site:

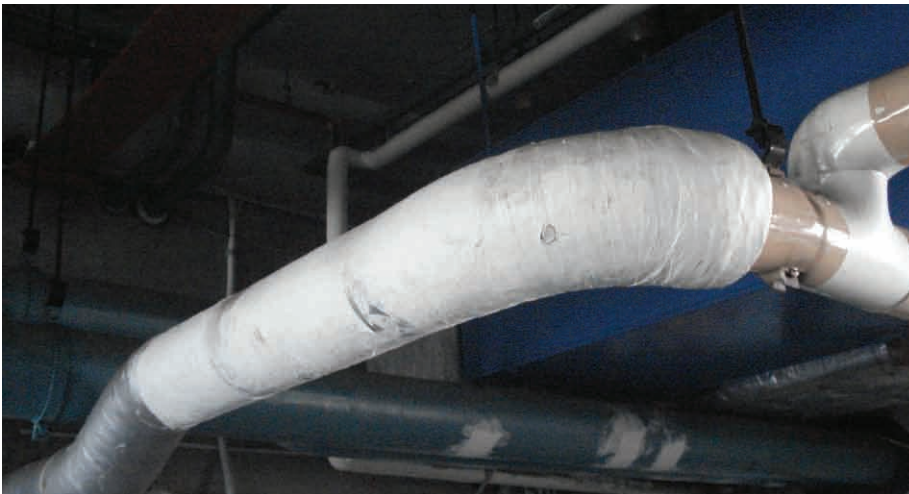
FRIABLE ASBESTOS – PIPE LAGGING

Friable asbestos material is any material that contains asbestos and is in the form of a powder, or can be crumbled, pulverized or reduced to powder by hand pressure when dry. Examples of friable asbestos include:

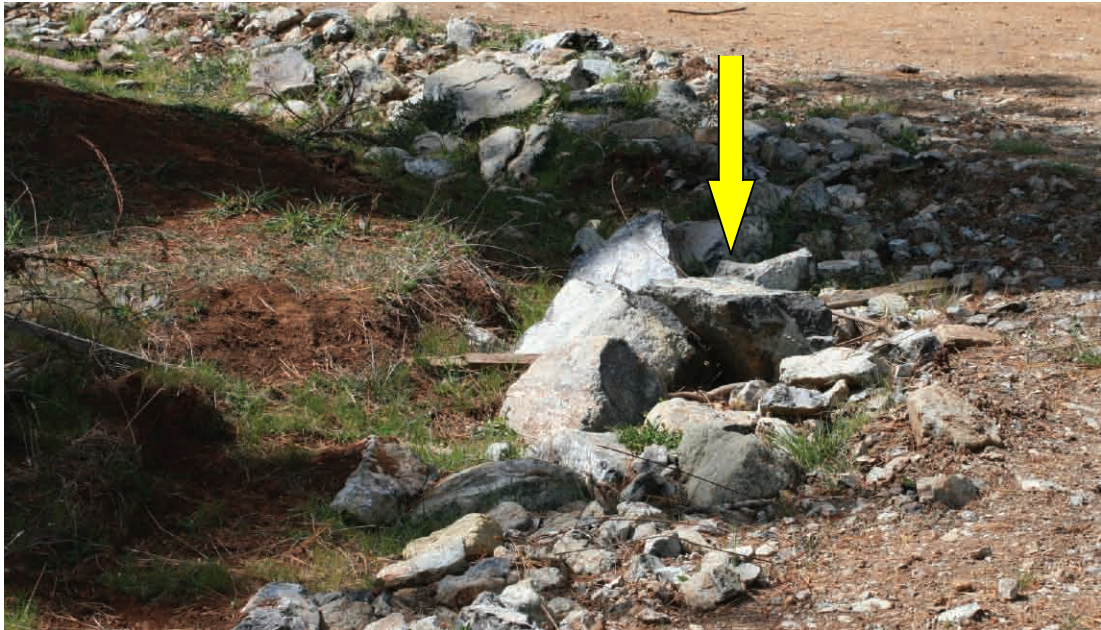
ROCKS CONTAINING NATURALLY OCCURRING FIBROUS SILICATE MINERALS

Asbestos is found as a naturally-occurring mineral in many areas of NSW. Where naturally occurring asbestos (NOA) is encountered – eg in road works, pipe works and telecommunications works – the risk from the NOA disturbance should be assessed by an occupational hygienist.

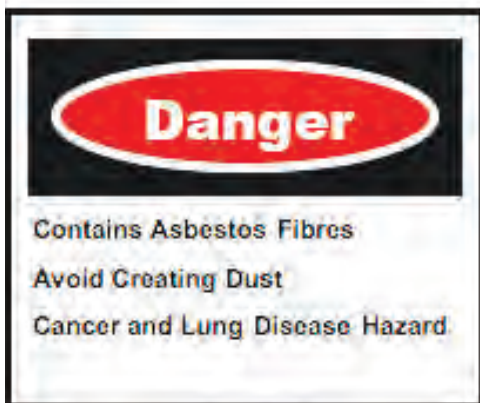
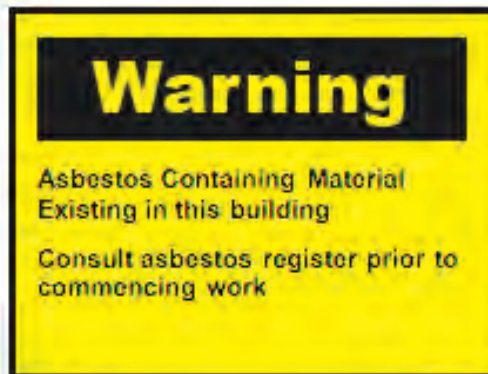
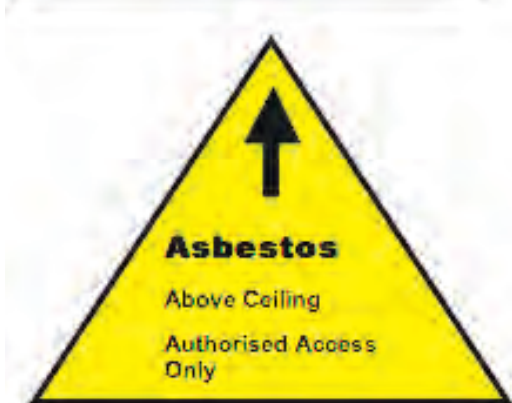
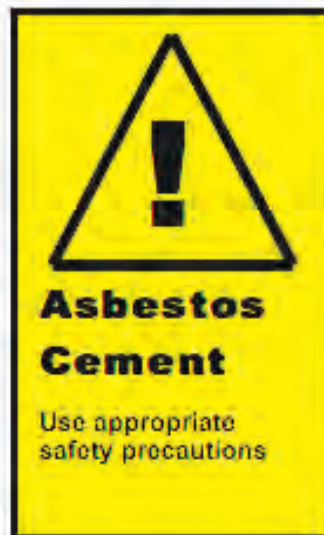
WARNING SIGNS AND LABELS

Source Code of Practice for the Management and Control of Asbestos in Workplaces [NOHSC 2018 (2005)]

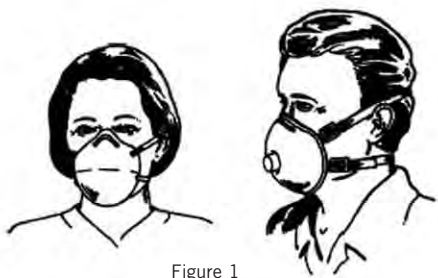
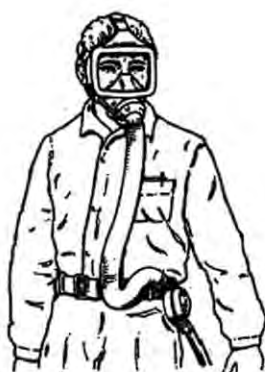
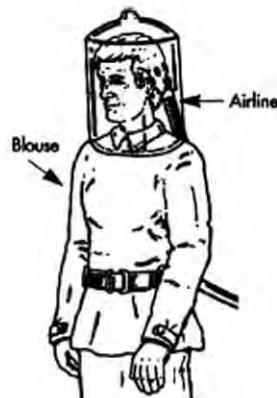
The following list of respirators runs from least efficient (figure 1) to most efficient (figure 7).

FIGURE	RESPIRATOR
1	Disposable, half-face particulate respirators
2	Half-face, particulate filter (cartridge) respirator
3	Powered, air-purifying, ventilated helmet respirator
4	Full-face, particulate, filter (cartridge) respirator
5a	Full-face, powered air-purifying particulate respirator – face piece
5b	Full-face, powered air-purifying particulate respirator – power pack
6	Full-face, positive pressure demand air-line respirator
7	Full suit or hood, continuous flow air-line respirator
