Report on
Stage 2 Contamination Assessment

Proposed Northbank Enterprise Hub
Lot 1001 DP 1127780, 365 Tomago Road
Tomago

Project 49608.01
October 2011

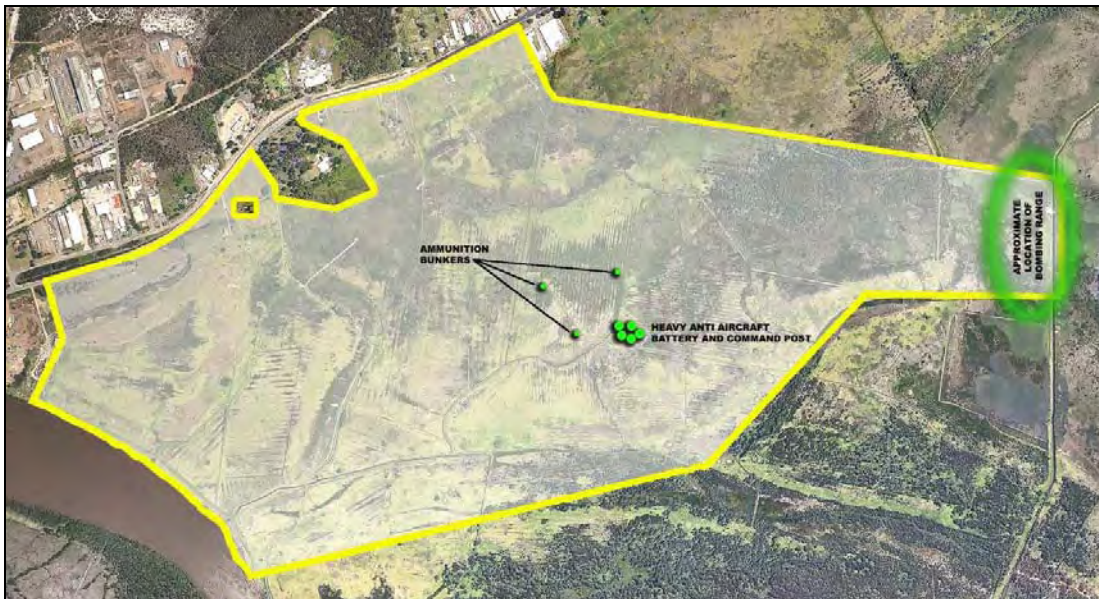
Figure 3: Aerial image showing location of former bombing range, and other remaining military fabric from EJE report

- During WWII, Tomago House together with some buildings on the surrounding farms were occupied by the military authorities;
- During April 1942 and for the duration of the war, the RAAF operated a practice bombing range on the eastern portions of Lots 4, 5 and 6 (Figure 3);

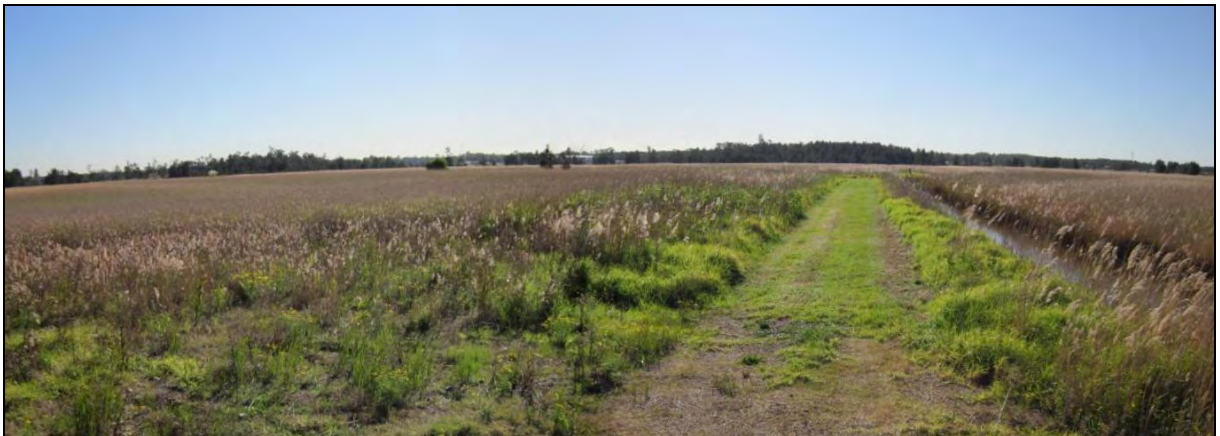
Photo 1: Low-lying plain with thick reeds and adjacent open channel / drain to the east of the site in the north eastern corner of the site

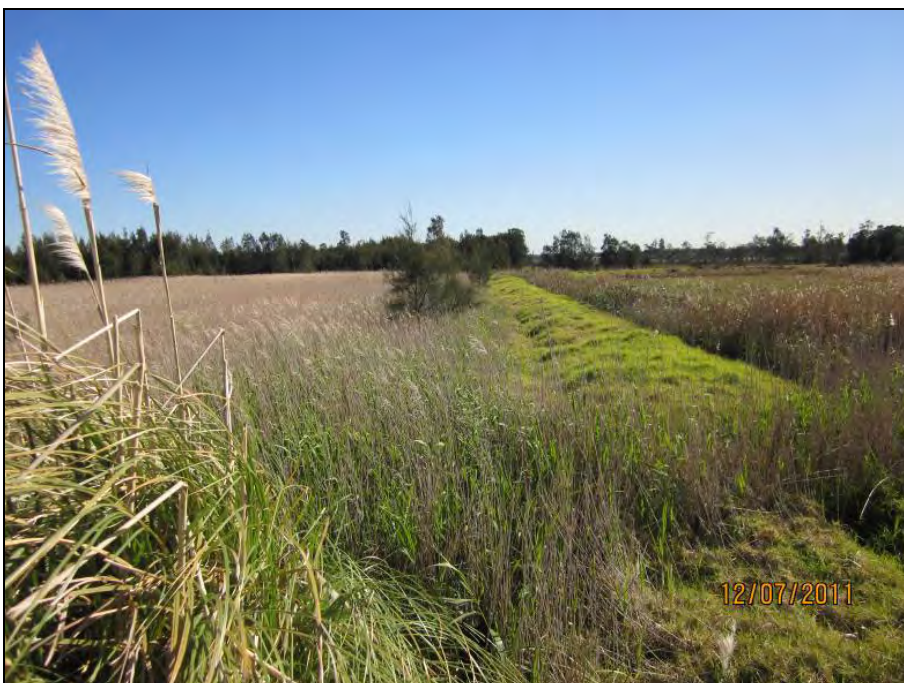
- Former access tracks were observed adjacent to a number of drains across the northern section of the site (Photo 2, Photo 4 to Photo 6) and may have been constructed from materials excavated from adjacent drains;

Photo 2: Low-lying plain with thick reeds within the site (left), fill mound / adjacent drain along the northern site boundary and pine forest within the northern portion of the site (background)

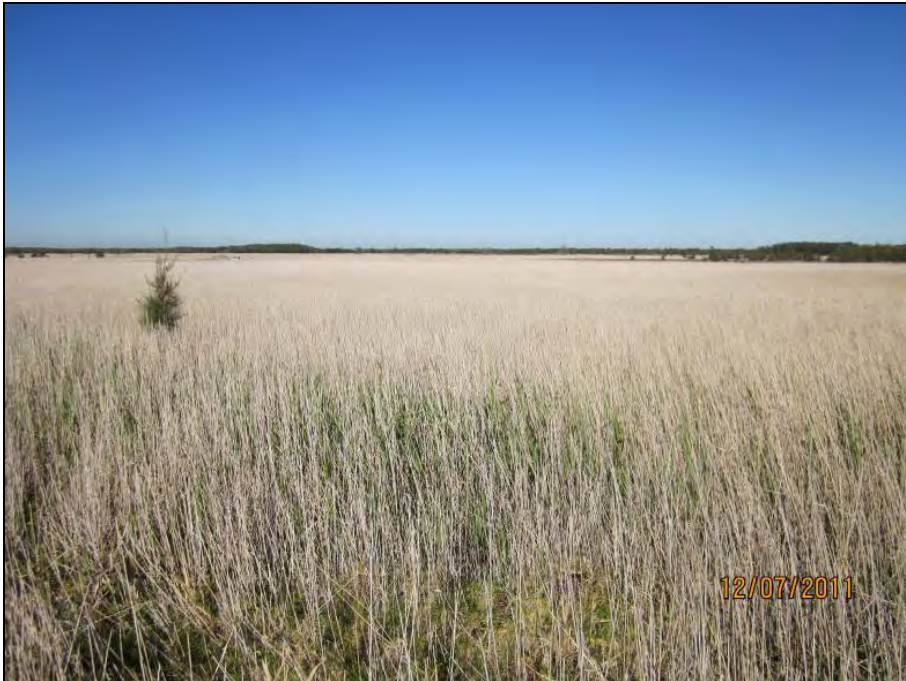
Photo 3: Low-lying plain with thick reeds within the north eastern portion of the site

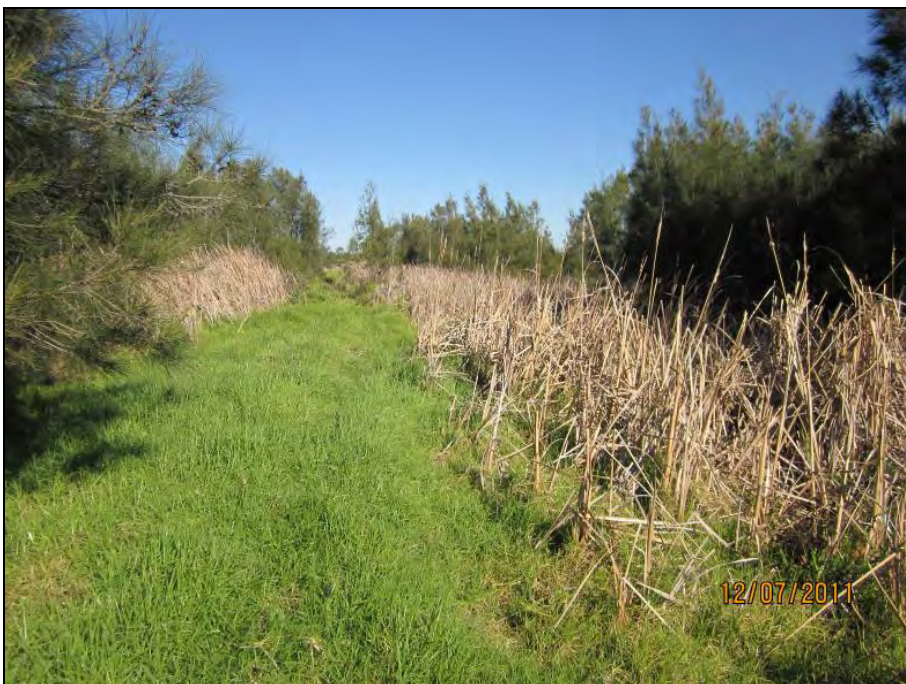
Photo 4: Former raised access track (thick grass covered) with adjacent low lying pine forest and drains (dense reed cover)

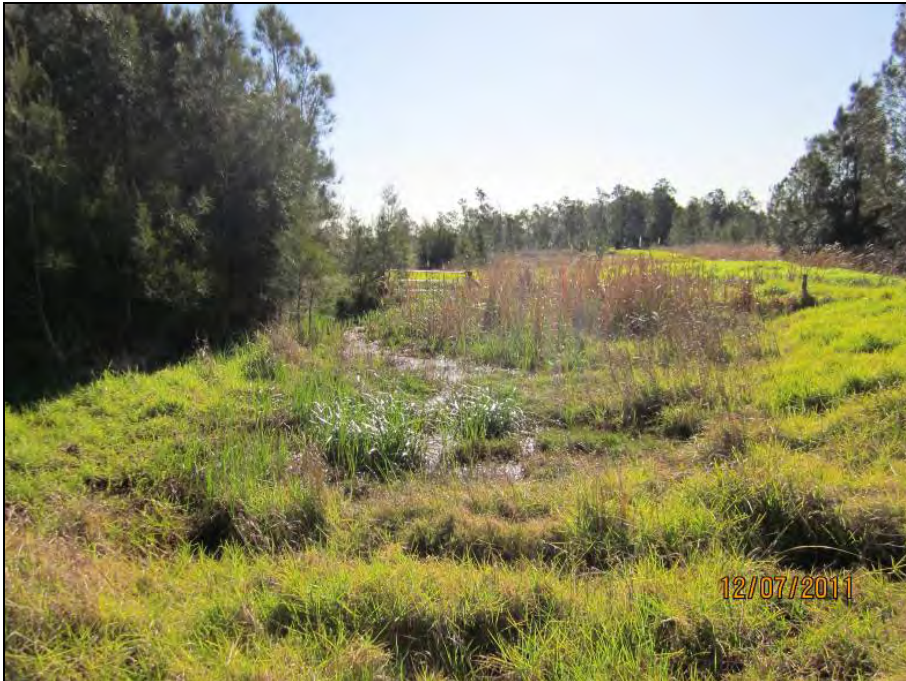
Photo 5: Surface water at the ground surface migrating onto the site at the northern boundary

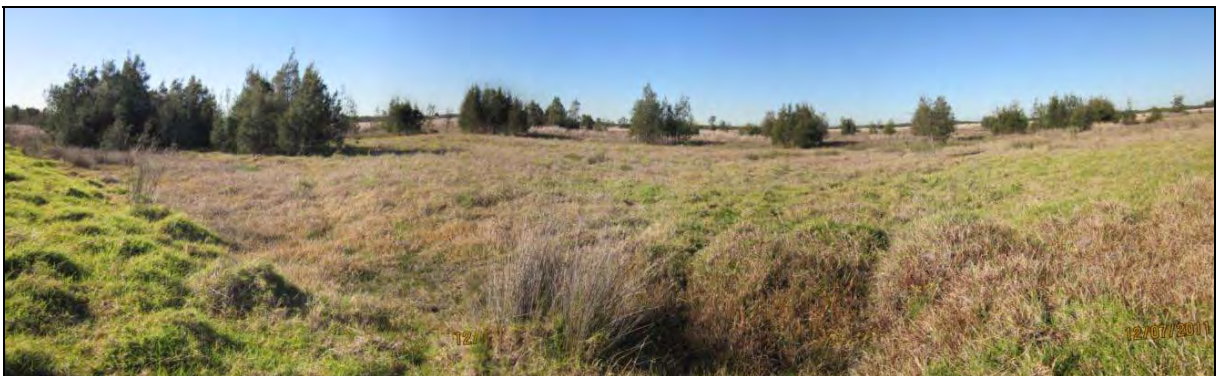
Photo 6: Low-lying plain with thick reed / grass cover within the north eastern portion of the site, raised access track (left)

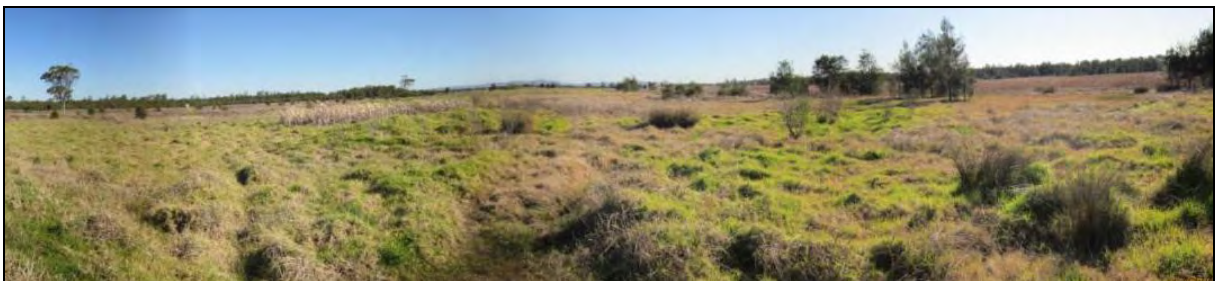
Photo 7: Low-lying plain with thick grass cover in the foreground (slightly elevated area) and thick reed cover (background at right – water logged lower area) within the north eastern portion of the site

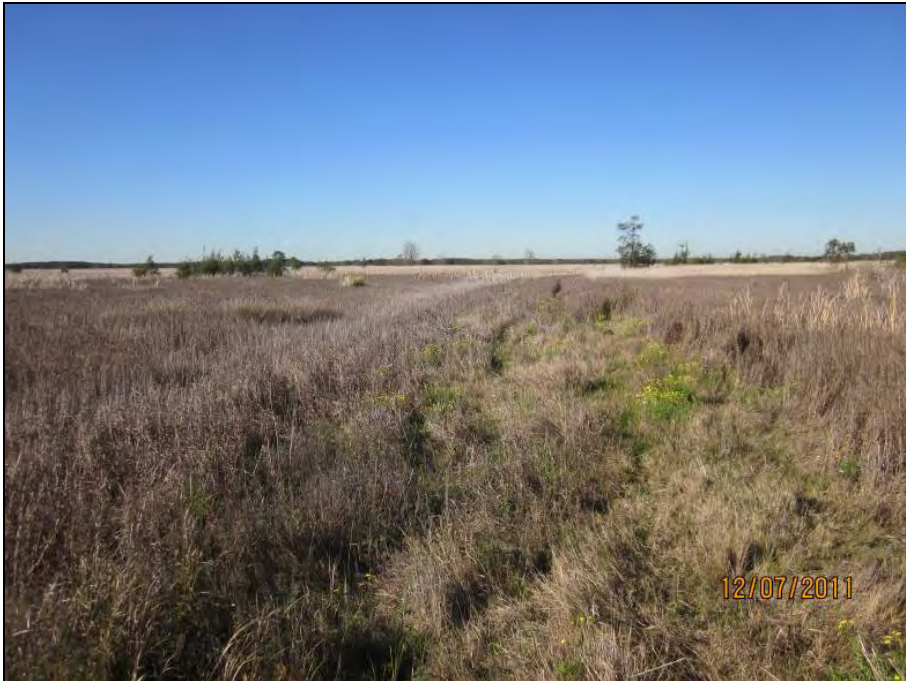
Photo 8: Low-lying plain with reed cover (water logged)

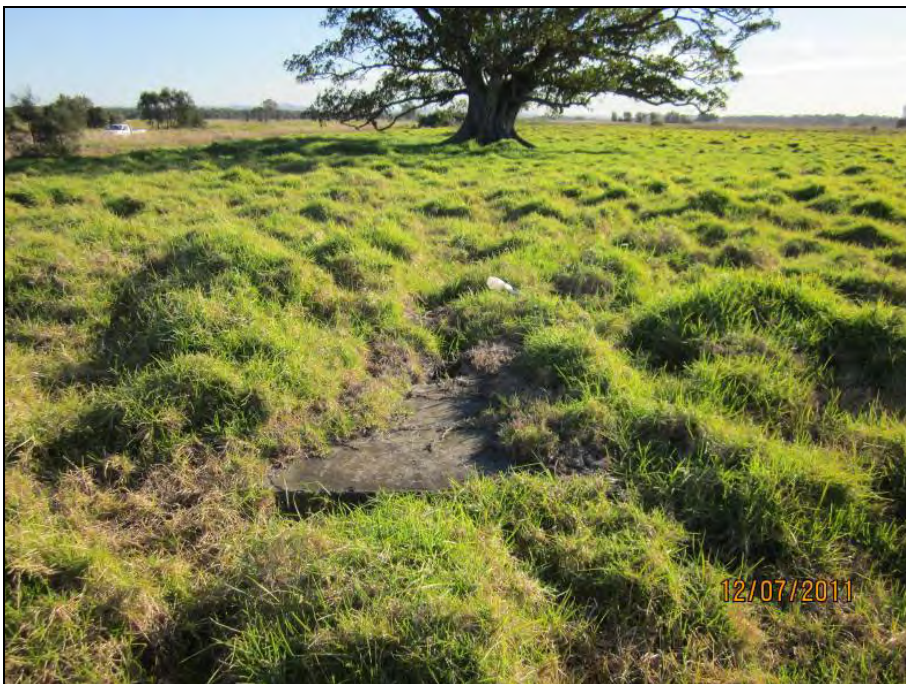
- A septic tank (Photo 9) and house slab with fibro sheeting fragments and other building materials (Photo 10) was observed in the southern portion of the site near a large fig tree;

Photo 9: Septic tank with broken concrete lid in the southern portion of the site, thick grassed covered field in background, drain with thick reed cover (left)

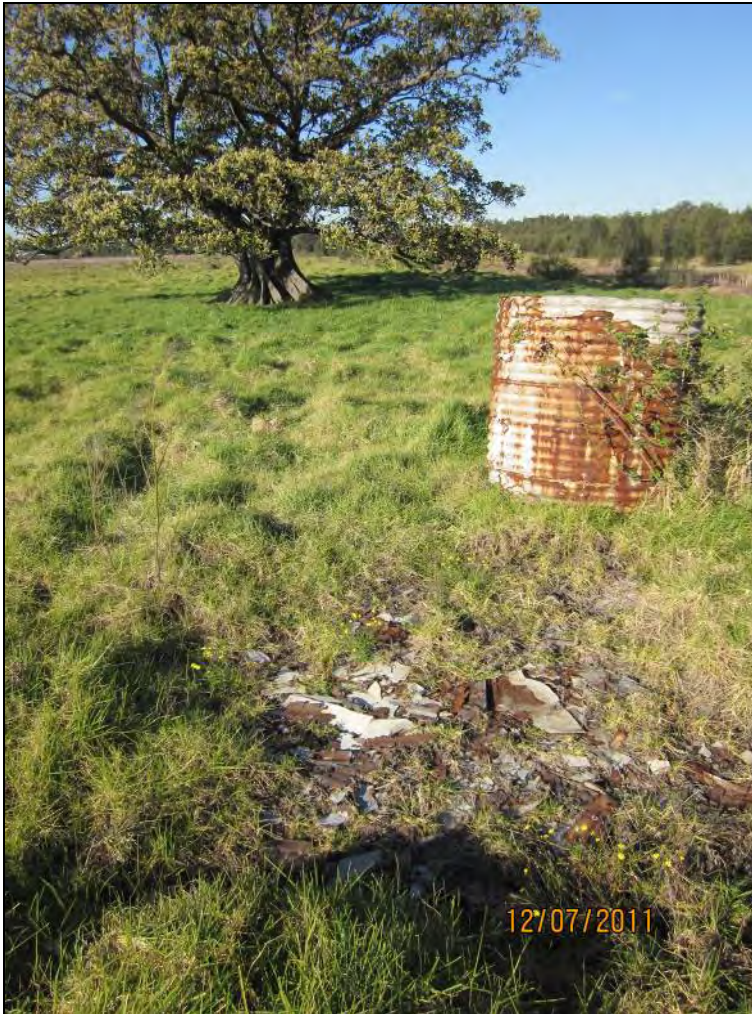
Photo 10: Fibro sheeting fragments and other demolition was at the surface of a former concrete house slab, rusted corrugated iron water tank (right) and thick grassed covered field (left)

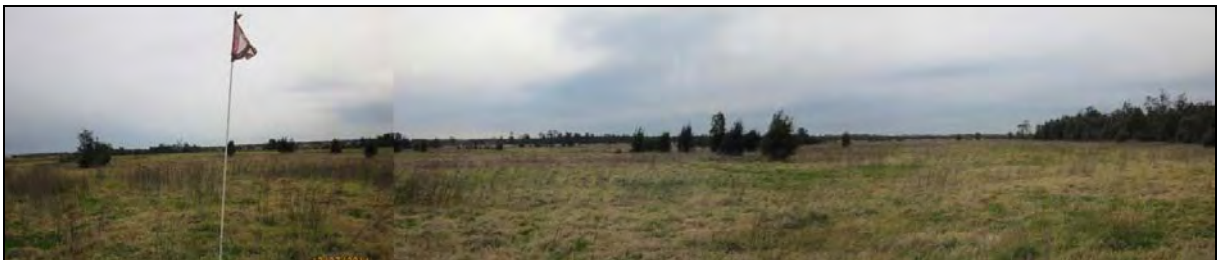
- The south eastern portion of the site comprised a thick grass / blackberry bush cover with some shallow drains and some water logged areas (Photo 11). A lower lying area comprising a thick tree cover and partially water logged surface was located to the south / south west of the drainage line in the south eastern corner of the site;
- Concrete piers (Photo 15) and a corrugated iron water tank (Photo 14) from a former residence were observed in the south western portion of the site. A 3 m by 3 m excavated hole (approximately 1.5 m deep was located immediately to the west of the former residence – purpose unknown).

Photo 11: Thick grass covered plain in the south eastern corner of the site. Pine tree line (right) is the eastern boundary of the site

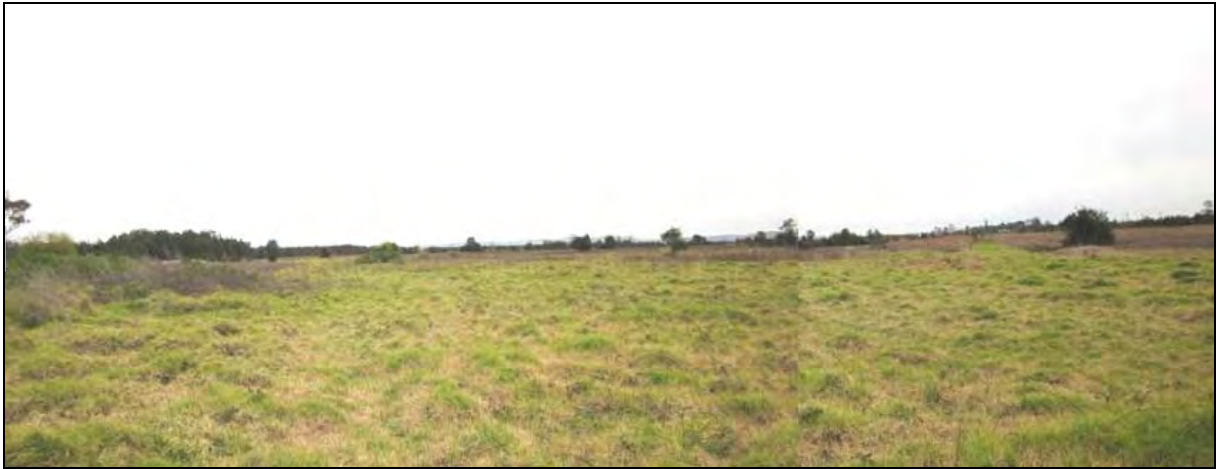
Photo 12: Thick grass covered plain in the north eastern portion of the site. Thick reed cover within creek / drain (left), former raised access track with adjacent water logged thick reed cover (right)

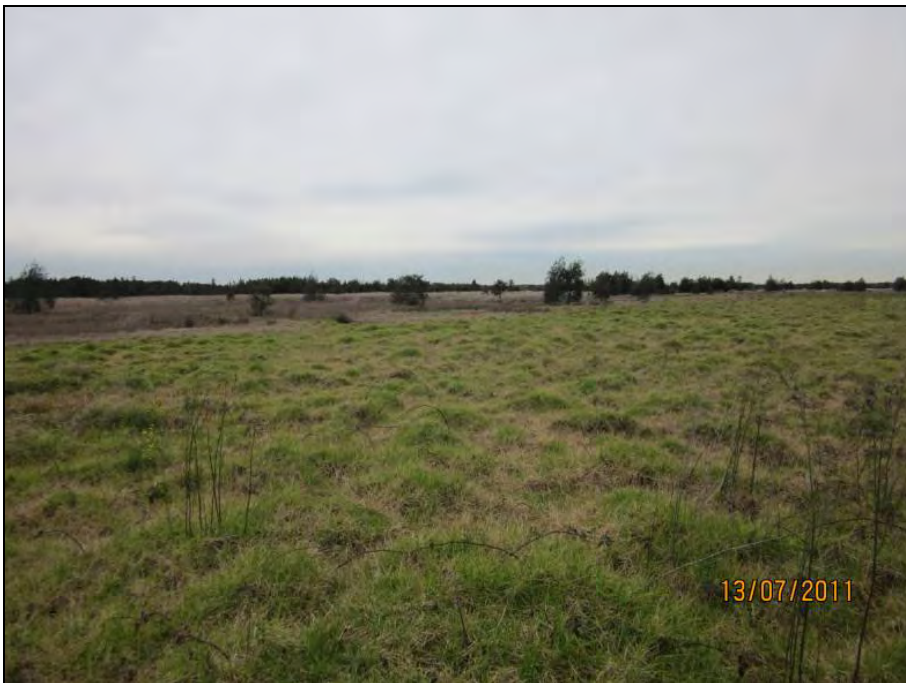
Photo 13: Thick grass covered plain in the north eastern portion of the site. Thick reed cover water logged area in background

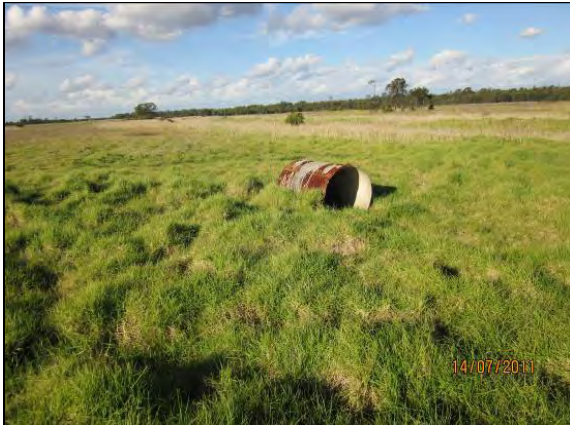
Photo 14: Corrugated iron water tank associated with former residence, with thick reed cover associated with the adjacent drain in the background

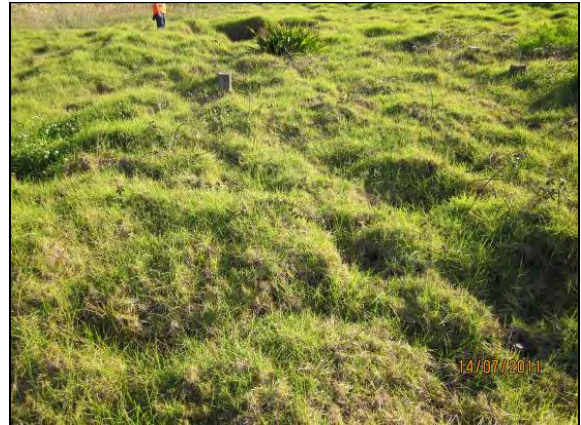
Photo 15: Thick grass covered footing associated with a former residence in the south-western portion of the site
