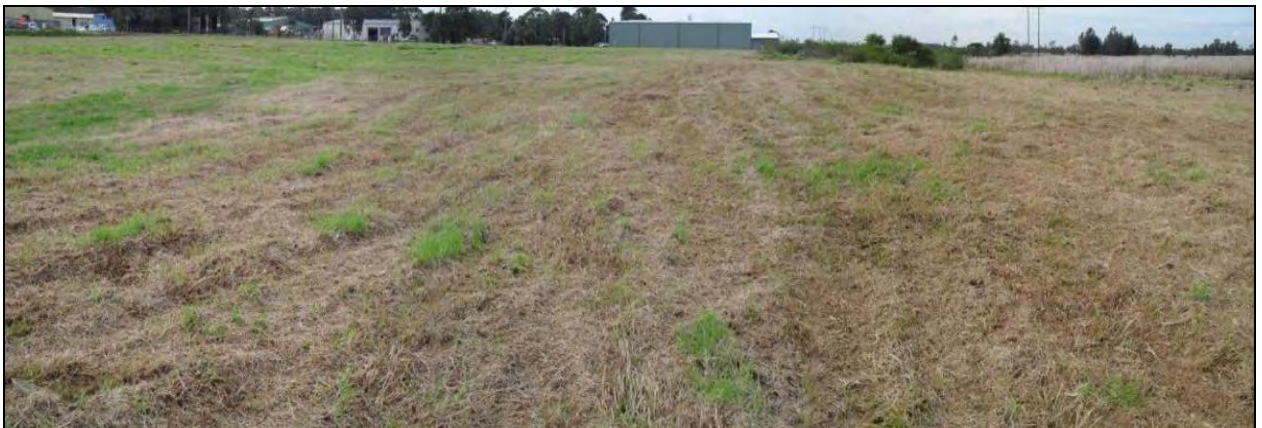
**Photo 1 – Looking north east across grassed paddock over Aeolian soil profile. Alluvial low-lying soils in right corner.**

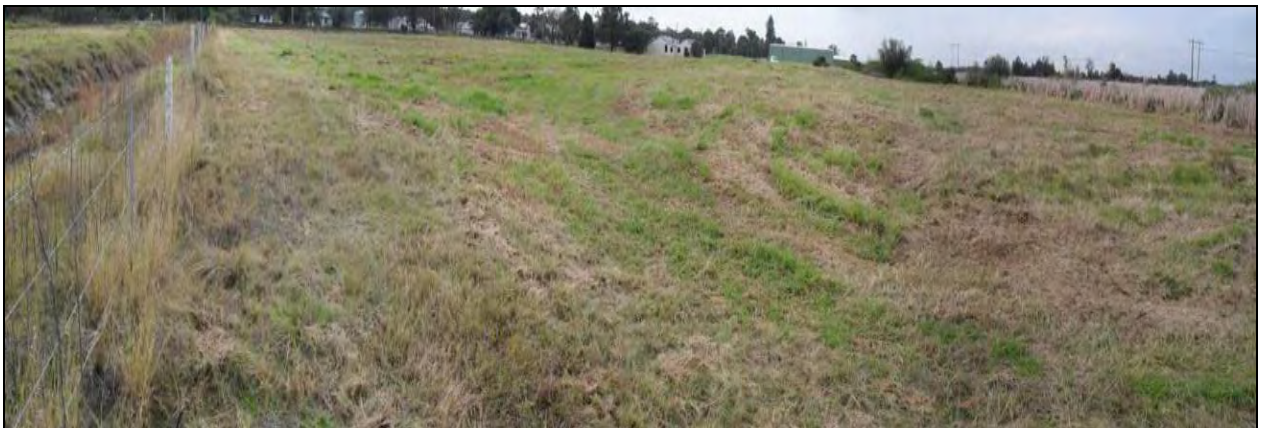
Site slopes are relatively flat and generally less than 1° to 2°. Localised steeper batter slopes were observed at the edge of the fill embankments, within drains and at the boundary of the alluvial/ Aeolian soil profiles, where the sandy raised area of the site falls to the lower lying clayey soil landscape (Photo 1). Ground conditions, however were observed to be undulating in various sections of the site, particularly in the northern section of the site, which may indicate the possible presence of filling (Photo 2).

**Photo 2 – Looking north/north-east across grassed paddock. Undulating fill evident in right side of photo.**

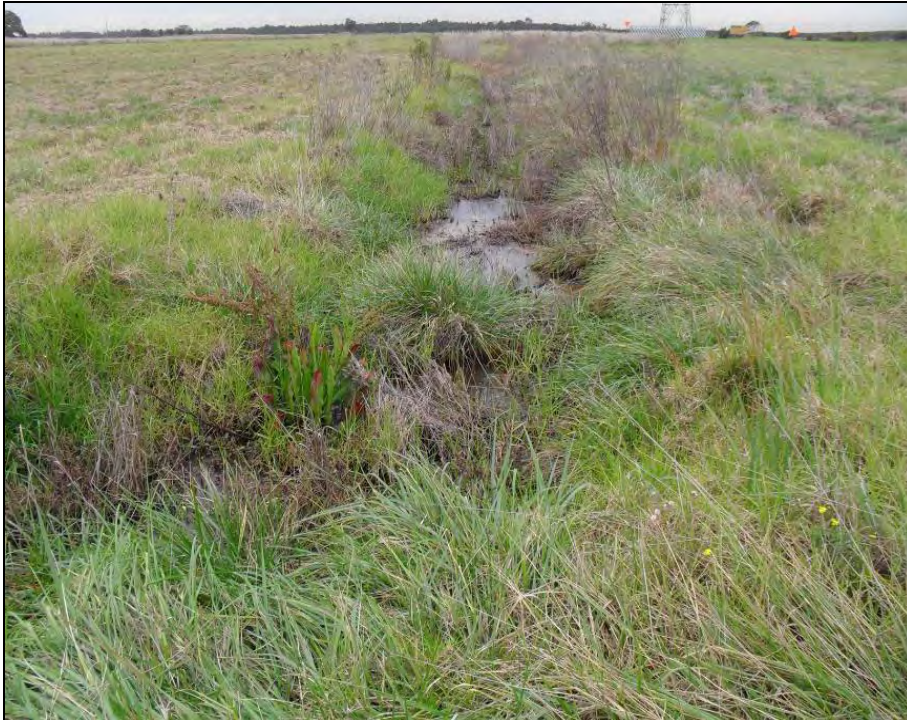
**Photo 3 – Shallow drain in south western corner of site. Orange algae at surface.**

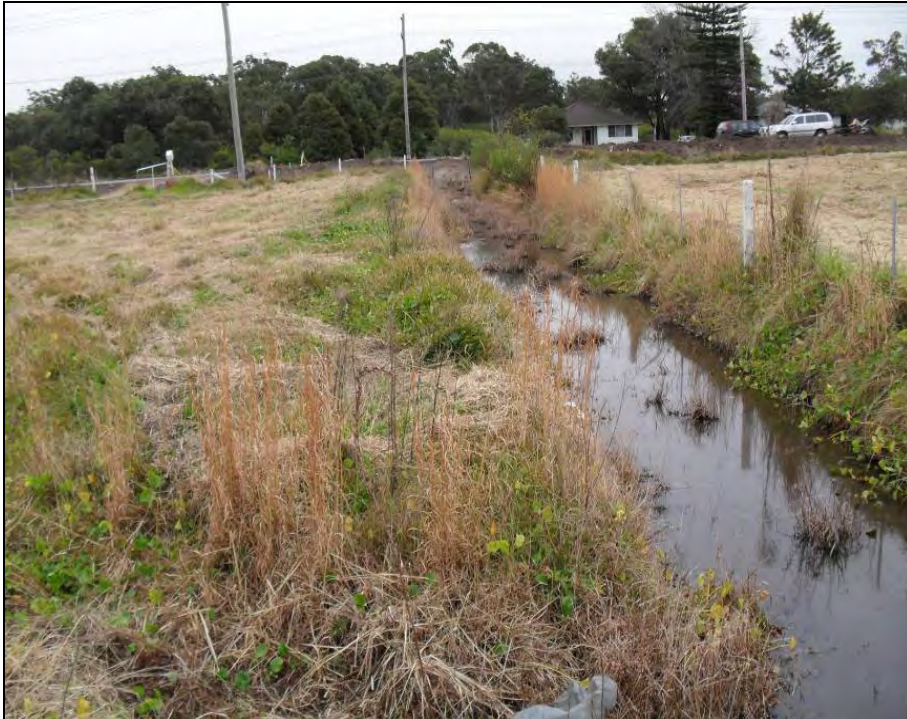
**Photo 4 – Drain about 2 m wide in northern portion of site (looking north). Some orange algae and waxy film on surface, plus bricks, concrete observed in drain.**

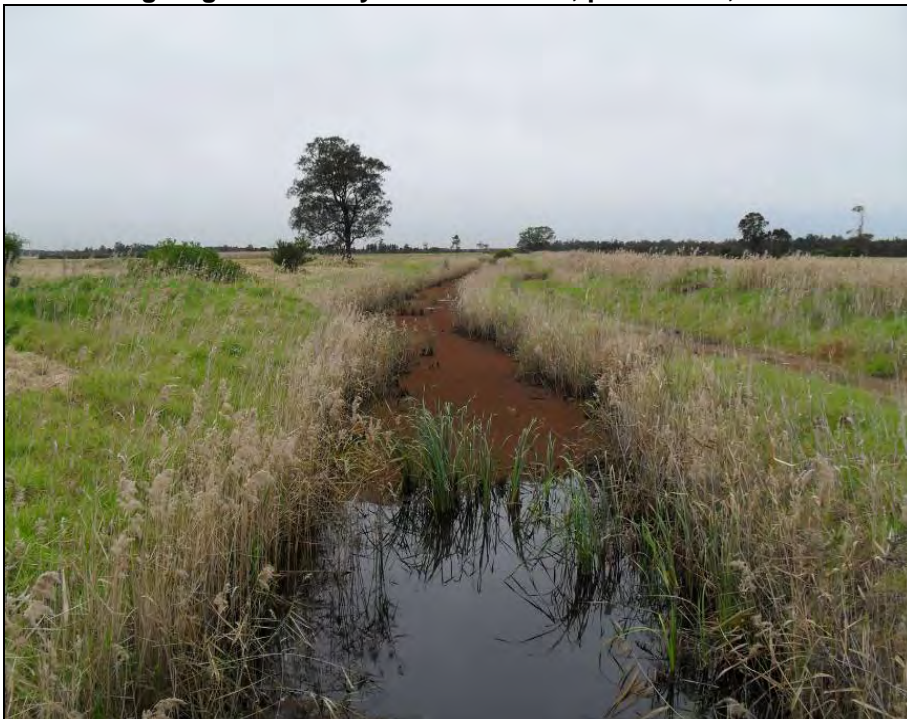
**Photo 5 – Drain about 4 m wide and 2 m deep in south-western portion of site. Red algae observed at surface. Spoil stockpiled to the south of drain.**

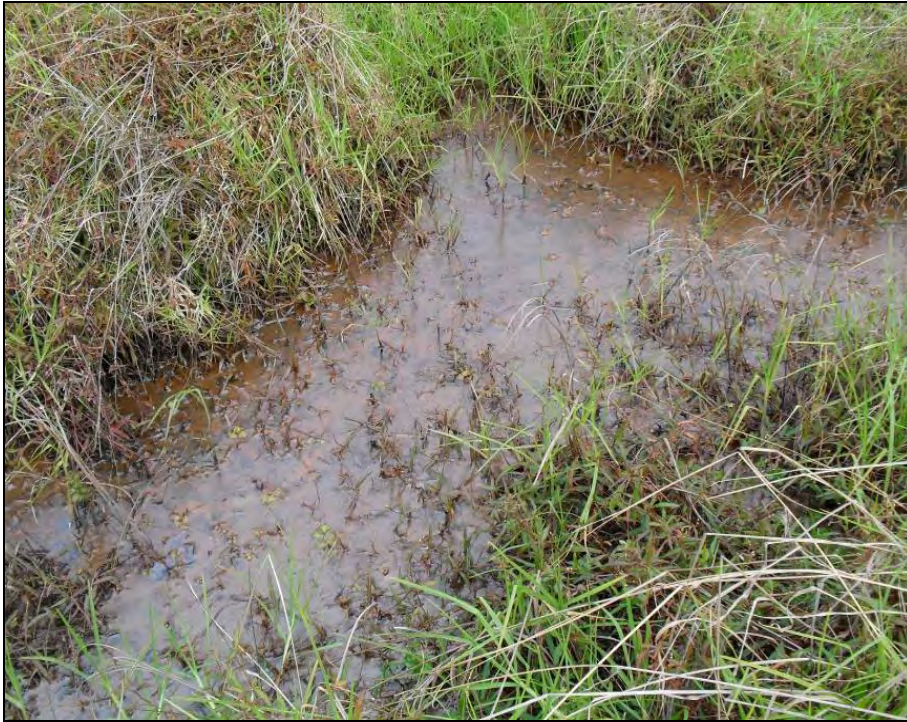
**Photo 6 – Orange algae within shallow drain to south of transmission tower.**

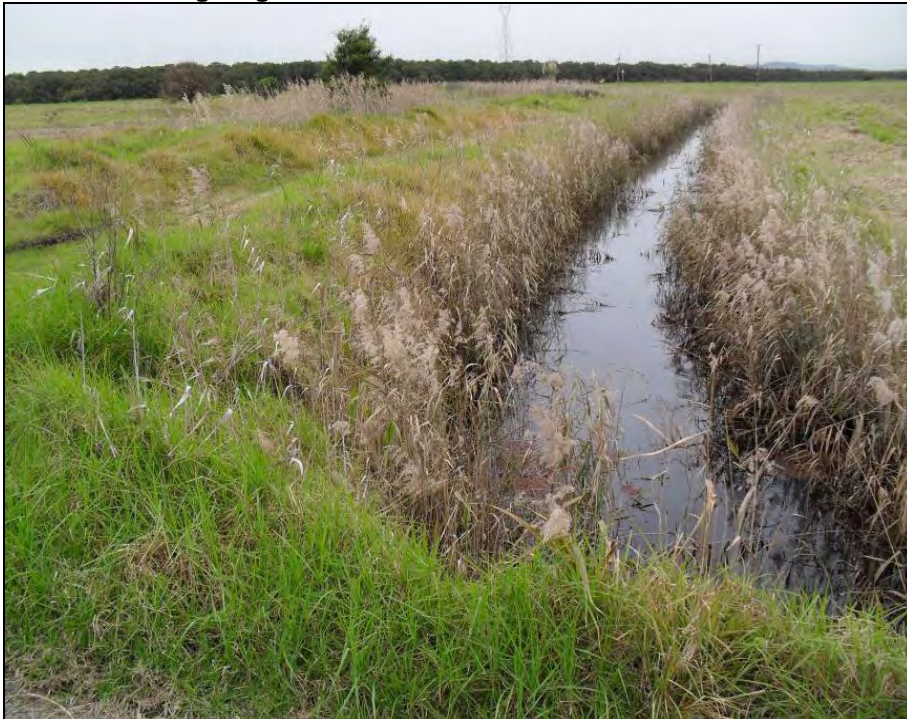
**Photo 7 – Drain with adjacent stockpiled spoil (looking west towards Hunter River)**

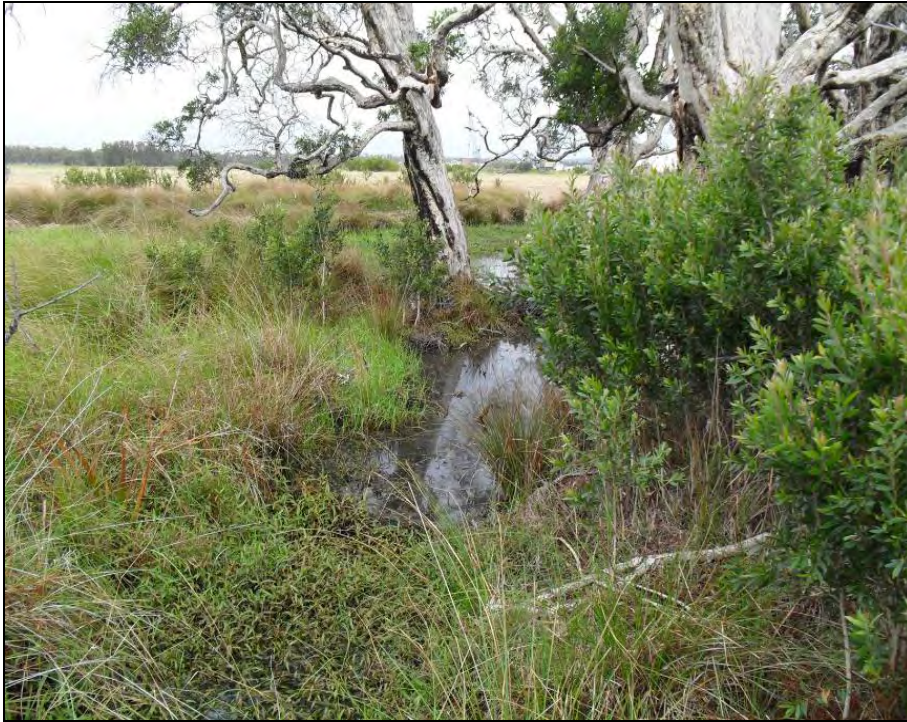
**Photo 8 – Shallow surface water within creek/drain within the north western portion of the site (looking south west)**

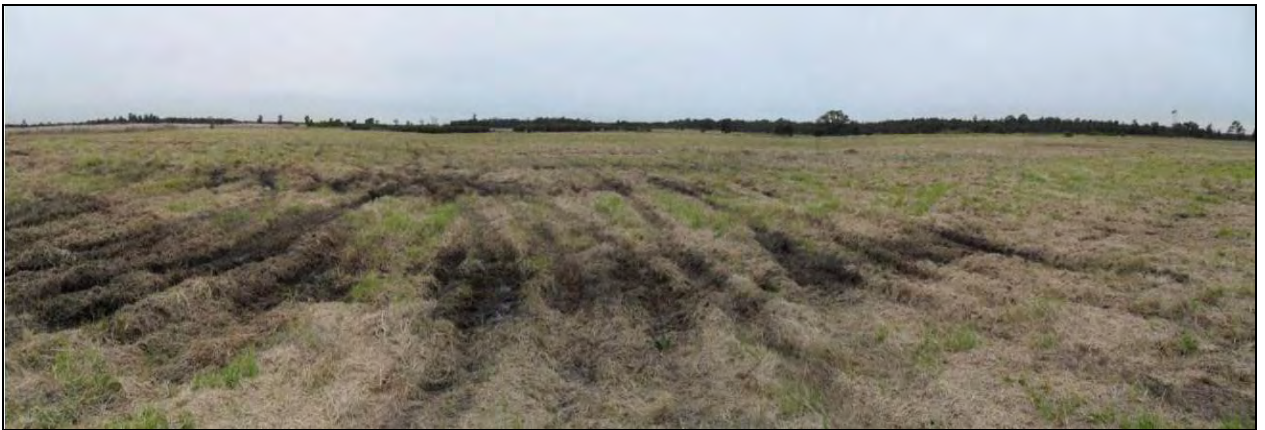
**Photo 9 – Slashed paddock with rutting from tractor exposing clayey topsoils (looking south-east)**

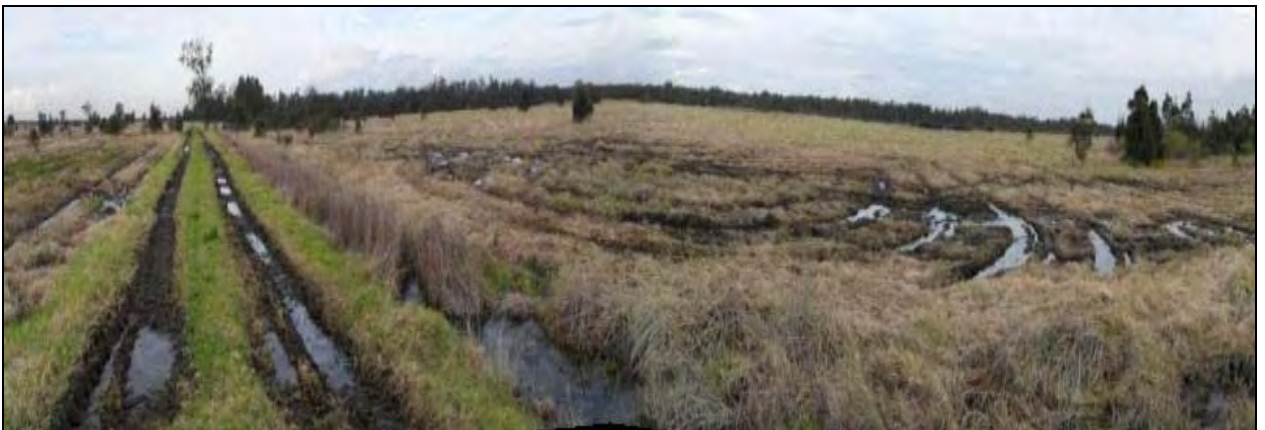
**Photo 10 – Saturated ground surface along access track and adjacent slashed paddock. Rutting from tractor evident across area (looking east to south)**

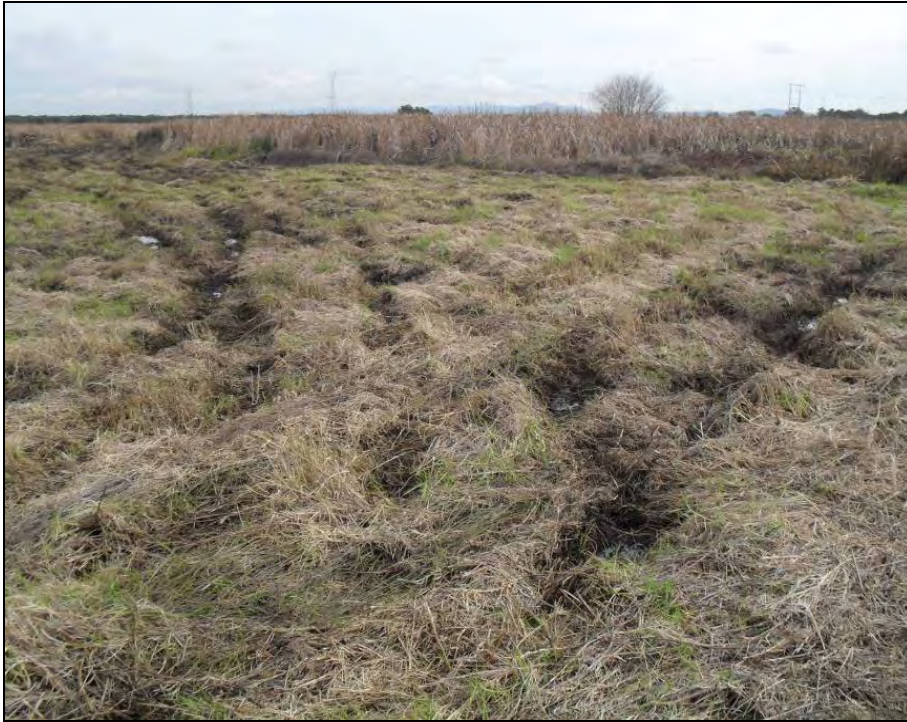
**Photo 11 – Low-lying saturated surface soils in slashed paddock with rutting evident from tractor (looking south west)**

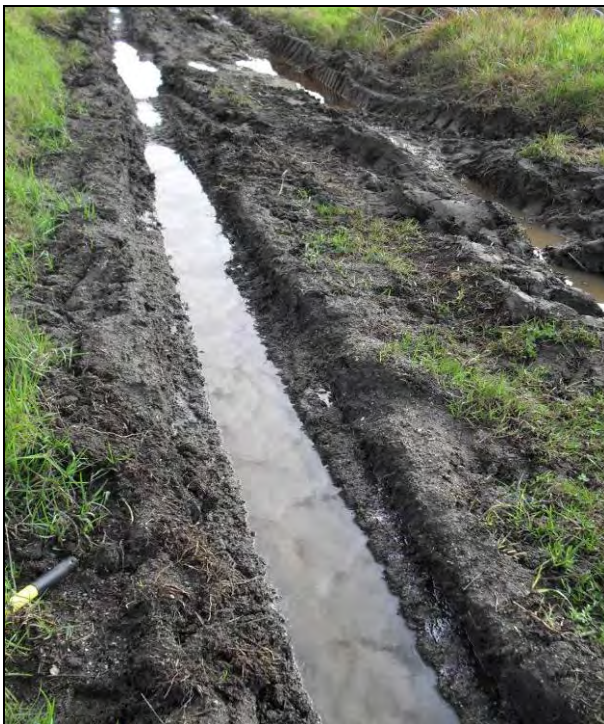
**Photo 12 – Ash fill within track and possible hydrocarbon sheen at right edge of rutting**

A few access tracks have been formed across the site (Photos 19 & 20). Granular fill comprising gravels, crushed aggregate (Photo 16), ash (Photo 12), coal reject and railway ballast is evident at the surface of the tracks. Ponded surface water within rutting in areas where ash filling was evident comprised localised surface sheen (possible hydrocarbon related – Photo 12).

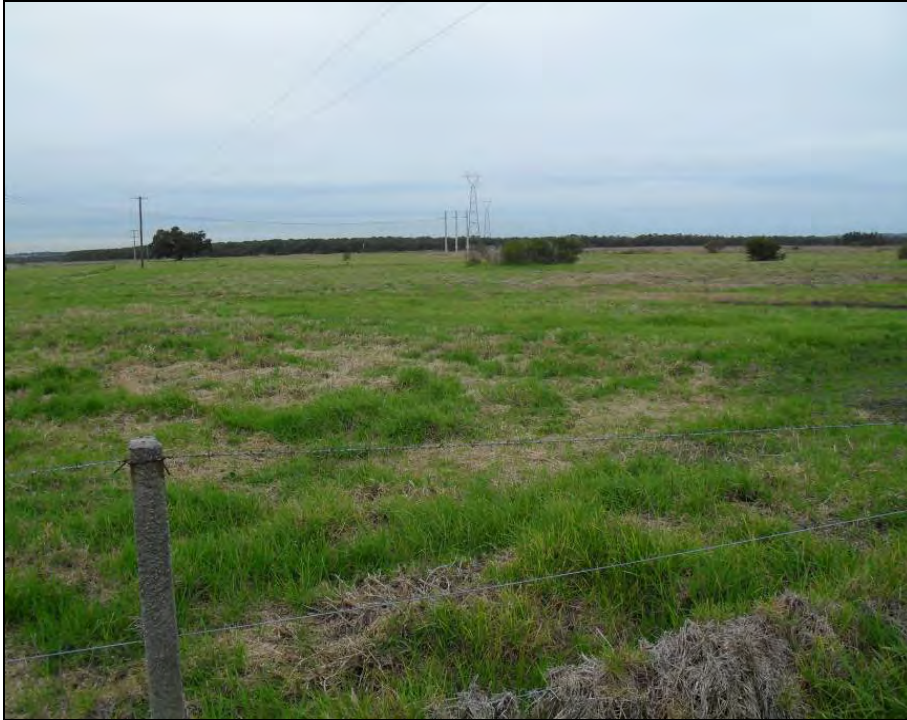
**Photo 13 – lush grass cover in north western portion site (looking south-west)**

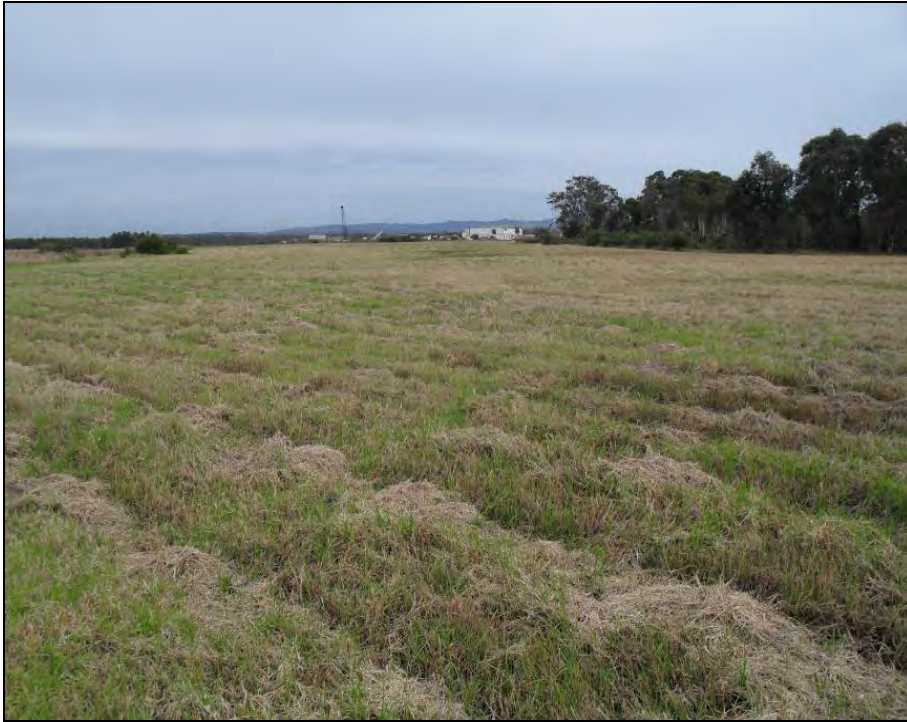
**Photo 14 – Lush grass cover in north western portion of site (looking west)**

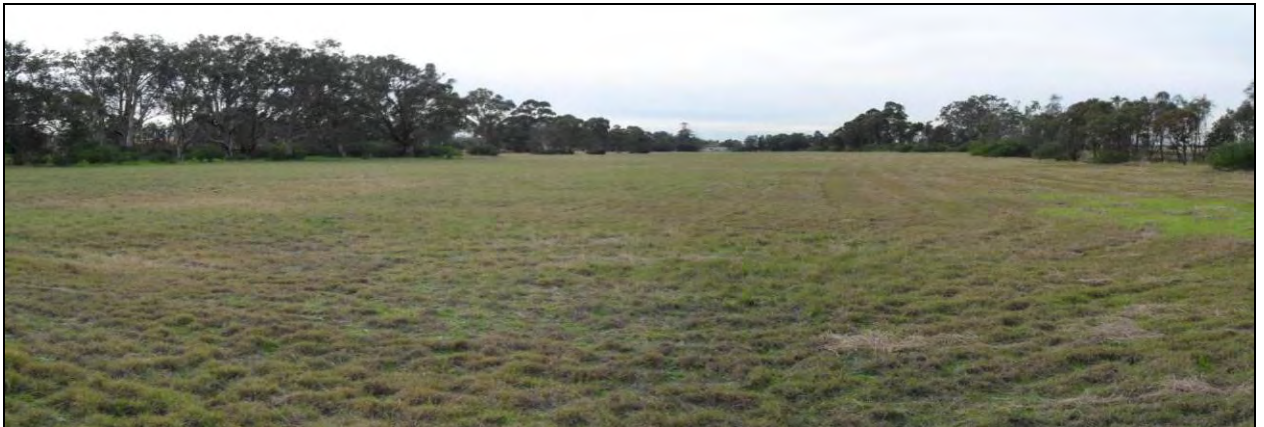
**Photo 15 – Mature trees (left) and scrub adjacent to creek (right) with grassed paddock (middle) in north western corner site (looking east)**

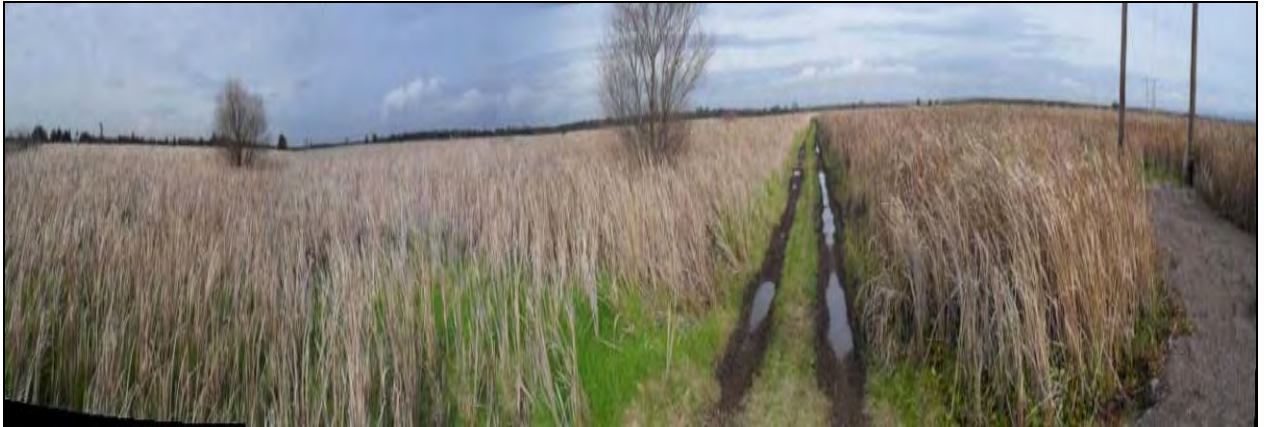
**Photo 16 – Looking south-east to south-west across dense reed cover in low-lying area. Saturated surface soils evident along access track (centre). Granular fill along transmission easement (left).**

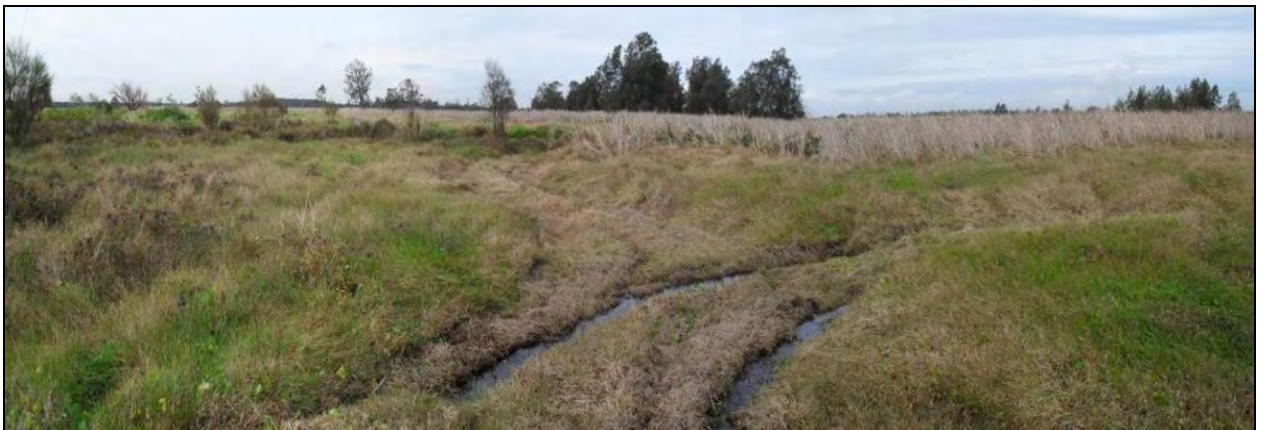
**Photo 17 – Looking south-east to south-west across low-lying saturated surface soils and thick reed cover in the northern corner of the site.**

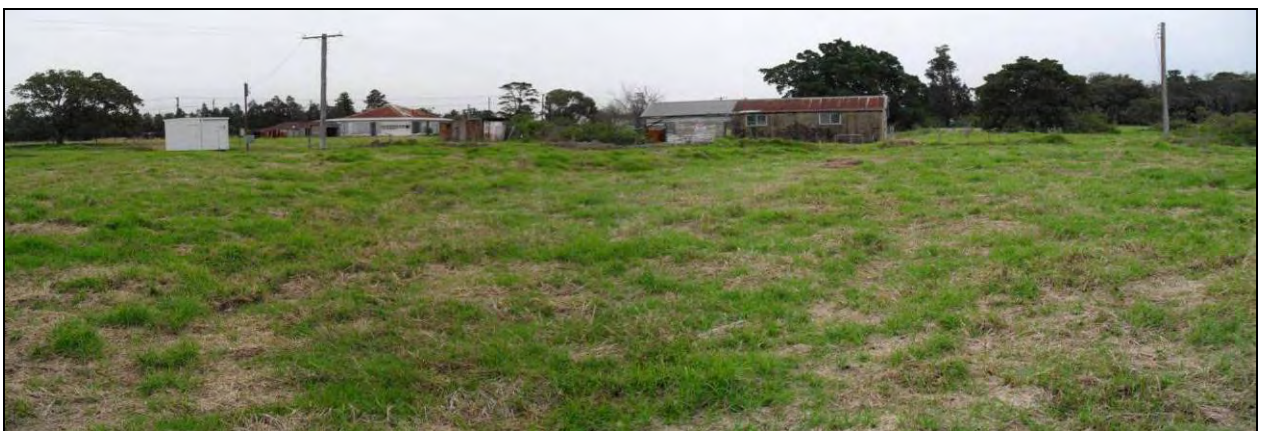
**Photo 18 – Thick undulating grass cover to south of sheds (possible filling associated with former structures). Mature trees around former structures in background.**

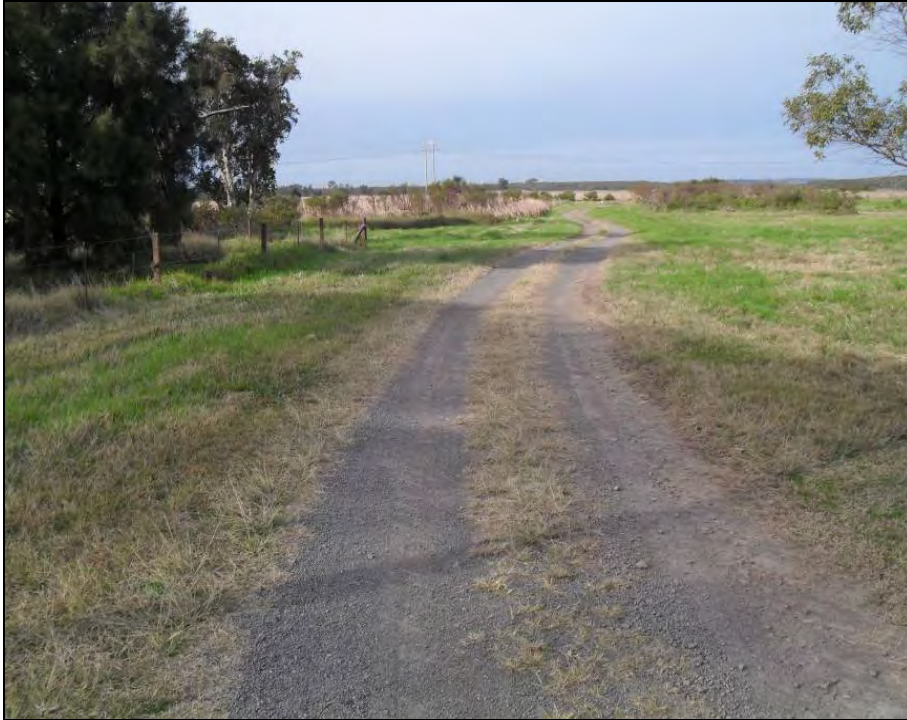
**Photo 19 – Gravel/crushed rock along access track adjacent Tomago House property (looking south)**

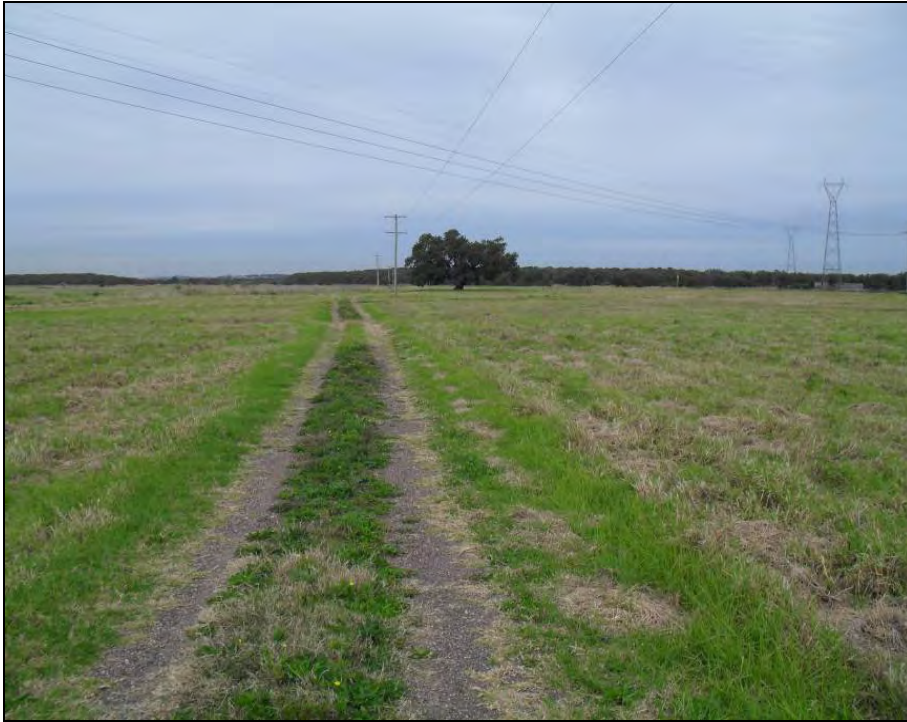
**Photo 20 – Gravel/crushed rock along access track in western portion site (looking south)**

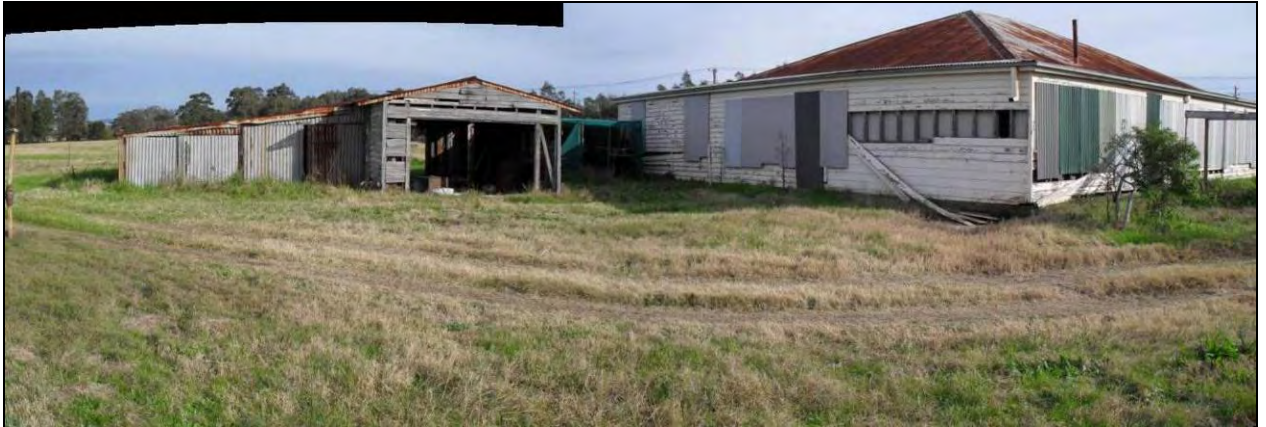
**Photo 21 – Vacant dwelling and rear garage/shed. Fibro sheeting observed in dwelling materials and fragments observed at surface near dwelling (looking west)**

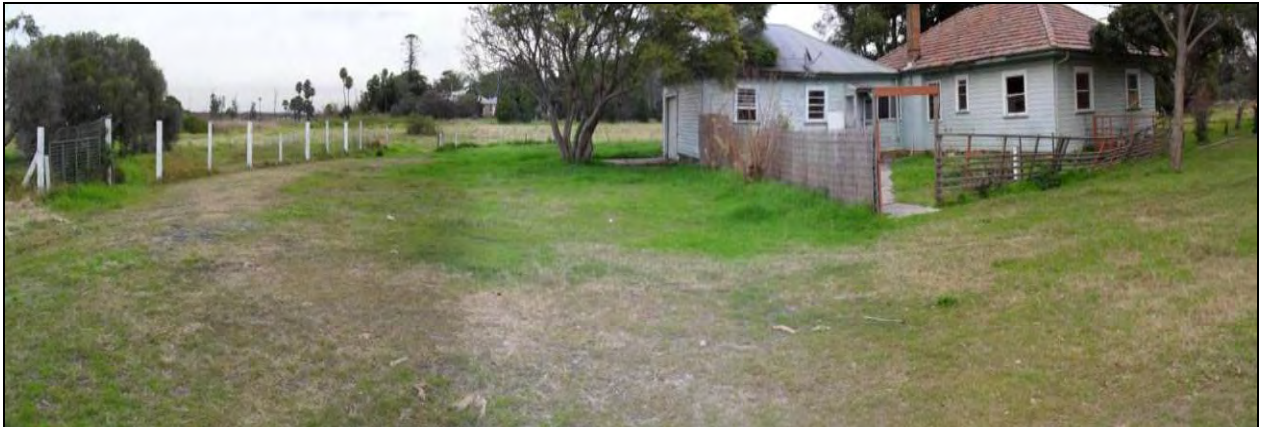
**Photo 22 – Vacant dwelling and rear garage (looking west). Fibro observed around bottom edge of brickwork. Some ash filling observed in gravel driveway (left).**

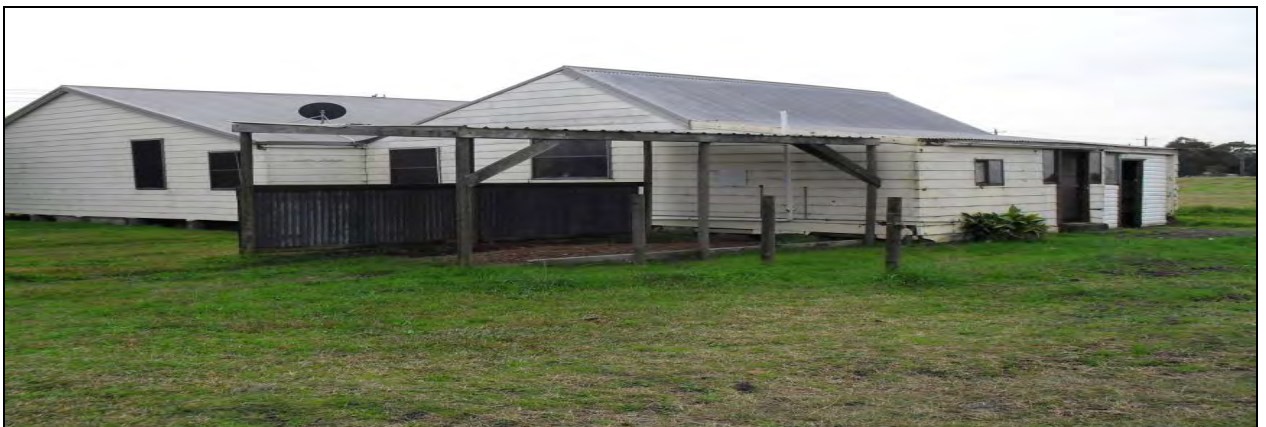
**Photo 23 – Vacant dwelling and rear carport (looking north-east). Fibro sheeting observed in internal walls. Undulating ground around house (Possible fill).**

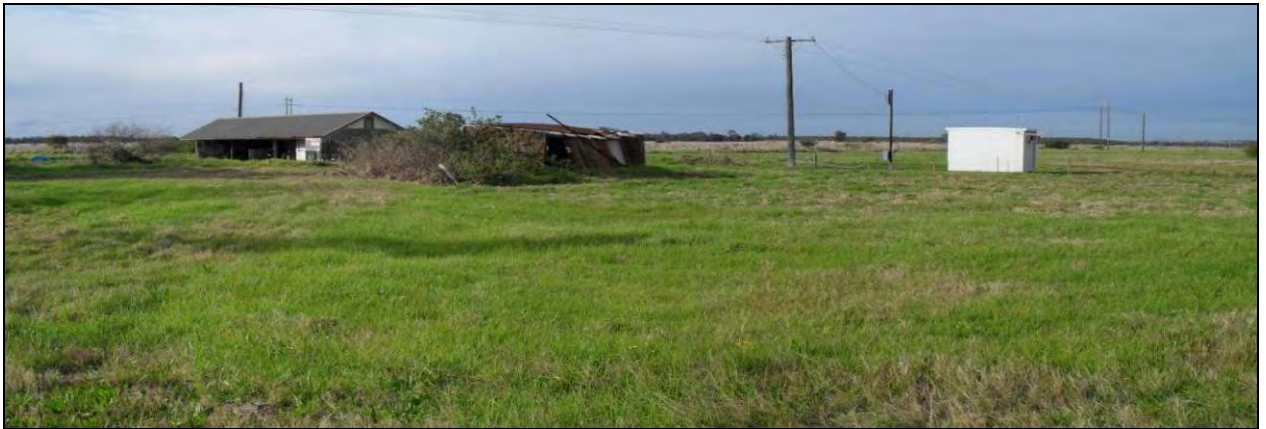
**Photo 24 – Vacant sheds constructed from fibro sheeting, bricks, corrugated iron, timber. Fibro sheeting fragments, gas bottles, 44 gallon drums, scrap metal etc observed around sheds (looking south east)**

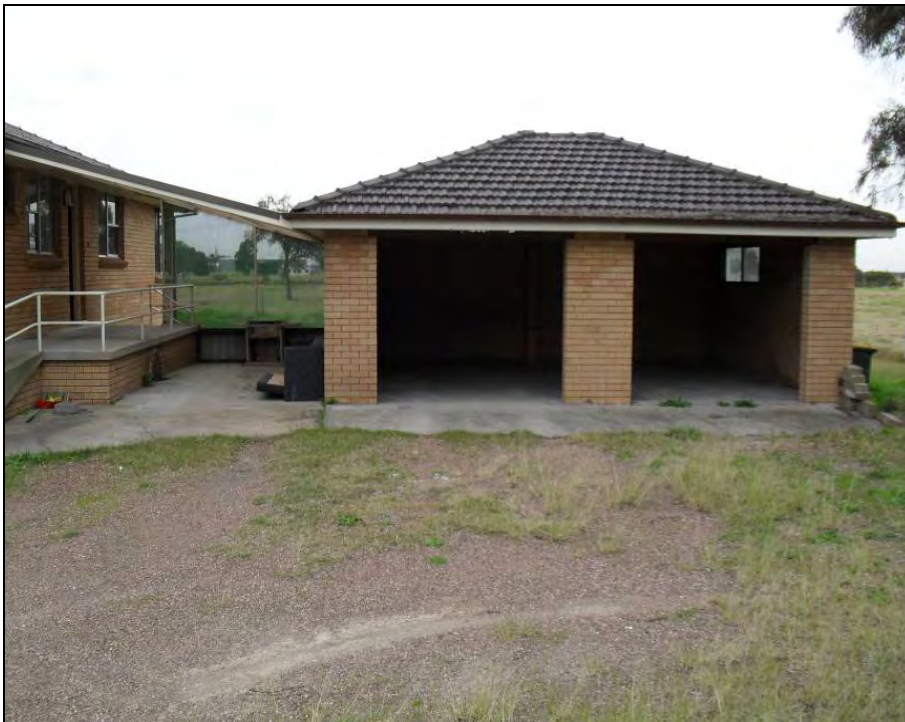
**Photo 25 – Brick garage adjacent vacant brick residence with gravel driveway in foreground (looking east)**

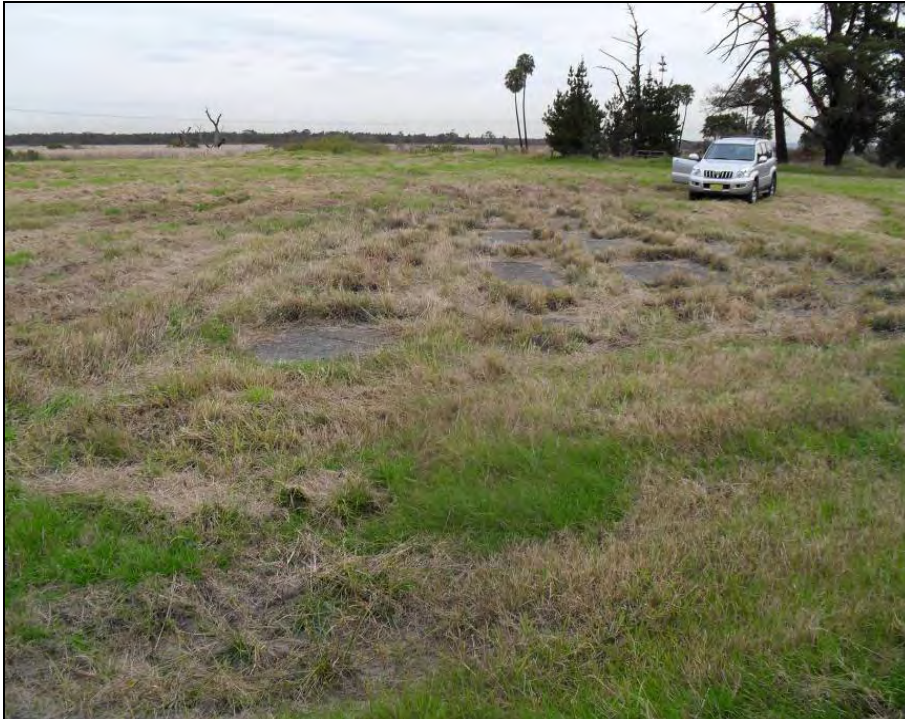
**Photo 26 – Raised area with concrete slab at surface. Some metal reinforcing, bricks, metal pipe, tiles etc observed at the ground surface (looking south).**

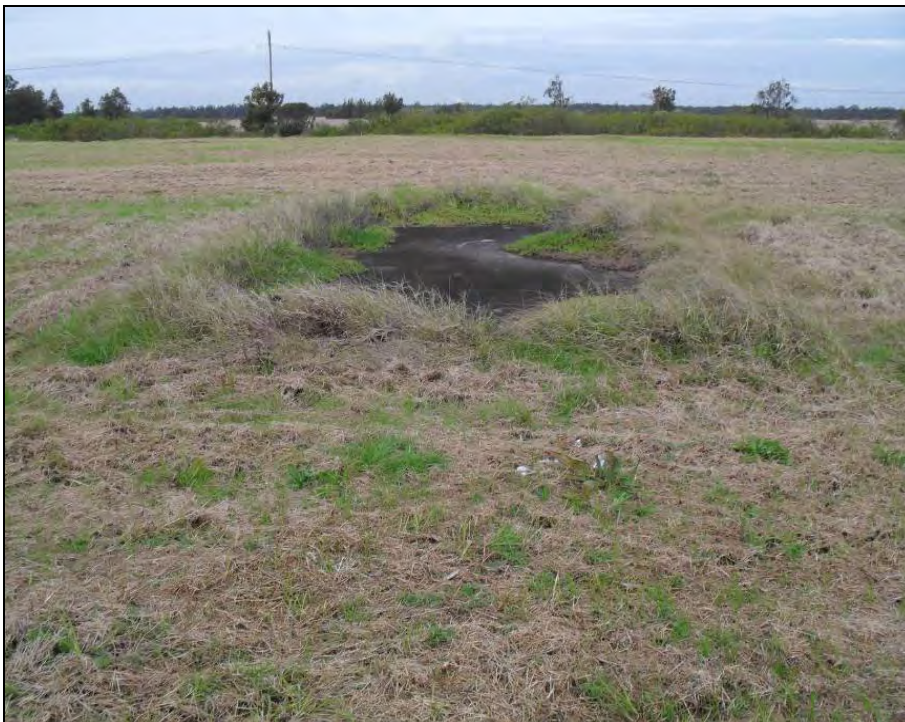
**Photo 27 – Concrete slab in grassed paddock. Metal fragments/wire at surface of slab. (looking south)**

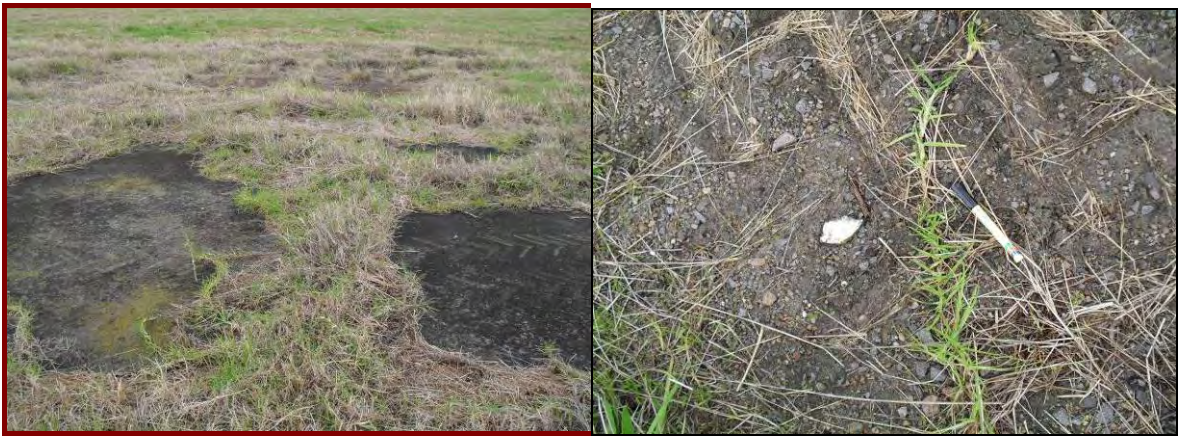
**Photo 28 & 29– Concrete Slab in grassed paddock. Some asphalt pavement to south of slab. Some fibro fragments and gravel observed over slab surface.**

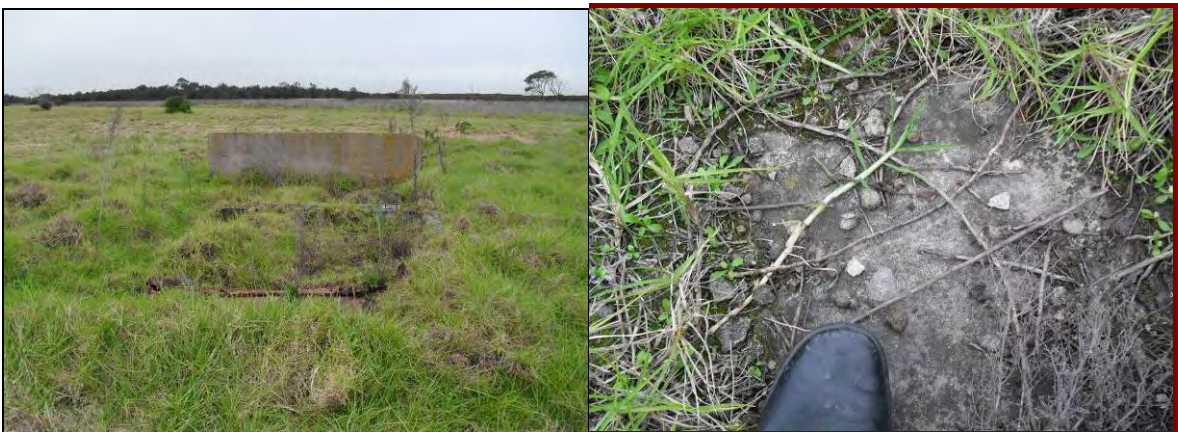
**Photos 30 & 31 – Concrete slabs of former structure in south western corner of site. Fibro fragments, glass fragments, plastic, metal observed at ground surface.**

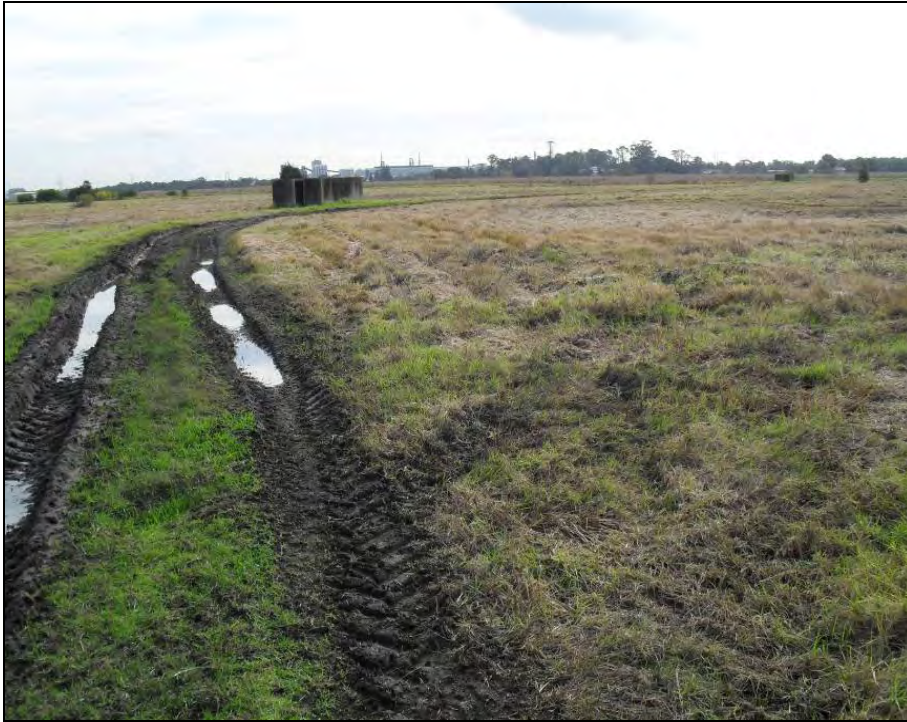
- A few unused concrete walled/roofed compounds (Photo 32);
- Four octagonal shaped brick walled structures and adjacent sunken concrete structure in the eastern portion of the site (Photos 33 to 35);

**Photo 32 – Concrete storage sheds in paddock (looking west)**

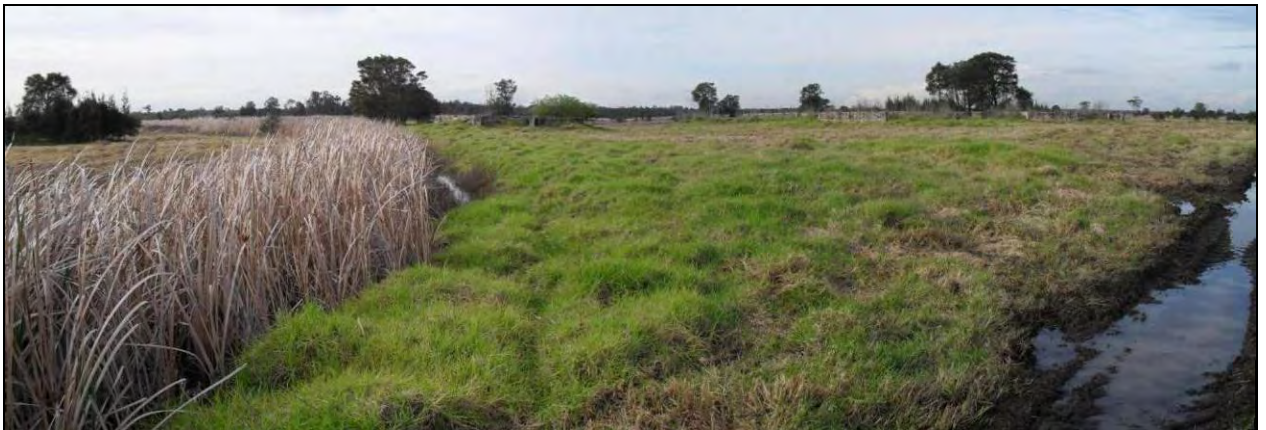
- Mr Roser understands that the site included former gun emplacements, likely from WWII, the remnants of which may be the octagonal shaped structures identified in the eastern portion of the site during the walkover inspection (see Section 5);

**Photo 33 – Octagonal brick structures east of drain (looking north-east)**

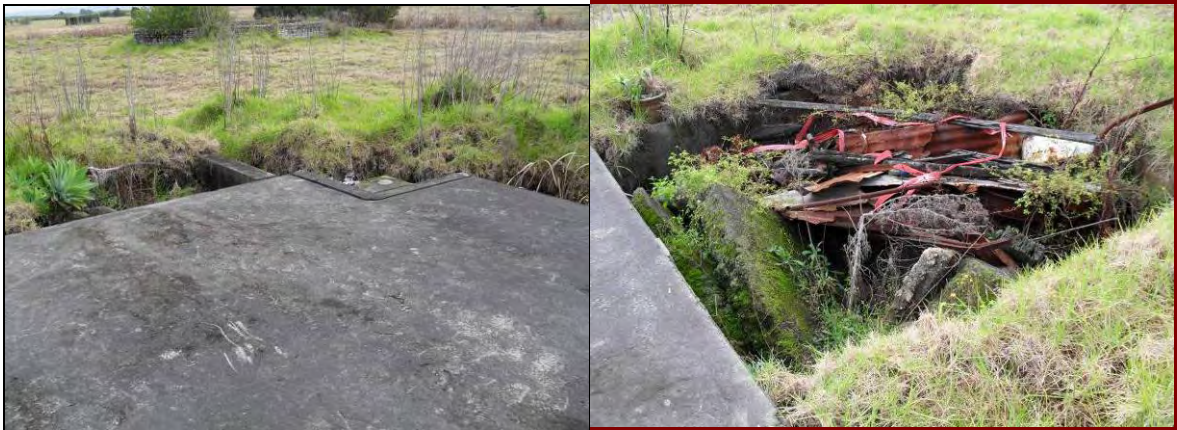
**Photos 34 & 35 – Concrete lid of structure north of octagonal brick structures. Dumped demolition waste within sunken concrete chamber comprising scrap metal, concrete, metal sheeting, wire, timber, plastic, metal parts, possibly fibro cladding on walls.**

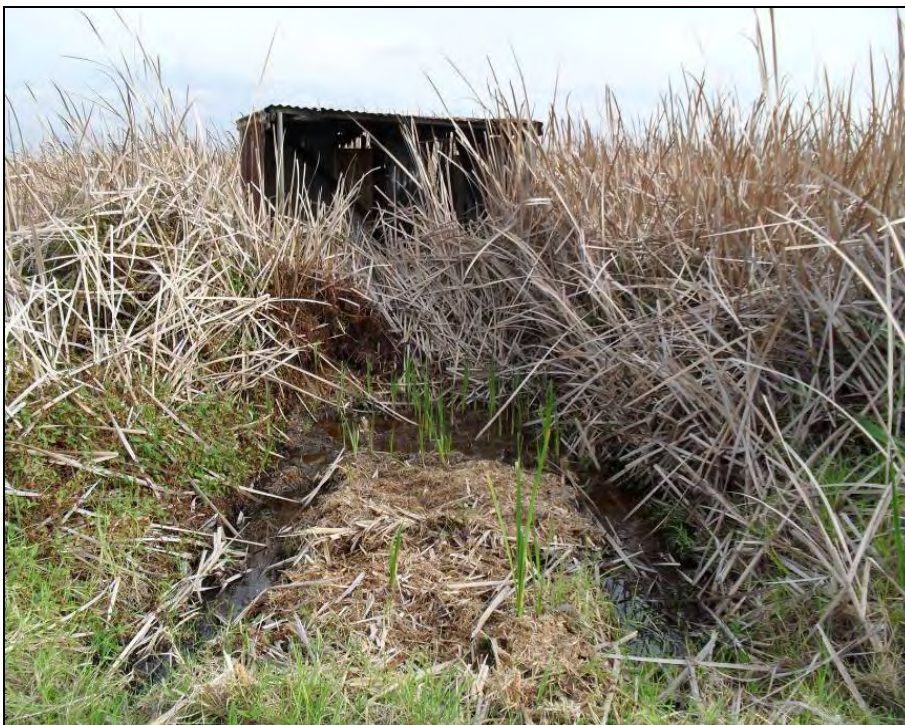
**Photo 36 – Corrugated iron shed in paddock. Overgrown by reeds. Ponded water at surface (looking south-west).**

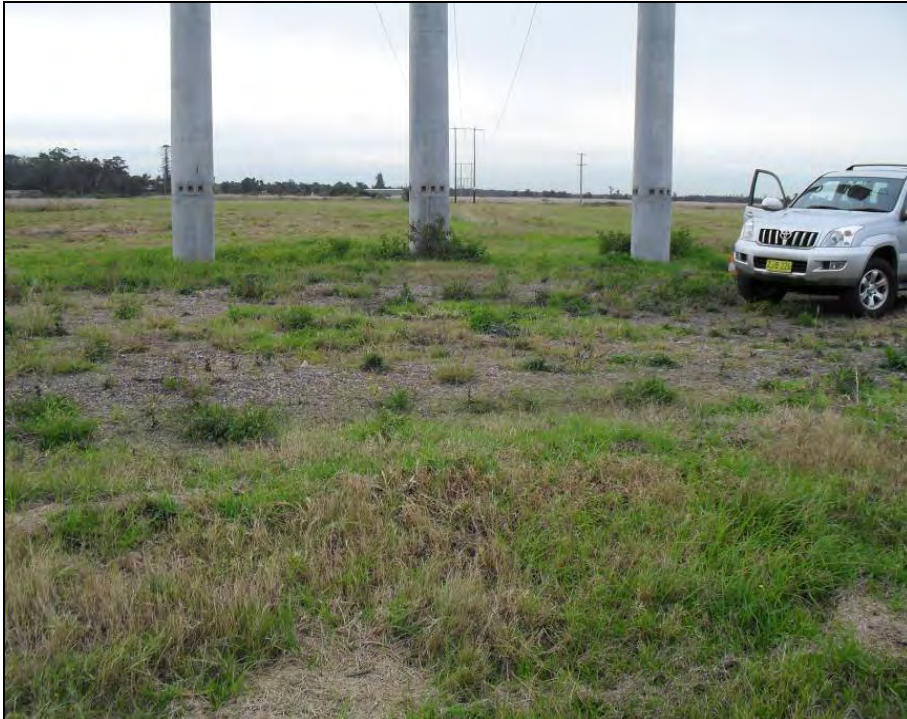
**Photo 37 – Base of electrical transmission power poles in paddock. Granular fill pad comprising crushed rock and gravel at the surface around poles (looking north-east).**

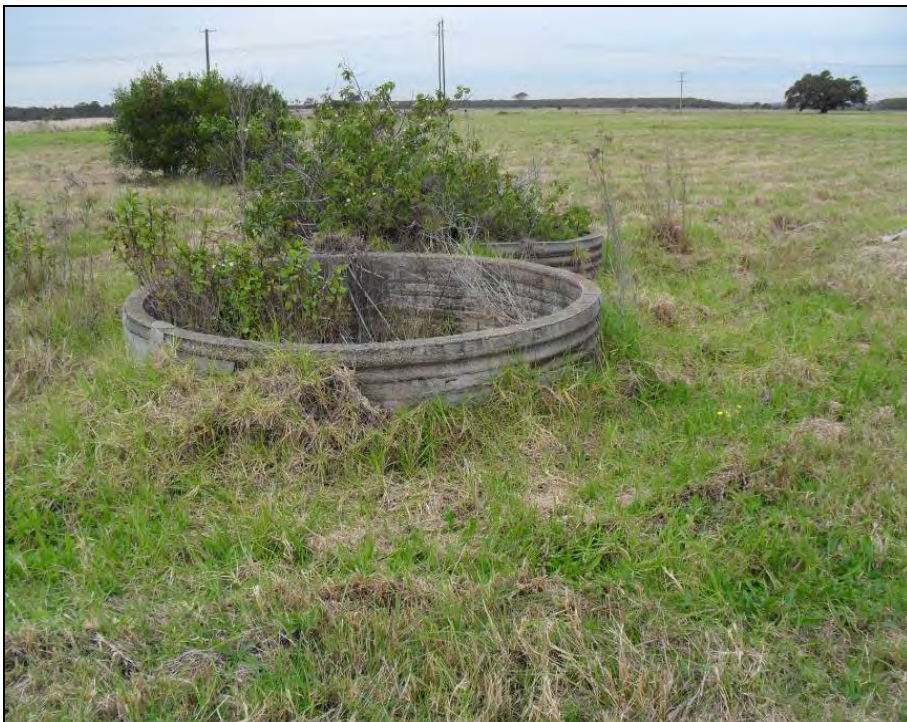
- Some circular and rectangular concrete troughs (Photos 38 & 39).

**Photo 38 – Concrete circular troughs with concrete base (looking south)**

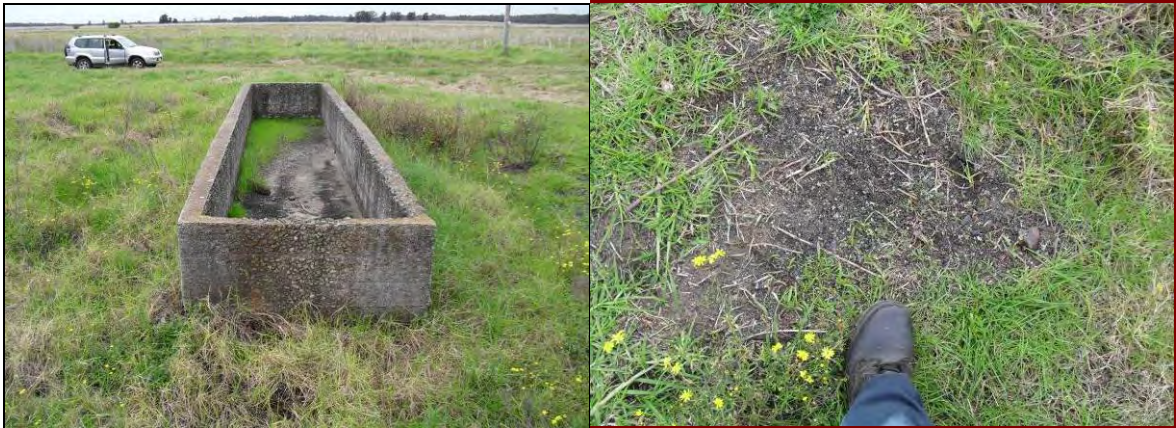
**Photos 39 & 40 – Rectangular concrete trough. Ash fill observed adjacent to trough.**
