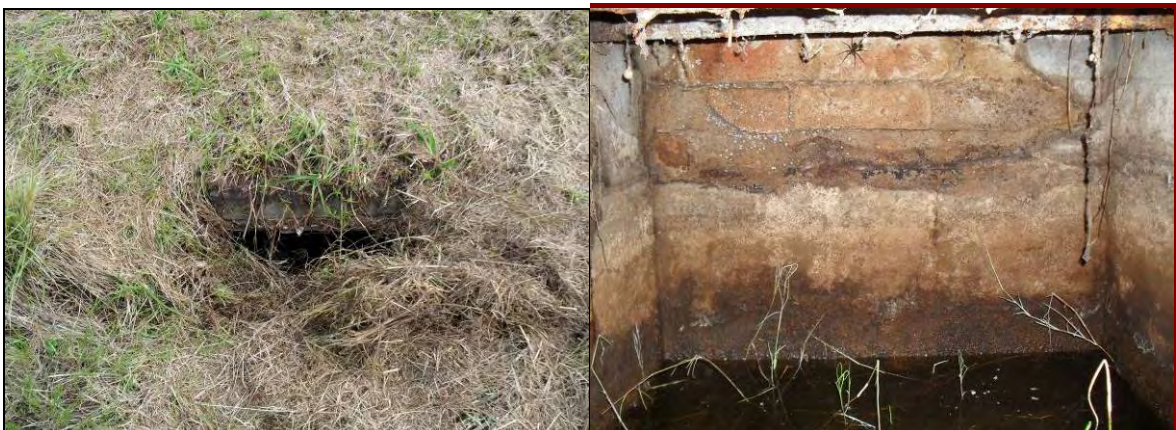
**Photos 41 & 42 – Hidden brick, concrete and fibro sheeting clad septic chamber within grass paddock**

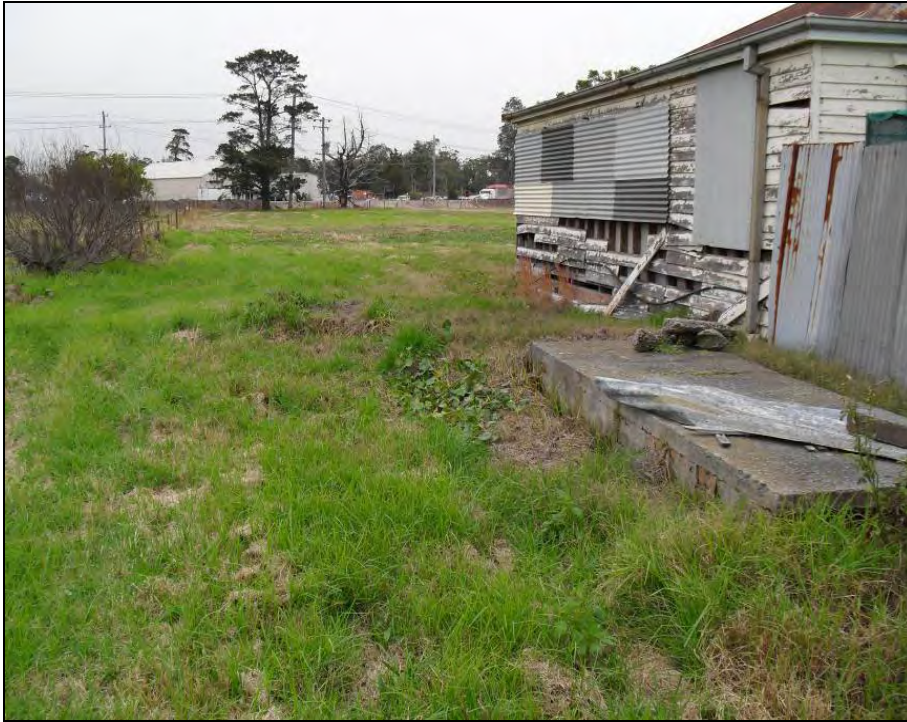
**Photo 43 – Septic tank and concrete/brick chamber adjacent dwelling (looking north)**

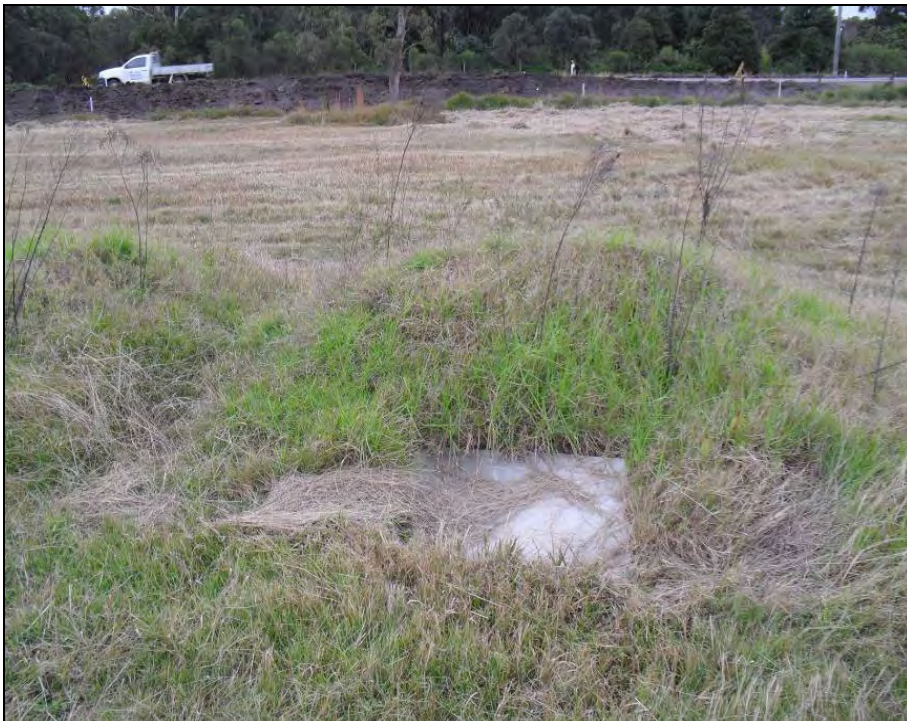
**Photo 44 – Fibro sheeting at base of fill stockpile (looking north)**

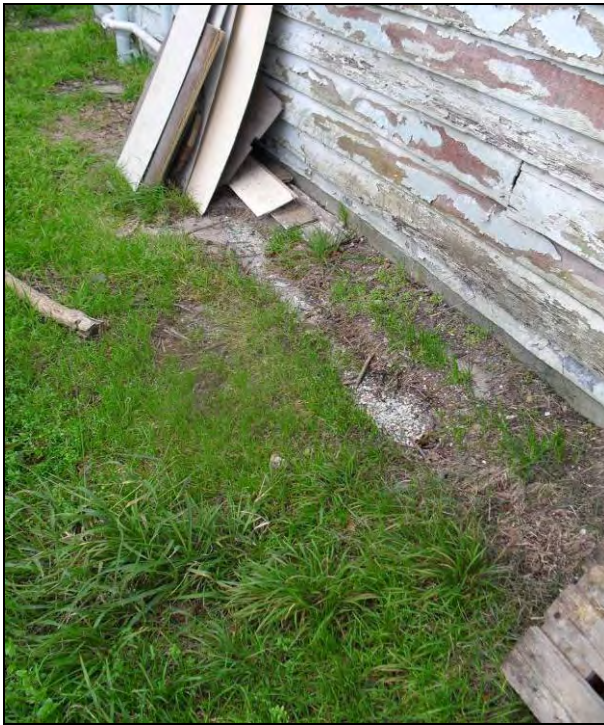
**Photo 45 – paint flakes at ground surface adjacent dwelling**

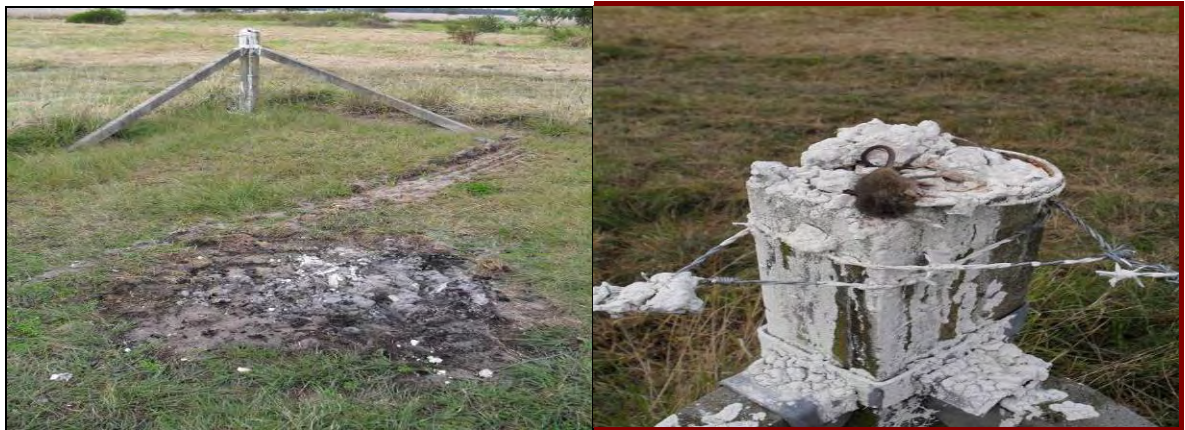
- Fibro sheeting fragments (possibly asbestos) observed at the ground surface or attached to the surface of concrete slabs (Photos 29 and 31);
- Former effluent disposal systems including septic tanks, concrete walled/roofed trenches/chambers, one of which was hidden beneath grass in the paddock (Photos 41 to 43);
- Former driveways and pavements which comprised variable granular filling including asphalt, rail ballast, crushed rock, crushed concrete etc;
- Fill materials including fill stockpiles in vicinity of former/current structures, some of which contained visible ash or fibro sheeting materials (Photos 18, 22 & 44);
- Paint residue and flakes adjacent structures (Photo 45);
- Burnt refuse and small quantities of white substance (Photo 46 & 47).

**Photo 46 & 47 – Burnt refuse at ground surface comprising glass, metal, ash, gravel and white substance (looking south-east). White substance on fence with dead mouse.**

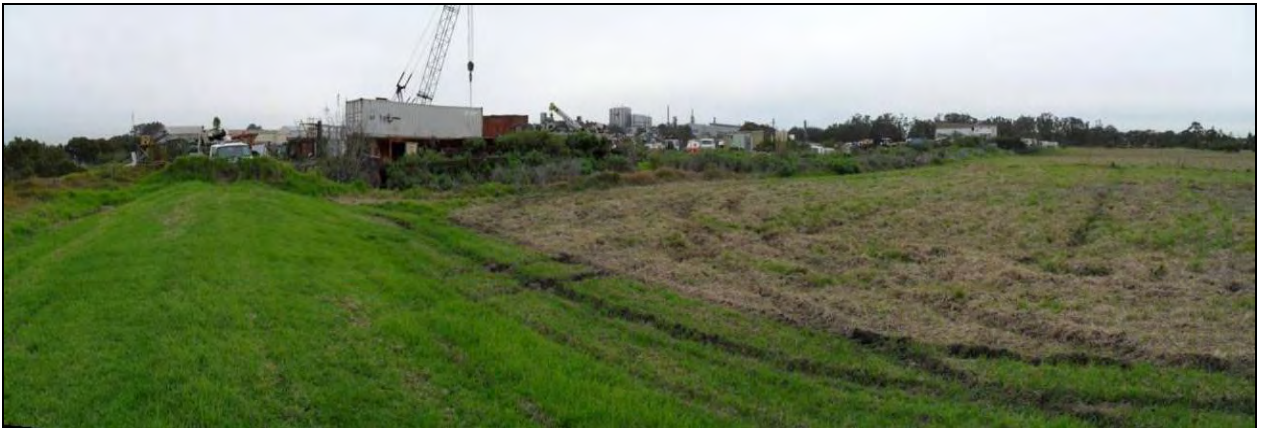
- Industrial development including scrap metal yard to the west of the site (Photo 48) comprises a storage yard containing cars, trucks, machinery wrecks, scrap metal, cranes, shipping containers etc;
- Industrial sheds to the east of the site (Photo 1);

**Photo 48 – Scrap metal yard to west of site. Photo taken from levee bank immediately north of Hunter River.**

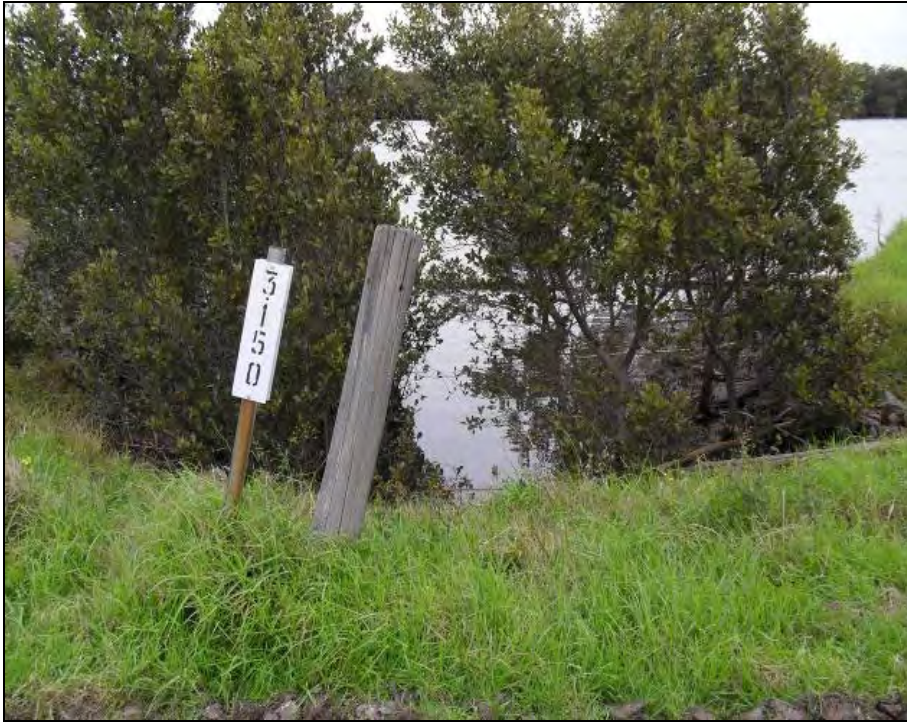
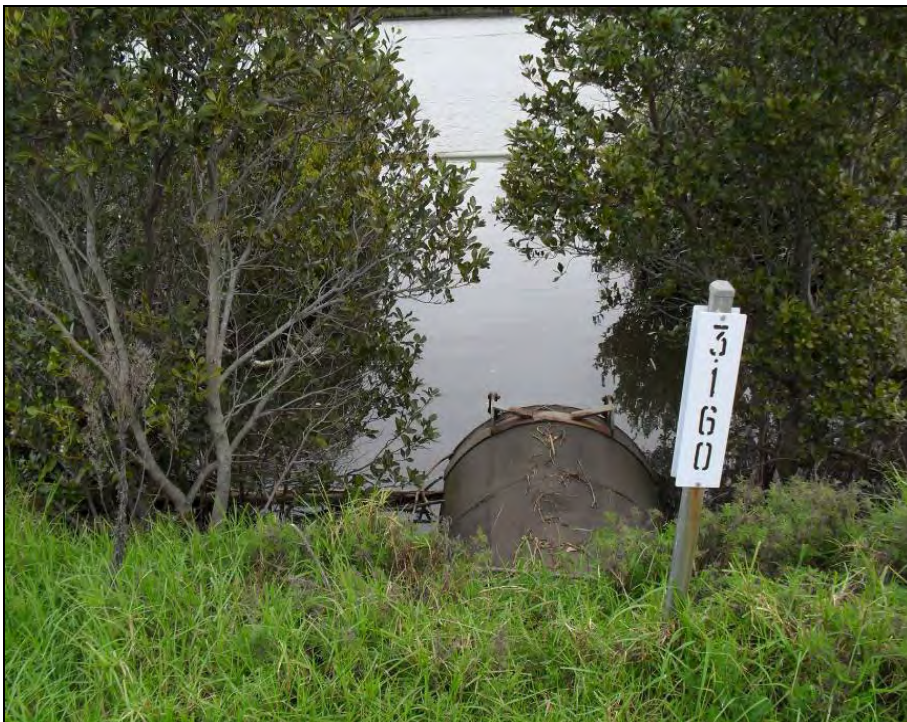
It is noted that the two drain outlets in the Hunter River (Photos 50 & 51) had a metal value across pipe outlet, to minimise the entry of river water.

**Photo 50 - Drain discharge point into Hunter River (looking south-west)**

**Photo 51 - Drain discharge point into Hunter River (looking south-west)**
