| TITLE: STAGE 1 ENVIRONMENTAL SITE ASSESSMENT<br>PROPOSED WARNERVALE TOWN CENTRE<br>SPARKS AND HAKONE ROADS, WARNERVALE<br>(SOUTHERN LOTS) | | | |
| CLIENT: Wyong Shire Council | | | |
| DRAWN BY: BJK | SCALE: NTS | PROJECT No: 41118A | OFFICE: Wyong |
| APPROVED BY: | | DATE: 1 March 2006 | DRAWING No: 1A |

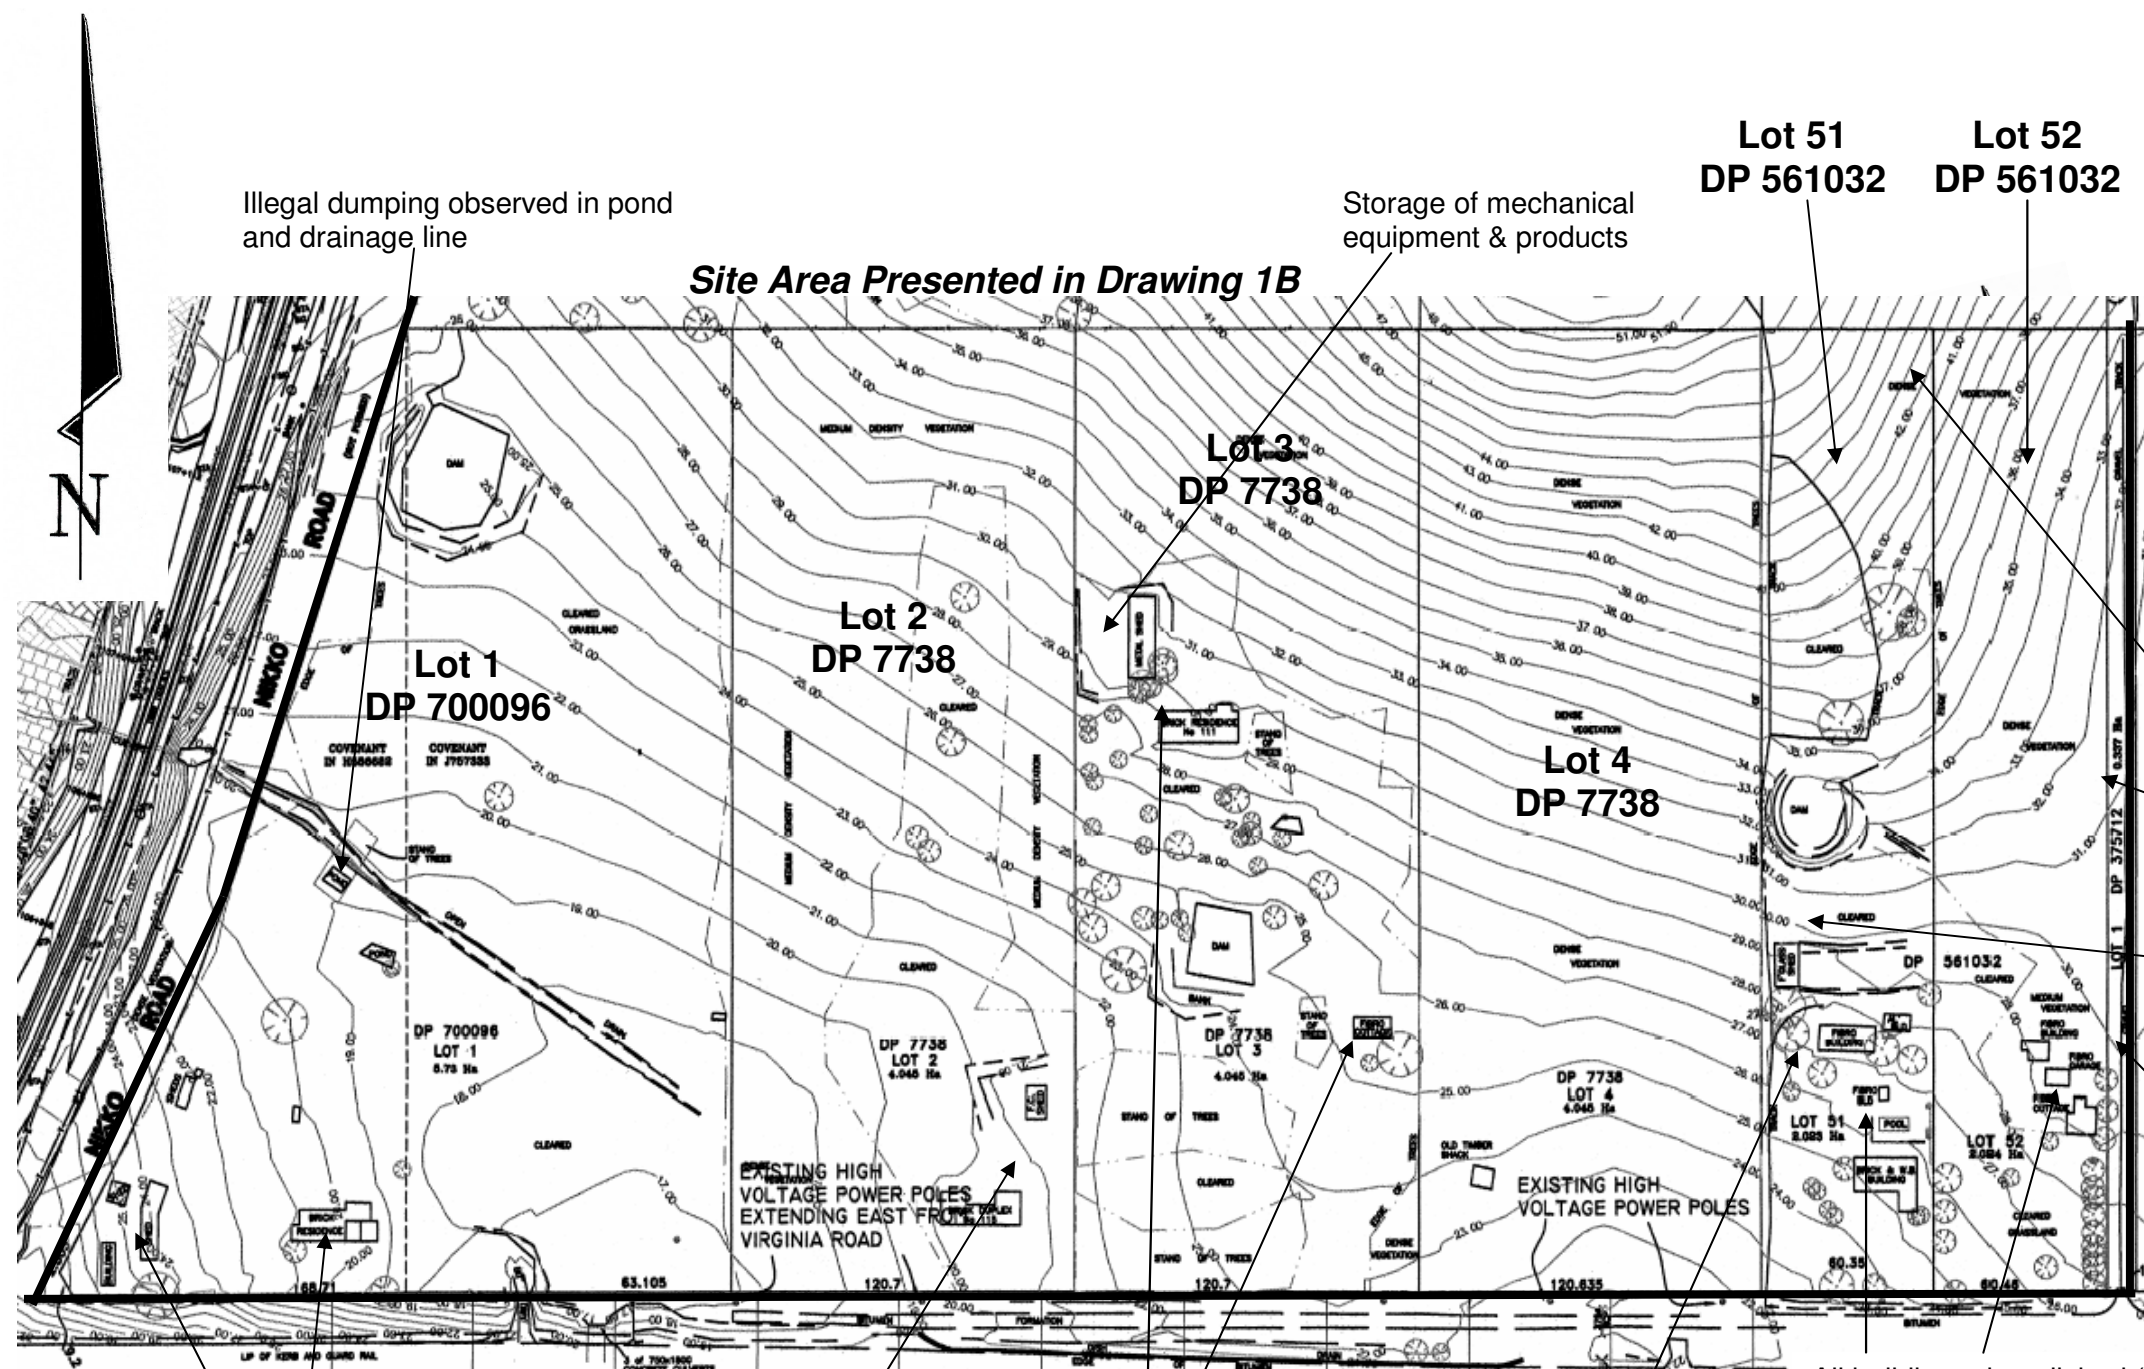
Some illegal dumping along council access road & towards northern boundary of Lots 51 & 52

Possible small greenhouses identified in 2001 aerial photograph

All buildings demolished (surface filling and/or inclusions in the surface soil in the vicinity of former buildings)

Filling beneath building platforms (possible cut/fill)

Filling beneath building platforms & access roads

Approximate location of dam observed in 1954 aerial photograph
