| <b>TITLE: STAGE 1 ENVIRONMENTAL SITE ASSESSMENT<br/> PROPOSED WARNERVALE TOWN CENTRE<br/> SPARKS AND HAKONE ROADS, WARNERVALE<br/> (SOUTHERN LOTS)</b> | | | |
| CLIENT: Wyong Shire Council | | | |
| APPROVED BY: | | DATE: 1 March 2006 | DRAWING No: 2A |

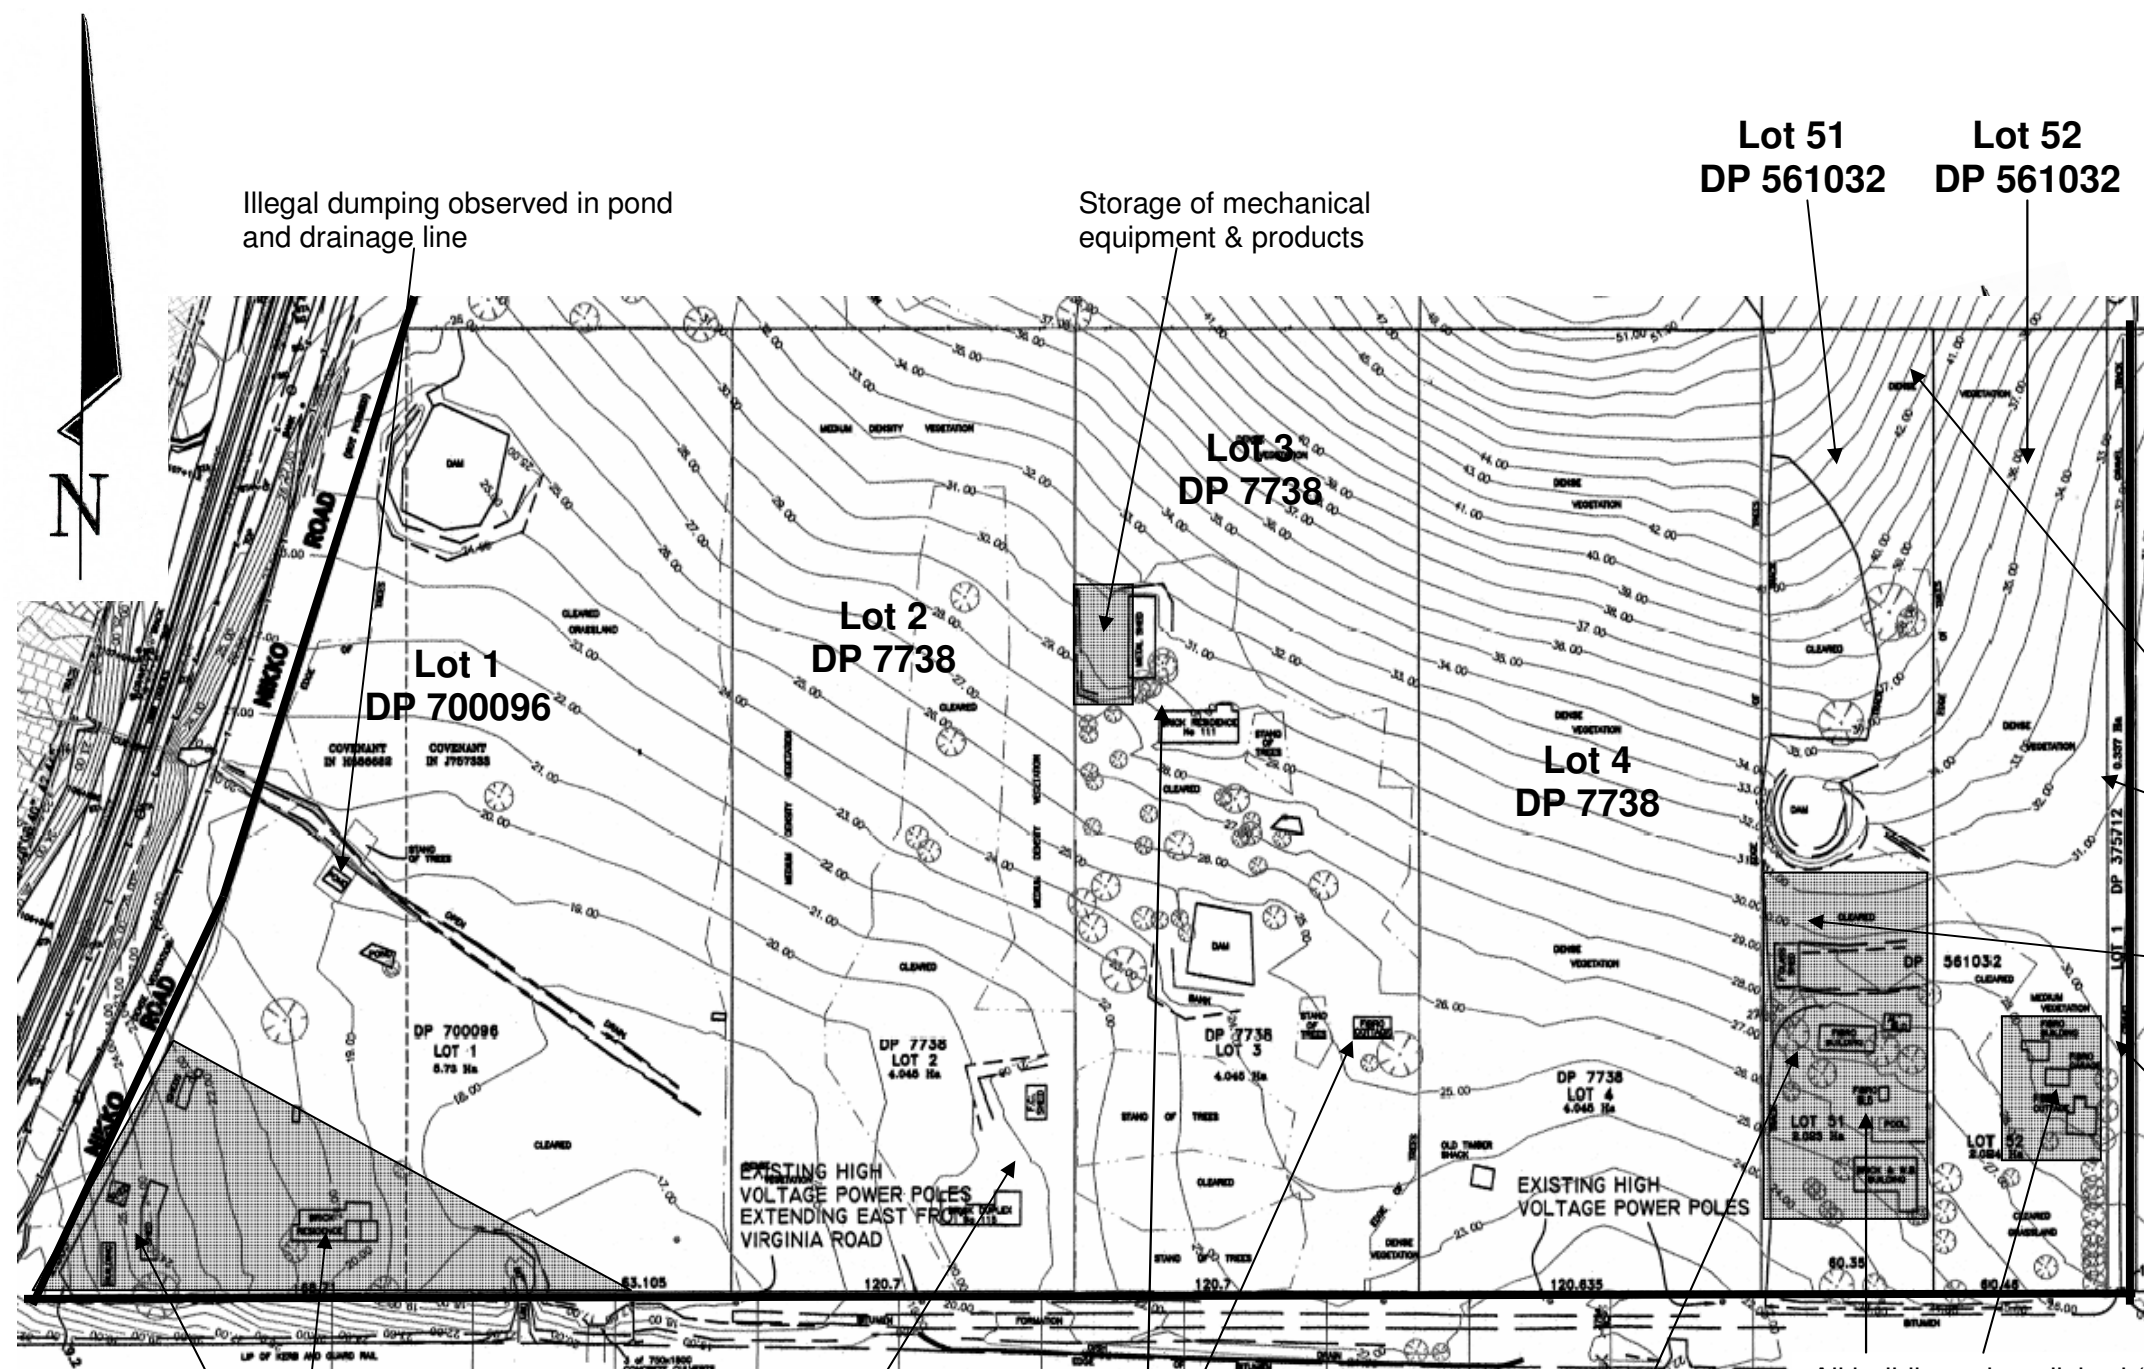
Illegal dumping along council access road & towards northern boundary of Lots 51 & 52

Possible small greenhouses identified in 2001 aerial photograph

All buildings demolished (surface filling and/or inclusions in the surface soil in vicinity of former buildings)

Filling beneath building platforms (possible cut/fill)

Filling beneath building platforms & access roads

Approximate location of dam observed in 1954 aerial photograph

All buildings demolished (surface filling and/or inclusions in the surface soil in the vicinity of former buildings)

- Drawing adapted from site layout plan provided by client
- Site Boundary
  - Shaded areas indicate potentially contaminated areas, recommended for assessment using a Systematic and Judgmental Sampling Strategy
  - Other potentially contaminated areas identified, recommended to be assessed through a Judgmental Sampling Strategy
