# Wollongong Hospital

## Stage 1 Aboriginal Archaeological Assessment

### Final Report

Report prepared for Johnstaff Projects  
September 2011

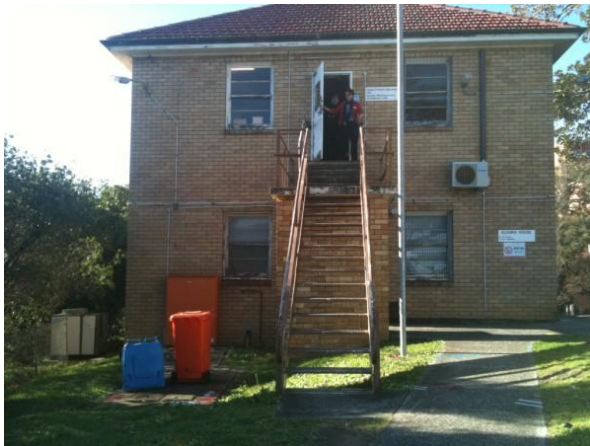
The study area has been heavily developed across the entire site, with extensive cutting and filling present to create level building pads (Figure 5.1). The study area had very low archaeological visibility due to the extent of development across the site. The majority of open areas were either grassed, concreted paths or internal access roads. Exposures of the soil where Aboriginal objects may have been identified were limited to tracks and occasional patches within vegetated areas (Figure 5.2). All exposures exhibited high levels of disturbance, with introduced inclusions noted throughout (including road base, demolition rubble, etc).

The area around Elouera House slopes to the north, with the southern side higher than the northern side (Figure 5.1). Extensive excavation is present in this area, as demonstrated by the high retaining walls present (Figures 5.3 and 5.4). Services have been installed throughout this area, as indicated by the presence of inspection pits and surveyors marks which have been recently placed around the site (Figure 5.5).

**Figure 5.1** Elouera House, view east, showing differences in ground levels. (Source: GML 2011)

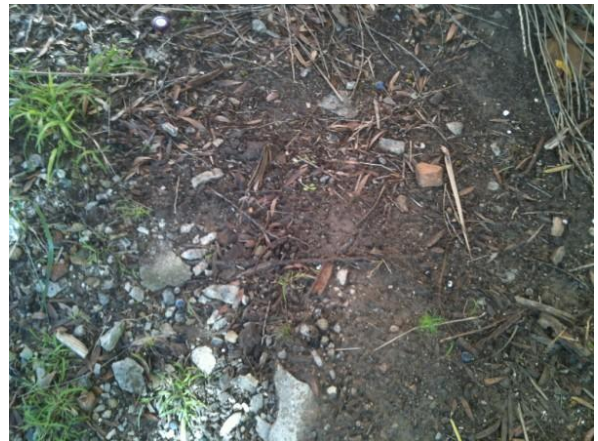
**Figure 5.2** General exposure within study area, showing inclusions. (Source: GML 2011)

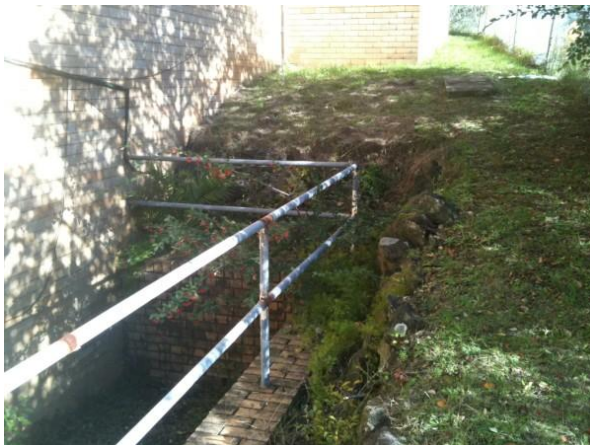
**Figure 5.3** Retaining wall adjacent to Elouera House. Note extent of excavation present. (Source: GML 2011)

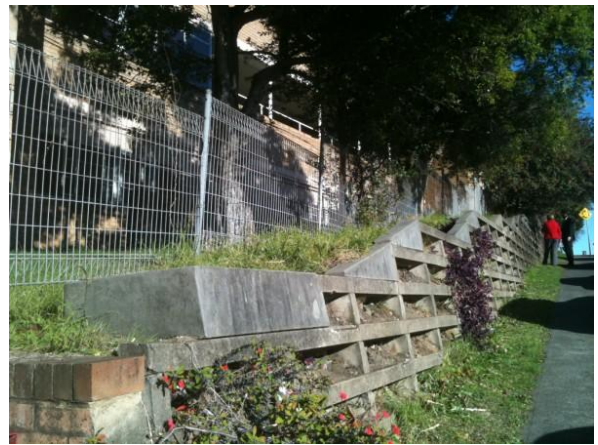
**Figure 5.4** Retaining wall along Loftus Street adjacent to Elouera House showing extent of excavation. (Source: GML 2011)

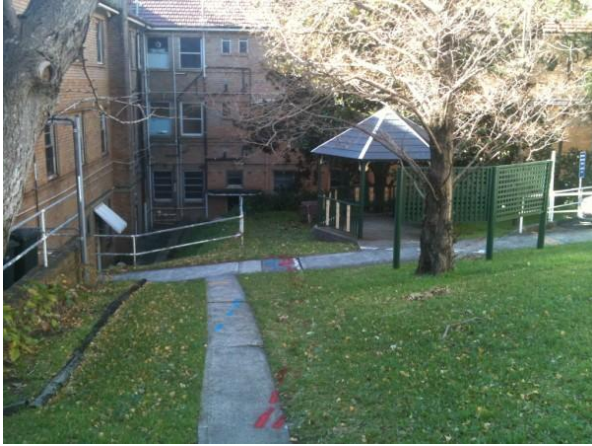
**Figure 5.5** Elouera House courtyard. Note presence of surveyors marks denoting subsurface services. (Source: GML 2011)

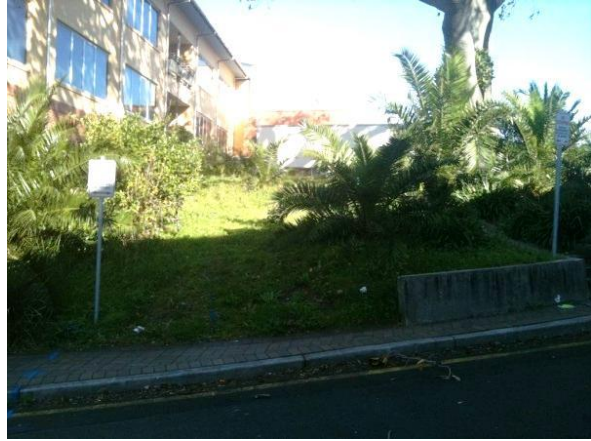
Directly across Hospital Road from Elouera House is a small landscaped area featuring two mature fig trees (Figures 5.6 and 5.15). This area appears to have had excavation occur around its boundaries, leaving a pedestal of unexcavated earth behind (Figure 5.7). However, examination of the ground surface exposures within this area confirms the introduction of fill. It is likely that excavation works around this pedestal area would have disturbed surface soils.

**Figure 5.6** Landscaped area opposite Elouera House. (Source: GML 2011)

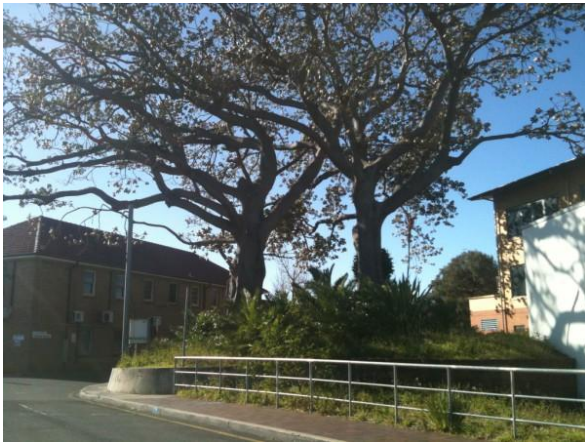
**Figure 5.7** Fig trees within landscaped area opposite Elouera House. (Source: GML 2011)

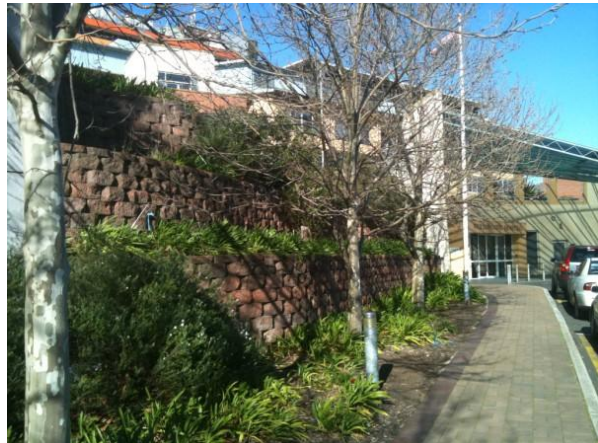
**Figure 5.8** Retaining wall at Loftus Street entrance showing extent of excavation and filling. (Source: GML 2011)

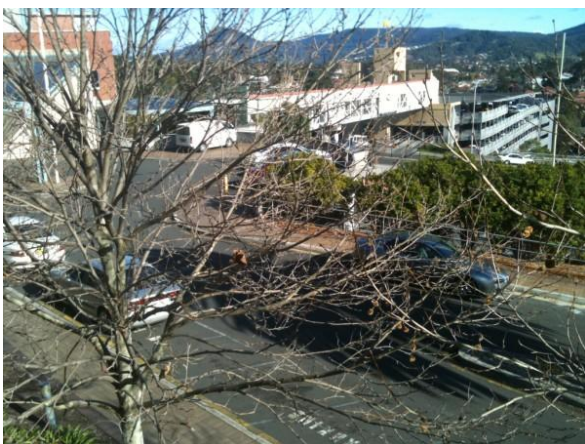
At the Loftus Street entrance, high terraced retaining walls are present (Figures 5.8 and 5.9). This demonstrates the extent of excavation and filling which has occurred in this area.

**Figure 5.9** From top of retaining wall at Loftus Street entrance overlooking development area. (Source: GML 2011)

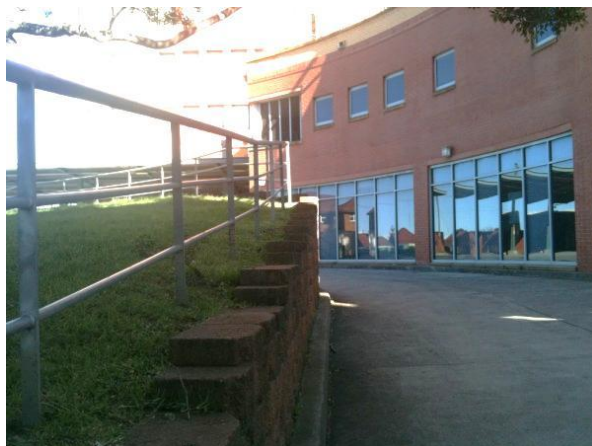
**Figure 5.11** Retaining wall adjacent to Hospital Road, showing extent of excavation here. (Source: GML 2011)

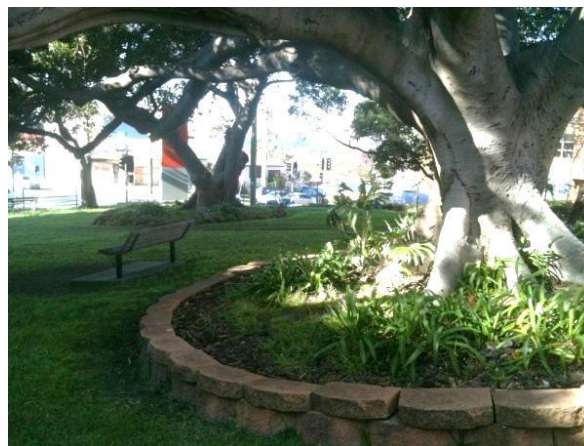
**Figure 5.12** Mature fig trees and landscaping within the pedestal area in southeastern corner of site. (Source: GML 2011)

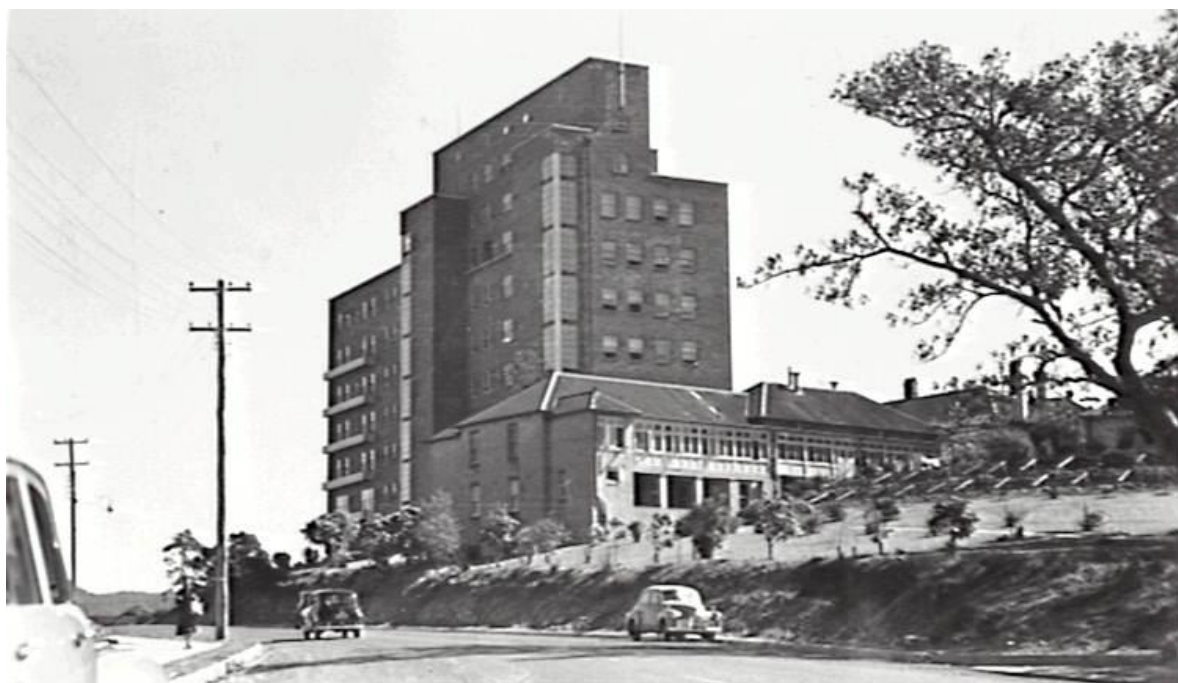
**Figure 5.13** A 1953 photograph of the hospital site from Princes Highway/Crown Street. Fig tree shown at right is within unexcavated pedestal area. Note landscaping around tree. (Source: Wollongong Library)

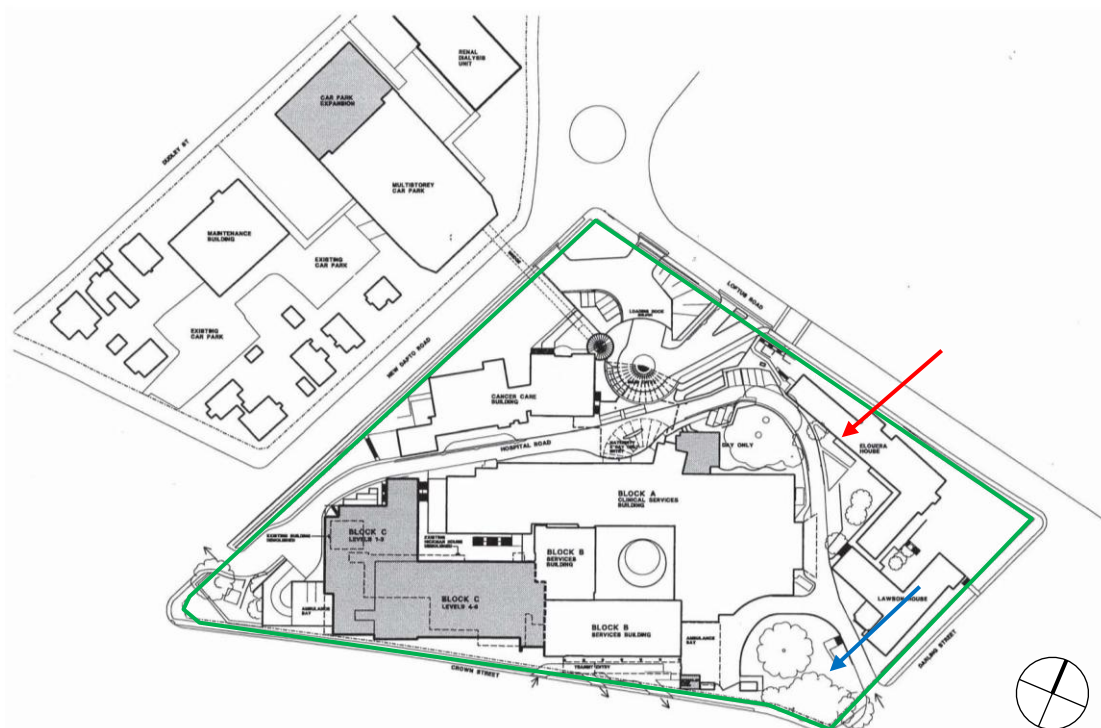
One grassed area in the southeast corner of the site (corner of Princes Highway/Crown Street and Darling Street) was noted to have potential for natural ground surfaces. Construction of the Princes Highway to the south has resulted in excavation to level the road (Figure 5.10), while construction of Hospital Road also required excavation (Figure 5.11), resulting in a pedestal of earth in the centre which has been landscaped (Figure 5.12). However, this area has been modified by levelling and landscaping around the two large fig trees in the centre (Figure 5.15).

**Figure 5.15** Site plan of Wollongong Hospital. External, outdoor areas within the boundary of the site (outlined in green) were inspected. Mature fig trees (red arrow) and pedestal area with fig trees (blue arrow) are indicated (Source: South Eastern Sydney & Illawarra Area Health Service)
