Statement of Environmental Effects,  
Proposed Wollongong Hospital  
Carpark

ARBORIST REPORT (MOORE TREES)

# Arboricultural Development Assessment Report

3-11 Dudley Street  
Wollongong NSW 2515  
Lot 3-11 DP 1043216

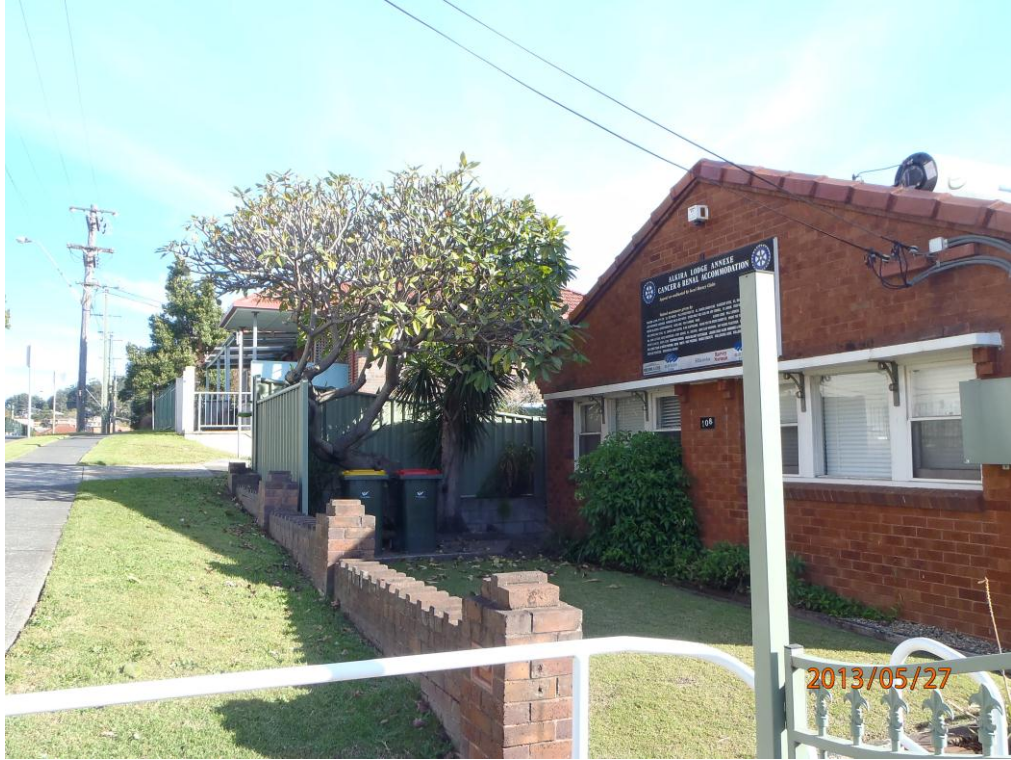
- 3.5 Tree 1** is a mature exotic Frangipani (*Plumaria acutifolia*) located on the New Dapto Street frontage (Plate 1). The tree has a decurrent asymmetrical canopy that is in good health and appears structurally sound.

**Plate 1: Tree 1. P. Vezgoff.**

4.1 Trees 1- 6 are not significant trees to the site and are proposed to be removed for the purpose of the development.

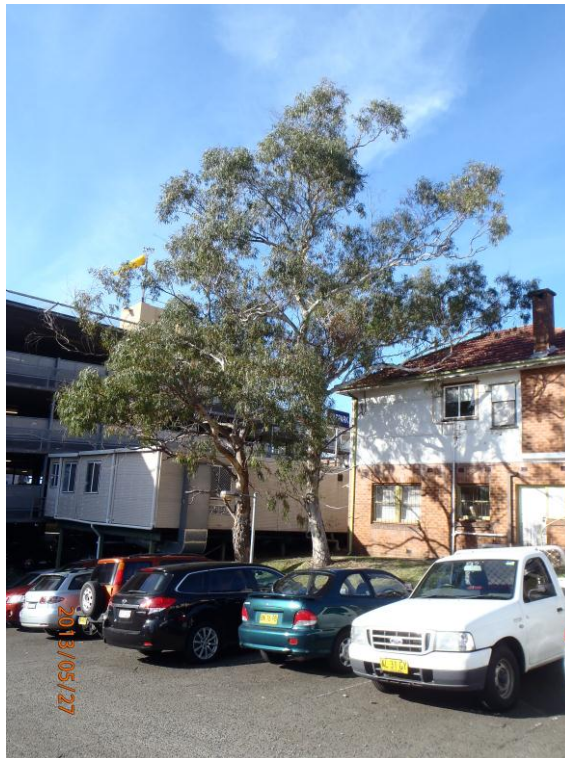
- 3.6 Trees 2 and 3** are both mature native Willow gum (*Eucalyptus scoparia*) located within the existing car park area (Plate 2). Both trees have decurrent symmetrical canopies that are dominant in the surrounding area. Both canopies have storm damage likely due to wind tunnelling that occurs around the existing car park complex. Dead wood is also present throughout the canopy.

**Plate 2: Trees 2 and 3. P. Vezgoff.**

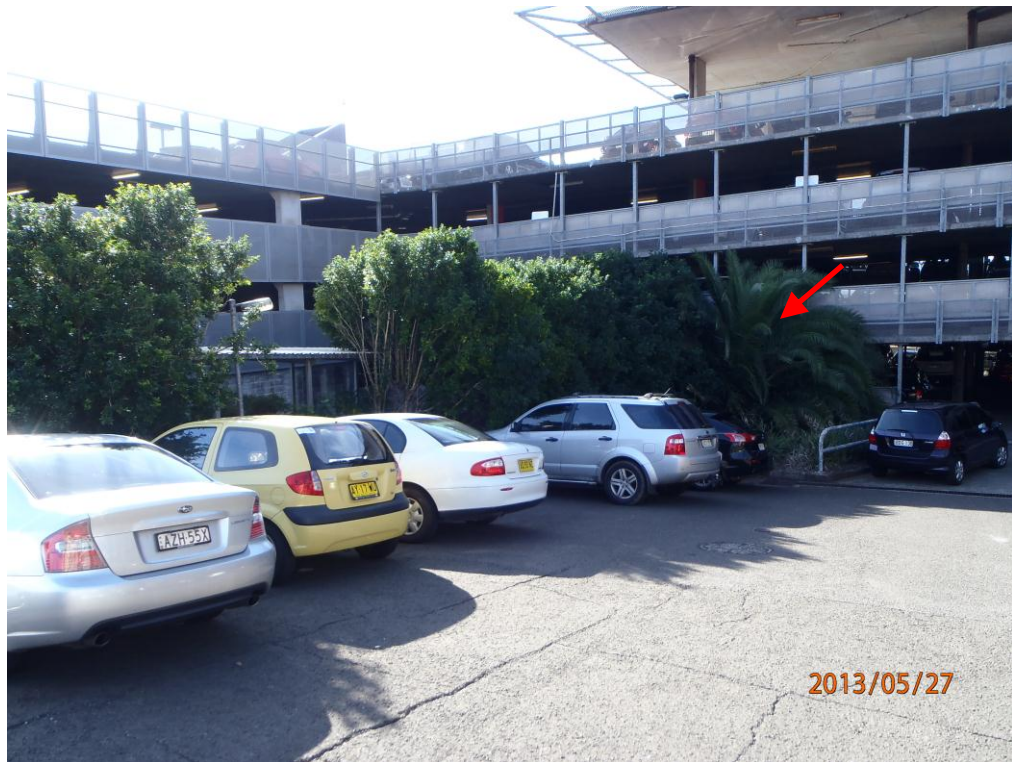
- 3.7 Tree 4** is a young exotic Date palm (*Phoenix canariensis*) growing against the existing car park building (Plate 3). The tree has an excurrent symmetrical canopy in excellent health and condition. Many Local Government Areas (LGA) consider this species a weed species.

- 3.8 Tree 5** is a hedge planting of Mock Orange (*Murraya paniculata*) that forms a partial, if not, token screen (Plate 3). The trees are in good health and appear structurally sound.

**Plate 3:** Trees 4 (Red arrow) and the hedge. P. Vezgoff.

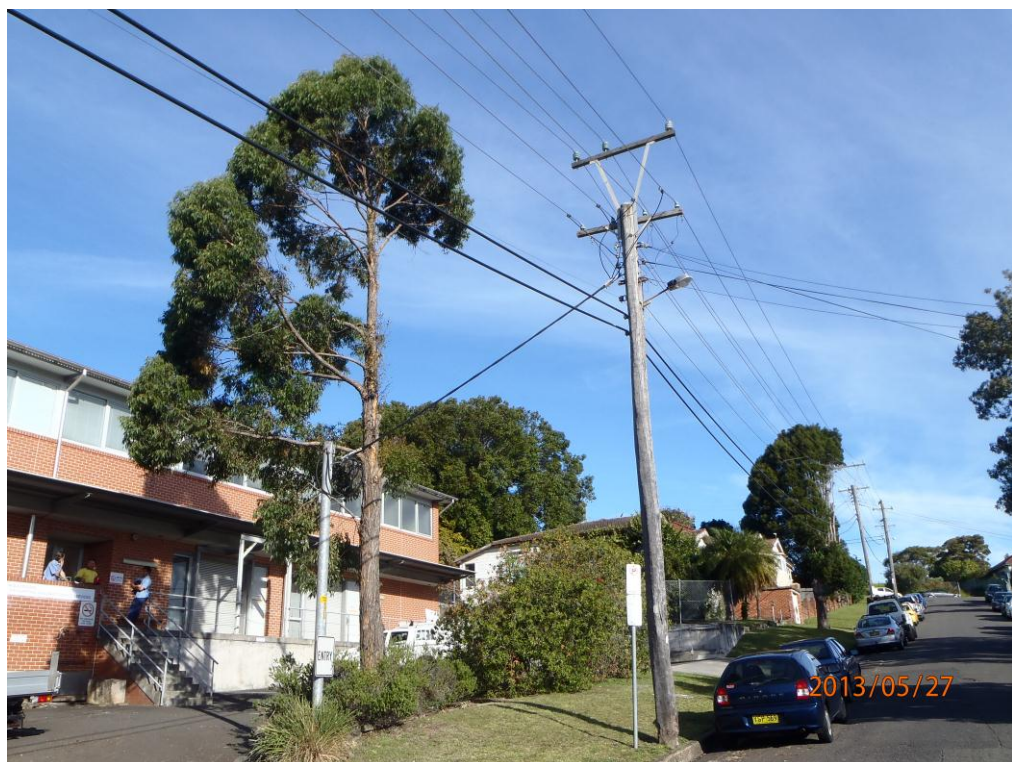
- 3.9 Tree 6** is a mature native Tallowwood (*Eucalyptus microcorys*) located on the Dudley Street frontage. The tree has a decurrent symmetrical canopy however it has undergone extensive pruning on the western side to allow for power line clearance (Plate 4). It was also noted, several metres away, a large mature Brushbox that has been lopped at 2.5 metres for wire clearance. Tree 6 is in good health and appears structurally sound. However the continued line clearance will certainly be an ongoing issue.

**Plate 4:** Image showing Tree 6 and the extensive pruning for wire clearance. P. Vezgoff.

4.2 It would appear the only area available for compensatory planting are the road verges which are ultimately Council property. The Dudley Street frontage has existing power lines and as such a small shrub species rather than a tree species is recommended.

4.3 Some suggested species that grow well under power lines and require minimal ongoing pruning are as follows:

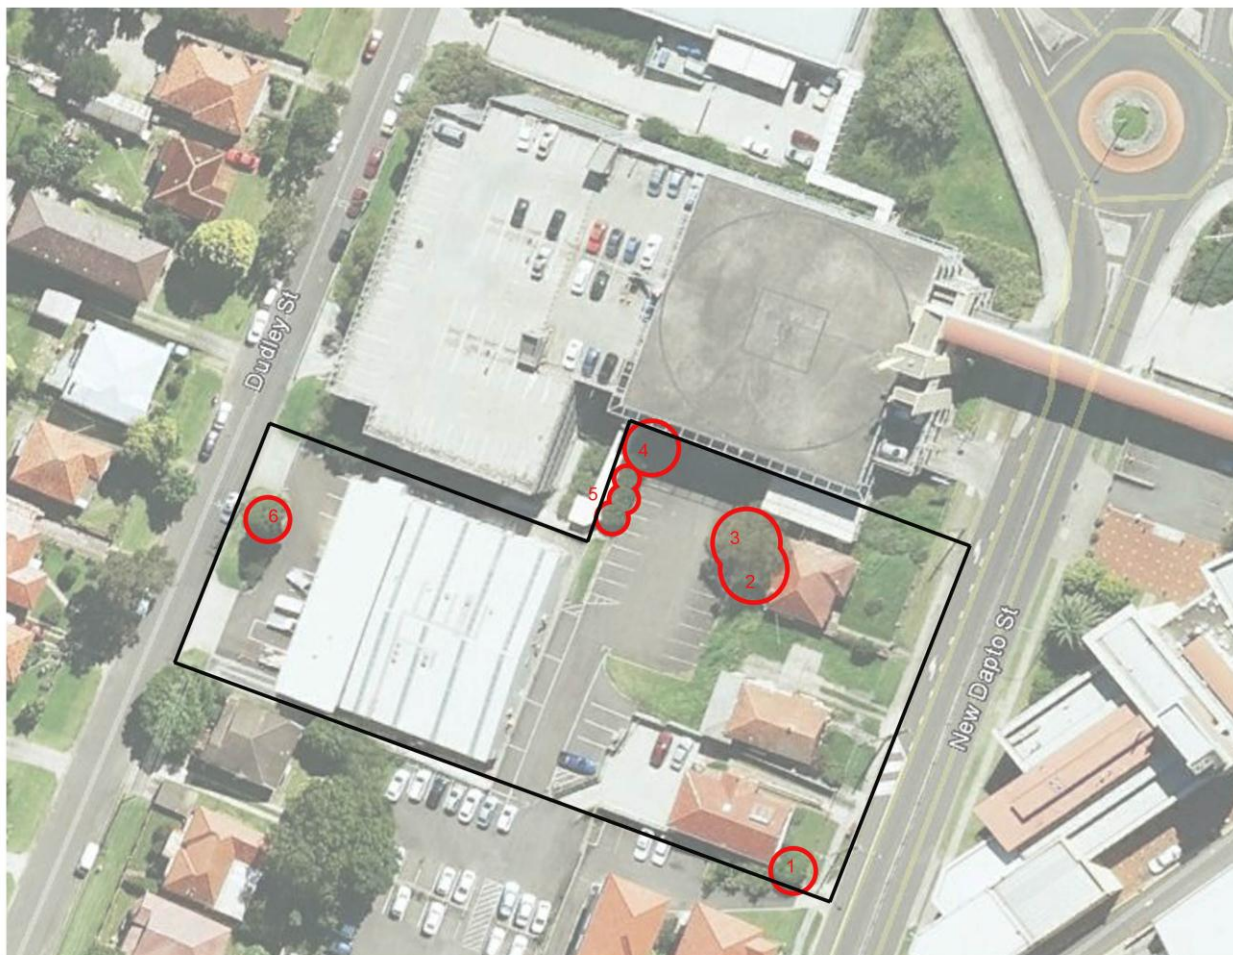
## Tree Location Plan

Tree to be removed
