Report on  
Geotechnical Investigation

Proposed Commercial Development  
Site 8B, Sydney Olympic Park

Prepared for  
Fitzpatrick Investments Pty Ltd

Project 72233  
February 2011

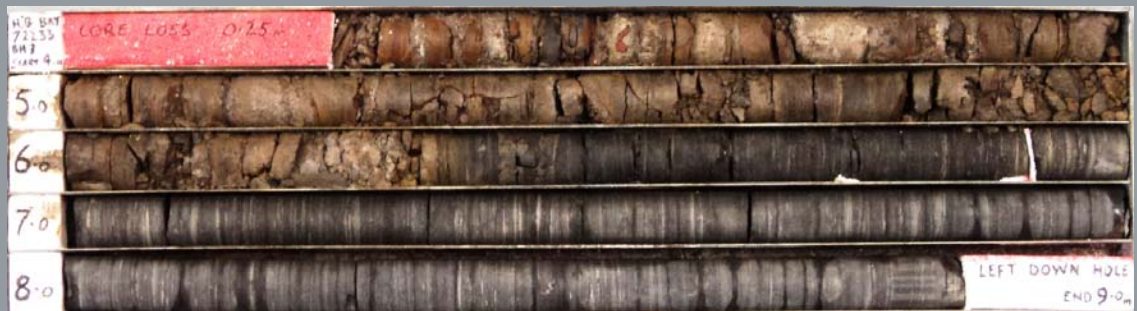
4.0 - 9.0m

DOUGLAS PARTNERS PTY  
SITE 8B, SYDNEY OLYMPIC PARK - HOMEBUSH  
BORE 101 PROJECT 72233 JAN 2011

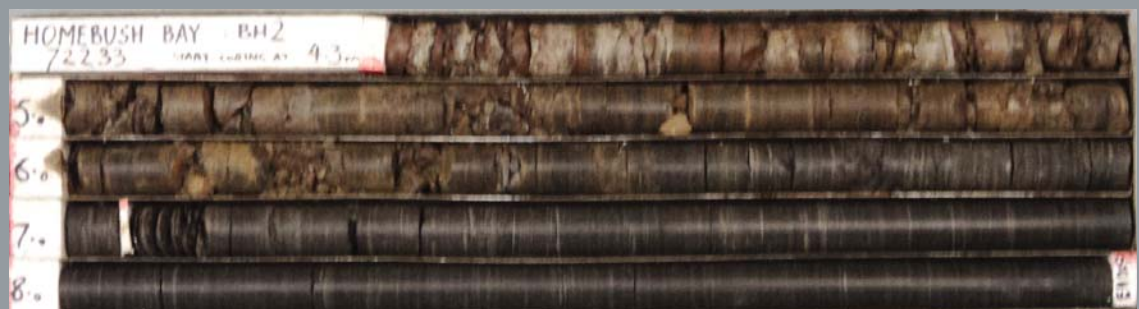
4.3 – 9.0m

DOUGLAS PARTNERS PTY  
SITE 8B, SYDNEY OLYMPIC PARK - HOMEBUSH  
BORE 102 PROJECT 72233 JAN 2011

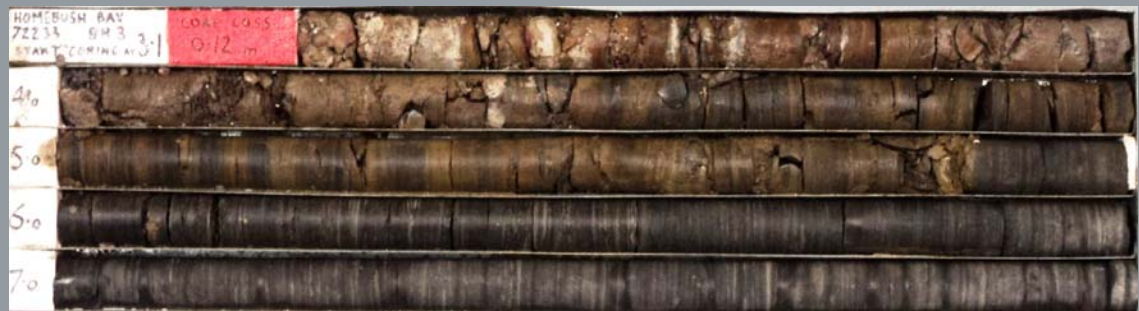
3.1 – 8.0m

DOUGLAS PARTNERS PTY  
SITE 8B, SYDNEY OLYMPIC PARK - HOMEBUSH  
BORE 103 PROJECT 72233 JAN 2011

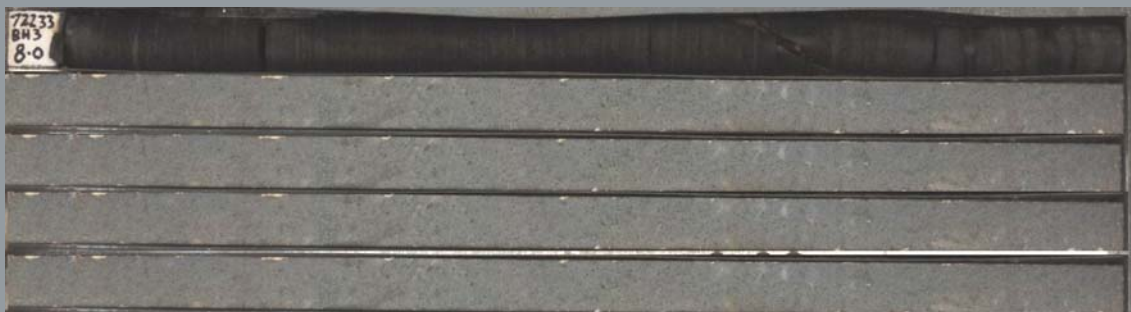
8.0 – 9.0m

DOUGLAS PARTNERS PTY LTD  
SITE 8B, SYDNEY OLYMPIC PARK - HOMEBUSH  
BORE 103 PROJECT 72233 JAN 2011

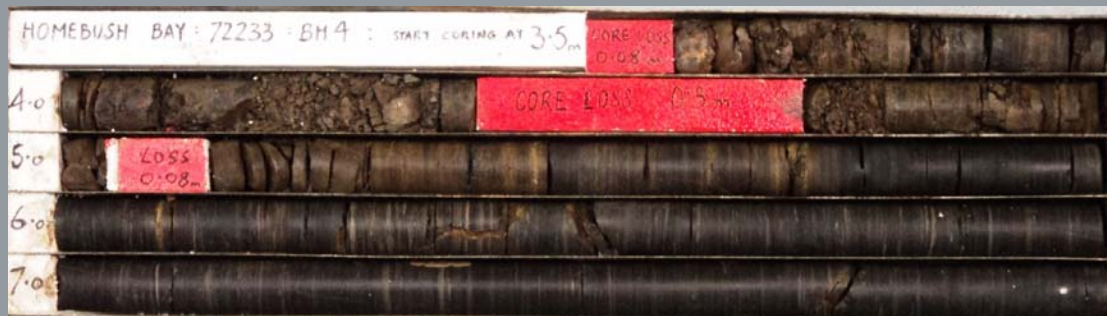
3.5 – 8.0m

DOUGLAS PARTNERS PTY  
SITE 8B, SYDNEY OLYMPIC PARK - HOMEBUSH  
BORE 104 PROJECT 72233 JAN 2011

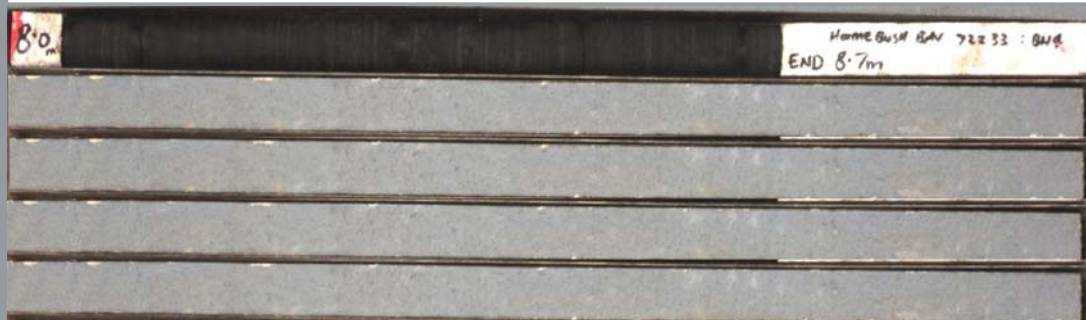
8.0 – 8.7m

DOUGLAS PARTNERS PTY LTD  
SITE 8B, SYDNEY OLYMPIC PARK - HOMEBUSH  
BORE 104 PROJECT 72233 JAN 2011

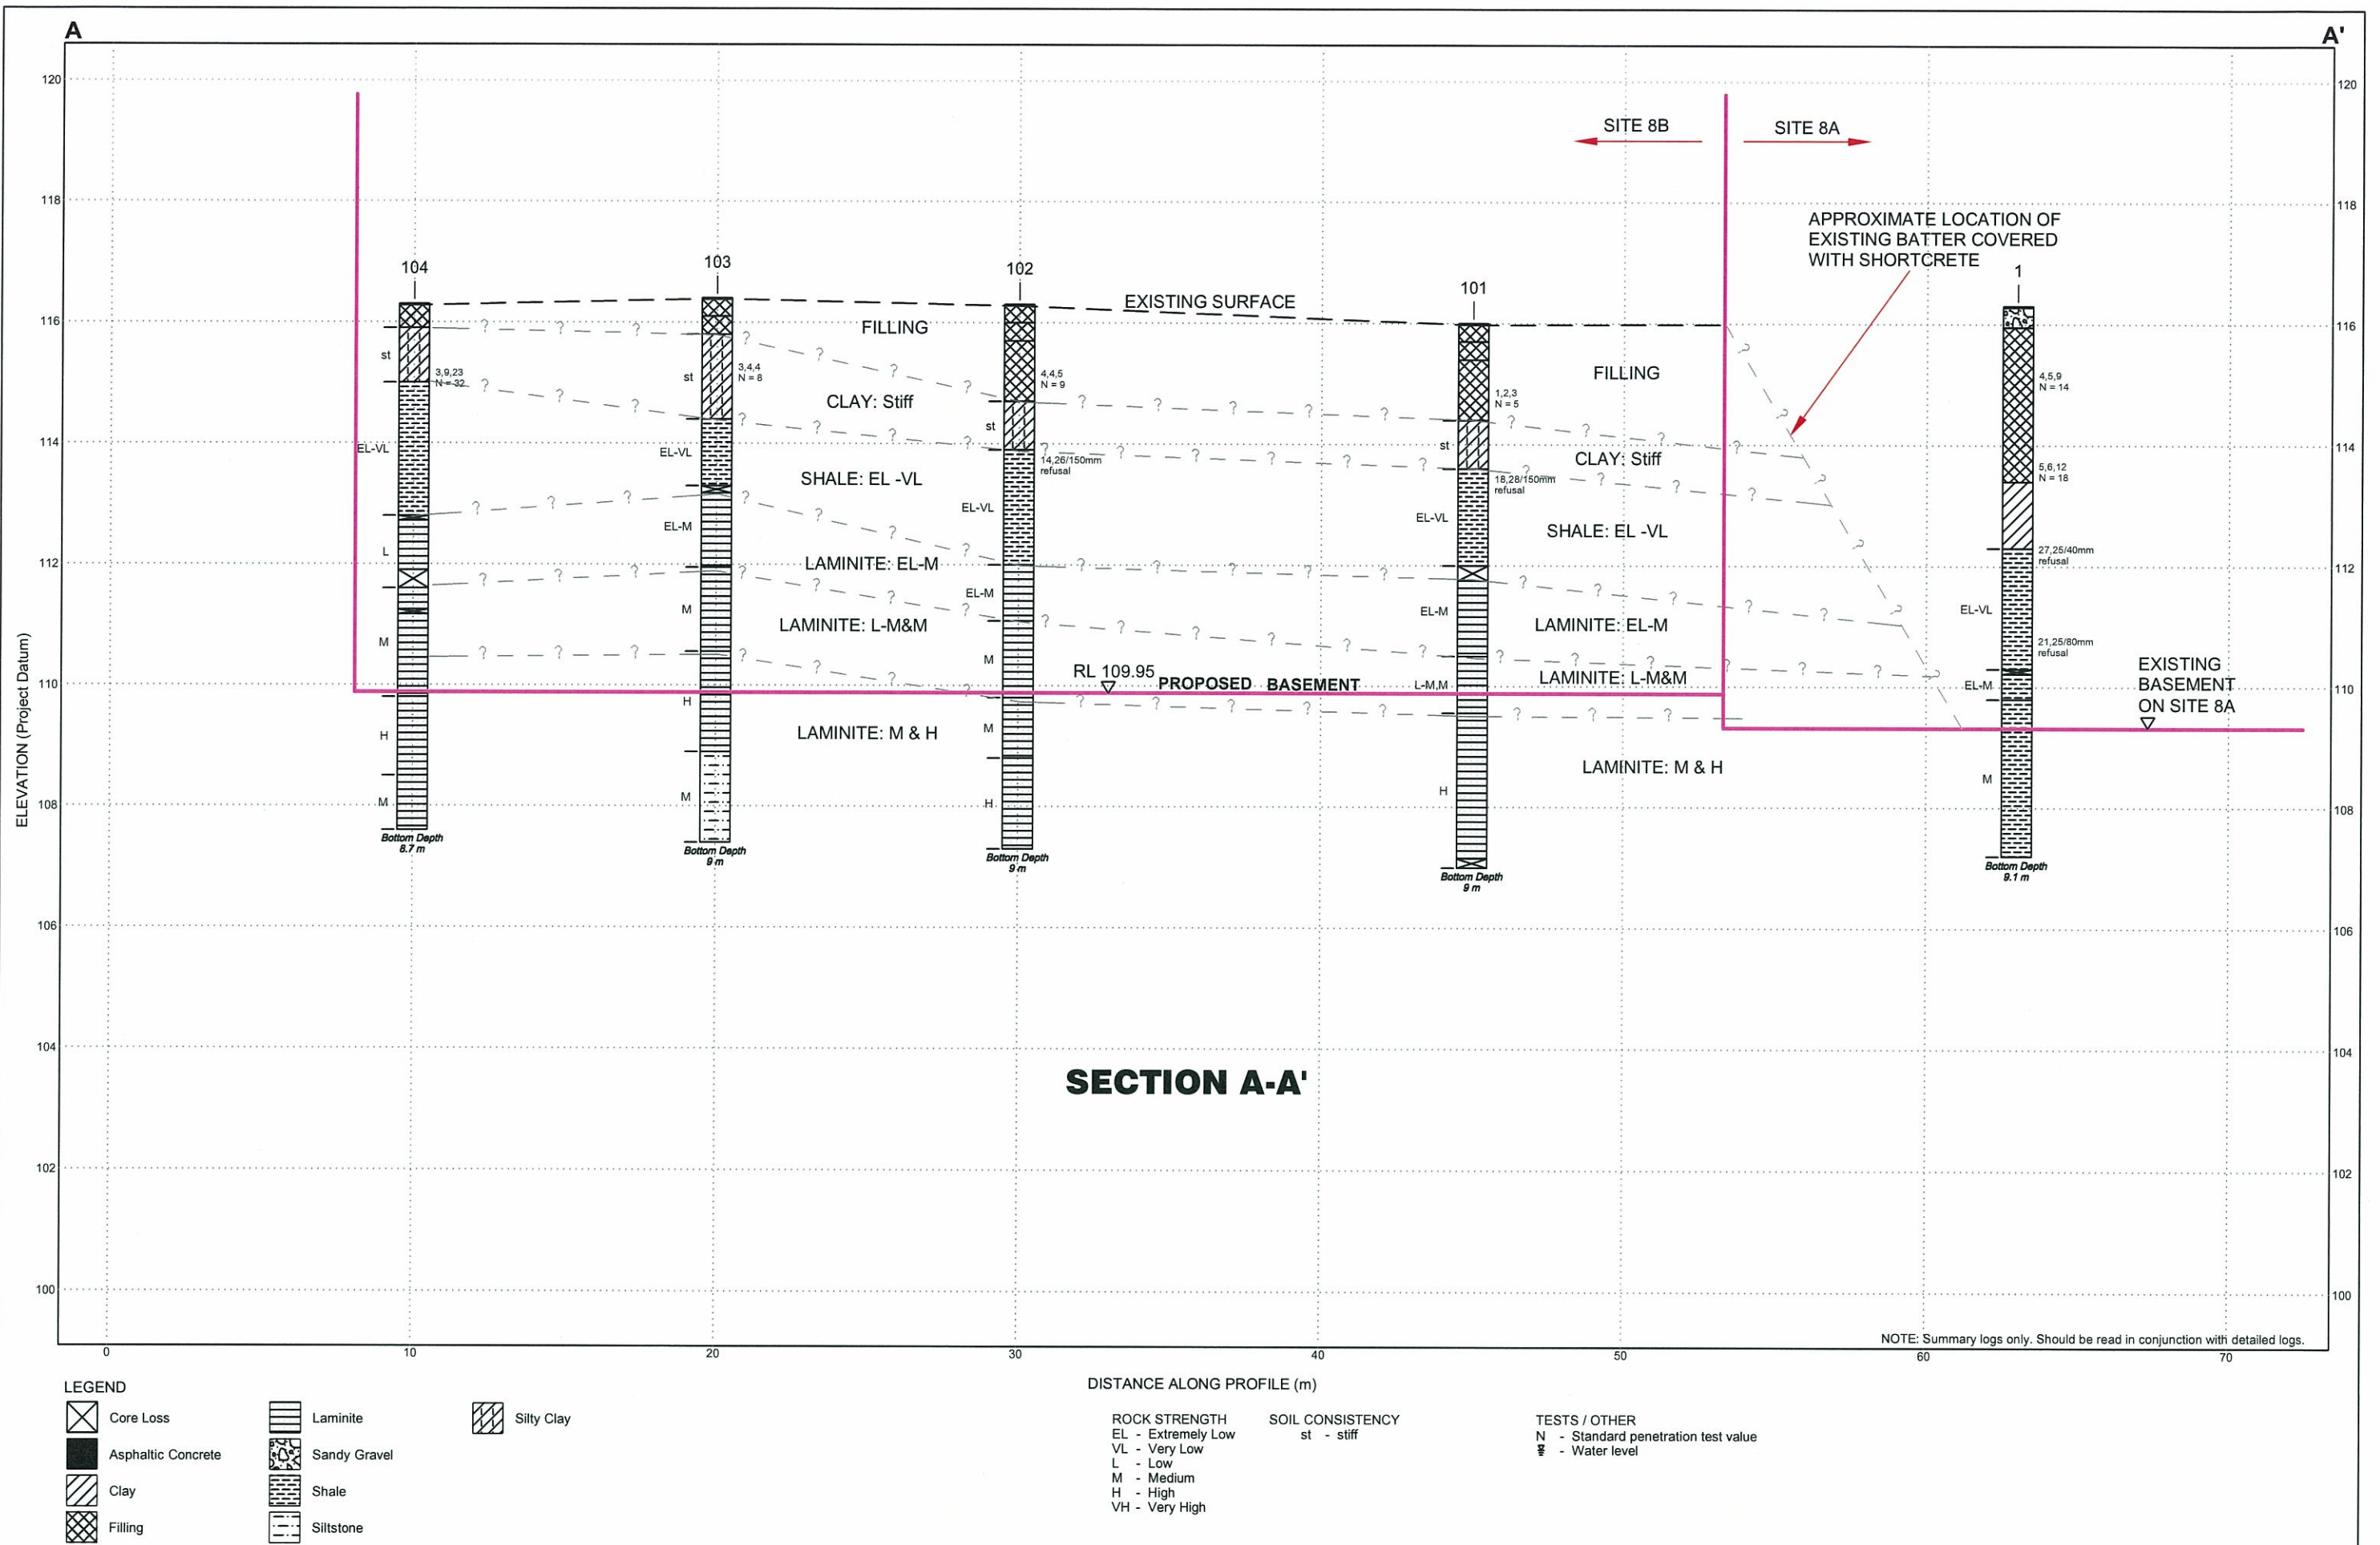
Drawing 1 – Location of Boreholes  
Drawing 2 –Geotechnical Cross-Section A-A'
