HERITAGE IMPACT STATEMENT & ARCHAEOLOGICAL ASSESSMENT

**BANK STREET
COMMERCIAL WHARF**

**5-11 BANK STREET,
PYRMONT NSW.**

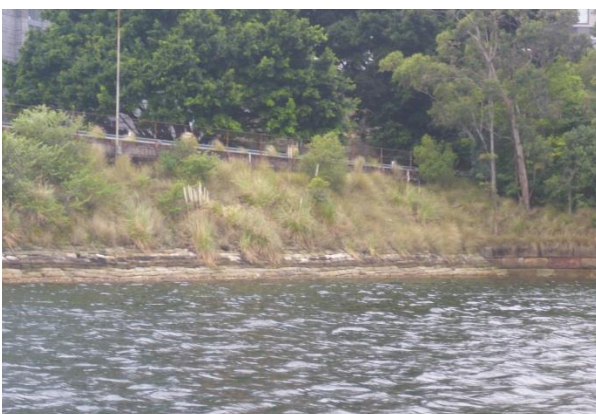
Picture 1 - Bridge embankment and stone sea wall (to the north of the subject site)

A low sea wall consisting of large sandstone blocks constructed as coursed ashlar, is present around the shore line in the study area from the southern embankment of the old Glebe Island Bridge to Poulos Brothers at 21-29 Bank Street. The wall stands two to three courses above high tide (approx. 1m) and has several courses below the low tide water level. It is interrupted by the southern pylon of the Anzac Bridge and the Dragon boat ramp as well as a number of drains. There are additional small remnants of this wall to the south of the study area adjacent to the Bidvest building and adjacent to the carpark of the fish markets.

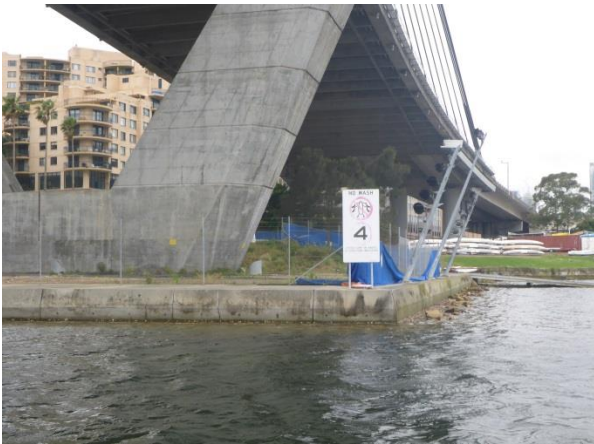
Picture 5 – Anzac Bridge and Dragon boat storage

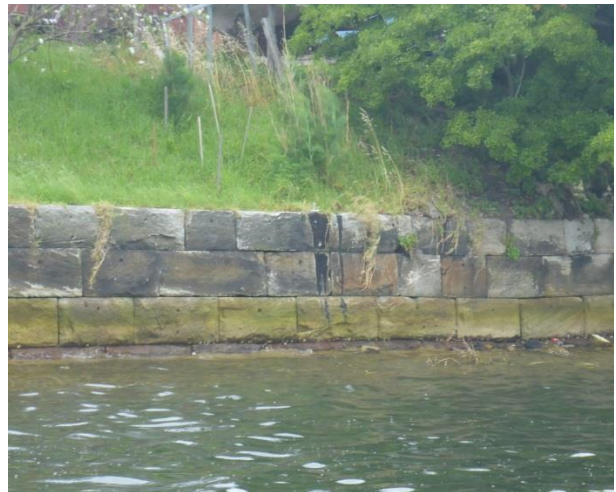
Picture 8 - Detail of the seawall

Presumably the sandstone sea wall in the study area originally lined the bay shore from south of the fish markets to the Glebe Island Bridge abutment, but has been removed or disturbed in sections due to development on the waterfront. The sea wall is likely to date to the early 1900s and it is also possible that it has been modified or rebuilt since the 1980s.²⁶ Sections of sea wall and remains of wharves can be found in many parts of Sydney Harbour.

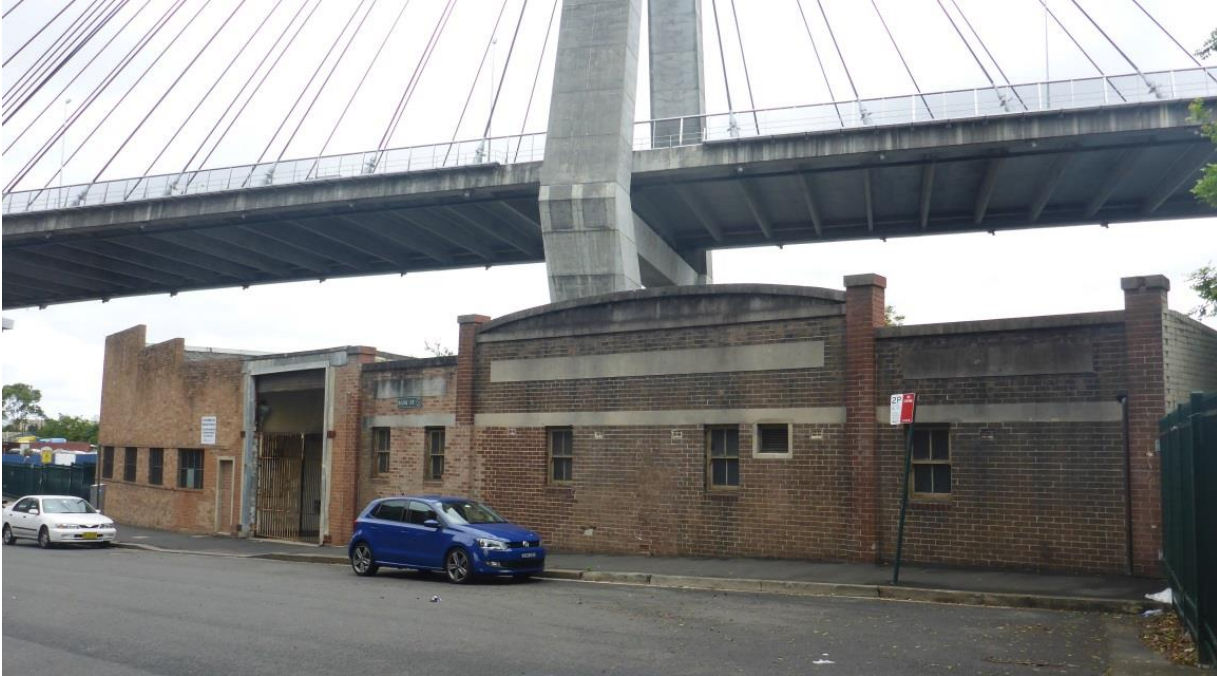
Picture 9 - The northern building is the earliest extant building on the site, with the fabric suggesting an early inter-war construction

No.1 Bank Street adjoins the site to the north and comprises a complex of three 1-2 storey industrial buildings incorporating a single storey inter-war brick building fronting Bank Street, the southern adjoining extension, constructed in the 1940s and the later 20th century 2 storey building on the waterfront.

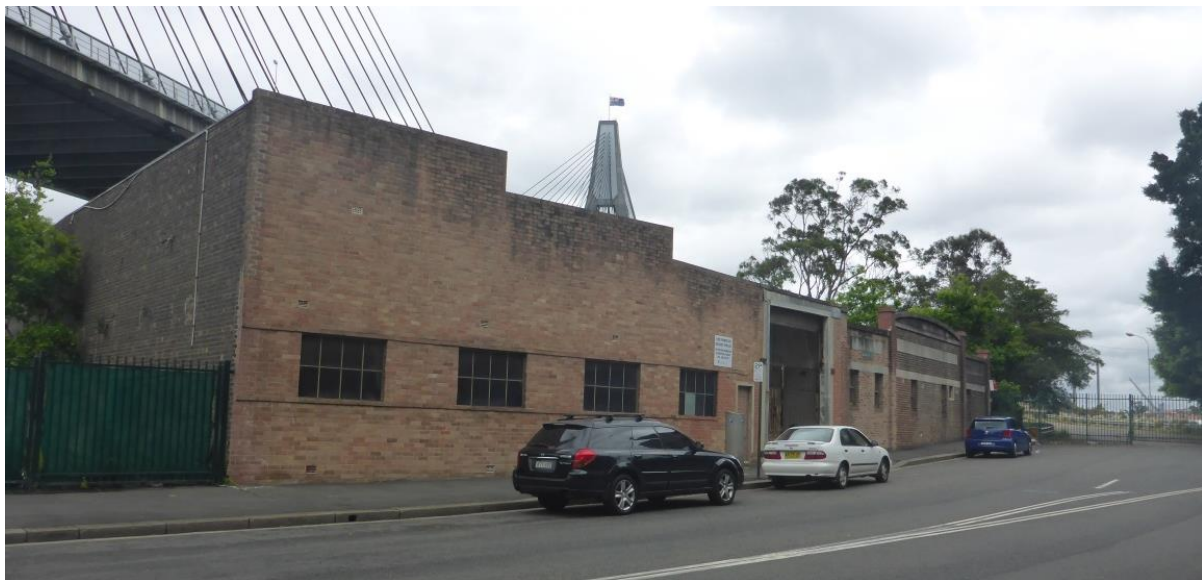
Picture 10 - The southern extension of 1 Bank Street was constructed in the mid-1940s however has been variously altered since, including works to the roof form

By 1949 the southernmost building at 1 Banks Street had been constructed and replaced an earlier building on the site (the present street façade likely dates to this period however the building has been variously altered since with numerous applications for alterations in the 1950s, 1960s and 1970s). Another building was constructed on the western edge of the allotment, however much of the land in the study area to the south remained vacant and was used for storage. City of Sydney archives indicate that 1 Bank Street was being used for the storage and grading of potatoes in the mid-1950s. By the 1970s the large jetty had been demolished but the adjacent land held materials possibly associated with the lots to the north. Various uses are documented for the site in the 1980s including boat building and sail making, marine service and maintenance; studio uses are recorded in 1983 including a pottery workshop and glass painting studio. It later partly functioned as an upholstery shop (1986).

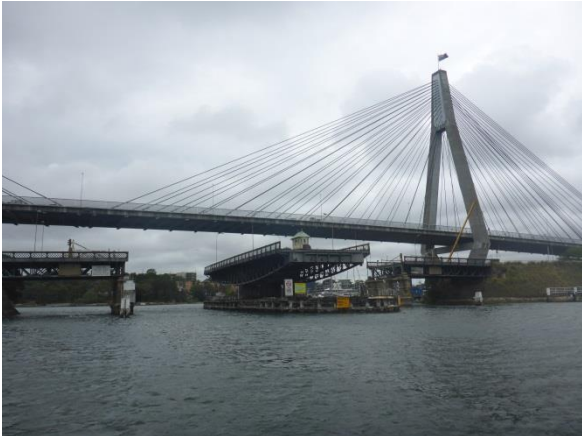
Picture 20 – The former Glebe Island Bridge, shown below the Anzac Bridge

The Bridge is an electrically-operated, low-level, steel central swing-span road bridge. The central swing-span is supported by a massive pivot pier, founded on a nest of timber piles capped by concrete, on which it can rotate through ninety degrees to allow passage of maritime traffic. The approach spans are two steel deck on stone-faced piers and stone-lined abutments. The bridge includes constructed embankments on both sides of its western approach².

The bridge has an approach span at each end of 24.7m, two main spans of 29.3m and an overall length of 108m. The roadway is 12.2m wide between kerbs and has a 1.5m wide footway on each side. The central pivot in the waterway is protected by an extensive ring of timber piles. The swing span is mounted on a steel roller track on the cylindrical stone masonry and concrete pivot pier (13.9m high and 12.9m wide) and is swung by means of a 600 volt motor. Traffic was controlled by lights and a pair of timber swing-gates on either end which were electronically interlocked to ensure that the bridge cannot open until the gates are closed. High quality Pymont yellow block sandstone is thought to have been used for dimension stone and Pymont coloured sandstone on the abutment facing and causeway fill.³

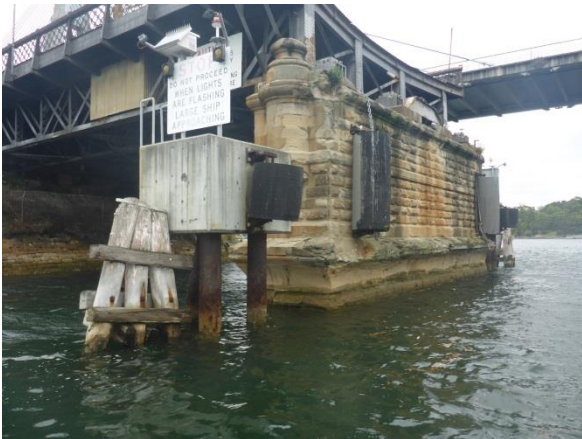
Picture 22 – Detail of the bridge pylon

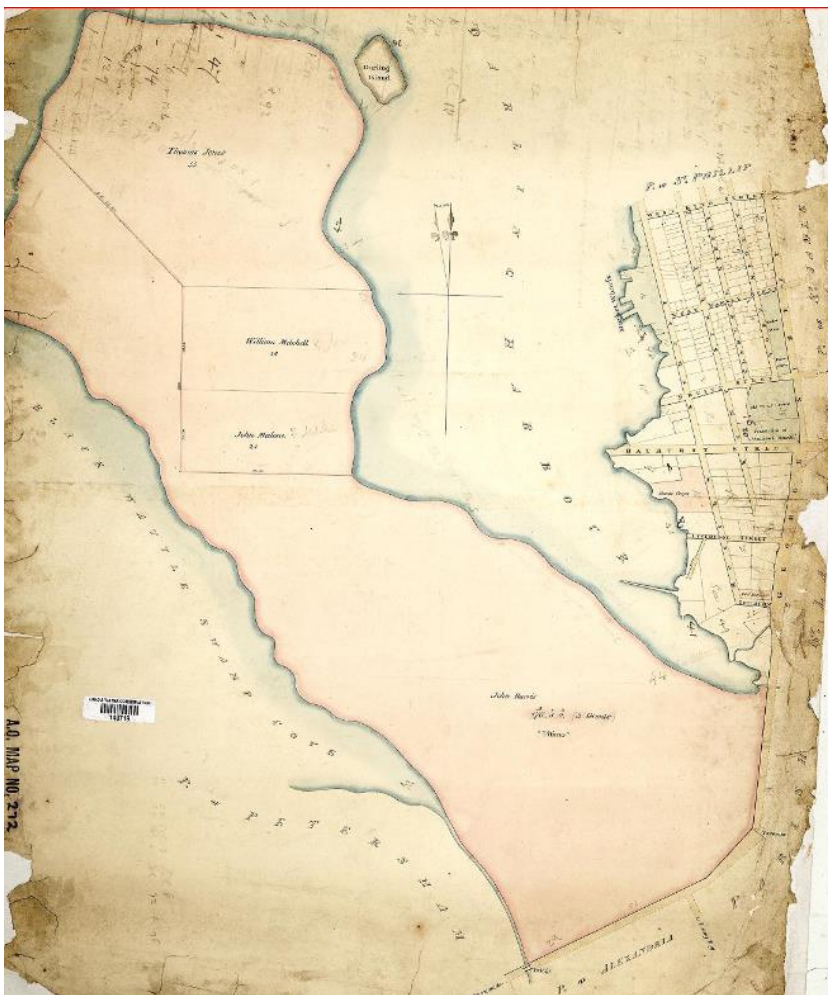
Figure 10 - Parish map showing Harris grant over much of the peninsula (undated)

Picture 26 - Plan of the peninsula showing Harris Ultimo land grant (including the eastern portion of Blackwattle Bay and the subject site). Harris's land comprised three grants, and totalled more than 176 acres. the tip of the peninsula was granted to Thomas Jones (55 Acres). to the south there are two smaller land grants to William Mitchell (18 acres) and John Malone (24 acres).

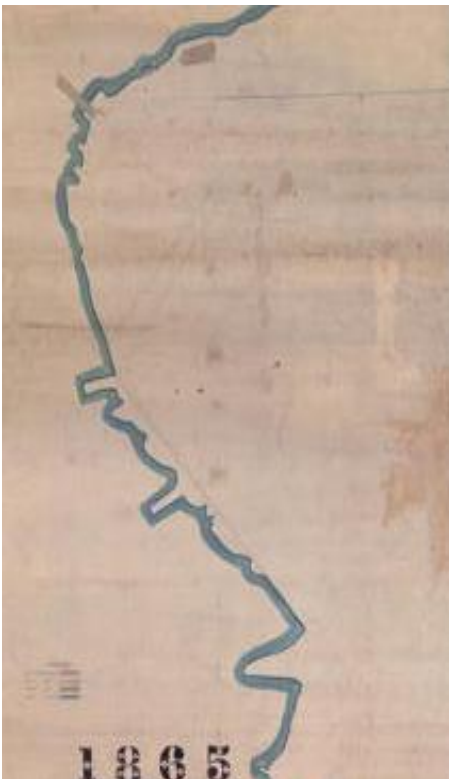
Figure 12 – Subject site

Picture 28 – Trigonometrical Survey 1865 Source: City of Sydney Archives

The earliest Glebe Island Bridge and potentially the road (Bank Street/ Then Abbatoir Road) dates from 1857 and was built to connect Glebe Island and the Abattoirs to Pymont. The connection to Victoria Road was only discussed later in the 1860's. The study area remained virtually unoccupied up until the 1880's, possibly due to the irregular shoreline and proximity to the quarries and abattoir. The 1865 plan shows the area undeveloped apart from indications of two small wharfs and the location of the bridge to Glebe Island. No buildings are indicated in the subject area (Figure 12).

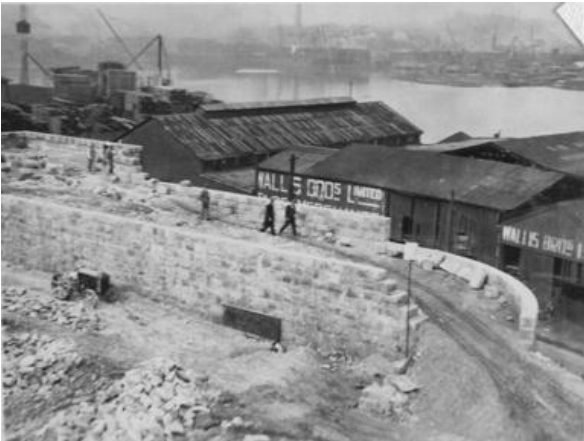
Figure 16 – Views of the site c.1930s

Picture 34 – View from Saunders street SW into Blackwattle Bay and showing Wallis timber yards (1934)

The 1928 land sale plan (Figure 14) and views of the site (Figure 16) indicates that much of the development associated with this early occupation were utilitarian shed buildings of timber and lightweight construction, with the exception of the northernmost brick building, which is the only surviving early 20th century building (north of the site at 1 Bank Street); the fabric of which suggests early inter-war construction c.1920. 1 Bank Street remained in the ownership of the Harris family until 1930 when lots 1 and 2 were purchased by Charles Caminiti of Sydney, Fish Merchant.

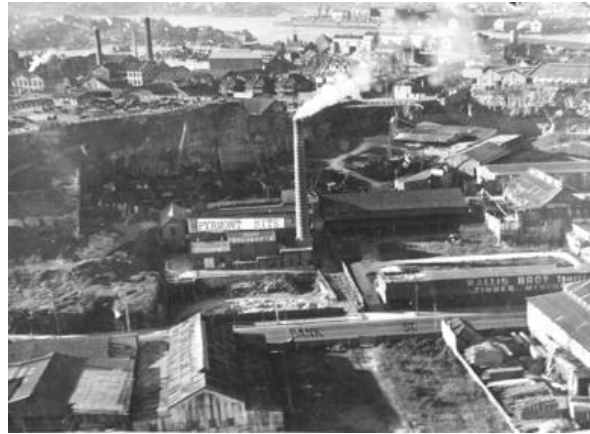
Picture 35 – View from Blackwattle Bay towards bank street with the subject site in the foreground, and Saunders Quarry and the incinerator behind (1933)

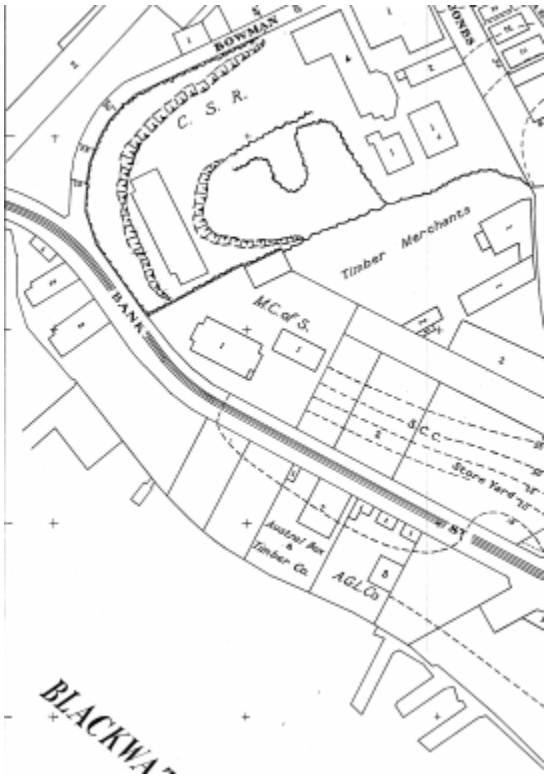
Picture 36 – Civic Survey 1938-50. This plan shows the location of buildings on the site and the wharfs.

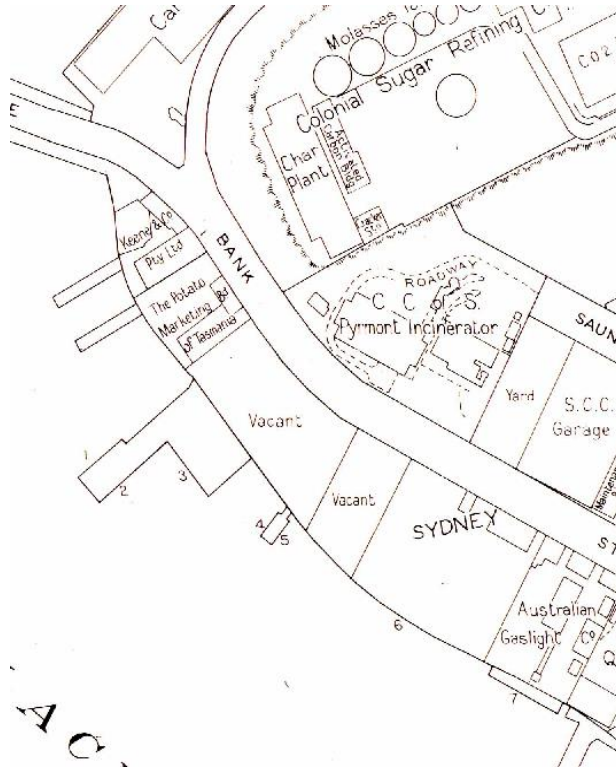
Picture 37 – City Building Survey 1956. This plan shows that additional wharfs have been constructed in the northern part of the site after 1950.

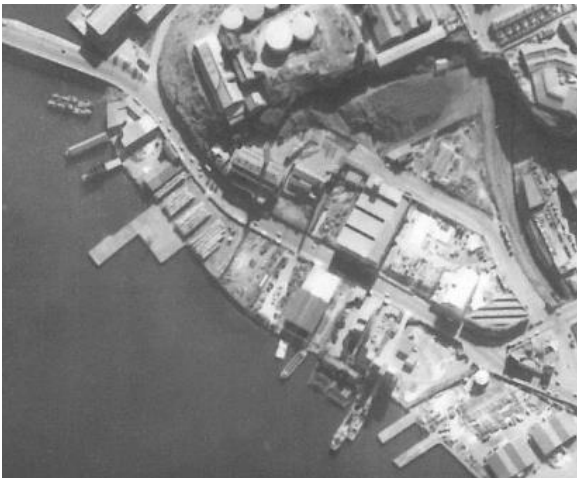
Figure 19 – The Changing foreshore- 1950s-1970s

Picture 38 – 1955 Aerial

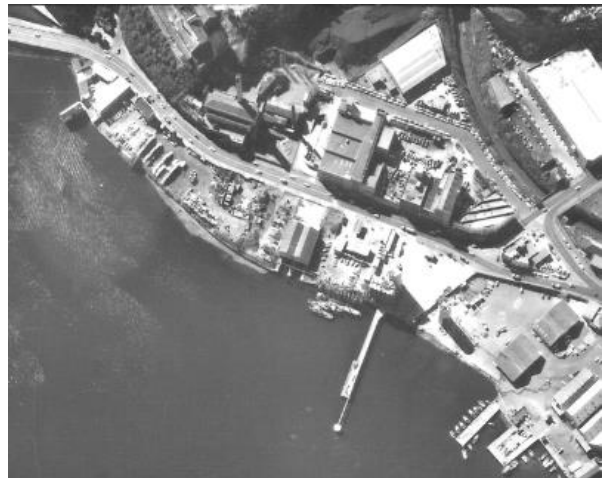
Picture 39 – 1972 Aerial
